# Continental Motors

## ENGINE EXAMINATION REPORT

| ENGINE MODEL | GTSIO-520-L |
| AIRCRAFT REGISTRATION | N421NS |

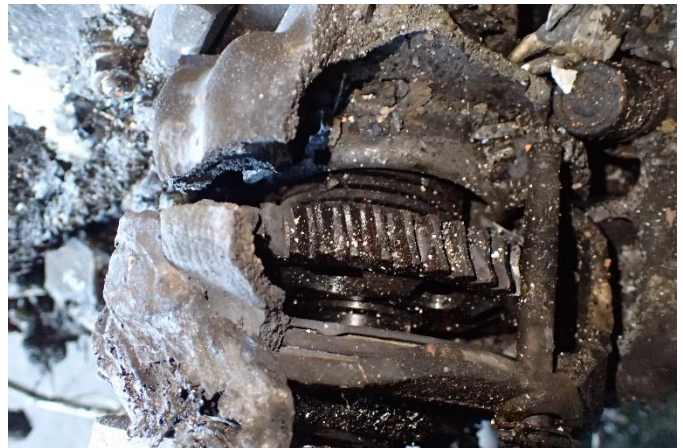
The starter adapter remained partially attached to its installation point and displayed a significant amount of impact damage and some thermal damage signatures. There were no anomalies noted.

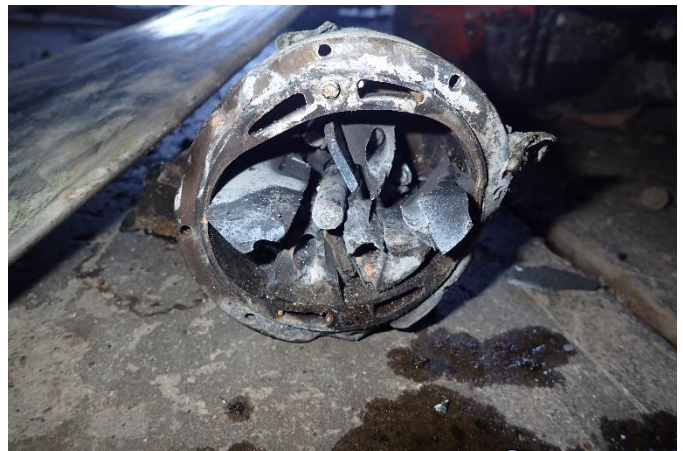
The vacuum pump had broken free from its installation point and displayed a significant amount of impact and thermal damage signatures. The drive coupling was not located at the time of the examination. The internal components were visible due to impact damage; the vanes and rotor displayed significant impact damage.

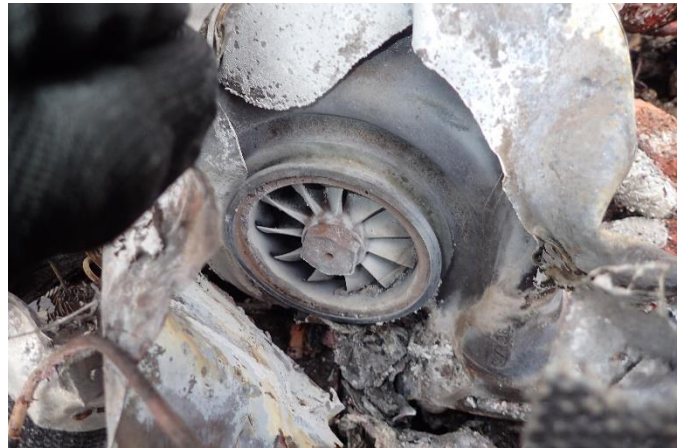
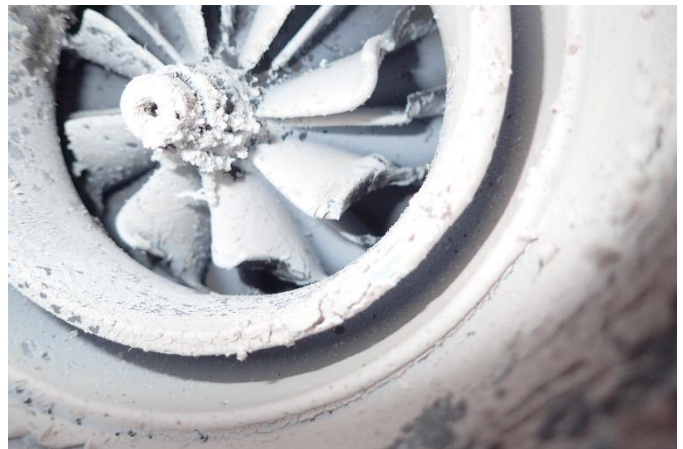
The turbocharger remained attached to its installation point and displayed impact and thermal damage signatures. It was noted that the V-band clamp remained attached to the tailpipe; however, it had disconnected from the turbocharger, the damage was consistent with impact damage. The turbine was visible and displayed normal operating signatures; it was noted that it was unable to be rotated which is consistent with the impact damage. The compressor was also visible and displayed impact and thermal damage signatures, the blades were bent and appeared to have partially melted.

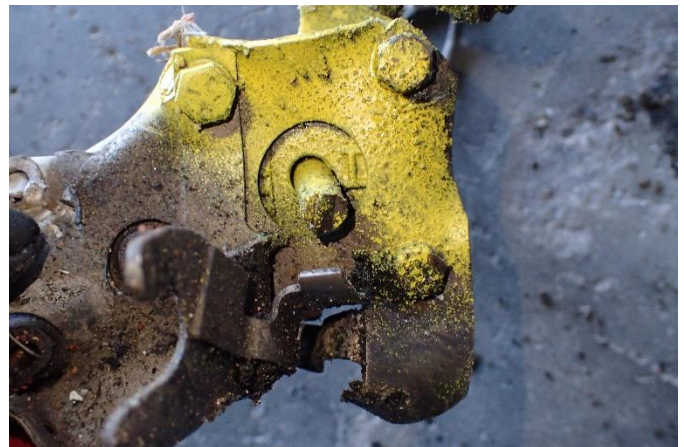
The wastegate had broken free from its installation point and displayed impact and thermal damage signatures. There were no anomalies noted.
