## Honeywell

Re: NTSB ID: CEN19FA088, N428CD, Piper PA-46-350P JetProp Conversion; Honeywell examination

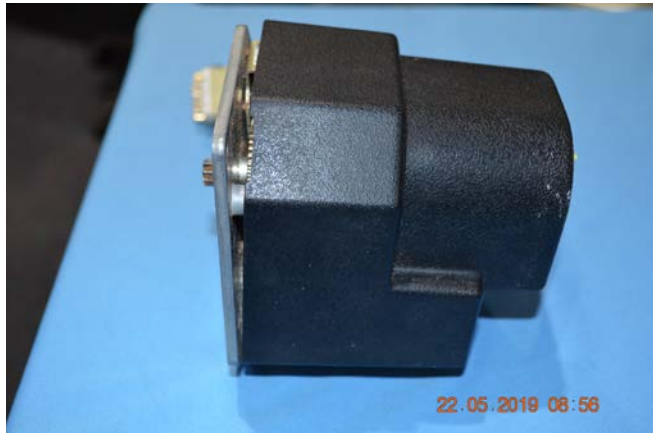
- The plastic servo cover attach plate is bent and not allowing the cover to fit properly.
- The cover was removed to allow visual inspection. Traces of dried dirt/mud present on electrical and mechanical assemblies – removed the debris as necessary to allow electrical testing.
- The servo was subjected to acceptance testing per maintenance manual, 006-15618-000. The unit failed two tests with minor out of tolerance measurements as noted below. Neither failure would adversely affect proper servo function. A copy of the test data sheet can be found in appendix A of this report.
  - o Test Step S: Strain Gauge sensing CCW Trim Sense, failed with reading of 1.21V (limit =  $1 \pm .2V$ ).
  - o Test Step S: Null, failed with a reading of .089V (limit =  $-.05V$  to  $+.05V$ ).

Cover attach bracket bent causing poor cover fitment

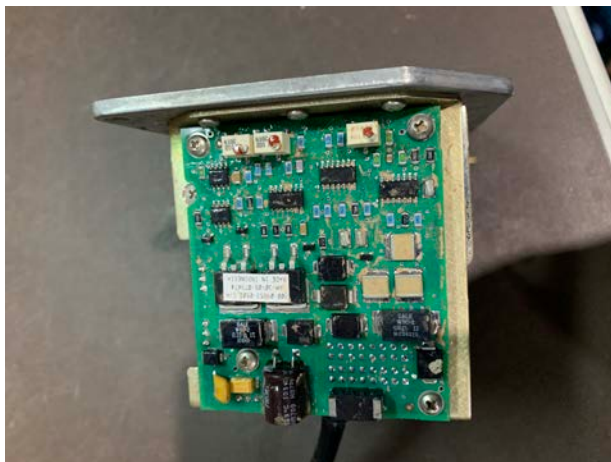
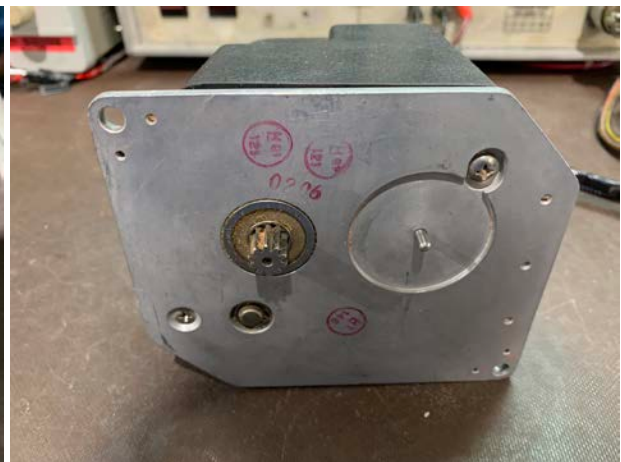
Dried dirt/mud present on electrical and mechanical assemblies

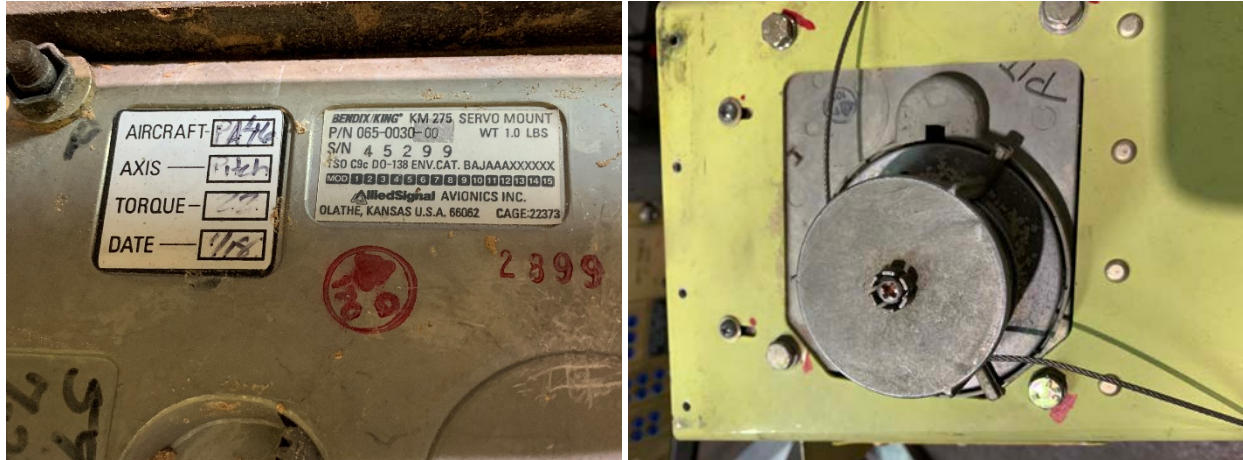
KM 275 Pitch Servo Mount – front and back views

- The KM 275 Pitch Servo Mount was received attached to associated aircraft bracket. They were separated to facilitate testing.
- Traces of dried dirt/mud present.
- The slip clutch was tested in the clockwise and counter-clockwise directions. The clutch slipped at 30 in-lbs. in both the CW and CCW directions. The specified limit is 22 +/- 2 in-lbs.

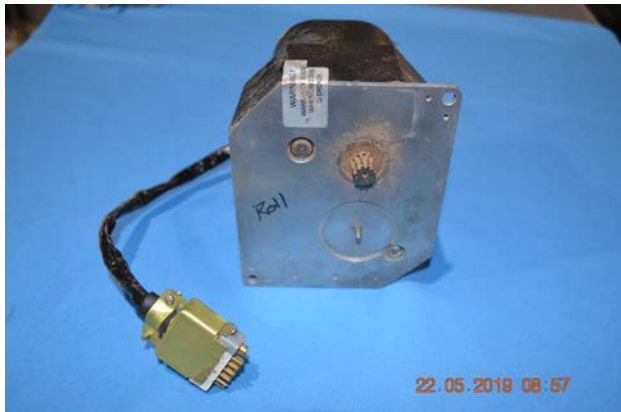
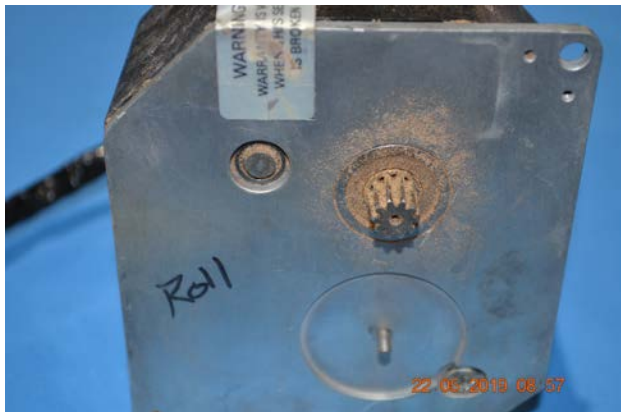
Dried dirt/mud on pinion gear and bearing

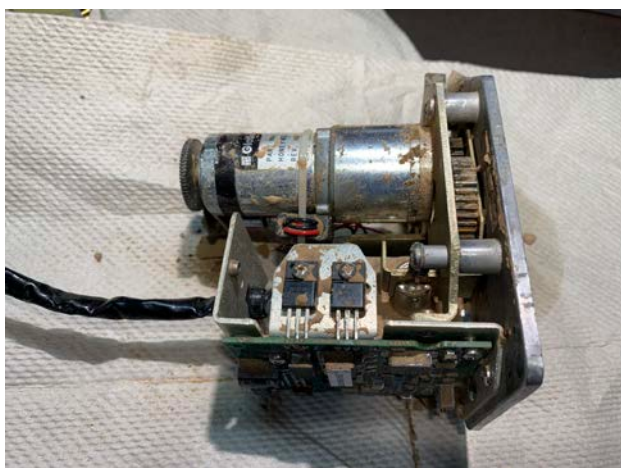
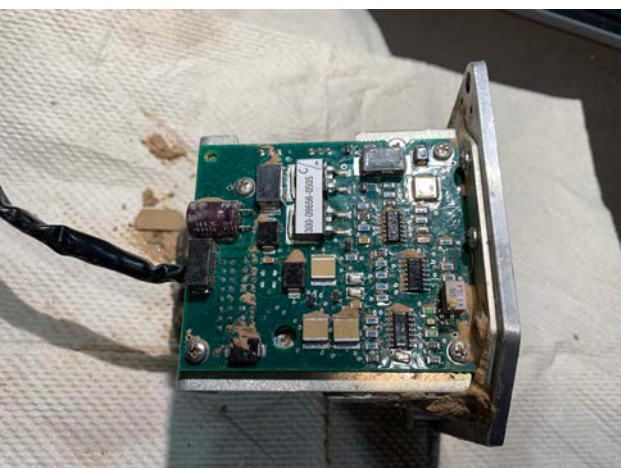
- The cover was removed to allow visual inspection. Traces of dried dirt/mud present on electrical and mechanical assemblies – removed the debris as necessary to allow electrical testing.
- The servo was subjected to acceptance testing per procedure 924-01337-0000, rev 25. The unit failed two tests with minor out of tolerance measurements as noted below. Neither failure would adversely affect proper servo function. A copy of the test data sheet can be found in appendix A of this report.
  - Proc step 5.3: Solenoid engage pulling against gravity – solenoid engages/disengages at 27.3 volts (limit = 20.6 volts max). Note: dirt/sand present in solenoid assembly.
  - Proc step 5.7: Torque characteristics – solenoid disengages in the CW direction in 3 seconds (limit = 2 seconds max).

Dried dirt/mud present on servo electrical and mechanical assemblies

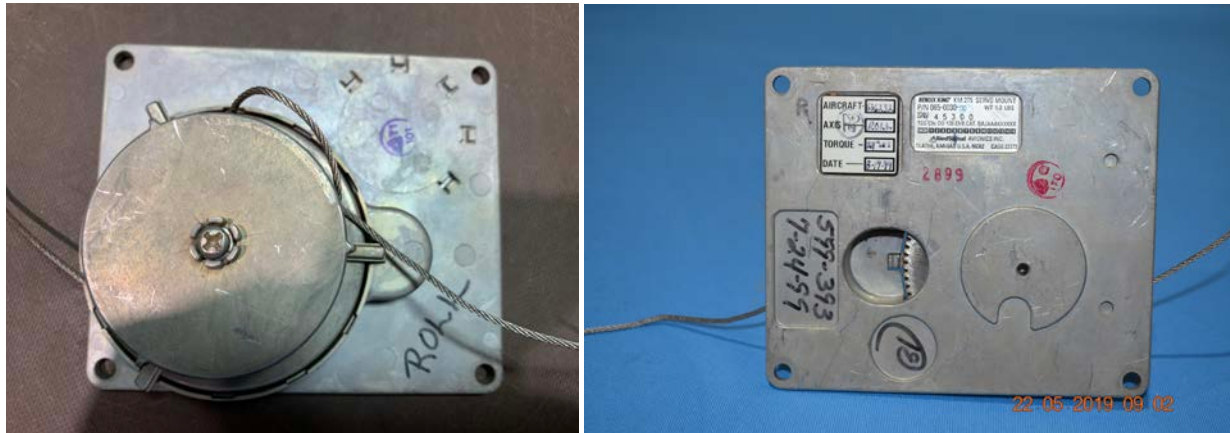
KM 275 Roll Servo Mount – front and back views

- Minor traces of dried dirt/mud present.
- The slip clutch was tested in the clockwise and counter-clockwise directions. The clutch slipped at 30 in-lbs. in both the CW and CCW directions. The specified limit is 22 +/- 2 in-lbs.

The KM 275 Roll Servo Mount functioned correctly; however, the clutch slipped at 30 in-lbs. against a limit of 22 +/- 2 in/lbs. The KM 275 Pitch Servo Mount functioned correctly; however, the clutch slipped at 30 in-lbs. against a limit of 22 +/- 2 in/lbs. The KM 275 Yaw Servo Mount functioned correctly; however, the clutch chatters -- slipped at 40 in-lbs. against a limit of 40 +/- 4 in/lbs. The out of tolerance conditions of these three servo mounts would not have an adverse impact on proper operation. The Airplane Flight Manual Supplement provides preflight instructions to confirm proper operation and ability to overpower the autopilot clutches. No pre-impact faults were detected.

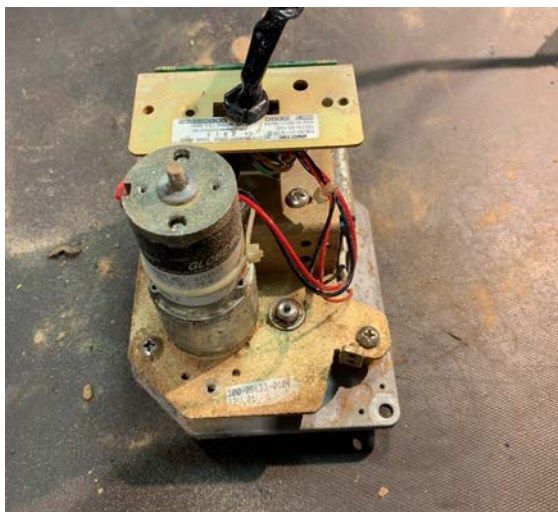
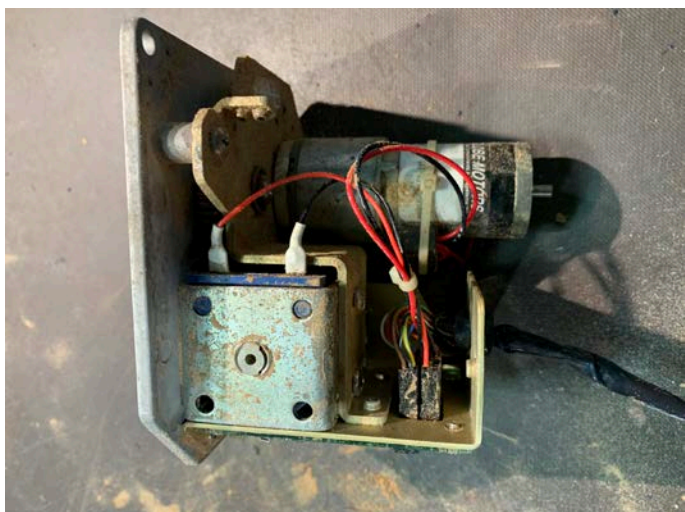
- The KS 271C Yaw Servo was received attached to servo mount and aircraft bracket. They were separated to facilitate testing.
- The cover was removed to allow visual inspection. Traces of dried dirt/mud present on electrical and mechanical assemblies – removed the debris as necessary to allow electrical testing.
- The servo was subjected to acceptance testing per procedure 924-01337-0000, rev 25. The unit failed two tests with minor out of tolerance measurements as noted below. Neither failure would adversely affect proper servo function. A copy of the test data sheet can be found in appendix A of this report.
  - o Proc step 5.4: Motor breakout CW input – measured 1.0 volts (limit = 0.3 volts max).
  - o Proc step 5.4: Motor breakout CCW input – measured -0.7 volts (limit = -0.3 volts max).

KS 271C Yaw Servo – dried dirt/mud/sand present

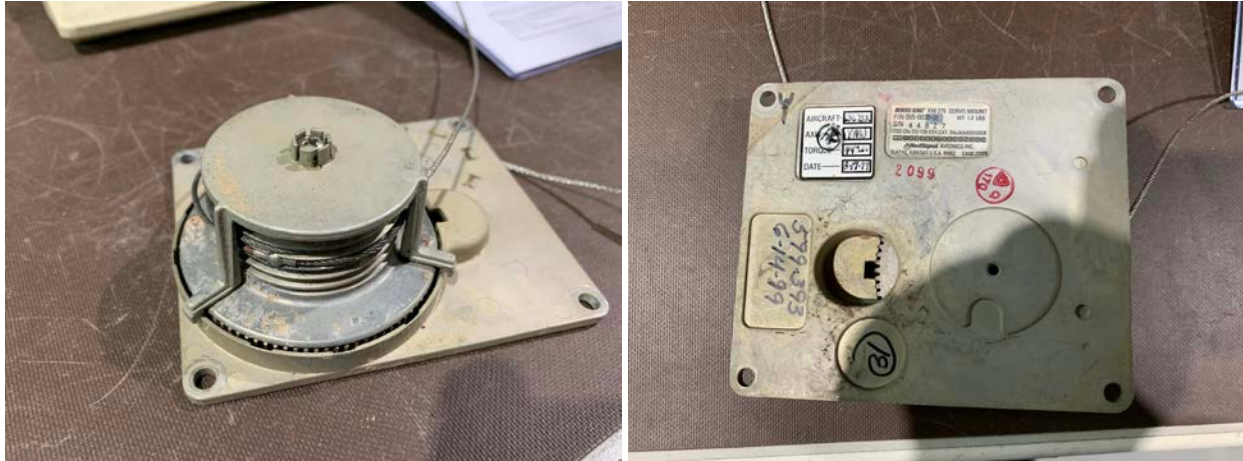
KM 275 Yaw Servo Mount – front and back views

- Minor traces of dried dirt/mud present.
- The slip clutch was tested in the clockwise and counter-clockwise directions. The clutch slipped and chattered at approximately 40 in-lbs. in both the CW and CCW directions (limit is 40 +/- 4 in-lbs.)

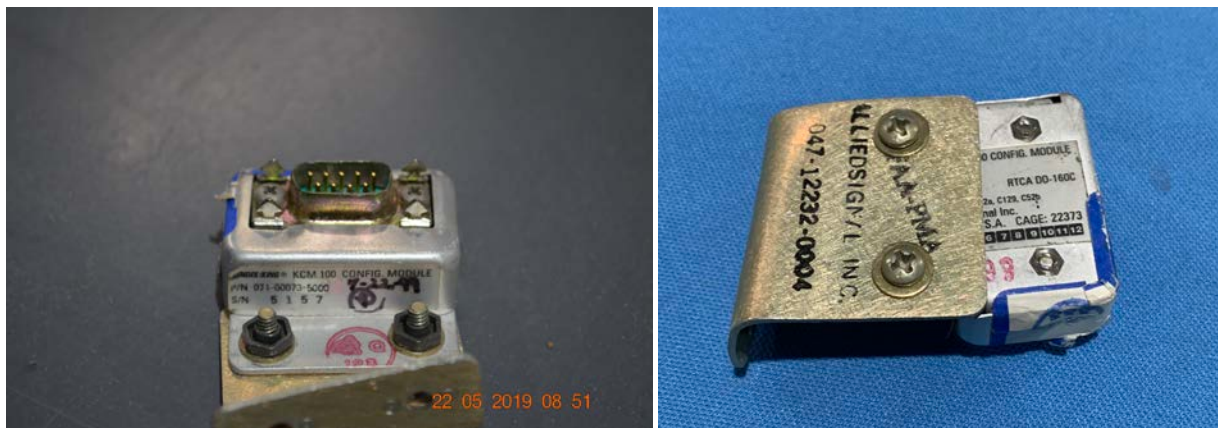
KCM 100 Configuration Module

Error code 172 (*MET fail*) was logged 10 minutes and 20 seconds after power was applied to the KFC 225 autopilot system. This error indicates a possible latent failure of the Manual Electric Trim Switches was detected. When *MET fail* is detected, manual electric trim is disabled. The autopilot will automatically disengage, but all flight director modes will remain active. The autopilot will remain unavailable until a successful preflight test occurs. The autopilot does not have to be engaged for an *MET fail* to be logged.

Error code 151 (*roll monitor fail*) was logged at 10 minutes, and 32 seconds after power was applied to the KFC 225 autopilot system. The *roll monitor fail* is logged when the aircraft experiences roll rates in excess of +/- 14 degrees per second or a roll attitude of +/- 45 degrees. The autopilot automatically disconnects when the roll monitor is tripped (logged as *roll monitor fail*) and all Flight Director (FD) modes are disengaged (set-up option). Twenty-six seconds later, error code 180 (*yaw fail*) was recorded, indicating that a yaw rate in excess of 12 degrees per second existed. When yaw fail is logged, YD mode becomes inactive without affecting other autopilot modes. Additionally, either of these failures may be logged because of a hardware failure (noted below) and the autopilot does NOT have to be engaged for these monitor trips to be logged. The Flightline Maintenance Manual (FMM), P/N 006-15557-0001, is located in Appendix A and describes these errors as follows:

The KCM 100 Config Module recorded three error codes during the accident flight – error 172 *MET fail*, error 151 *roll monitor fail*, and error 180 *yaw fail*. The error 172 *MET fail* would inhibit the manual electric trim operation and automatically disengage the autopilot if it was engaged; however, the Flight Director modes that were active prior to AP disengagement would remain active. If the error 172 *MET fail* occurs after a successful KC 225 preflight test, but prior to AP engagement, Manual Electric Trim (MET) operation and Autopilot mode are inhibited; however, Flight Director modes are available. If the error later clears, MET and AP operation are restored. If a condition exists that would cause error 172 *MET fail* to be present before commencing preflight test (before applying power to the autopilot system), then power is applied to the autopilot system, the KC 225 will pass preflight testing after power is applied, the monitor then promptly detects the *MET fail* condition, annunciating a “PT” fault on the KC 225 screen and logging error 172 *MET fail*. The FD modes are available, but MET operation and AP modes are inhibited. The *roll monitor fail* and *yaw fail* could be produced because of a stall/spin operation. Since these monitors are active anytime the KFC 225 autopilot system is powered up, it is not known if the autopilot was engaged during the accident flight.

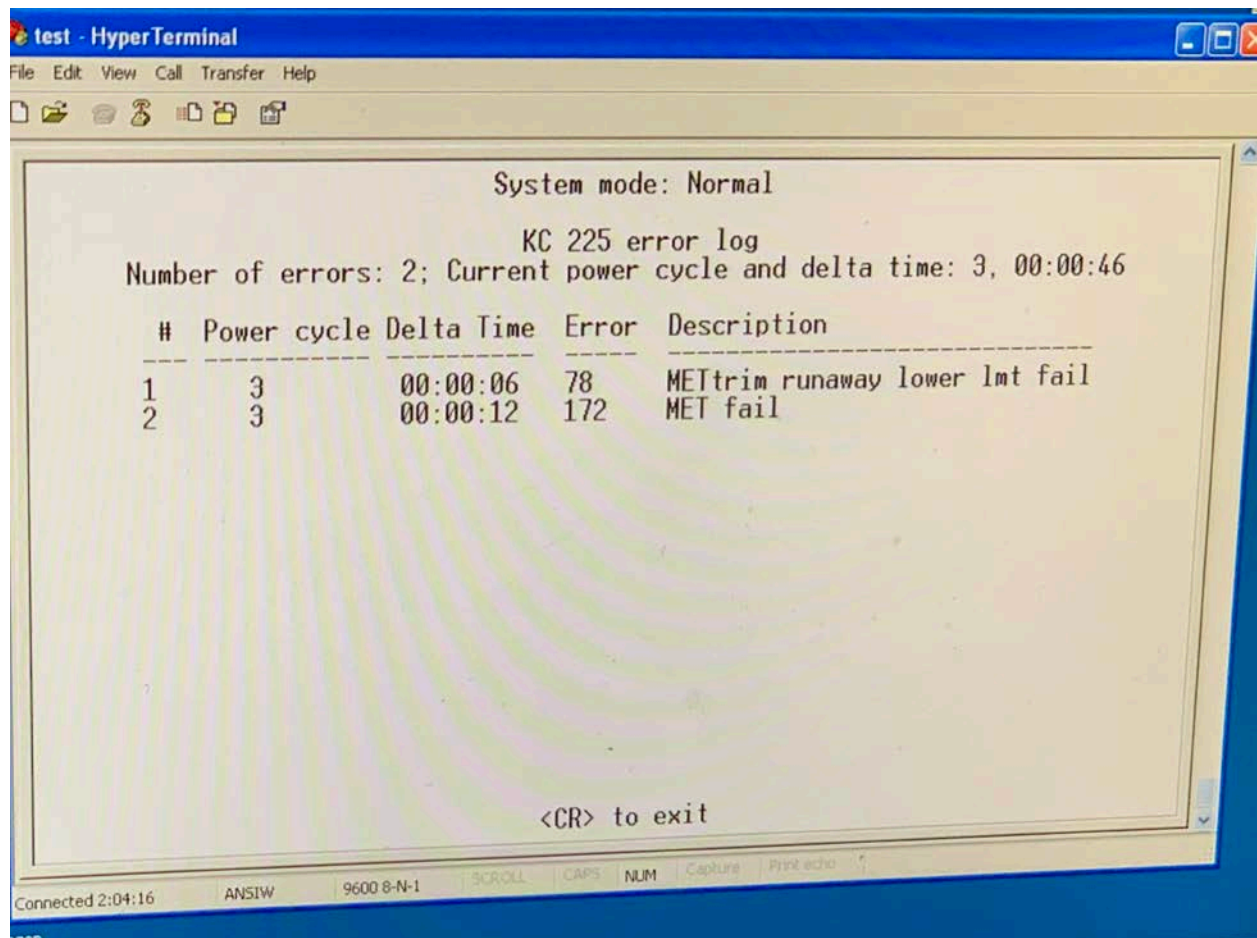
KC 225 error code log

The KC 225 Flight Computer was received installed into its associated rack. The outside of the unit was contaminated with dried dirt/mud/sand, consistent with being recovered from a river bottom. The unit was removed from the rack and opened to inspect for internal damage. The circuit boards were found covered/caked with dried dirt/mud/sand – see photos below. The boards were removed, cleaned, and re-installed. The unit was then connected to a KC 225 test panel and power was applied. No abnormal current draw was observed and the unit started preflight testing. The unit failed preflight test with a trim fault illuminated on the front of the test panel and error codes 78 (*MET trim runaway*) and 172 (*MET fail*) were produced. Error 172 was logged during the accident flight, but error 178 was not.

The KC 225 failed preflight test and produced two errors – error 78 *MET runaway* and error 172 *MET fail*. Error 78 was not logged during the accident flight. This indicates that the error 172 *MET fail* that was logged during the accident flight is not related to the Manual Electric Trim switches on the pilot’s yoke and indicates that the fault is within the KC 225 Flight Computer. When automatic autopilot disengagement occurs as a result of error 172 *MET fail*, it is communicated to the pilot via an audible tone, voice alert “AUTOPILOT” is announced if enabled, and the AP annunciation disappears on the KC 225 Flight Computer display; however, all Flight Director modes active at the time of disengagement remain active. The autopilot use is disallowed until the error clears or successfully completes preflight testing. No determination was made regarding the source of the KC 225 preflight test failure (error 172 *MET fail*).

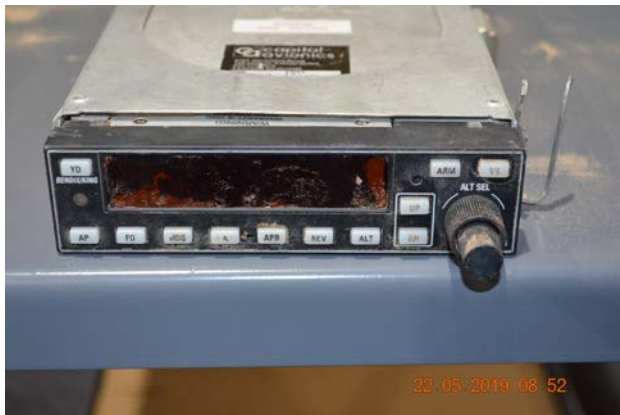
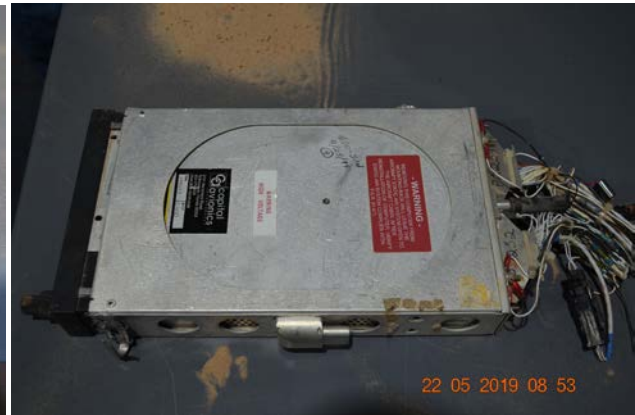
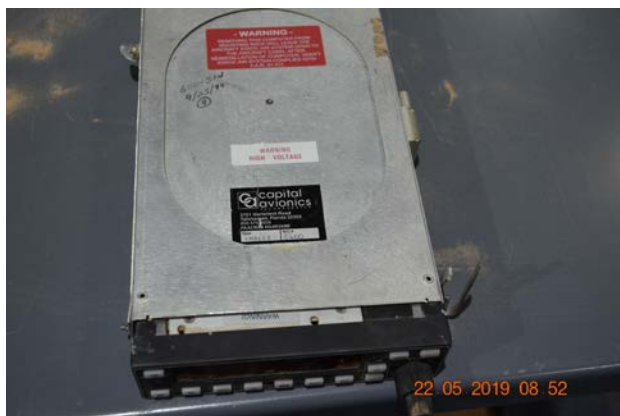
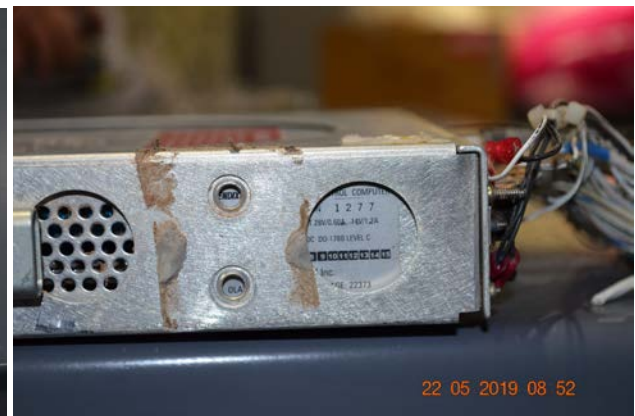
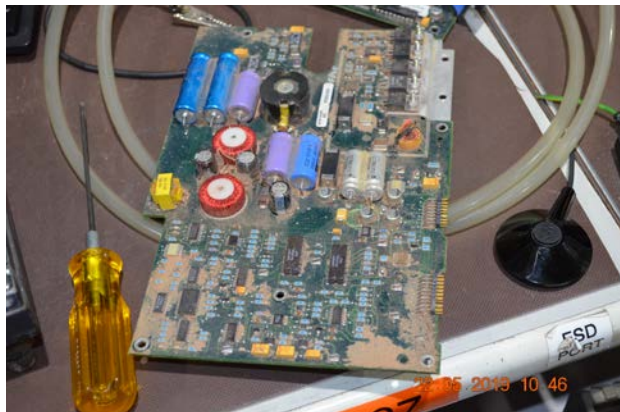
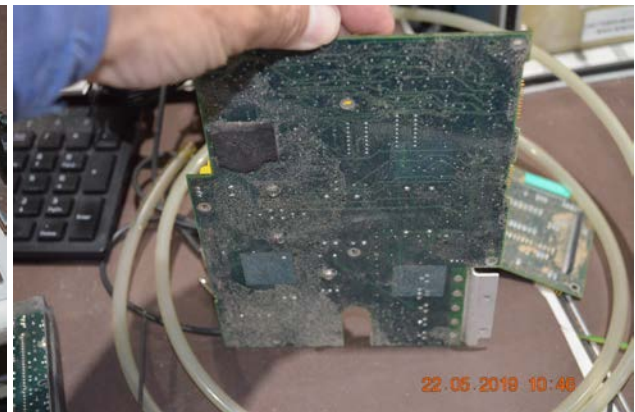
KC 225 Flight Computer – dried dirt/mud/sand present

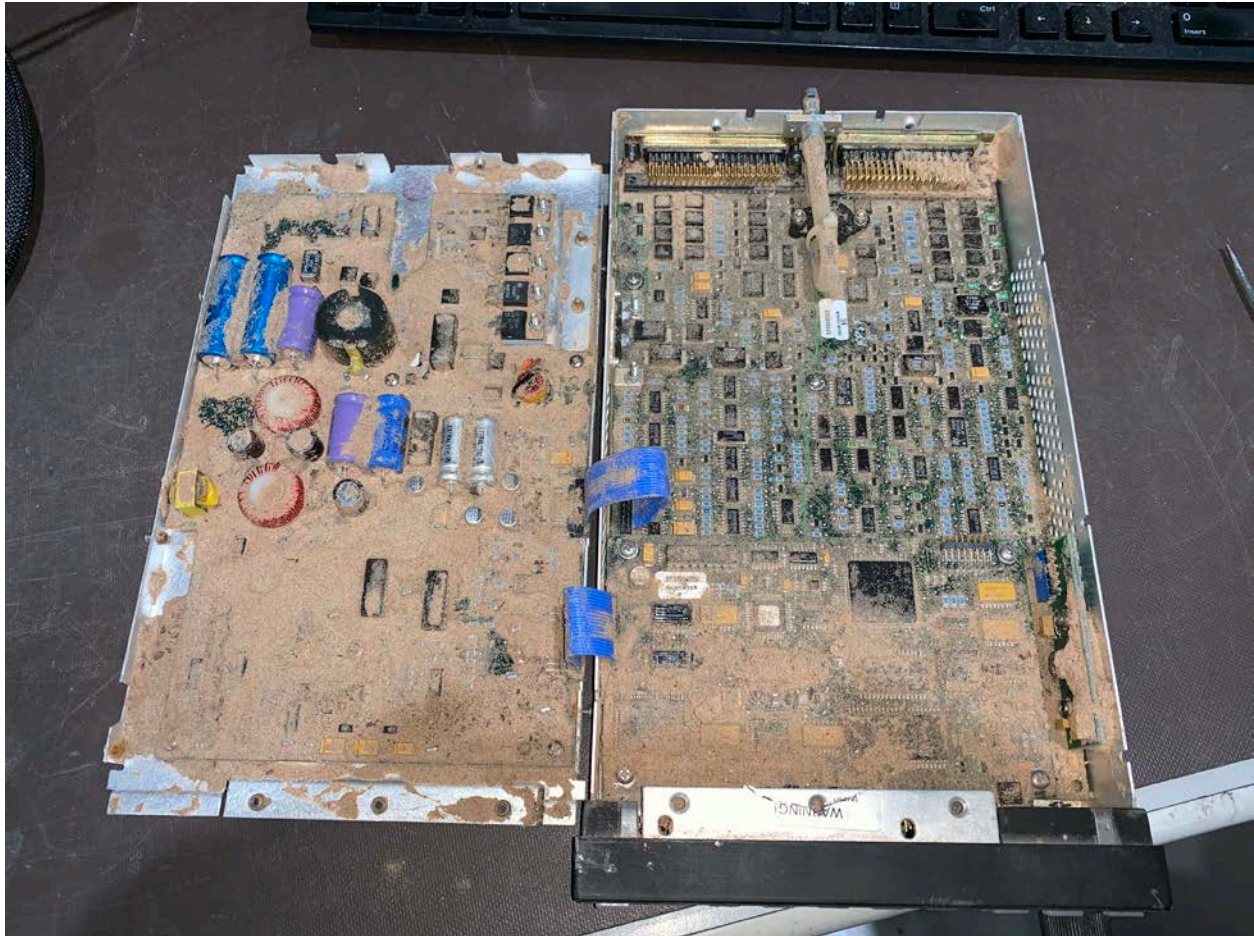
KC 225 Flight Computer opened depicting dried dirt/mud/sand caked inside

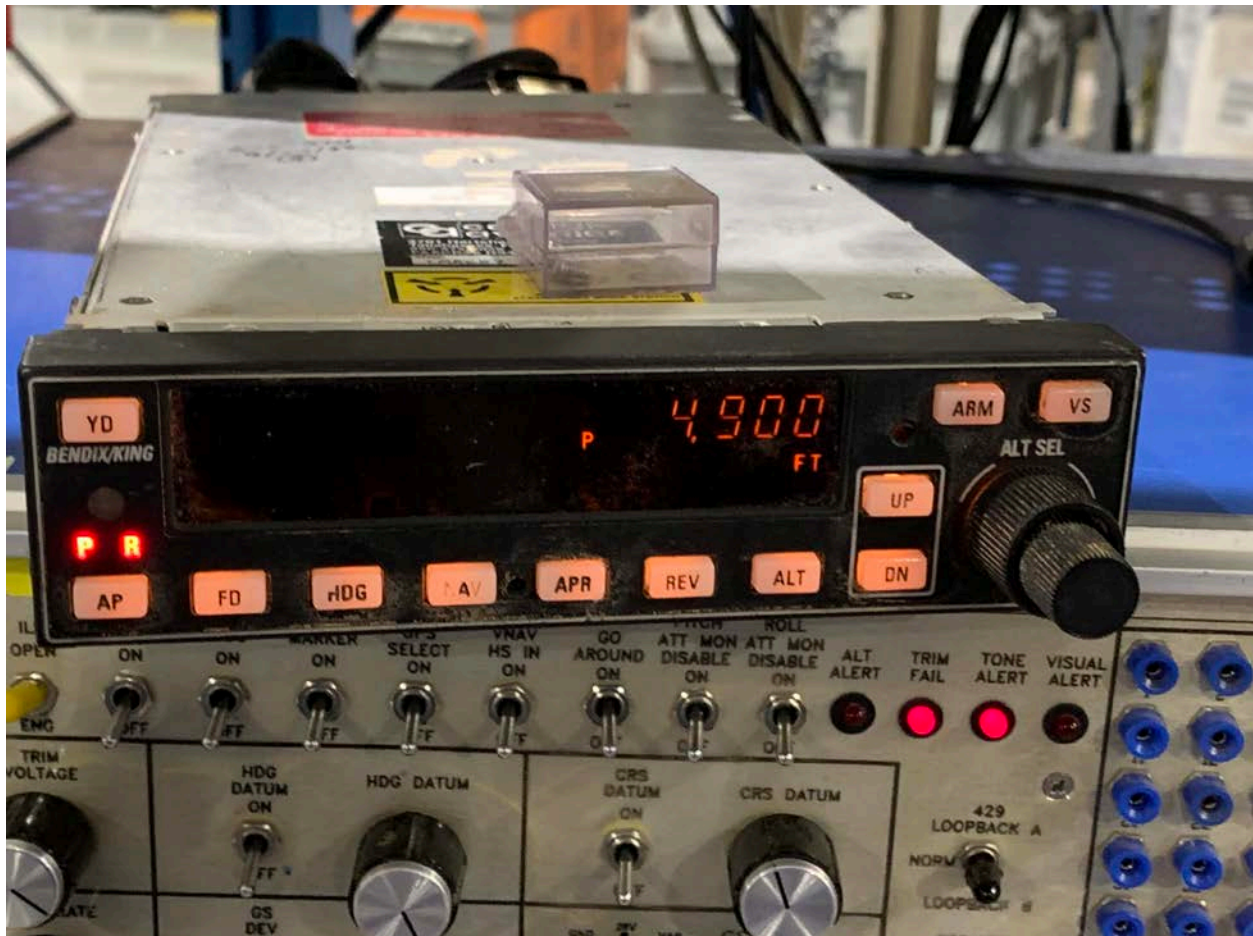
KC 225 Flight Computer – fails preflight test with trim fault illuminated on the test panel

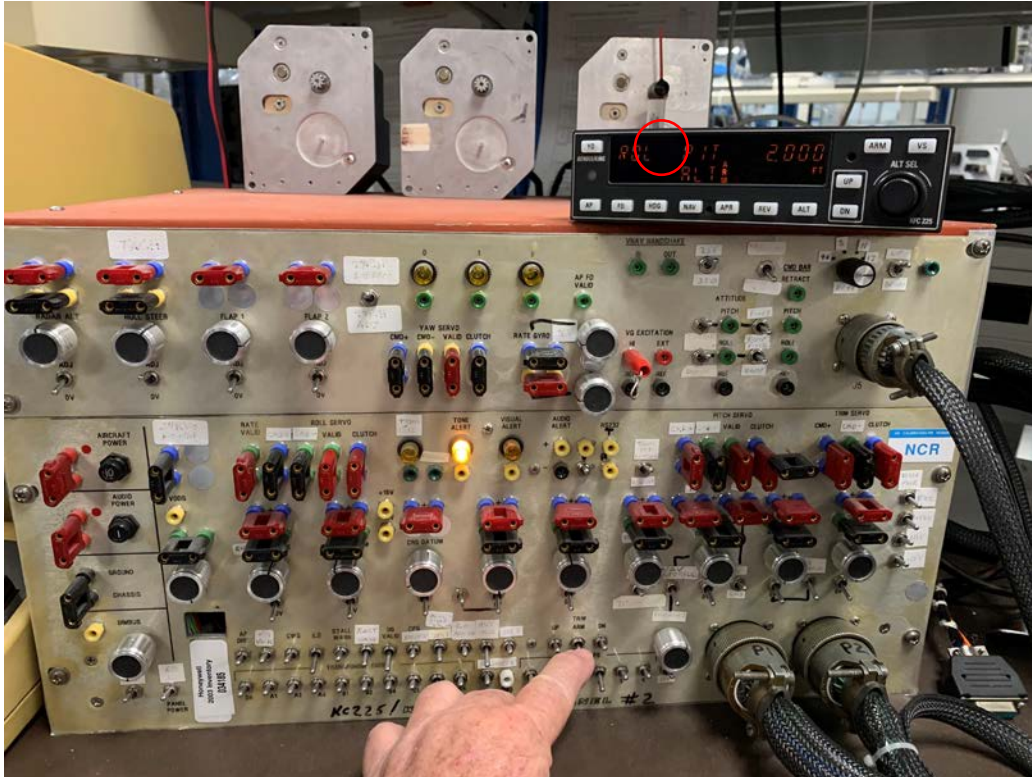
When the “Arm” switch is activated or moved to the down position, the autopilot automatically disengages and error 172 *MET fail* is logged. All FD that were active before disengagement remain active. Notice the absence of the “AP” notation where circled above.

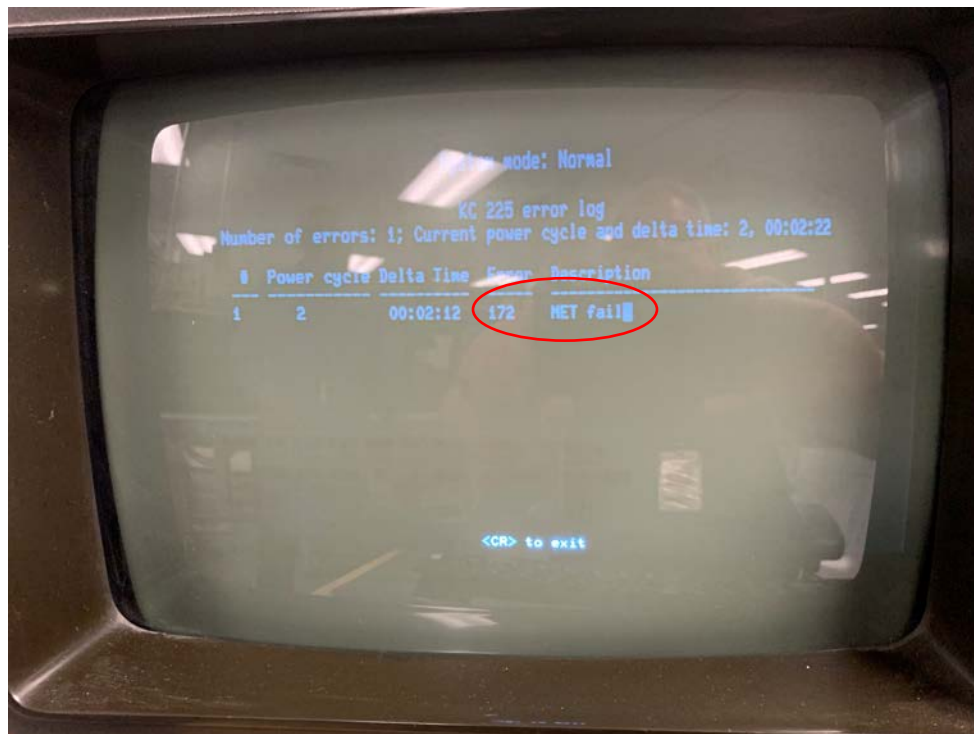
Error 172 *MET fail* logged when “Arm” switch on panel was activated, causing AP disengagement

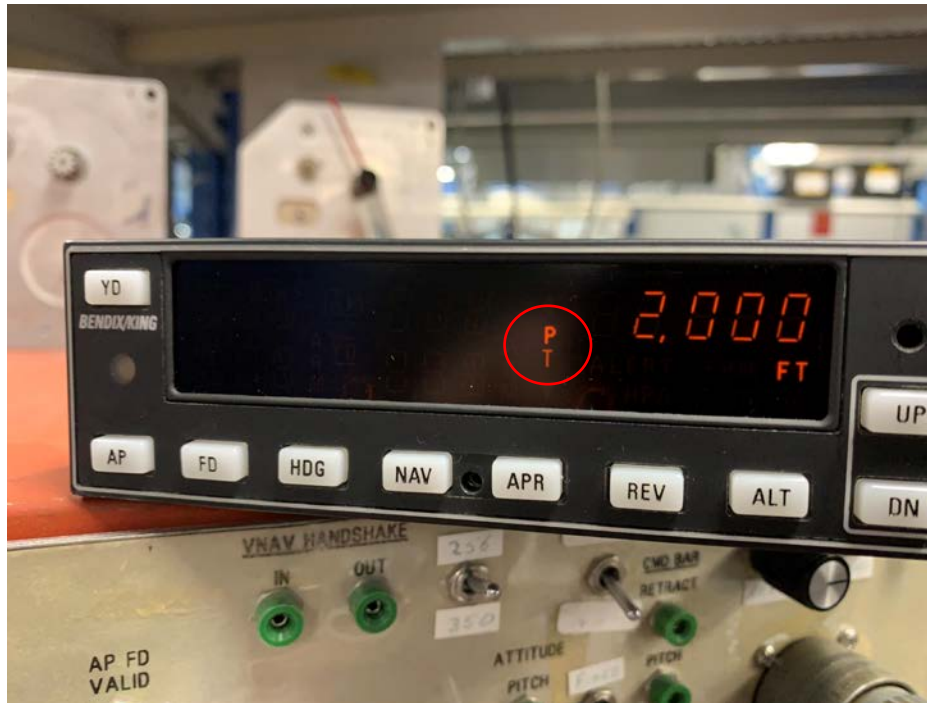
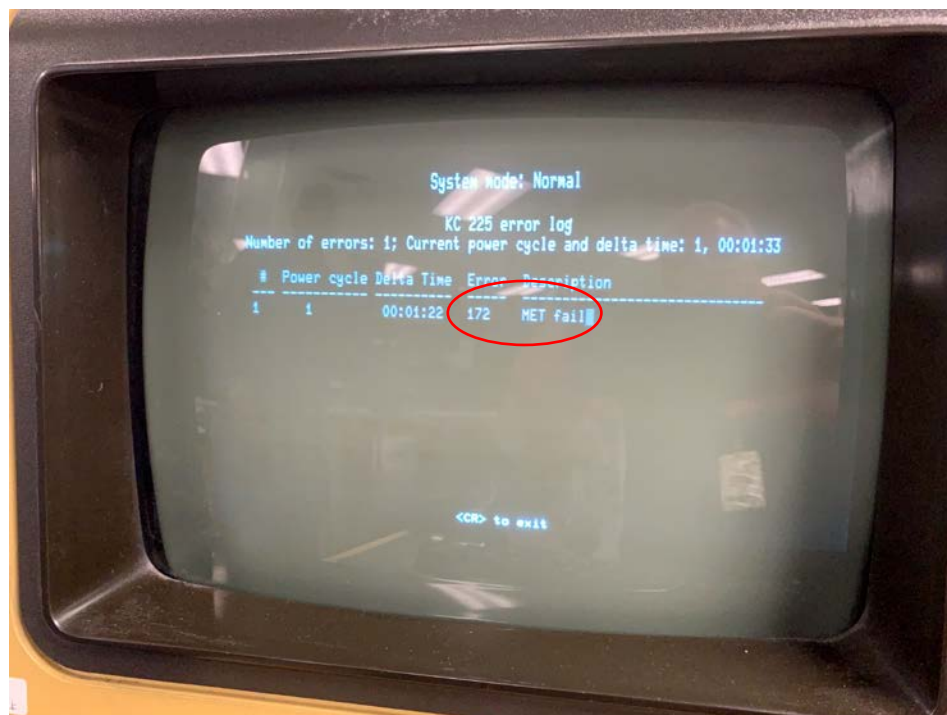
If the “Arm” switch on the test panel is activated prior to switching AP power on, the KC 225 passes preflight testing after power is applied, then the monitor detects the active “Arm” switch, annunciating a “PT” (Pitch Trim) fault on the KC 225 screen and logging error 172 *MET fail*. FD modes are available; however Manual Electric Trim operation and AP modes are inhibited. This demonstrates that the Manual Electric Trim monitor is always active when AP power is applied.
