## RECORD OF EXAMINATION

**NTSB Accident Number: CEN19FA095**

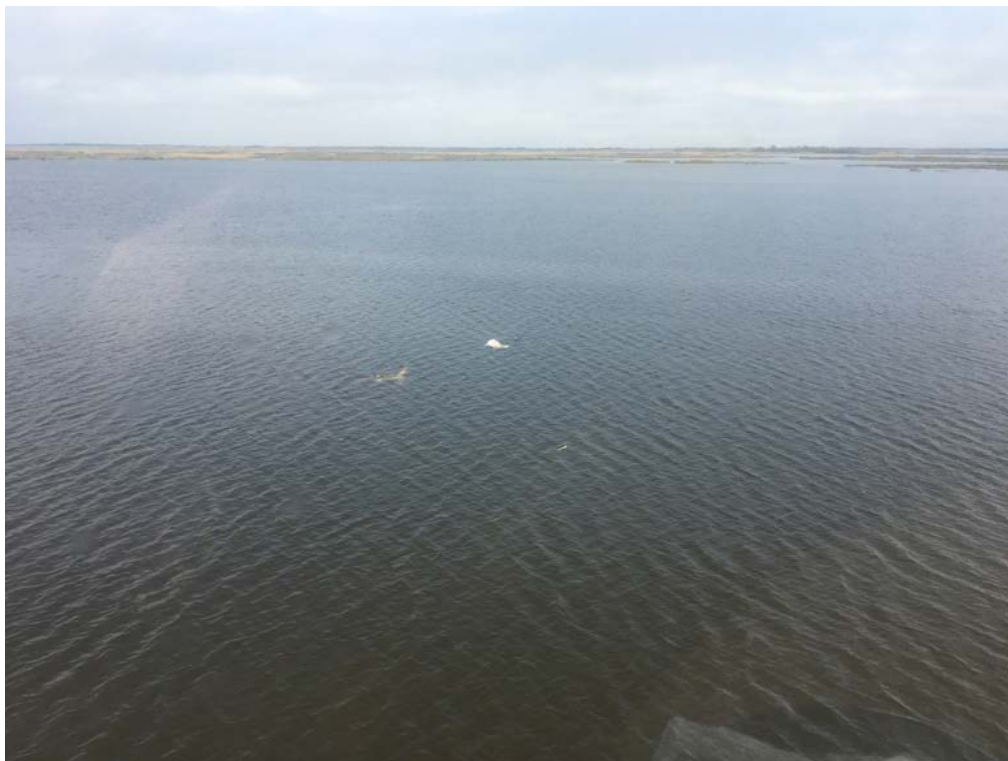
Figure 2: Wreckage Site Viewed Toward Northeast

The main wreckage of the helicopter was in a brackish marsh with an approximate tail to nose heading toward the southwest. The fuselage, engine, and main and tail rotors were located within an approximate distance of 100 feet. Terrain features in day visual meteorological conditions are depicted in Figure 2.
