## CASE NOTES

During the course of the investigation, the following observation and facts were collected:

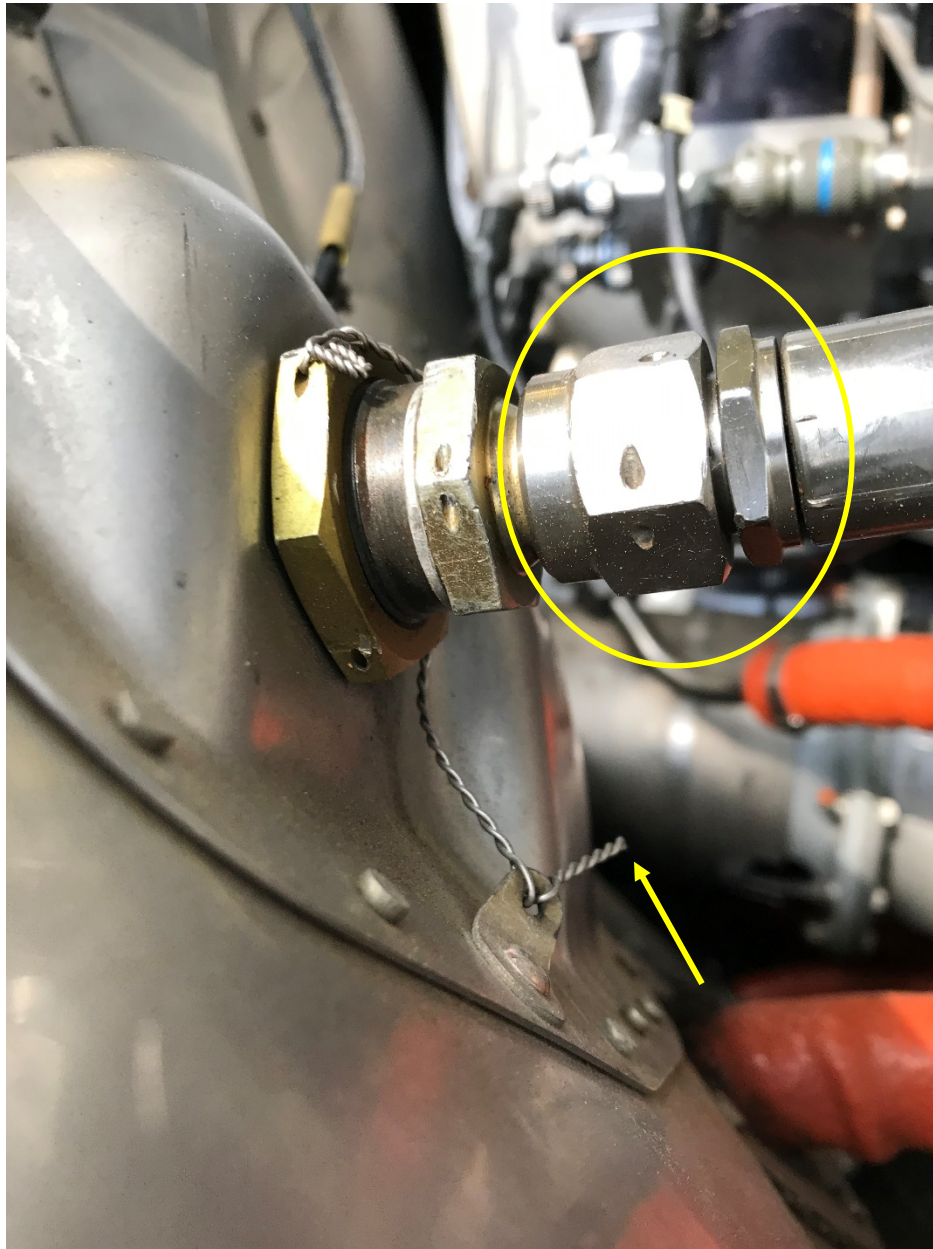
During opening of cowlings to inspect the engine, the main fuel line was found not properly secured. Below is a picture as found at the accident site.

*Figure 1 Cut safety wire and no safety wire on b-nut*

- A check of security of all the fuel, oil, and air lines revealed the fuel line between the firewall and HMU (shutoff valve/fuel pipe interface) was loose and without safety wire.

When the fuel line was found improperly secured, it was requested that Mountain Air inspect the other AS350 helicopters that they operate. A review of the remaining fleet found all the fuel lines properly secured.
