# Survivability Notes CEN19FA109

### I. ACCIDENT INFORMATION:

NTSB ID: CEN19FA109  
Location: Montgomery, TX  
Aircraft: Eurocopter AS350 B3  
Tail number: N818MC  
Accident date: March 27, 2019 1435 CDT  
Injuries: 1 fatal (Passenger), 2 serious (pilot/ passenger)

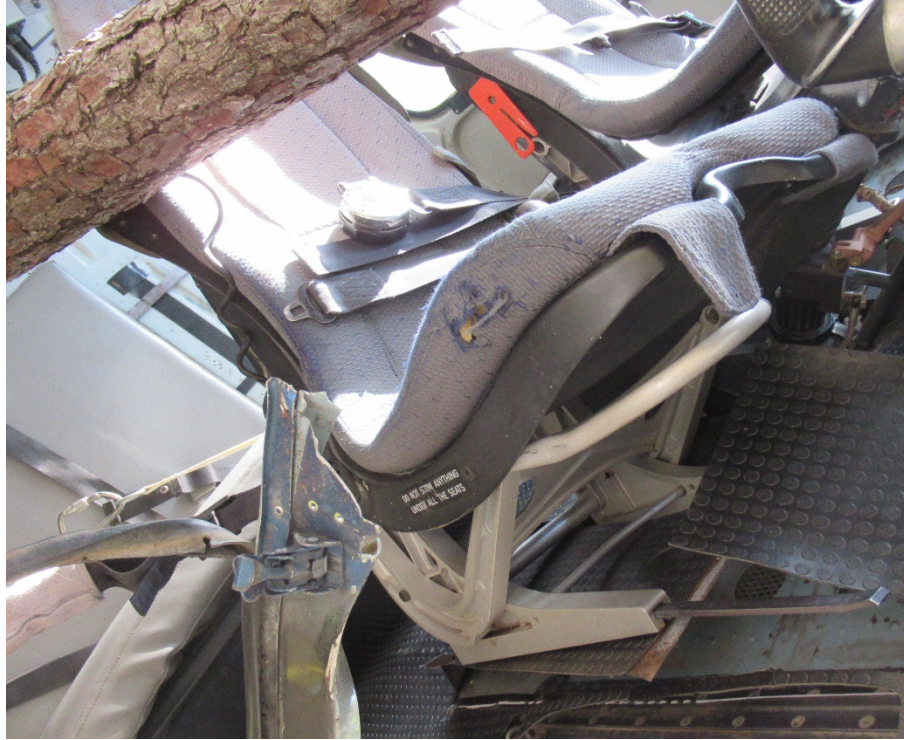
**Photograph 1 - Pilot Seat**

The pilot seat was located on the right side of the cockpit, the outboard seat track fractured and the seat separated from the floor on that side, the inboard seat track remained intact. The seat is a Sicma Aero Seat, now owned by Zodiac France, and the data label reads:

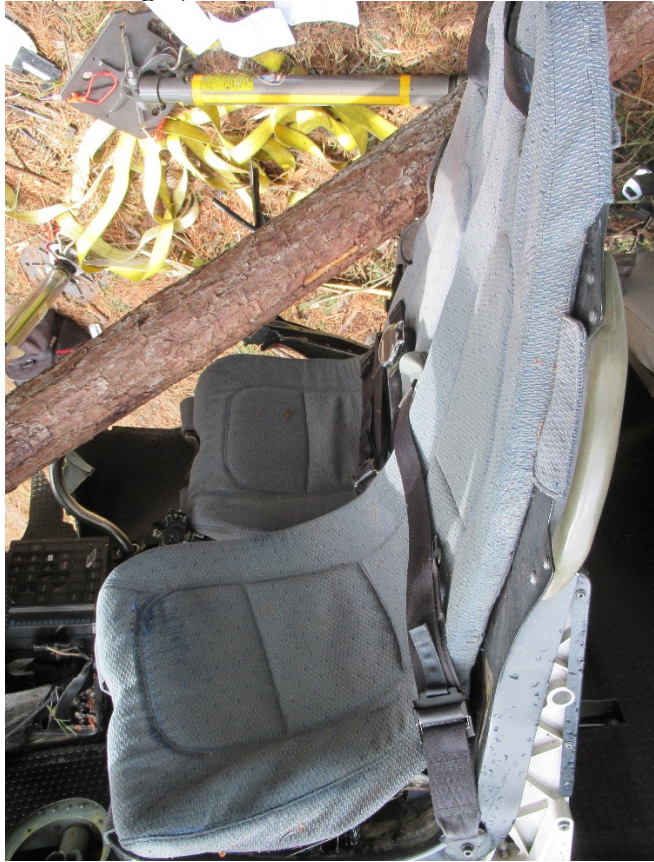
**Photograph 2 – Front Left Passenger Seat**

The passenger seat was located on the left side of the cockpit, it is a Sicma Aero Seat, now owned by Zodiac France, and was attached to the floor on both sides. The data label was not photographed.

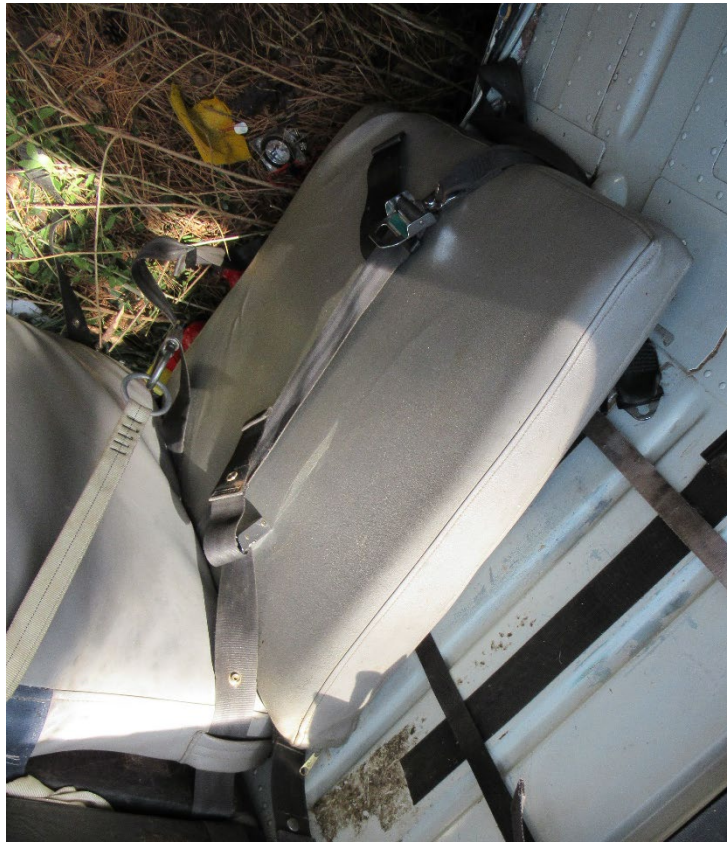
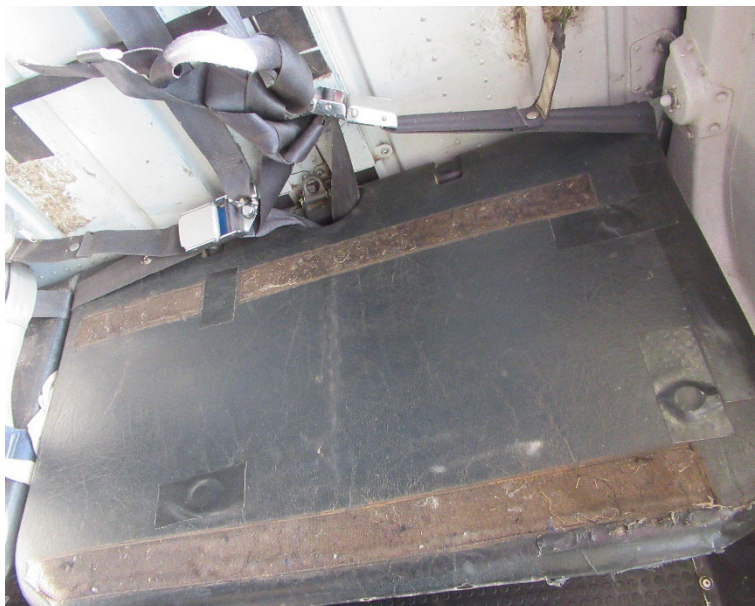
The rear bench seats consisted of two seating positions. Each bench seat was attached to the floor of the helicopter with 2 screw points. The aft seat tube attached to the rear bulkhead via a locking yoke. The aft left double bench was unoccupied and had its cushions removed and restraints tied together to keep them from moving within the cabin.

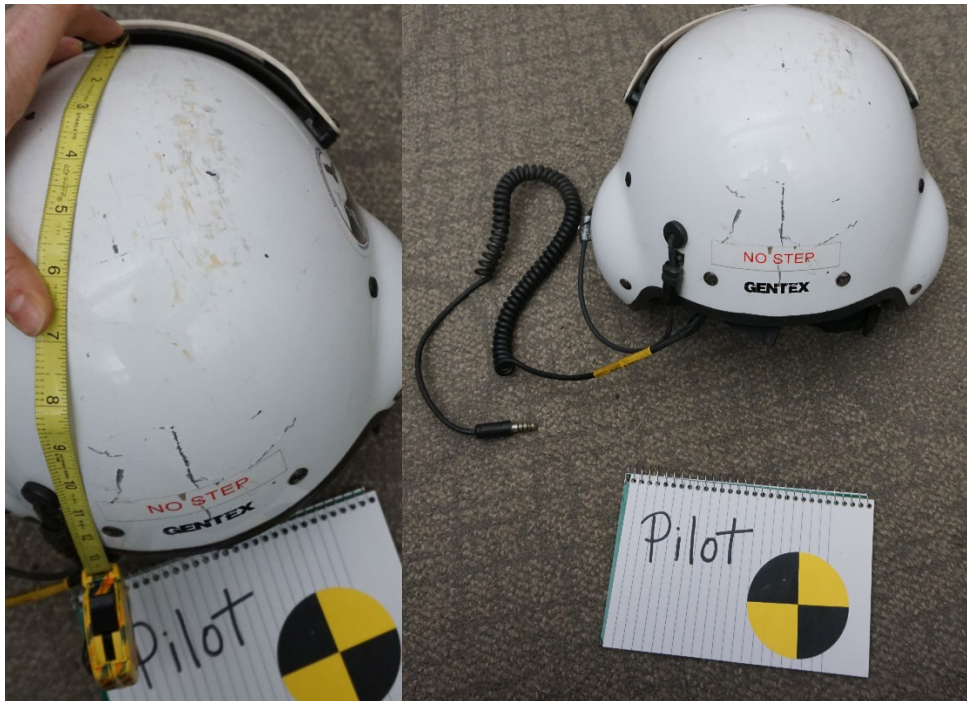
**Photo 5 - Pilot helmet**

Liner label markings worn off

Ear cups intact with visible wear

Rear of helmet show damage consistent with impact, starting at 1" from the aft bottom edge of helmet extending 3" upwards. Additional scratches and chips in the painted surface extend forward up to the NVG mounting cover. No additional damage is noted.

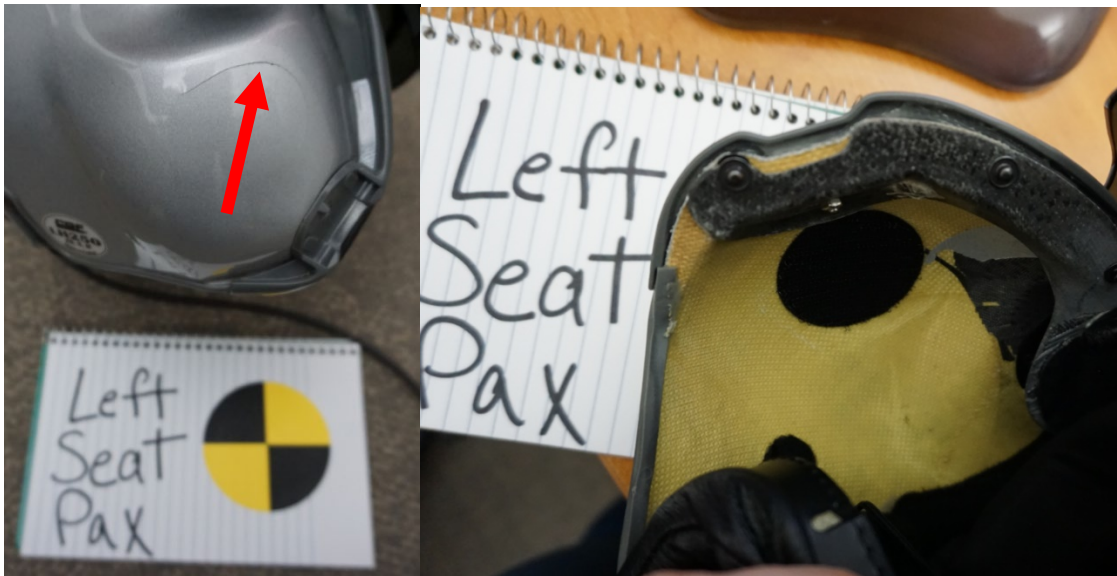
**Photograph 6 – Left Seat Passenger Helmet**

Right ear cup area has a noticeable crack on the exterior of the helmet. Interior shows no damage. The crackling in the paint extends outward from the large crack approximately 3”.

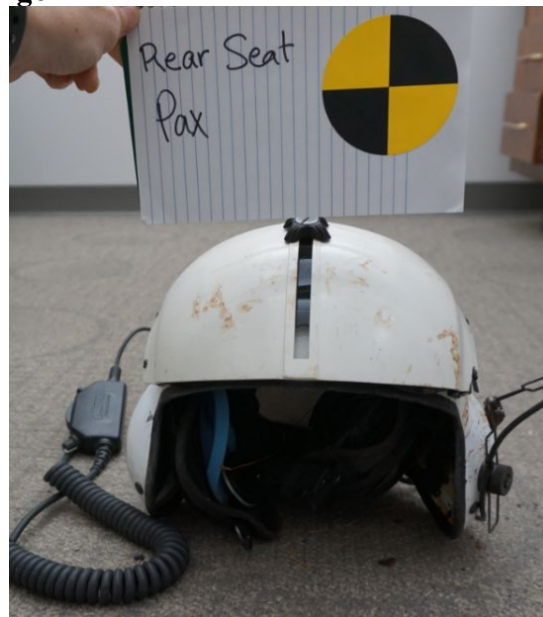
**Photograph 7 – Rear Passenger Helmet**

Helmet shows no cracks or indications of impact on the exterior on interior.

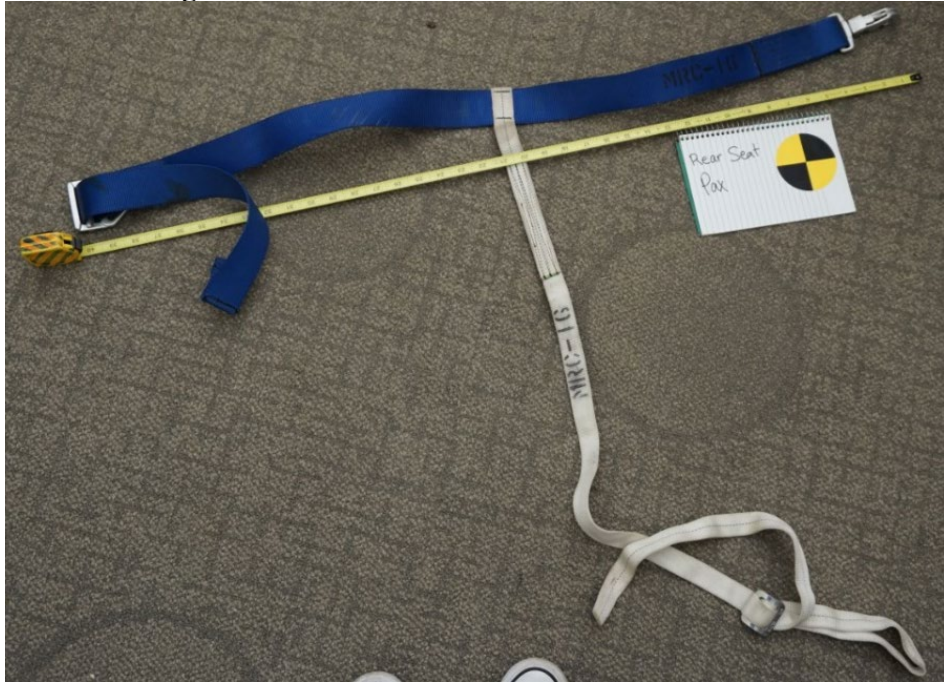
**Photograph 8 – Harness of Rear Supplemental Passenger Restraint System**

The webbing had no manufacturer tag but a marking of MRC-16 and the stitching was in a crisscross pattern with black thread the hook end. The blue webbing was bisected by an off-white colored webbing, 1-inch wide, centered at 20.5 inches from the end of the silver hook, and sewn in place.

The 1" wide webbing did not have a manufacturer tag but had a marking of MRC-16, with black thread. The stitching on the blue webbing was a 0.75-inch wide straight line of close set zig zag stitching in two places. The off-white strap was further secured 2 inches from the blue strap by a large crisscross pattern securing the tail of the webbing. The off-white strap was adjusted to a length of 35.5 inches as found.

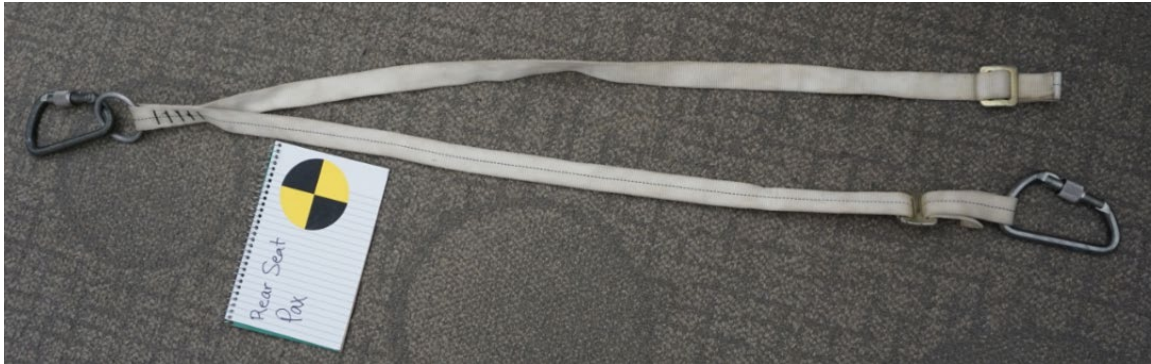
**Photograph 11 – Rear Occupant Tether**

A tether was attached to the aircraft in between the two double seat benches in the rear of the cabin. It is made of a length of 1 inch webbing that has been routed through a ring, doubled over and secured via 5 rows of zig-zag stitching. The proximal end is constructed by looping each of the two ends of the webbing through an adjuster to form loops where a second carabineer is passed through and secured to the cabin floor. The length of the webbing is 35 inches, each of the carabineers was 4.25 inches in length, and the ring had a diameter of 2 inches, for a total assembled length of 45.5 inches. The carabineer that secured the tether to the floor was connected to the floor anchor adjacent to the rear bulkhead where the lap belts were also connected.
