# National Transportation Safety Board

### Accident Site and Wreckage Examination Summary

NTSB Accident No: CEN19FA117  
Accident Date/Time: Tuesday, 9 April 2019, at 1033 CDT  
Accident Location: Harlingen, Texas  
26°17'33"N  
92°45'54"W  
39 ft mean sea level

Aircraft Make/Model: Air Tractor AT-502  
Aircraft Registration: N7314D  
Aircraft Serial No: 502-0003  
Engine Make/Model: Pratt & Whitney PT6A-15AG  
Engine Serial No: PCE-14143  
Propeller Make/Model: Hartzell HC-B3TN-3D  
Propeller Serial No: BUA30488  
Airworthiness Date: June 26, 1987  
Airplane Time: 10,822.8 hours since new (Annual Inspection, 01 April 2018)  
Engine Time: 9,762.6 hours since new (Annual Inspection, 01 April 2018)

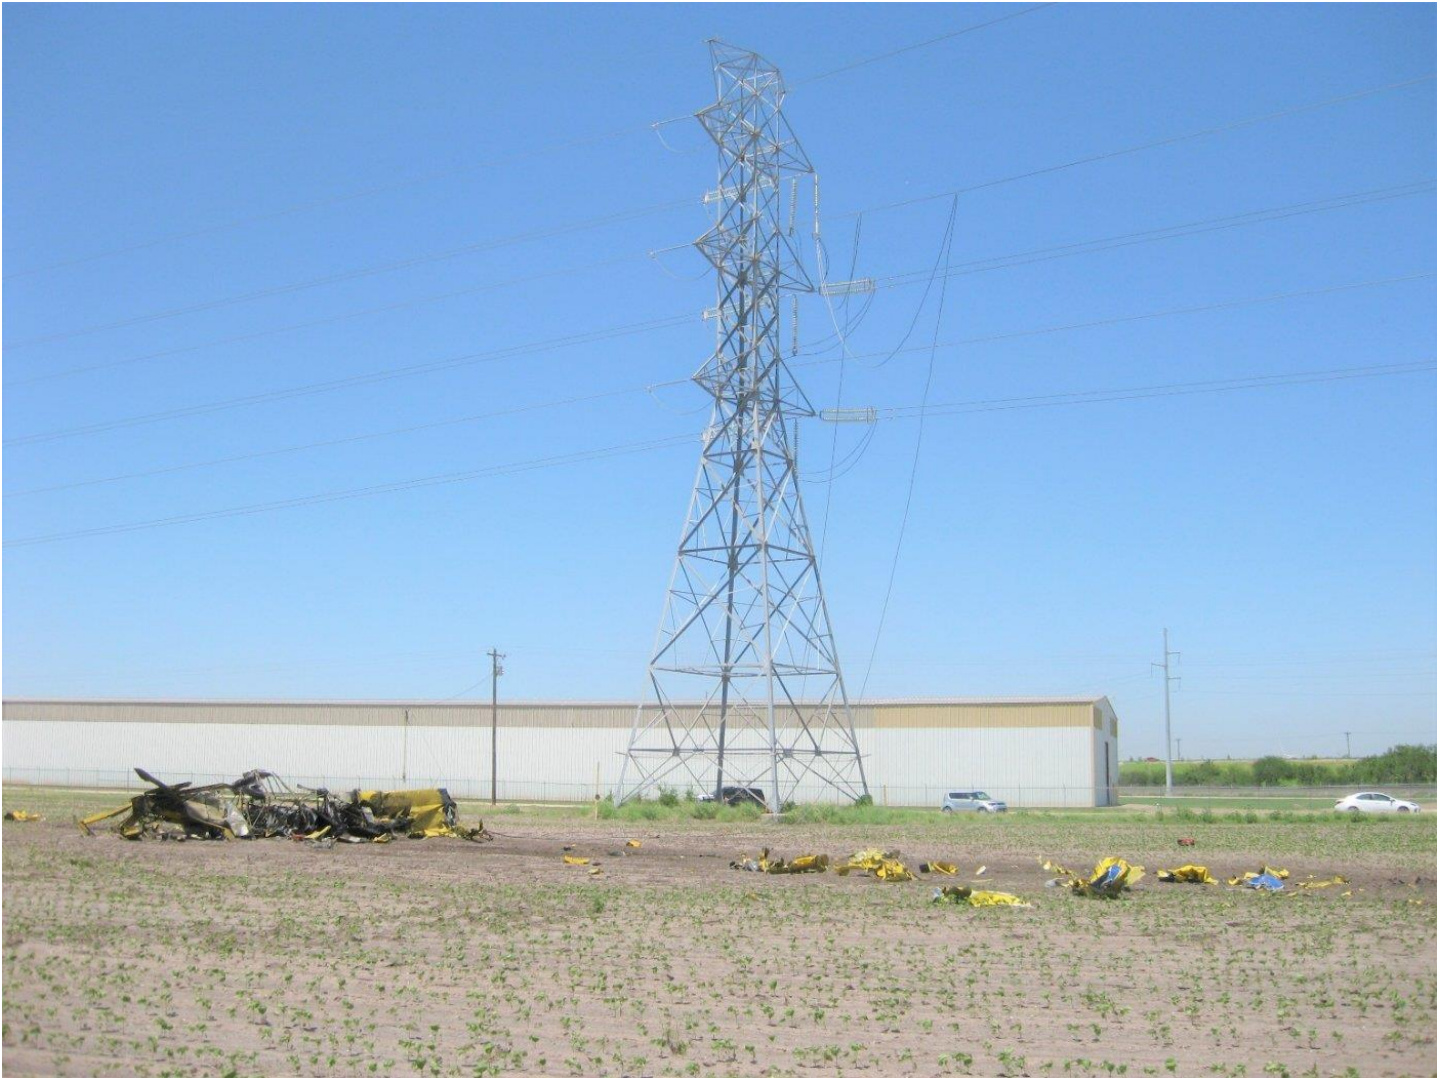
The main wreckage consisted of the fuselage, empennage, right wing, engine, and propeller. The main wreckage exhibited evidence of a prolonged postimpact ground fire. The fuselage was found upright with significant fire damage. All airframe structural components and flight control surfaces were identified at the accident site. Flight control continuity could not be established due to damage; however, all observed separations were consistent with overstress or damage sustained during the postimpact fire. The flap actuator was found in the fully retracted position. The left wing was highly fragmented during impact. There were two transmission cables conjoined with the main wreckage; one wrapped around the engine and propeller shaft, and the other

Figure 1. Main Wreckage and Impact Debris Path

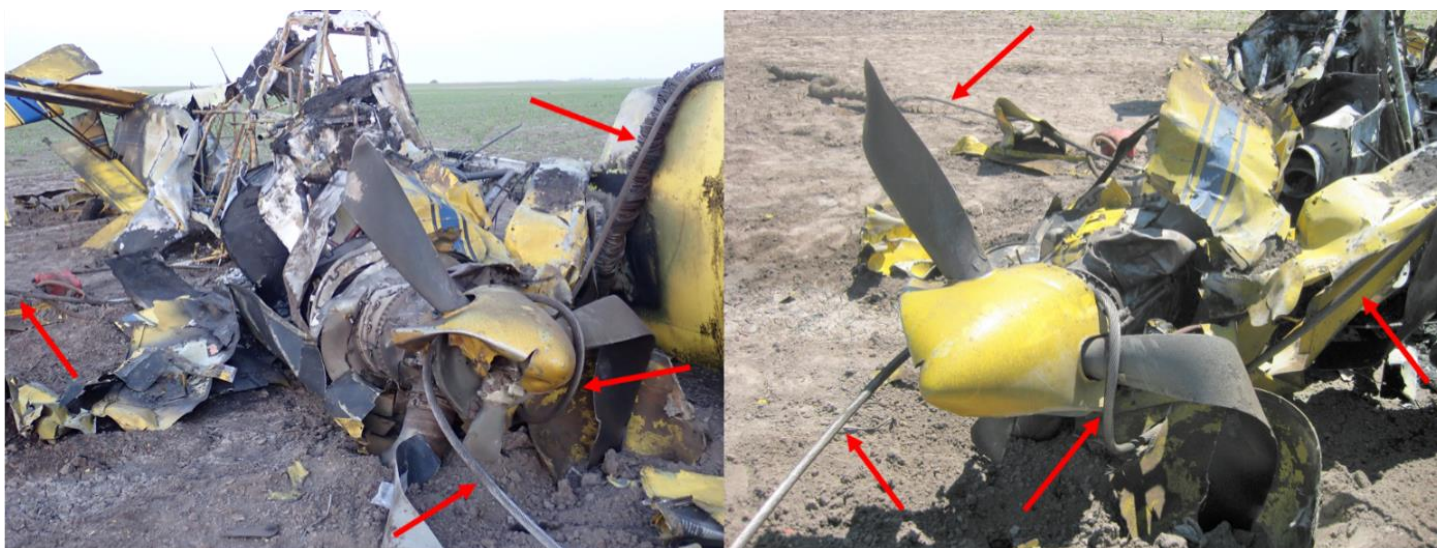
wrapped around the wing carry-through structure, right wing, and fuselage (Figure 2 and Figure 3). The forward face of the left main wing spar exhibited broad vertical marks 3-6 ft from the airplane centerline that were consistent with contact with a large diameter power transmission cable (Figure 3). The right wing was largely intact with fire damage to the inboard portion of the wing. There was no evidence of a cable strike on the leading edge of the right wing, horizontal stabilizer, or vertical stabilizer.

Figure 2 - Power Transmission Cables Conjoined with Main Wreckage (red arrows point to cables)

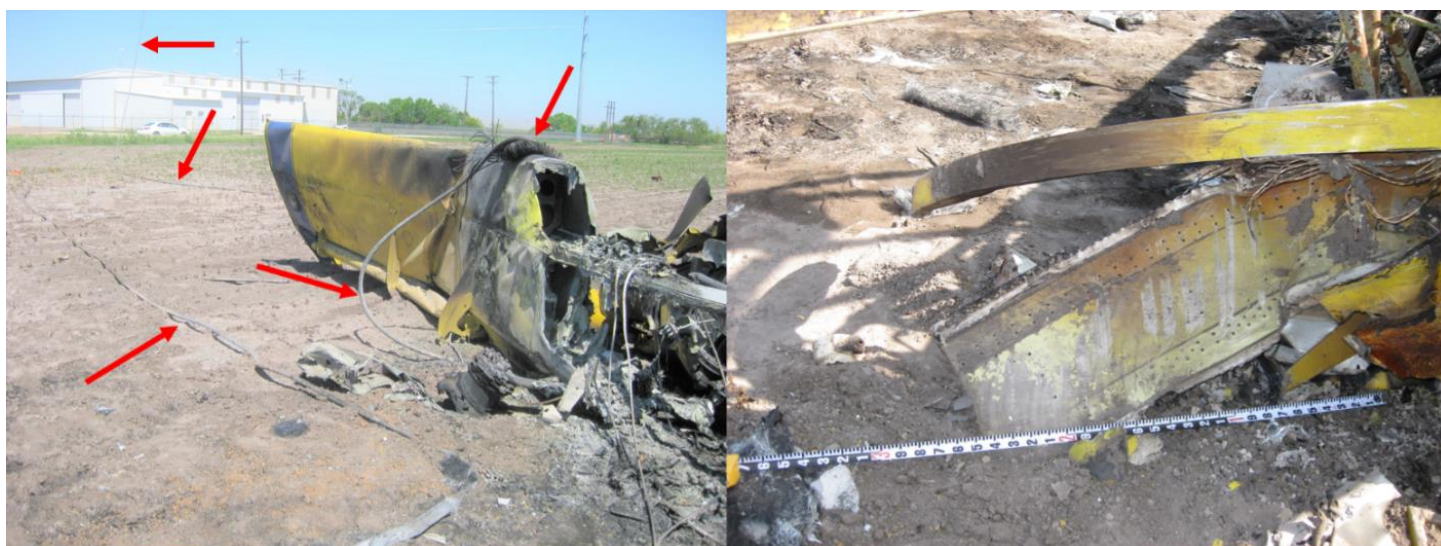
Figure 3 - Power Transmission Cables Conjoined with Right Wing (Left Image) and Cable Impact Marks to the Forward Face of the Left Main Wing Spar (Right Image)
