# The National Transportation Safety Board

Office of Aviation Safety  
Central Region  
Memorandum for the Record  
Airframe Examination  
Findings  
CEN19FA120  
Lake Mississippi  
April 13 2019

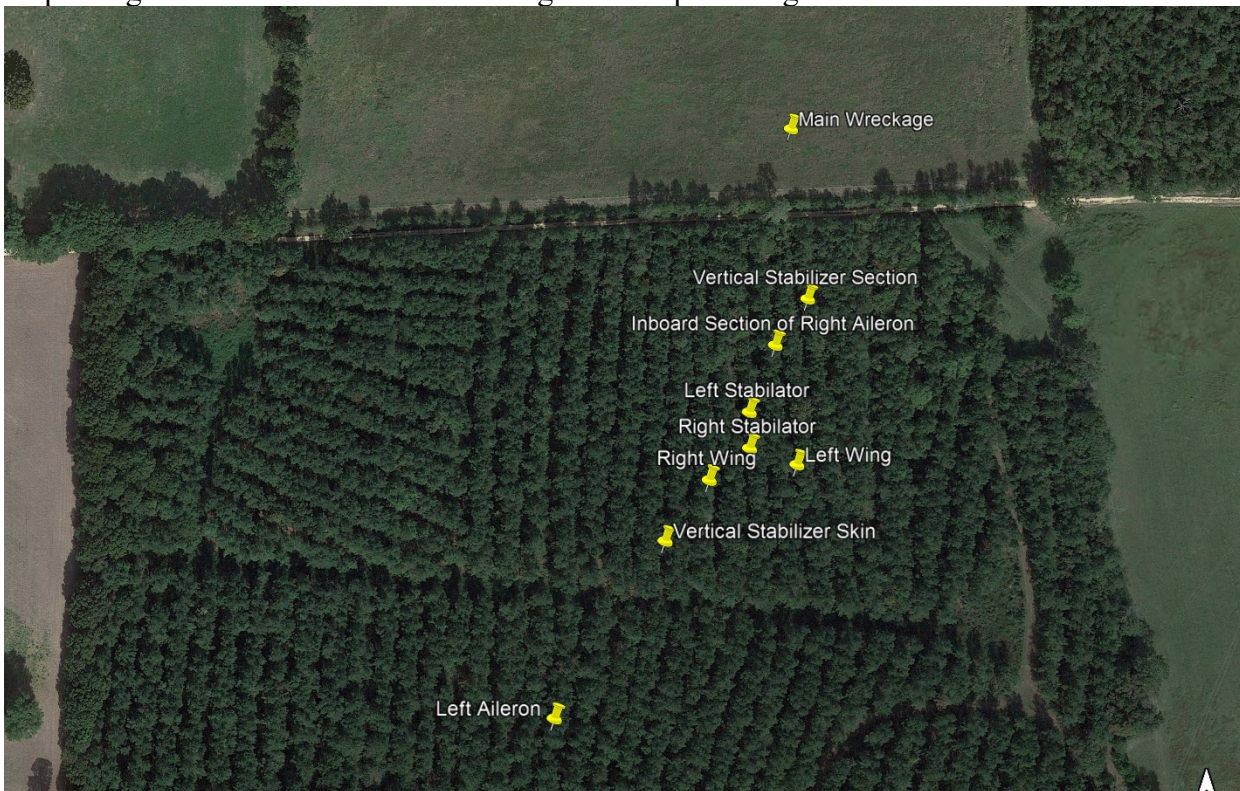
Examination of the main wreckage showed that the airplane impacted the ground at a high speed, near vertical condition. The airplane's engine and propeller were buried about 4-feet into the ground. There was no post-impact fire. The inboard sections of the left and right wings were attached to the fuselage at their respective roots and exhibited aft and upward deformations. Outboard sections of the left and right wings, and portions of the empennage, were not present with the main wreckage. A search of the wooded area adjacent to the main wreckage was conducted. The distance of the farthest part from the main wreckage (left aileron) was located about 1,500 ft from the main wreckage. Outboard sections of both the left and right wings were located about 1,000 ft from the main wreckage. The right and left horizontal stabilizers were located about 900 ft from the main wreckage. The debris path and separated sections of the wings and empennage were consistent with an in-flight breakup. See Figure 1.

Figure 1. Wreckage Distribution
