# ENGINE EXAMINATION REPORT

| AIRCRAFT MAKE & MODEL | Beechcraft 58 Baron |
| FILE NUMBER | 18-383 |

| EXAMINATION | | ACCIDENT DATA | |
|---|---|---|---|
| <b>DATE</b> | 10-8-2019 | <b>NTSB ACCIDENT #</b> | CEN19FA124 |

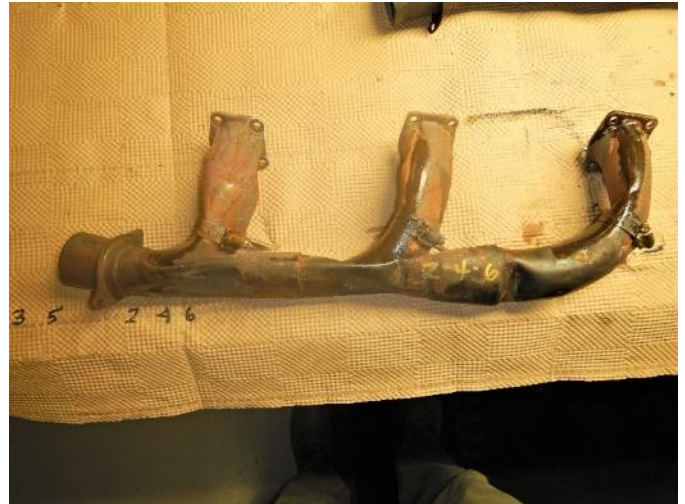
Condition: The left and right exhaust collector and risers exhibited crushing impact damage

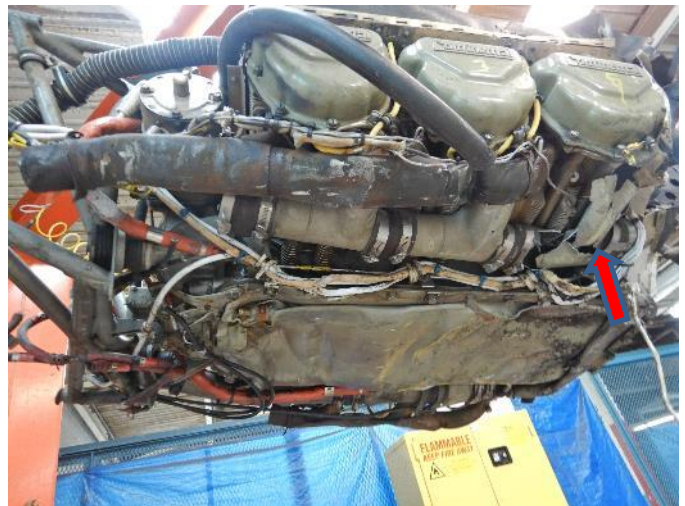
Condition: Induction elbows and connectors exhibited impact damage

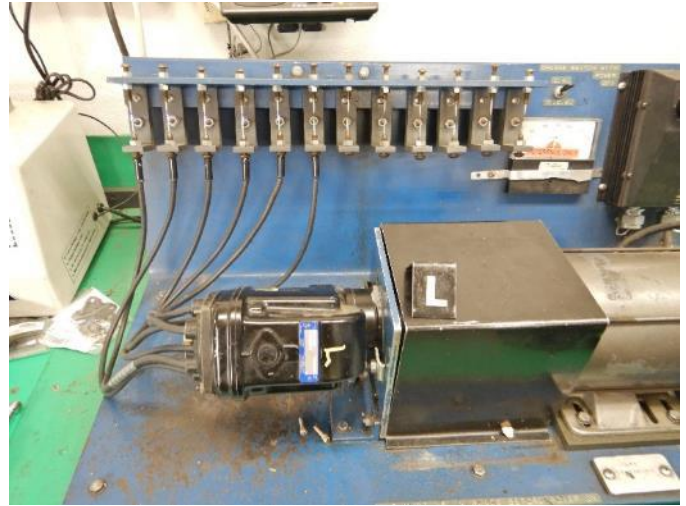
The magneto mounting ring was impact damaged, but the magneto operational test was normal producing spark at each ignition lead.

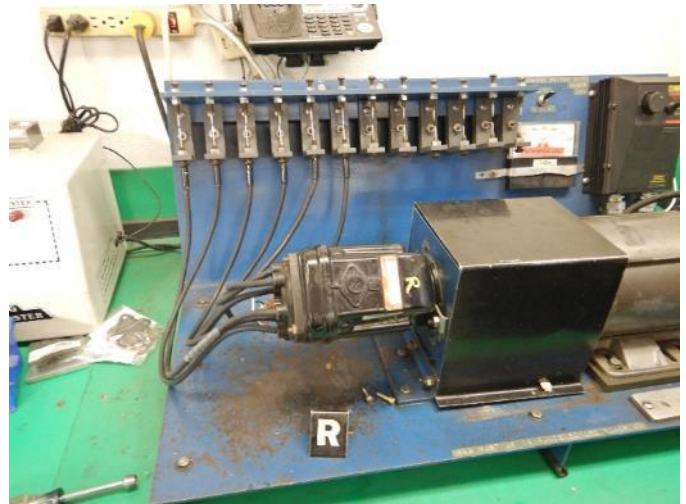
The magneto mounting ring was impact damaged, but the magneto operational test was normal producing spark at each ignition lead.

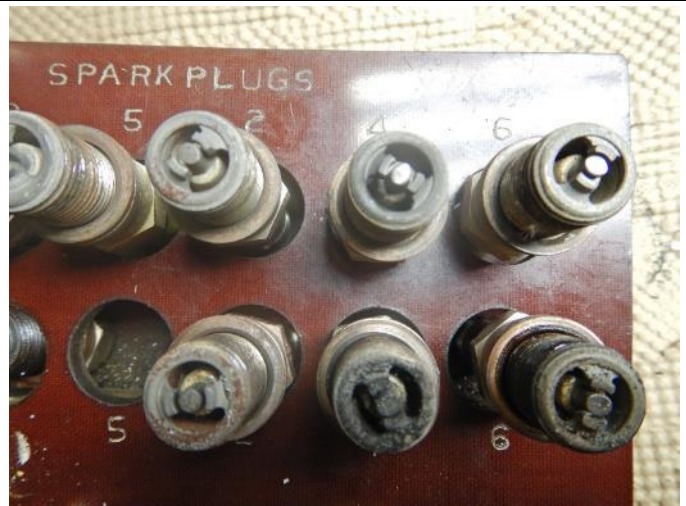
Condition: Minimal combustion deposits were present consistent with a lean fuel/air mixture. The sparkplug condition was normal to worn-out normal when compared to a Champion Check-A-Plug chart. Sparkplugs from # 4 (top) and # 3 & 5 (bottom) were impact damaged.

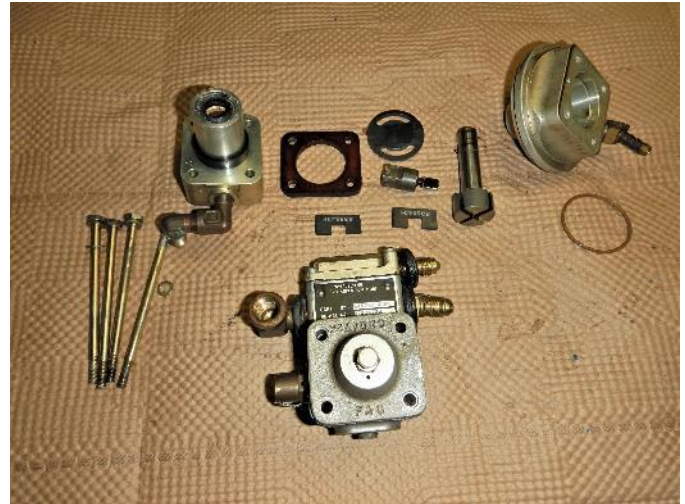
| FUEL PUMP | Manufacturer: Continental | P/N: R646212-55A1 | S/N: B16CA080R |
|---|---|---|---|
| Condition: | According to <i>Field Notes</i> from the accident site, "The coupling was intact, and the pump operated smoothly when manually rotated." At the Analytical Exam, the pump shaft would not slide from the fuel pump case due to light corrosion. Otherwise, the pump was normal in appearance. Pump impellers were intact. | | |

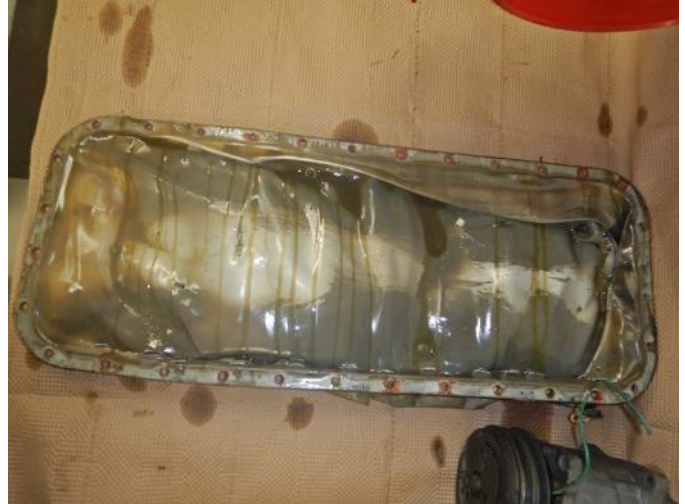
Condition: The oil sump was impact crushed.

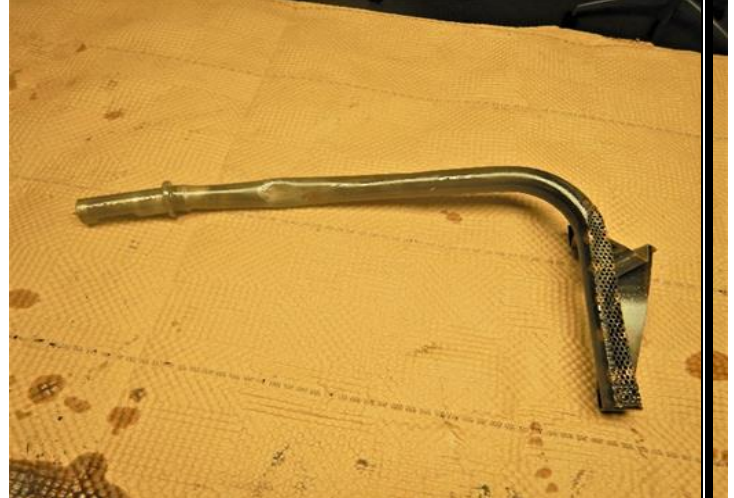
Condition: The pickup tube was clean, and the suction tube was impact damaged.

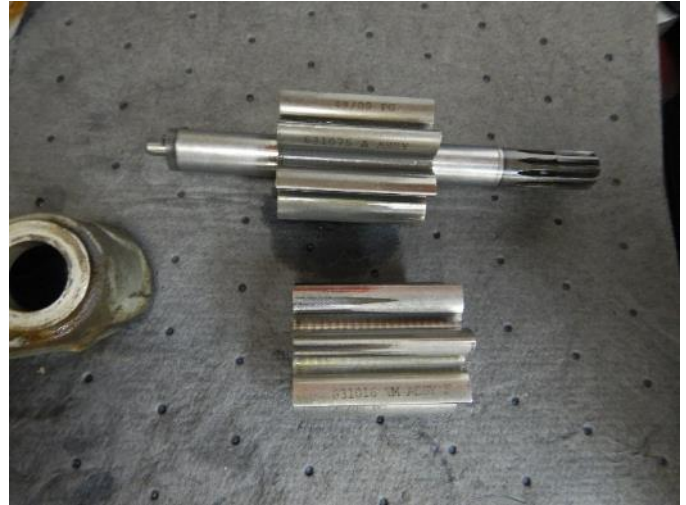
The oil pump rotated smoothly when turned manually. No evidence of hard particle passage on pump chamber or gears.

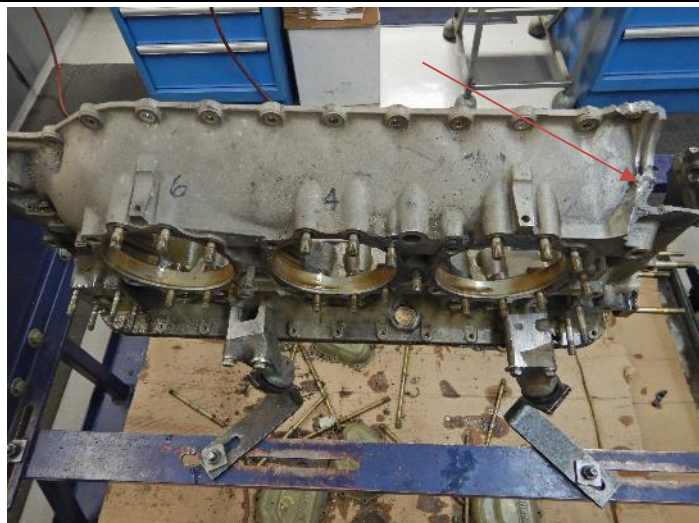
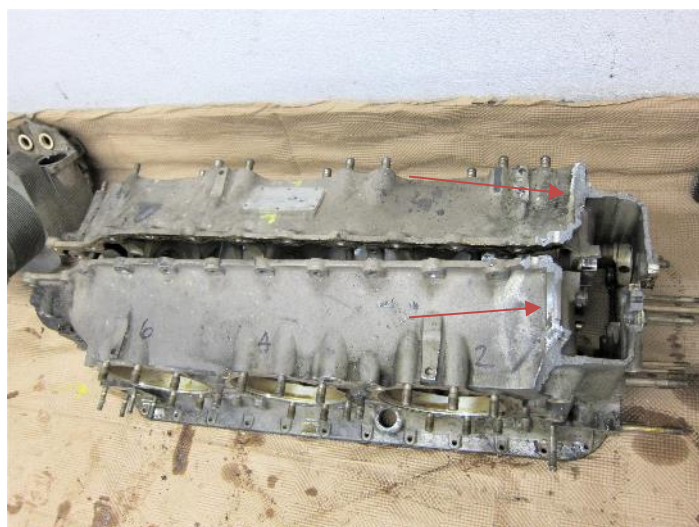
The top rear portion of the crankcase halves separated during disassembly of the engine due to impact damage near the magneto mounts. Otherwise, the crankcase was unremarkable. See red arrows.

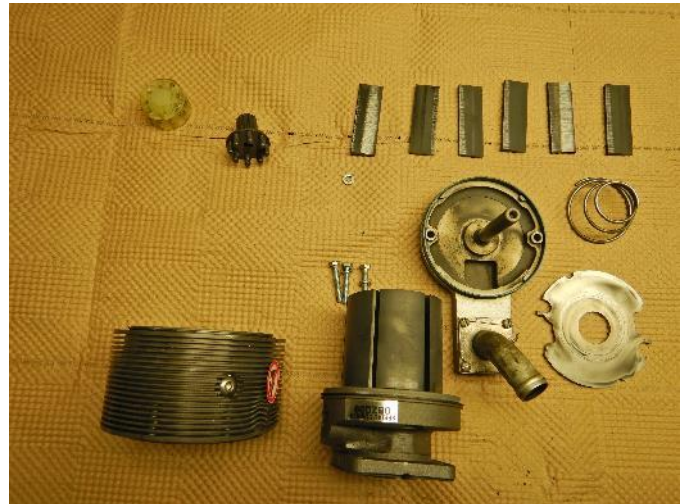
The outside pump housing was impact damaged. The carbon rotor and vanes were intact. The drive couplings were intact. The pressure plate and housing exhibited normal wear signatures.

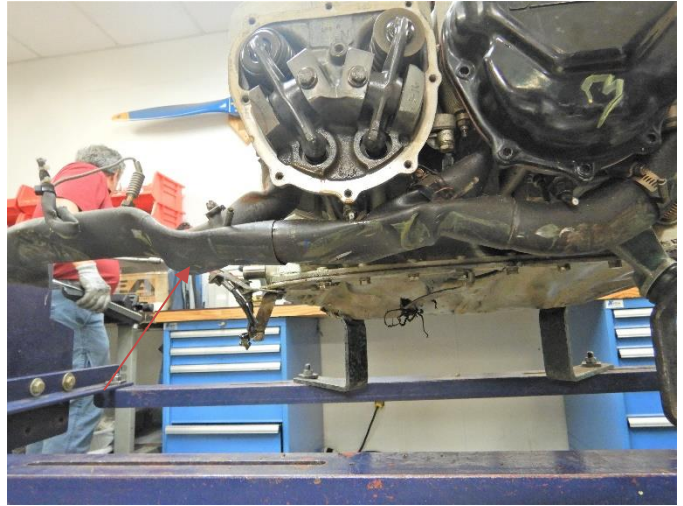
Condition: Exhaust components were impact damaged.

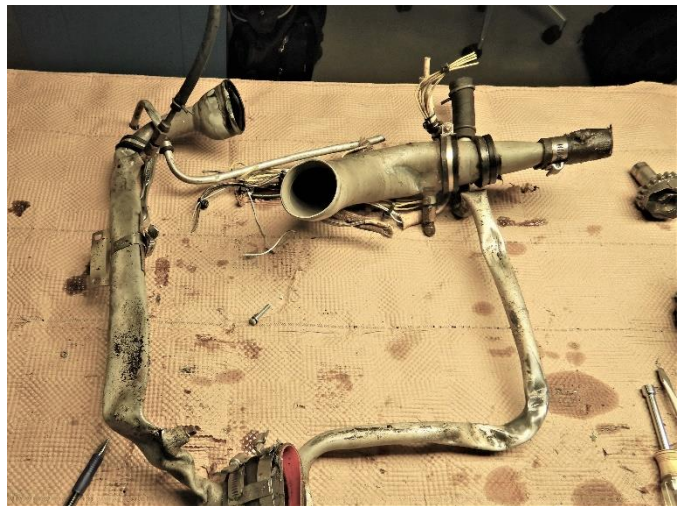
Condition: Several induction components exhibited impact damage.

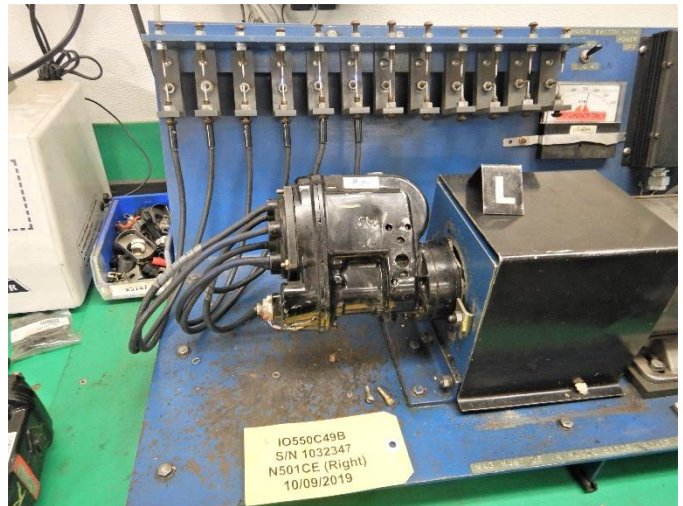
| Condition: | The mount flange was impact damaged. The impulse coupling released normally, and the magneto functional test was normal. | | |

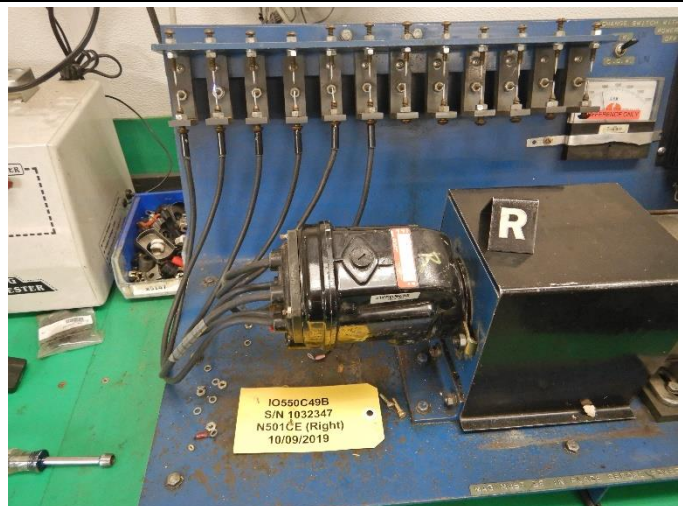
| Condition: | The mount flange was impact damaged. The impulse coupling released normally, and the magneto functional test was normal. | | |

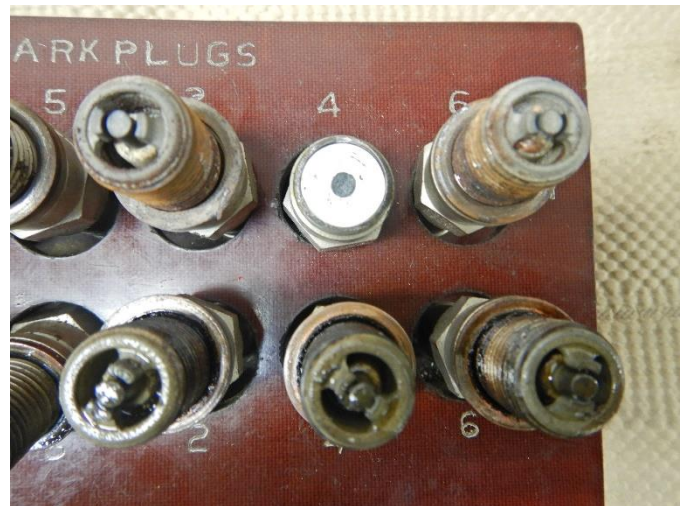
| Condition: | Top sparkplug # 4 and bottom sparkplug # 5 were impact damaged. When compared to a Champion Sparkplug "Check-A-Plug" chart, the condition was <i>worn out normal</i> with only minimal combustion deposits consistent with a lean fuel mixture. | |

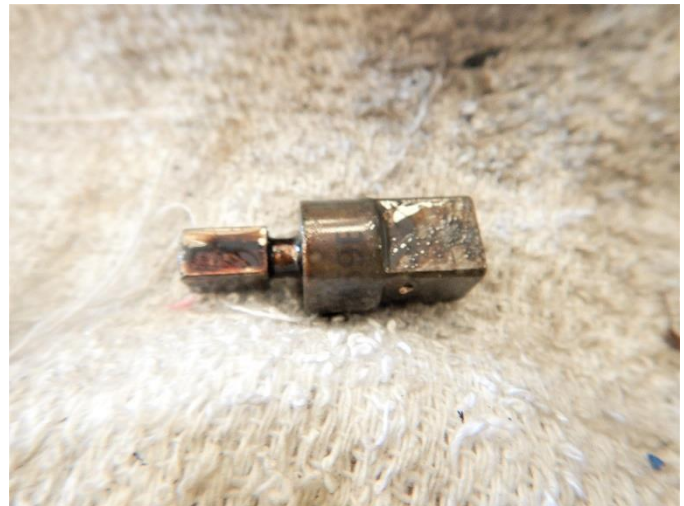
| FUEL PUMP | Manufacturer: Continental | P/N: R646212-55A1 | S/N: B16CA080R |
|---|---|---|---|
| Condition: | The fuel pump drive coupling was intact, and the fuel pump operated smoothly when manually rotated. A lead seal was present on the assembly bolts. The pump shaft would not slide from case bushing due to light corrosion on steel shaft. | | |

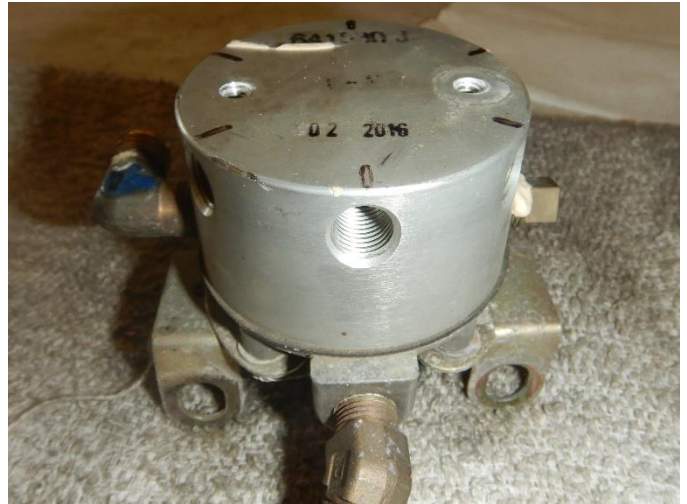
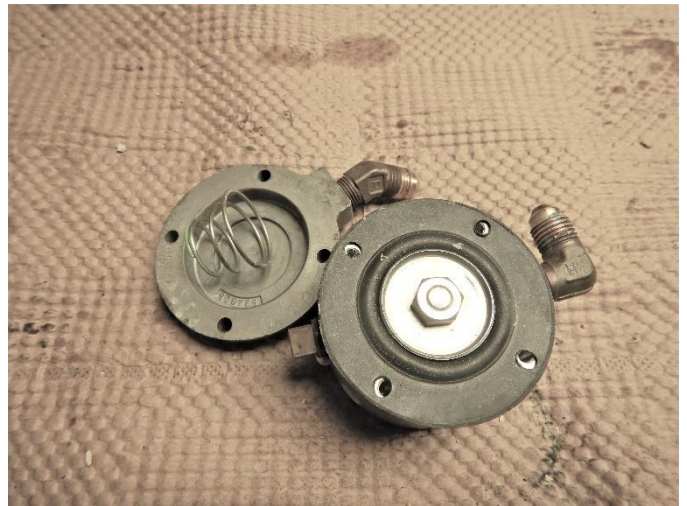
The fuel manifold data plate was removed by unknown persons at the accident site. The two assembly screws were missing. The data plate was located on the crankcase near the fuel manifold mount. The photo below on the top left is from the accident site. Assembly hardware was secured properly.

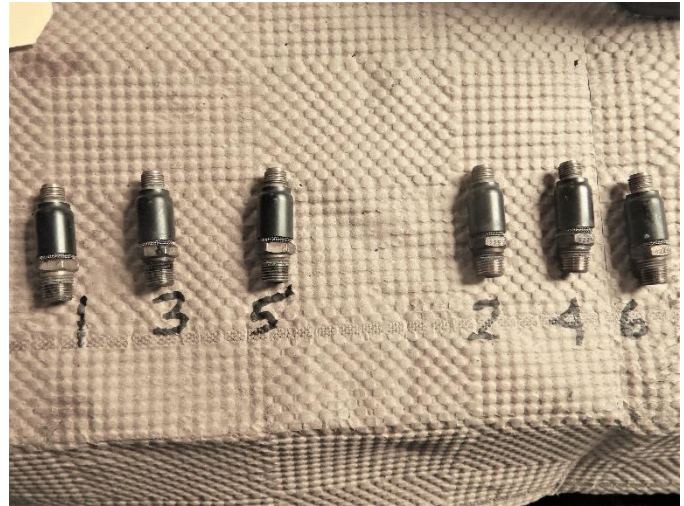
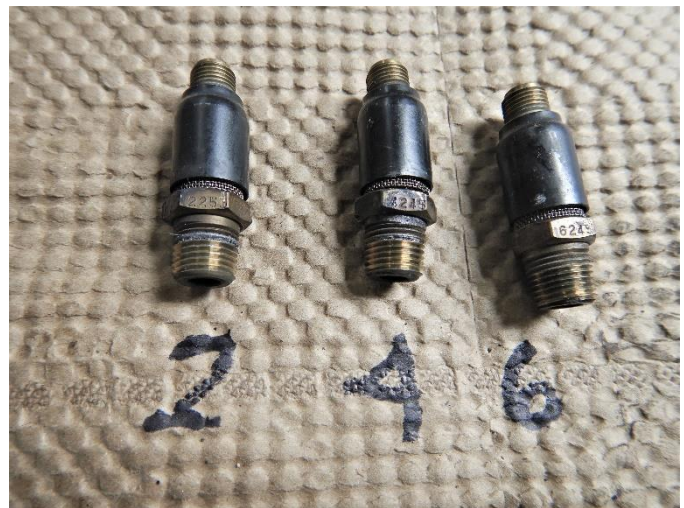
| Position | #1 | #3 | #5 | #2 | #4 | #6 |
|---|---|---|---|---|---|---|
| Condition: | All injection orifices were open. Injector # 4 was impact damaged. | | | | | |

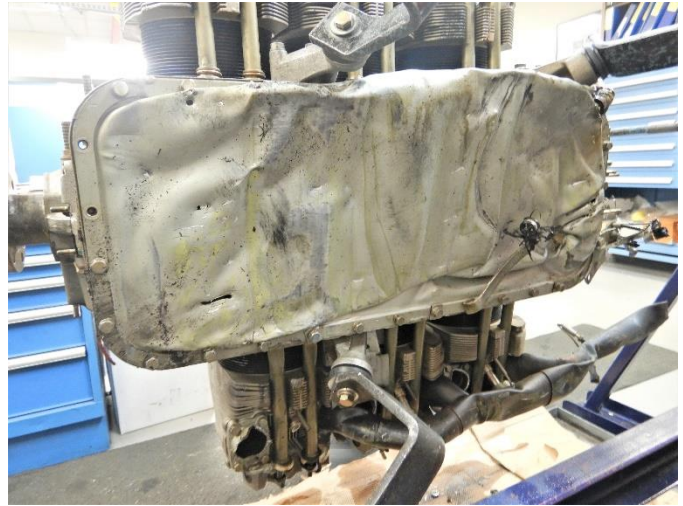
Condition: The oil sump was impact damaged.

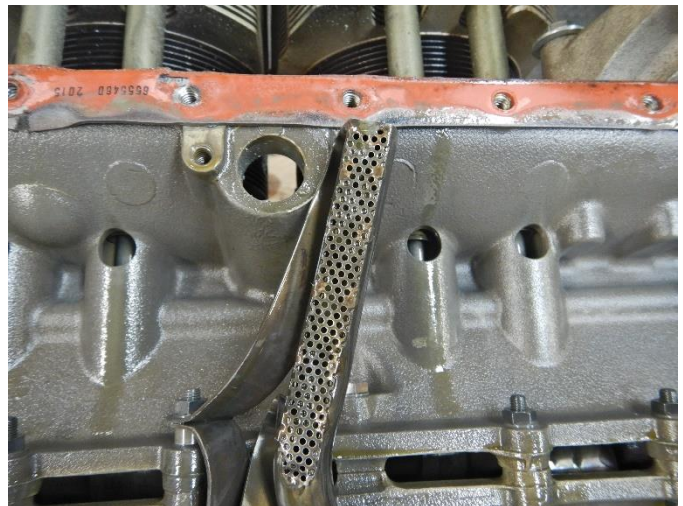
Condition: The pick-up tube was displaced upward due to impact forces. The screen was clean.

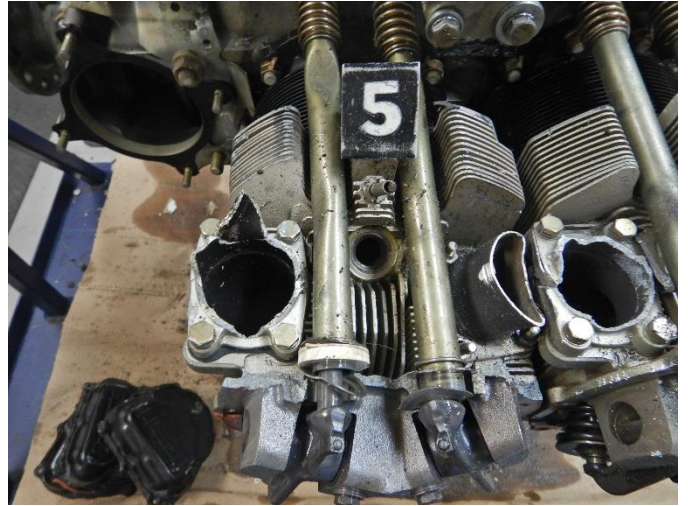
| Condition: | Cylinder # 5 exhibited impact damage to the lower cylinder head and push rods. | | |

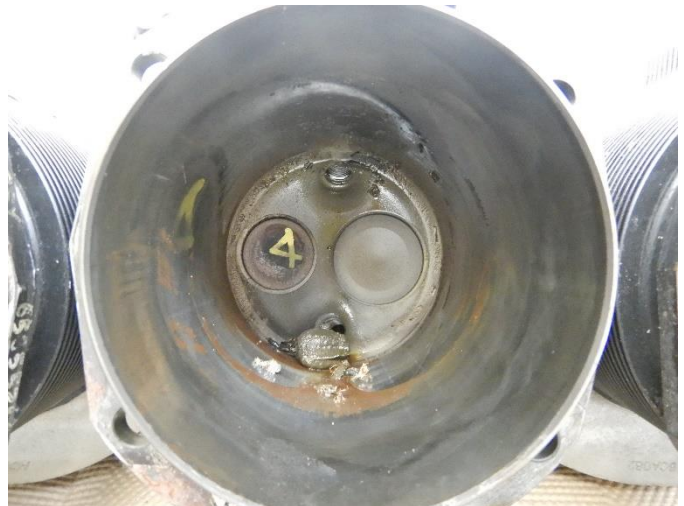
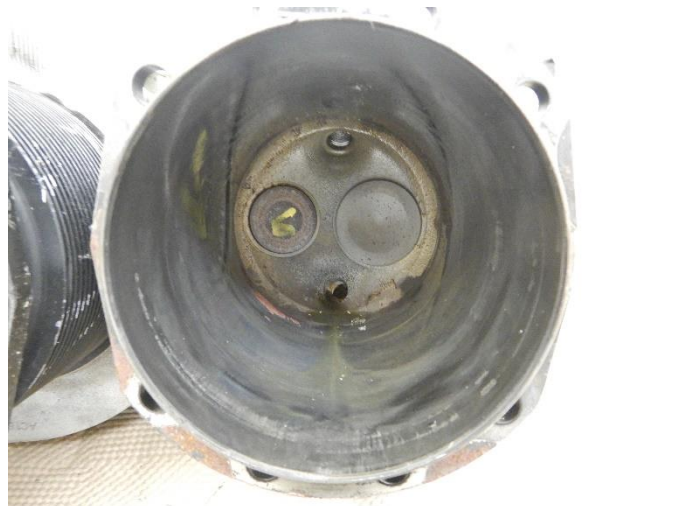
All valves were intact. Valve heads and combustion chambers were nearly devoid of combustion deposits.

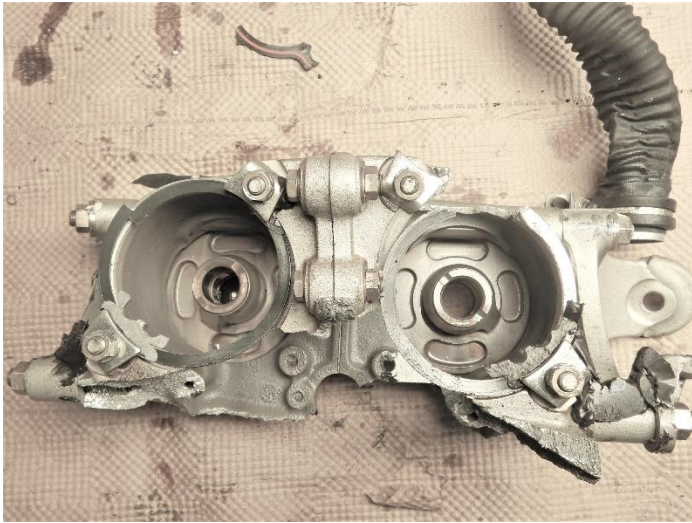
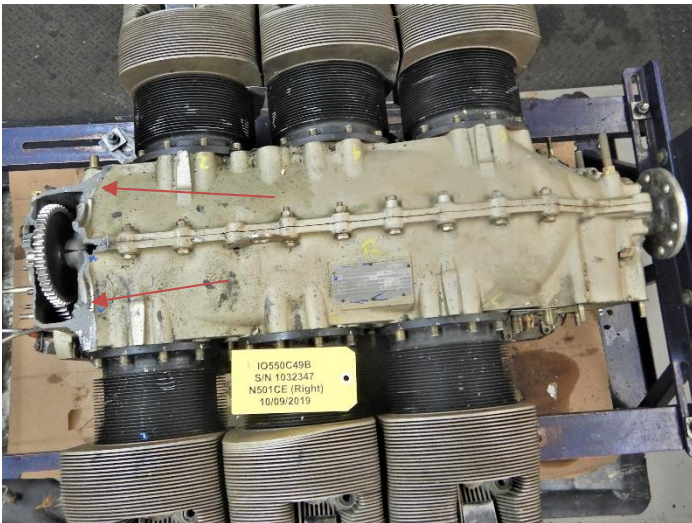
| Condition: | The rear-top portion of the crankcase at the magneto mount/top engine mount separated due to impact damage. The top section released during the engine examination. | | | |

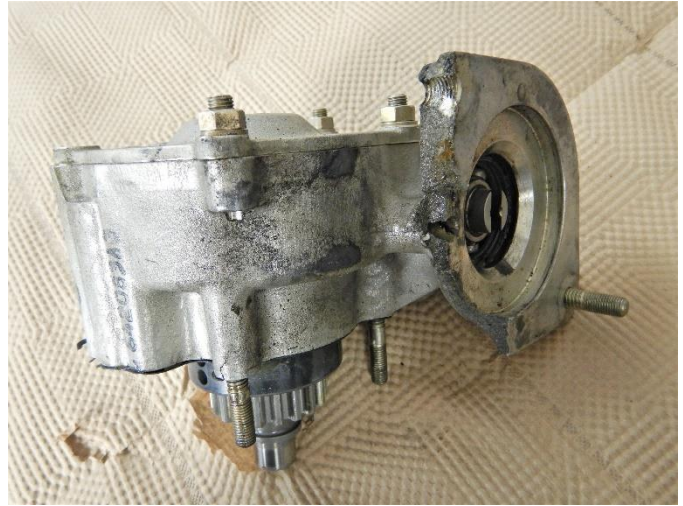
| Condition: | The starter motor mounting ring was broken. The starter adapter turned smoothly when manually rotated. | | |

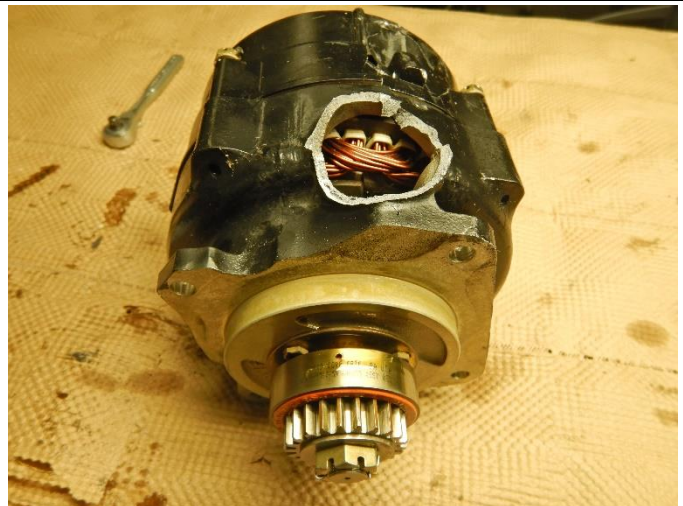
| Condition: | The alternator rotated smoothly. The lower case exhibited impact damage. The drive coupling was intact and secured properly. | | |
