## **NATIONAL TRANSPORTATION SAFETY BOARD**

### **Weather Study**

# **METEOROLOGY**

CEN19FA140

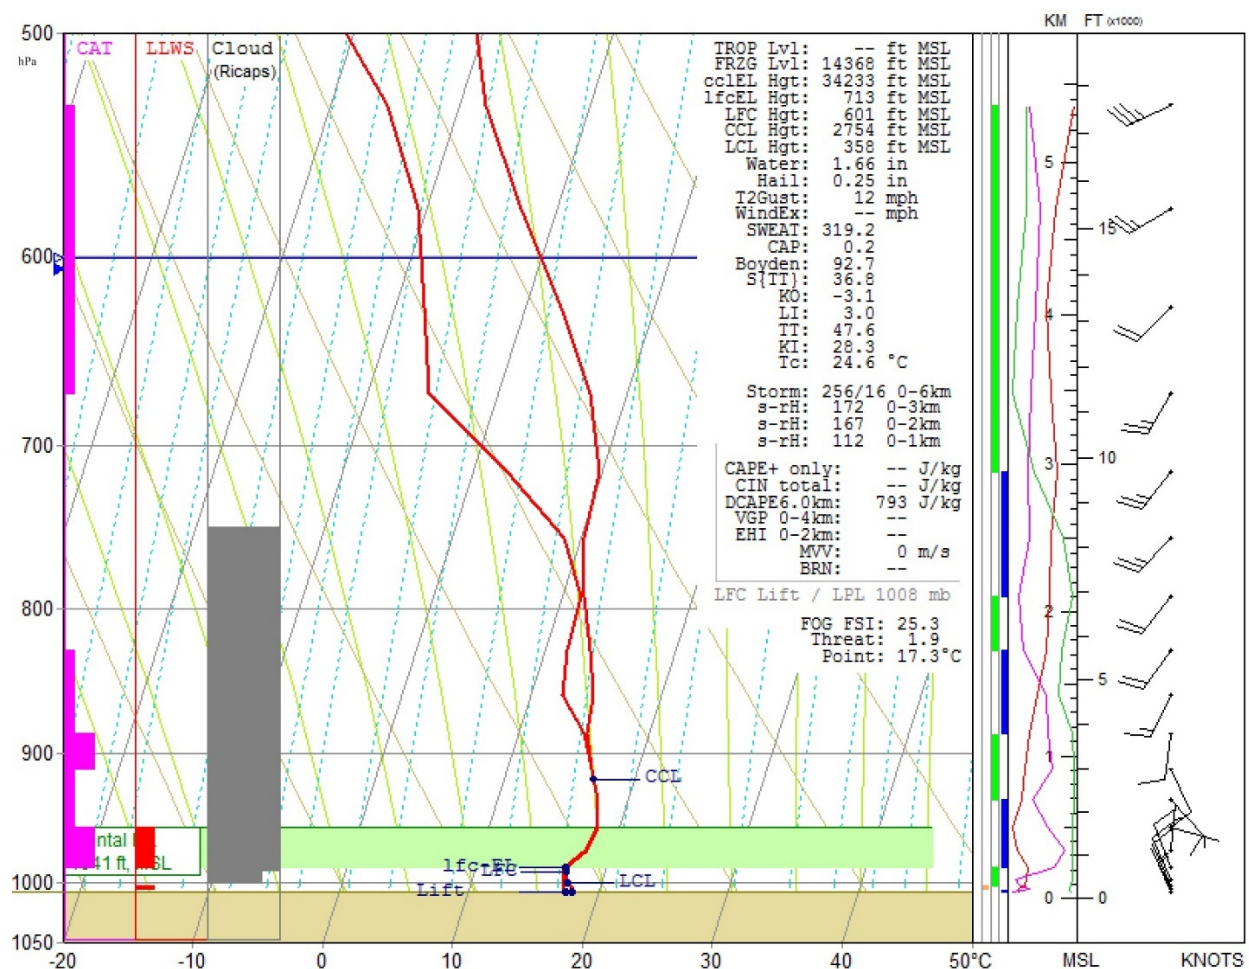
A High-Resolution Rapid Refresh (HRRR) model<sup>4</sup> sounding for the accident site at 0800 CDT (figure 1) was retrieved from the National Oceanic and Atmospheric Administration's Air Resources Laboratory. The sounding revealed that a temperature inversion was present between about 650 and 1,600 feet. The relative humidity was greater than 95 percent between the surface and about 4,200 feet, and the Rawinsonde Observation Program (RAOB) projected cloudy conditions from about 350 through 8,400 feet. RAOB produced a fog stability index of 25.3 (high severity) and a fog threat of 1.9 (medium severity). The wind in the lowest 800 feet was northerly or north-northwesterly at around 10 knots. Above this layer the wind veered significantly to a south wind at about 1,100 feet but remained at or below 12 knots. Between 1,110 and 10,000 feet the wind was southerly to southwesterly at magnitudes between 10 and 25 knots.

**Figure 1** – HRRR model sounding data in SkewT/LogP format for 0800 CDT at the accident site, surface to 500 hectopascals.

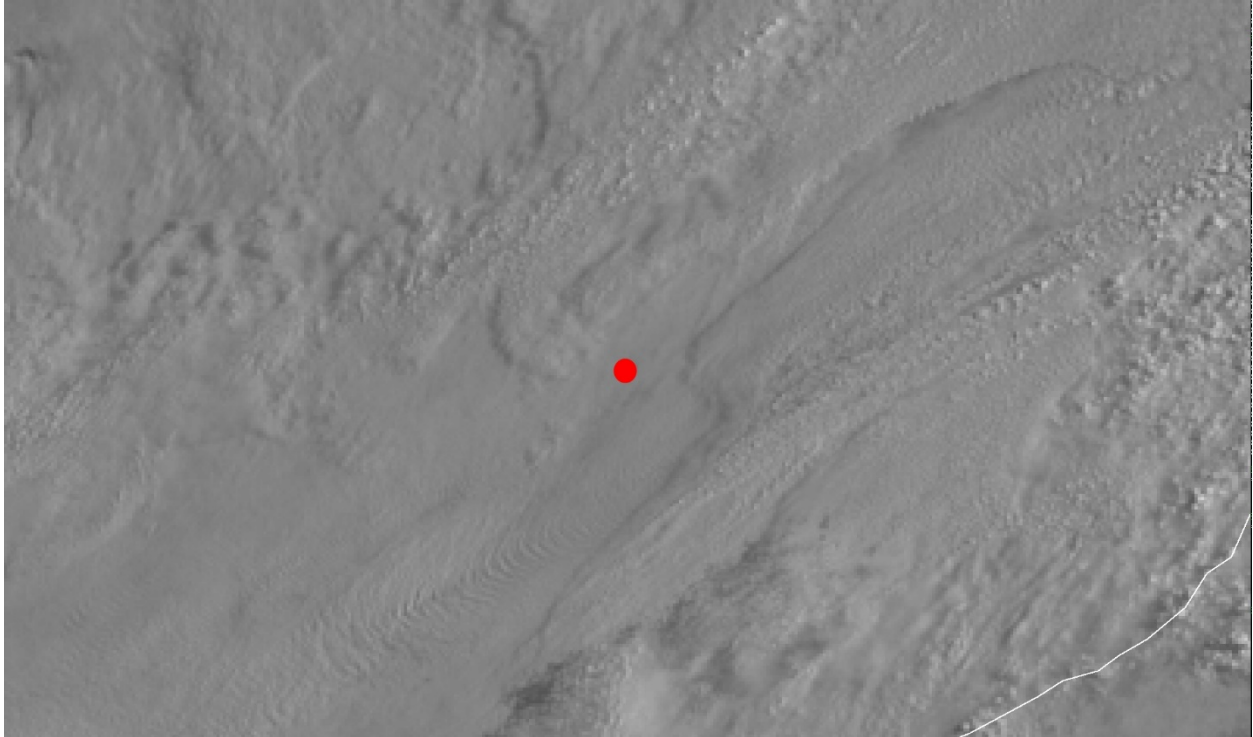
Geostationary Operational Environmental Satellite (GOES)-16 visible ( $0.64\mu\text{m}$ ) and infrared ( $10.3\mu\text{m}$ ) data were obtained from an archive at the Space Science Engineering Center at the University of Wisconsin-Madison. Imagery from 0831 CDT are presented in figures 2 and 3. The satellite imagery identified cloudy conditions over the accident region, with brightness temperatures of  $10^{\circ}\text{C}$  over the accident location. Considering the 0800 CDT HRRR sounding,  $10^{\circ}\text{C}$  corresponded to cloud top heights of about 9,000 feet.

**Figure 2** – GOES-16 visible imagery from 0831 CDT. Accident location denoted by red circle. This image has not been corrected for any parallax error.

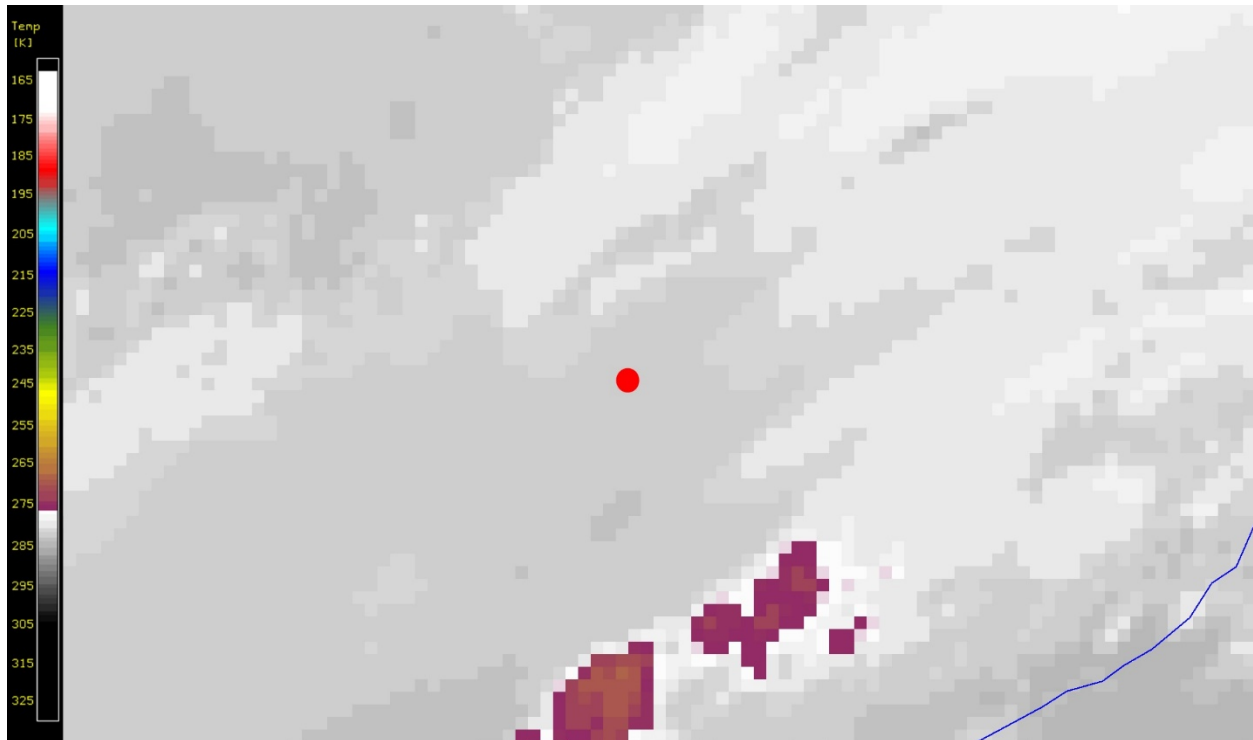
**Figure 3** – GOES-16 infrared imagery (brightness temperature in degrees Kelvin) from 0831 CDT. Accident location denoted by the red dot. This image has not been corrected for any parallax error.

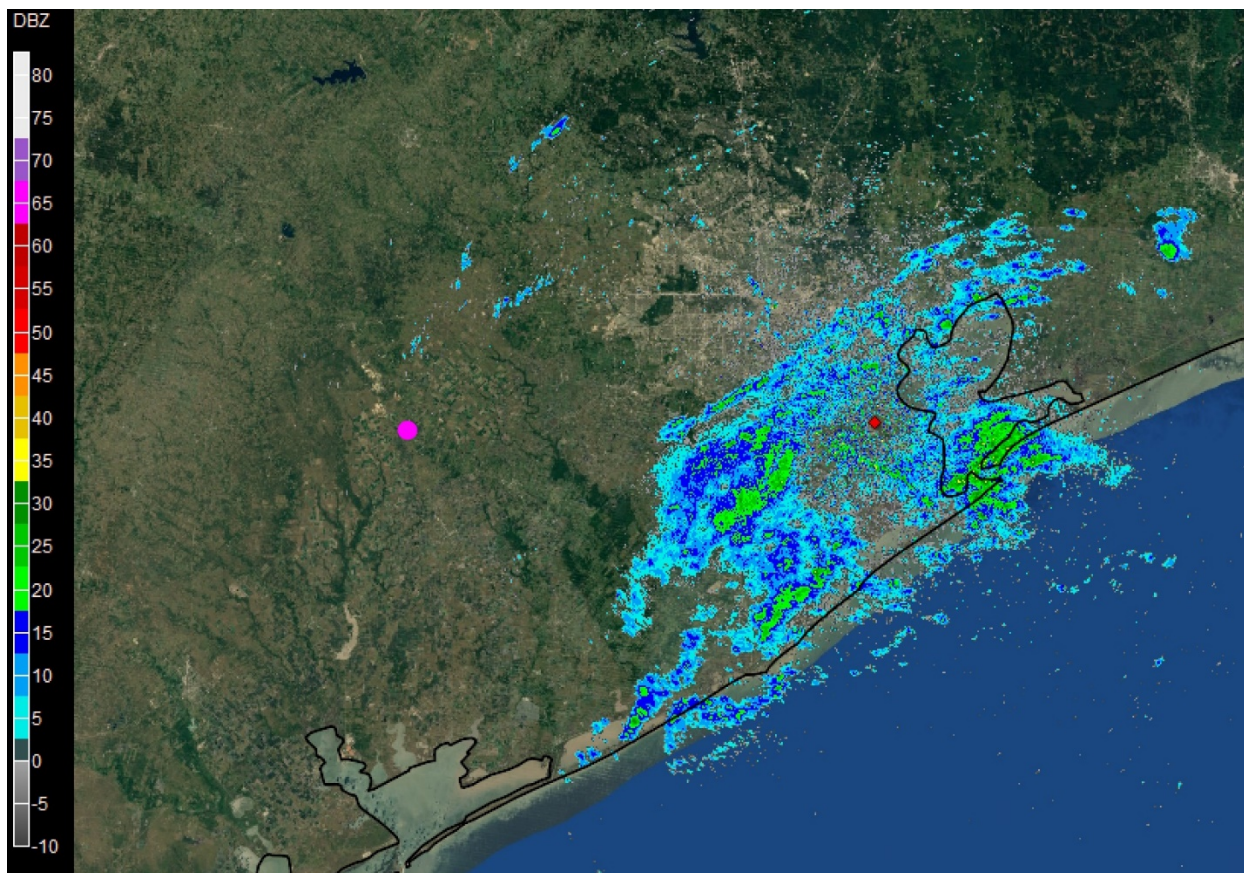
The WSR-88D<sup>5</sup> Level-II weather radar imagery from the KHGX site is presented in figure 4. KHGX was located approximately 69 miles east of the accident location at an elevation of about 115 feet. Assuming standard refraction and considering the 0.95° beam width<sup>6</sup> for the WSR-88D radar beam, the KLRX 0.48° tilt would have “seen” altitudes above the accident location of between about 3,300 and 10,300 feet. Around the time of the accident, there were no pertinent areas of reflectivity depicted at or next to the accident location.

**Figure 4** – KHGX 0.48° Level-II reflectivity product from a sweep initiated at 0815 CDT. Accident location marked by pink circle.

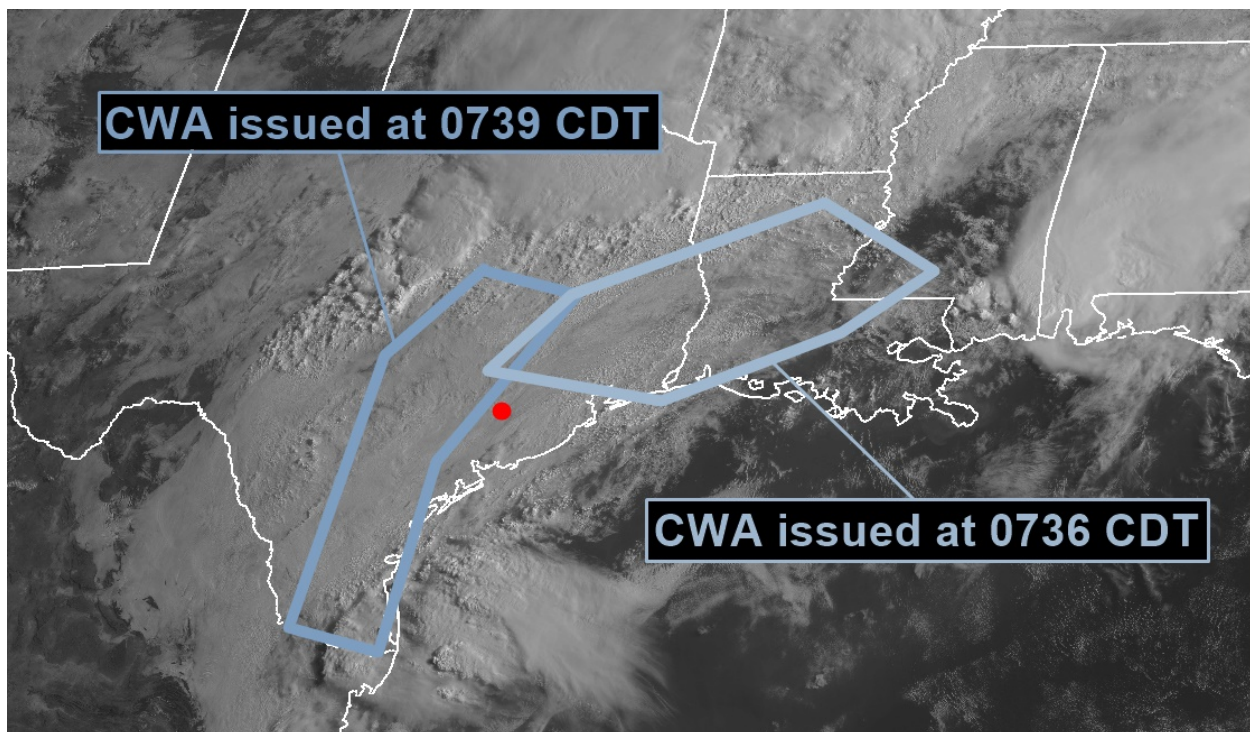
Two Center Weather Advisories (CWA) for LIFR conditions<sup>9</sup> were issued by the Center Weather Service Unit (CWSU) at the Houston Air Route Traffic Control Center (ZHU) that were active for near the accident location at the accident time (see figure 5).

**Figure 5** – CWAs issued by the ZHU CWSU active for near the accident location at the accident time. Accident location marked by red circle.
