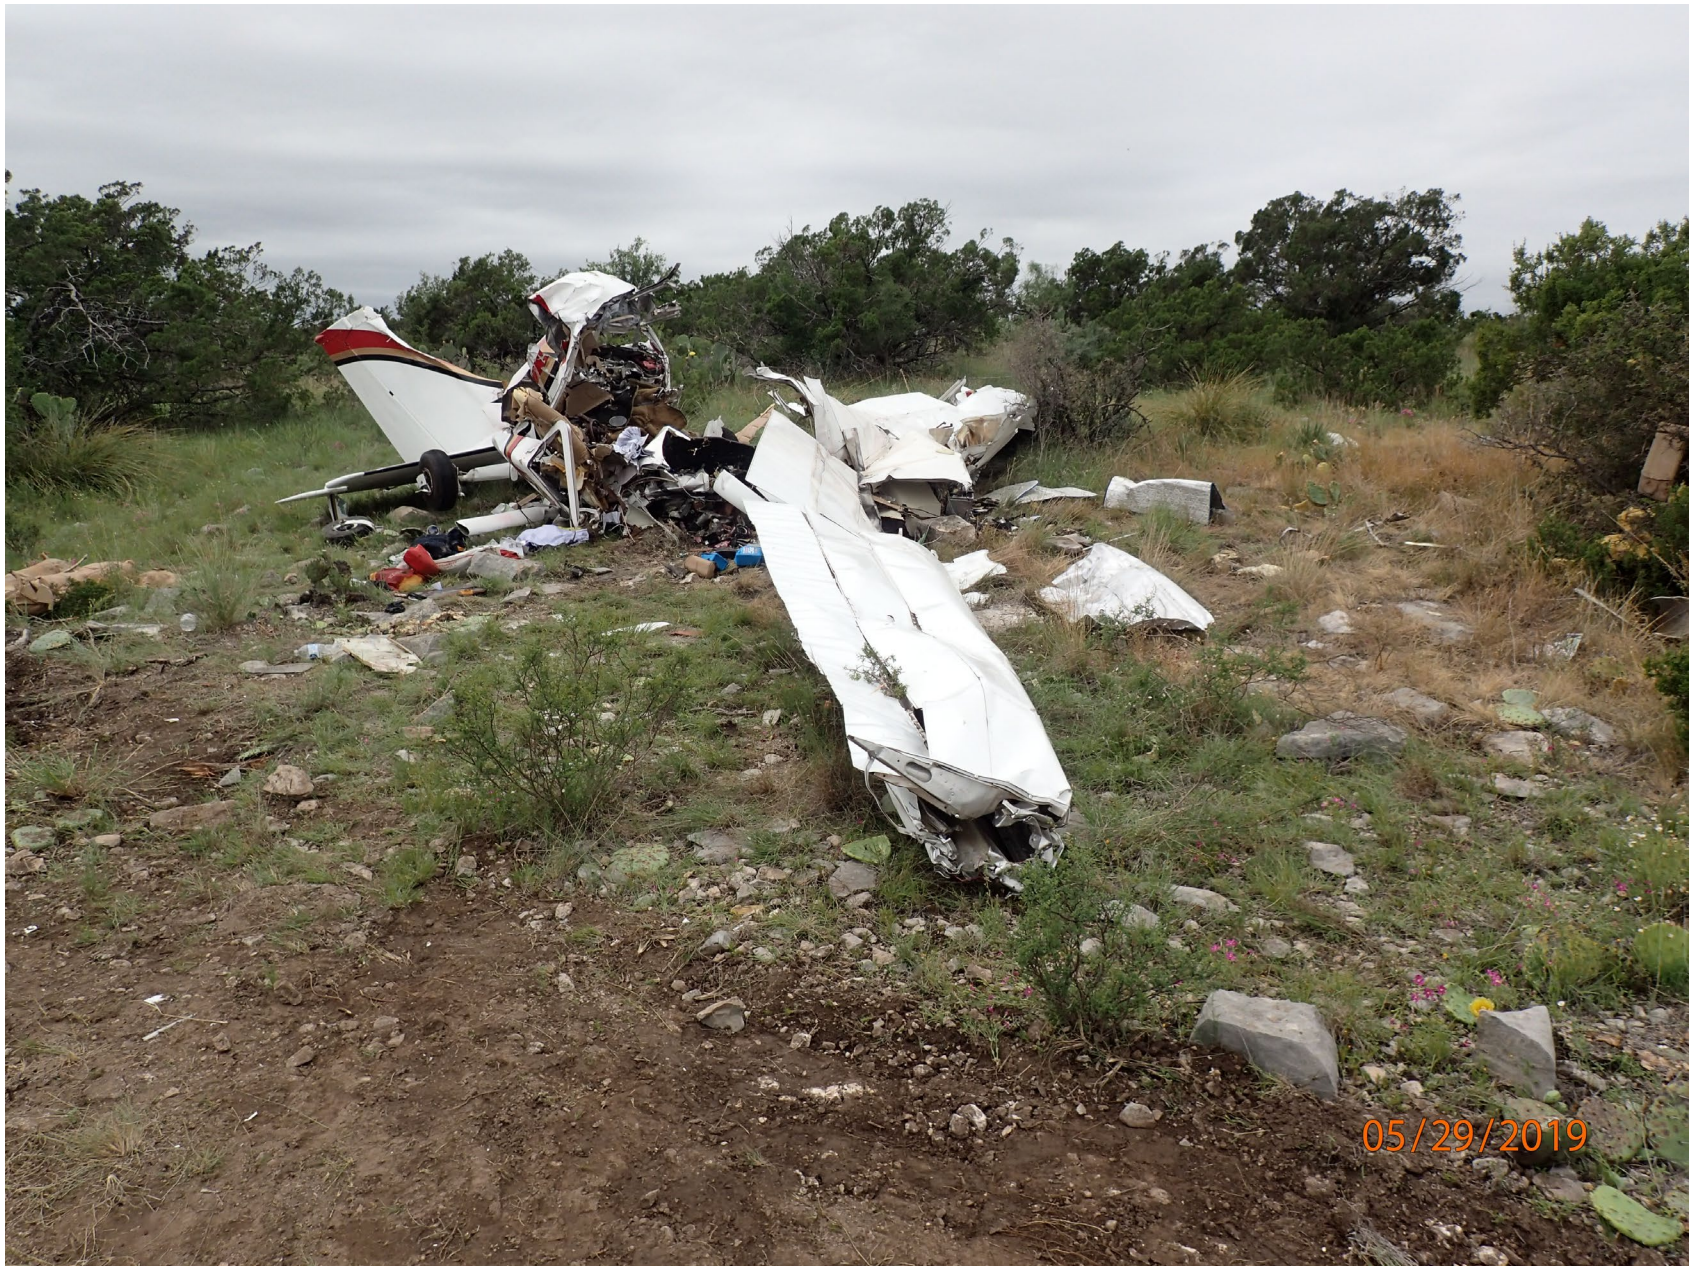
**Photo 1 – Accident Site as Viewed from the Right Wing Tip**

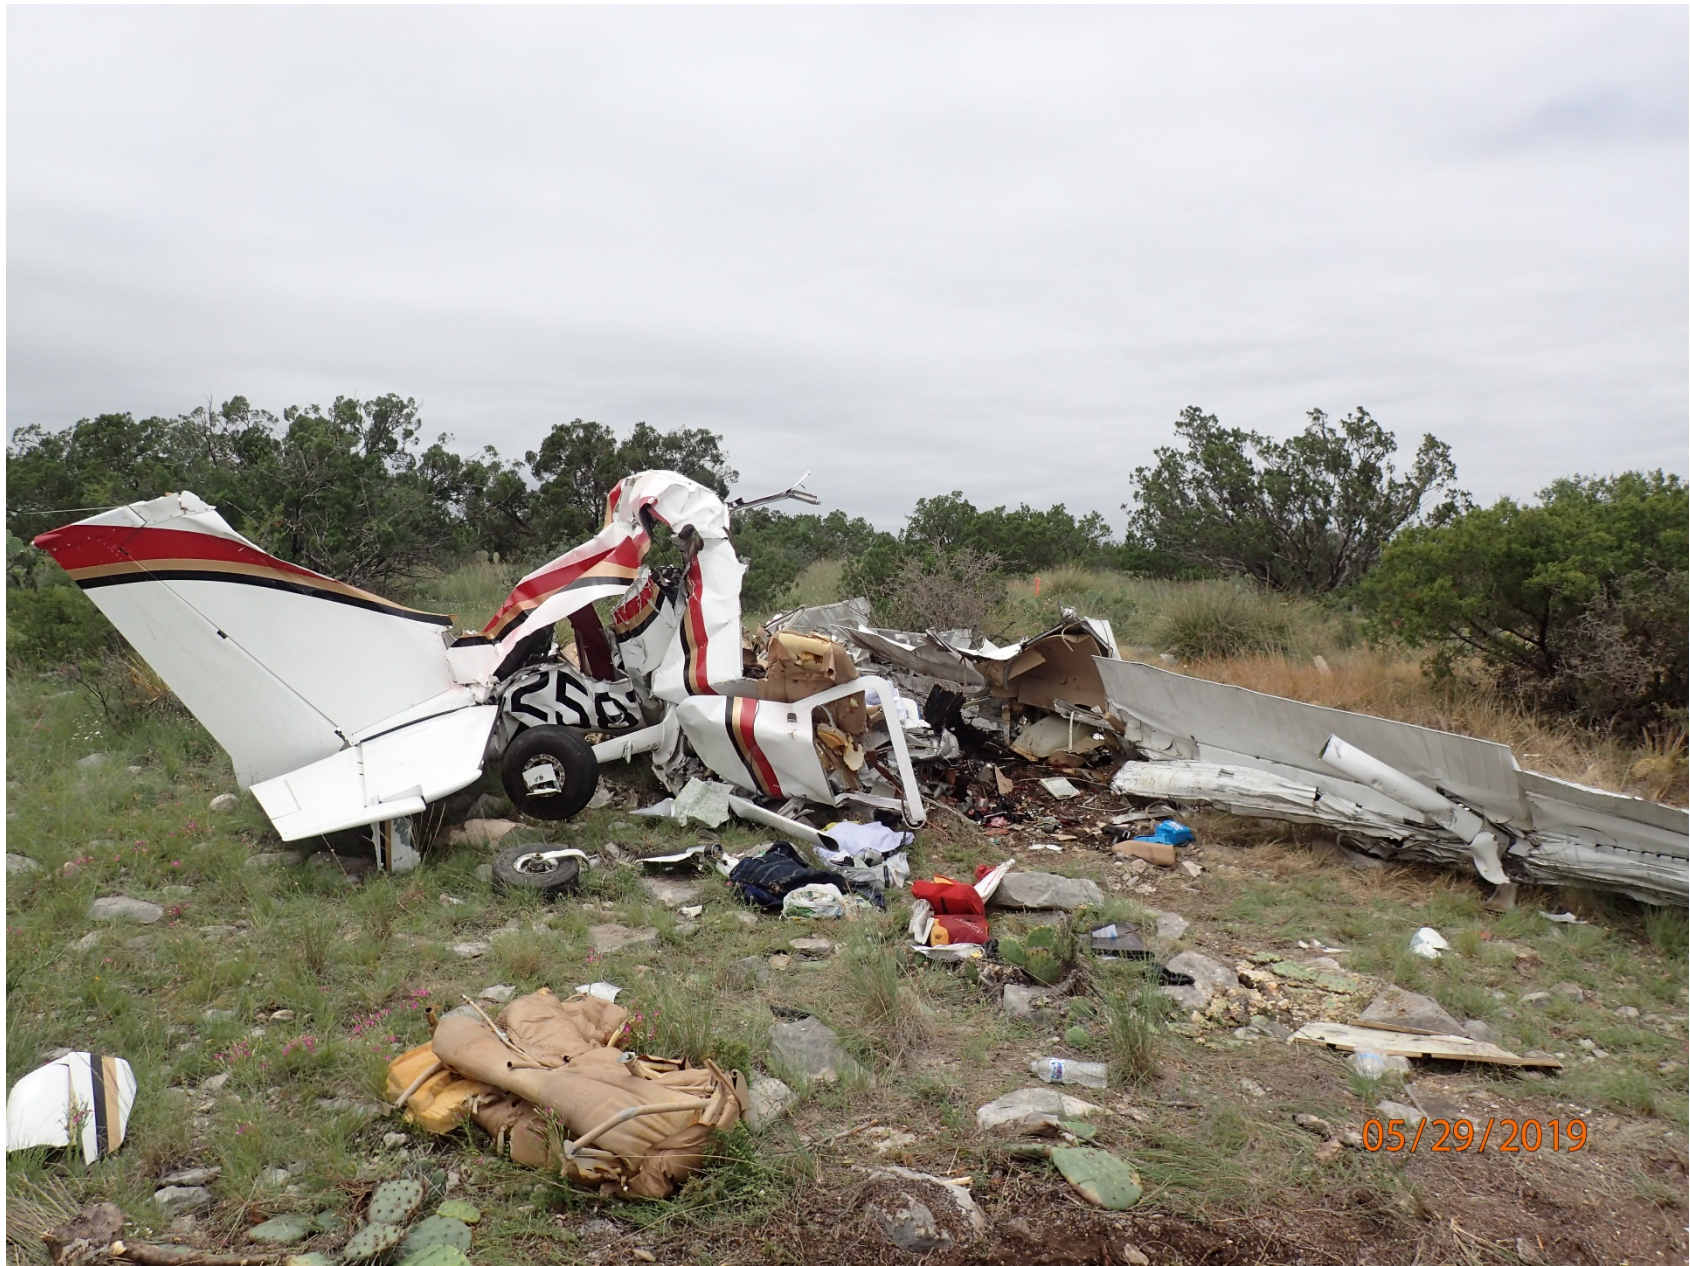
**Photo 2 – Accident Site as Viewed from the Tail Section**

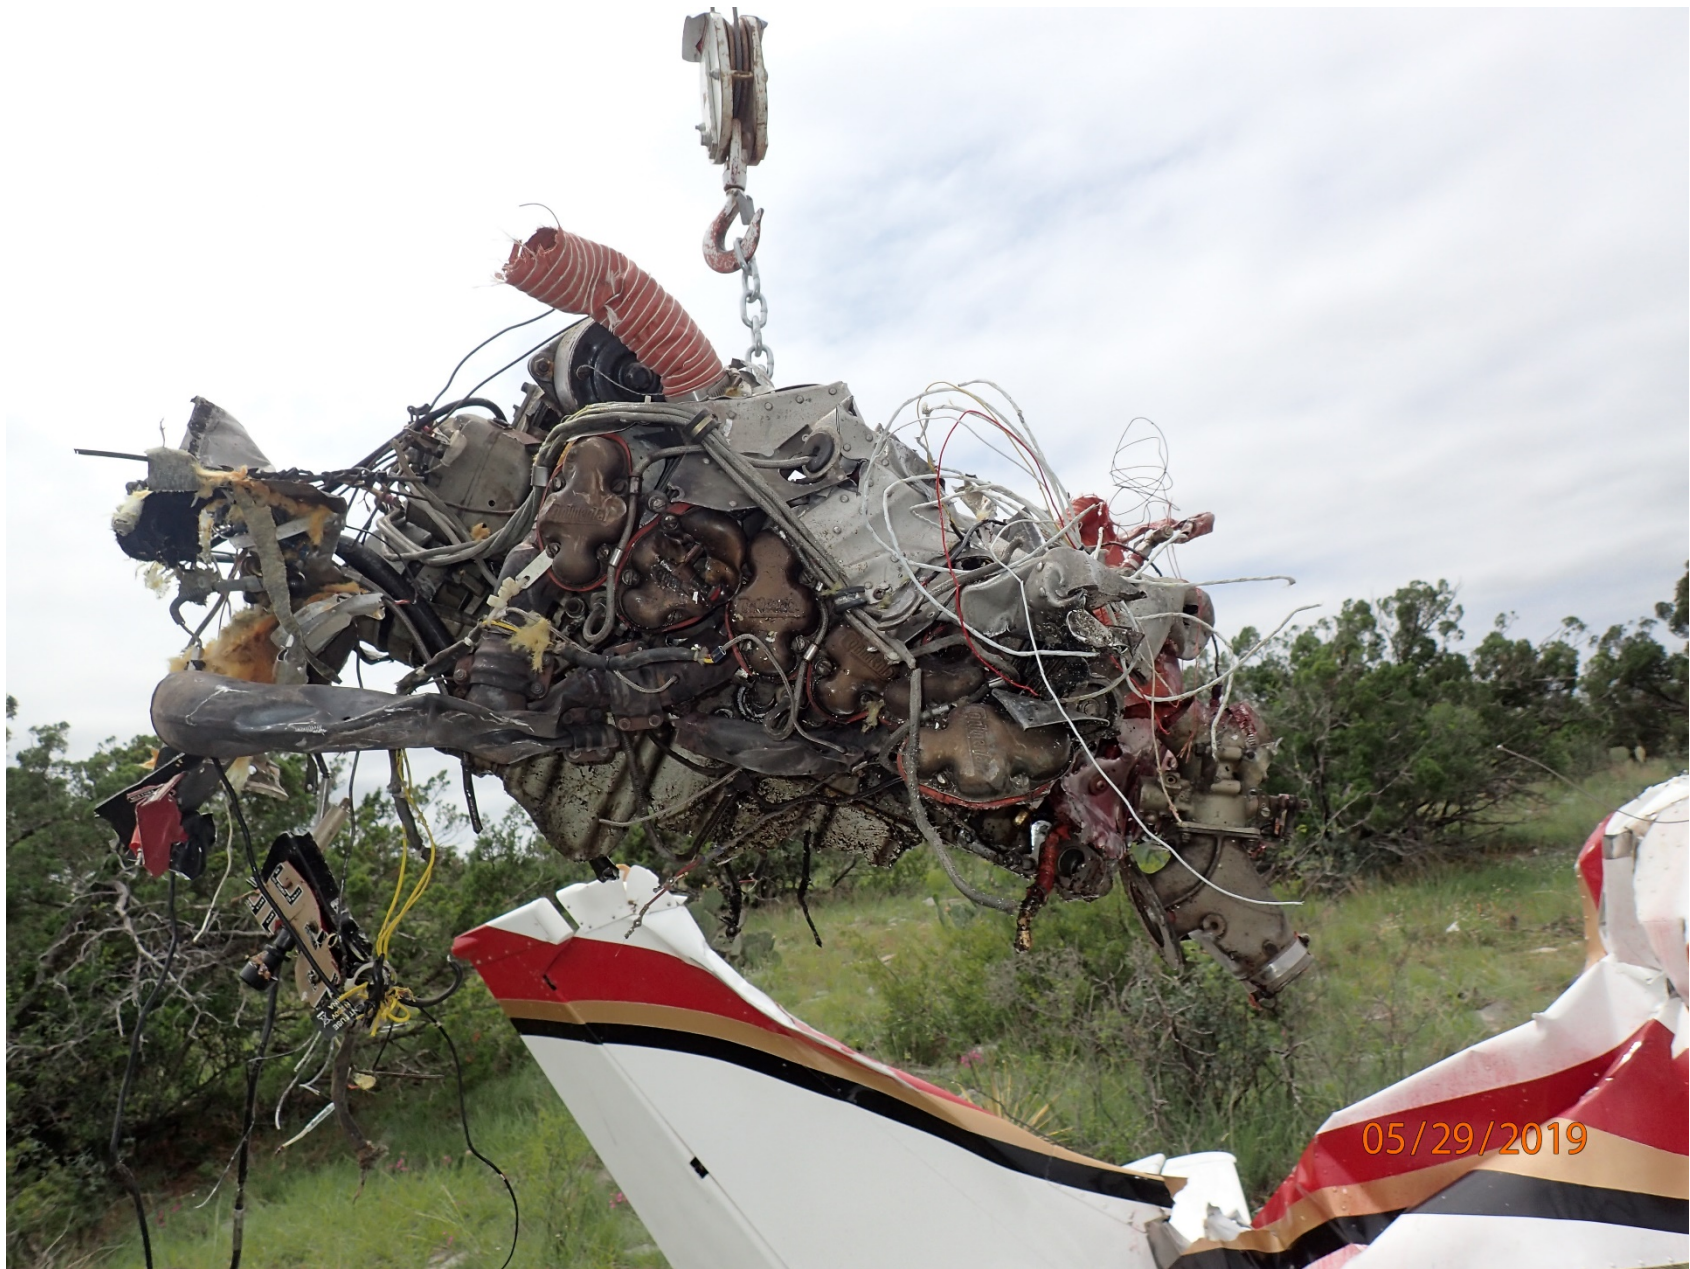
**Photo 3 – Airplane Engine After Removal from Embedded Terrain and Airplane Structure**
