CEN19FA170  
Piper PA-28-180, N9754J  
Accident date: 6/14/2019  
Accident Location: Huntsville, Texas

## EXAMINATION NOTES

### ON-SCENE EXAMINATION 6/16/2019 – 6/17/2019

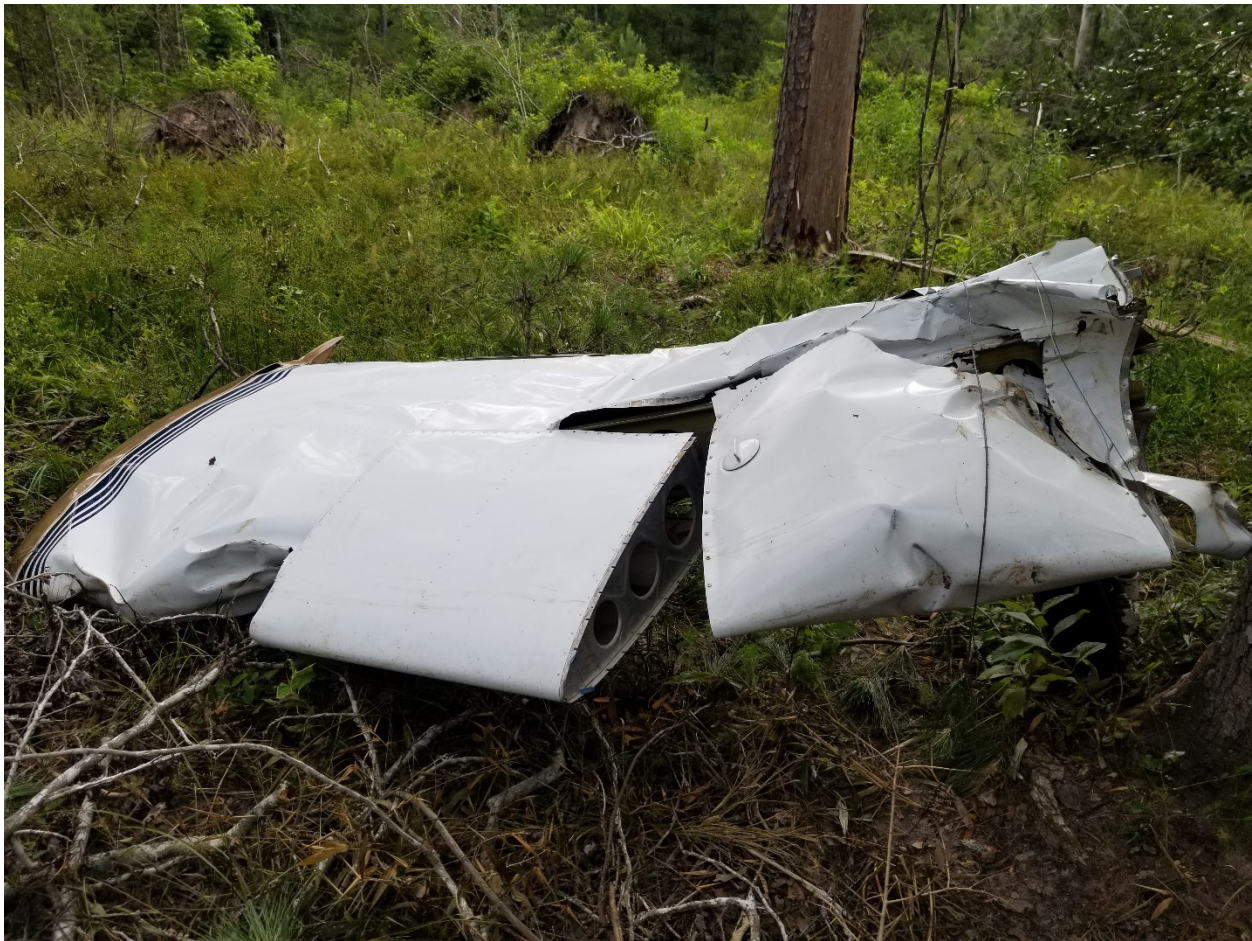
Figure 1- Right wing

The accident was reported to have happened about 1830 cdt on 6/14/2019, but was not discovered until 6/15/2019 when the injured pilot called 911. The accident occurred in a wooded area at GPS coordinates 30:46.942, -95:29.249, altitude 136 ft msl, GPS accuracy 10.6 ft. The initial impact was a tree that was struck about 50 ft above ground level. The right wing had a semi-circular indent in the outboard section of the wing with wood debris jammed into the wing structure. The wing was separated from the fuselage and was about 40 ft from the initial tree that was impacted. The inboard root section was separated from the remainder of the right wing and the root section was located next to the fuselage. The outboard section was bent rearward about mid-span. The right fuel tank was dented and ruptured. The interior surfaces of the tank were clean, and the fuel pickup was visible and clean.

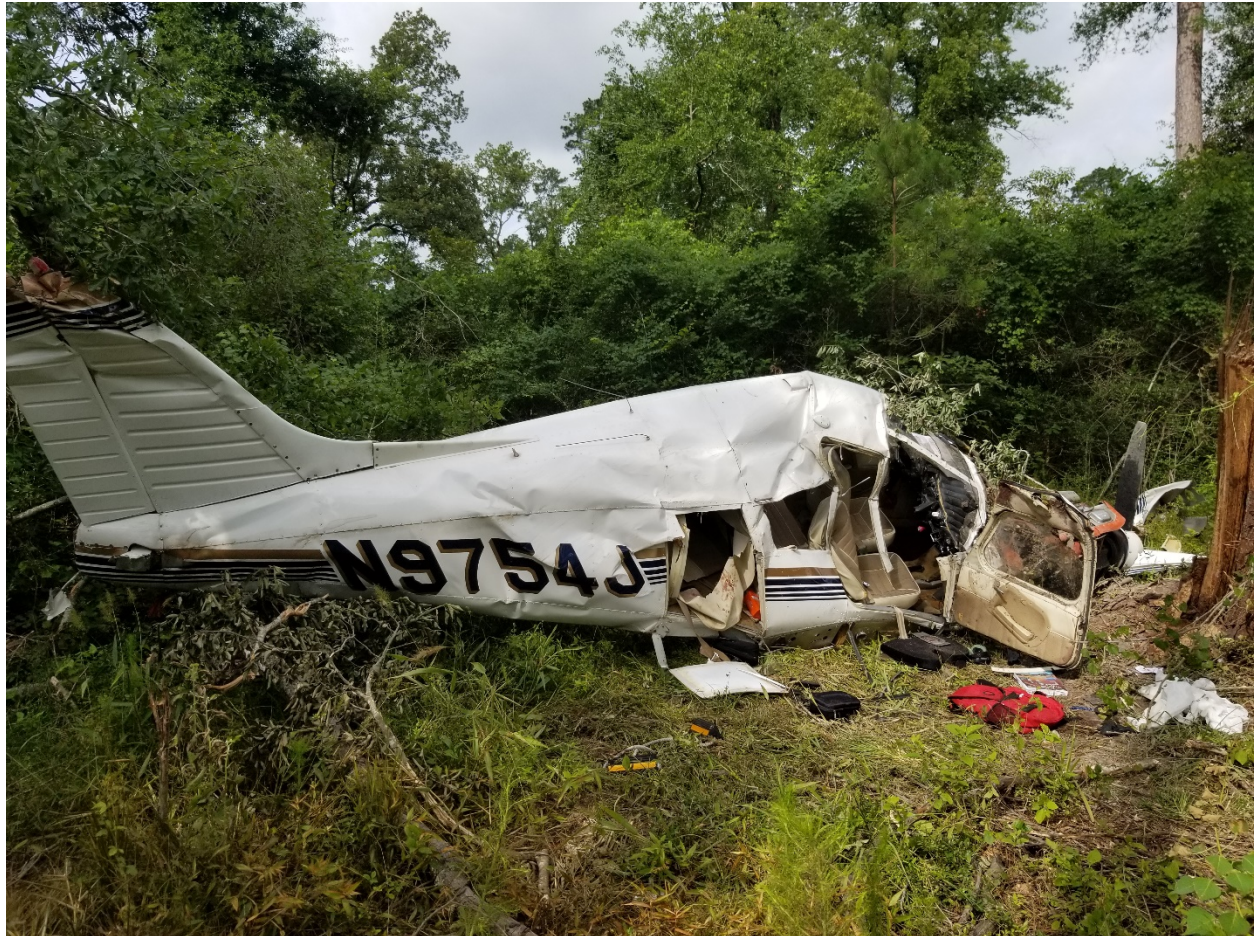
*Figure 2- Fuselage*

The fuselage of the airplane was upright during examination but was reportedly rolled to this position to facilitate extraction of the occupant. It was reportedly lying on its top right side and inverted. The fuselage came to rest about 100 ft and 300 degrees from the initial tree impact and was oriented in a 300 degree direction. There was crushing damage on the top right of the fuselage cabin and rearward bending of the right front seat back. The fuselage was predominately intact from the firewall to the tail with dents and bending from impact. Both sides of the horizontal stabilator had separated except for about a 6 inch section of spar that is hinged to the aft fuselage. The vertical tail and rudder remained attached to the fuselage. The left wing was separated and located next to the fuselage along with the root section of the right wing.

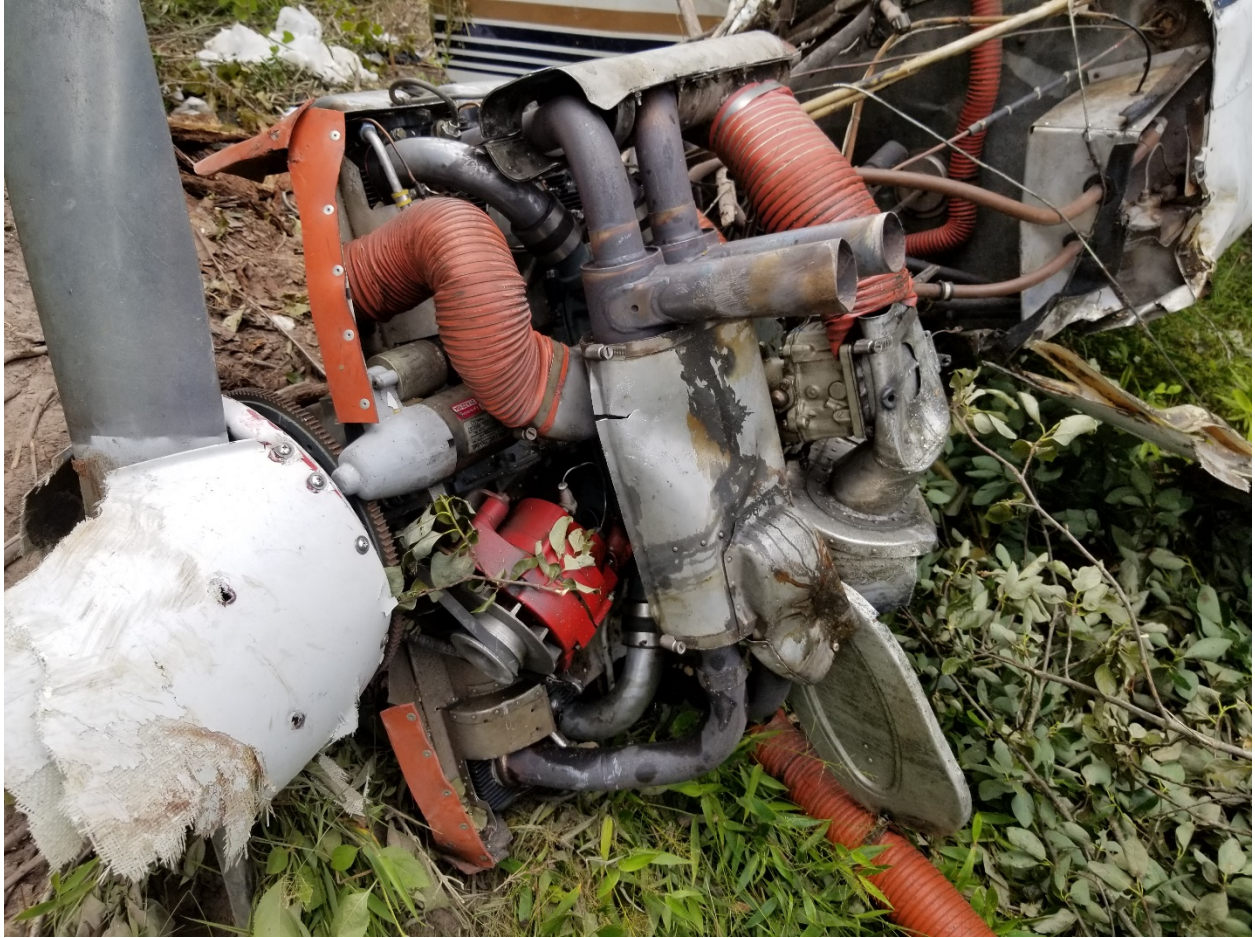
*Figure 3- Engine*

The engine was located at the front of the fuselage and its engine mount was broken. The engine was mostly separated due to the engine mount and remained attached only by engine control cables, wiring, and hoses. The engine was intact with little visible damage. One propeller blade was straight and the other was stuck in the dirt and bent forward. There was little evidence of rotation.

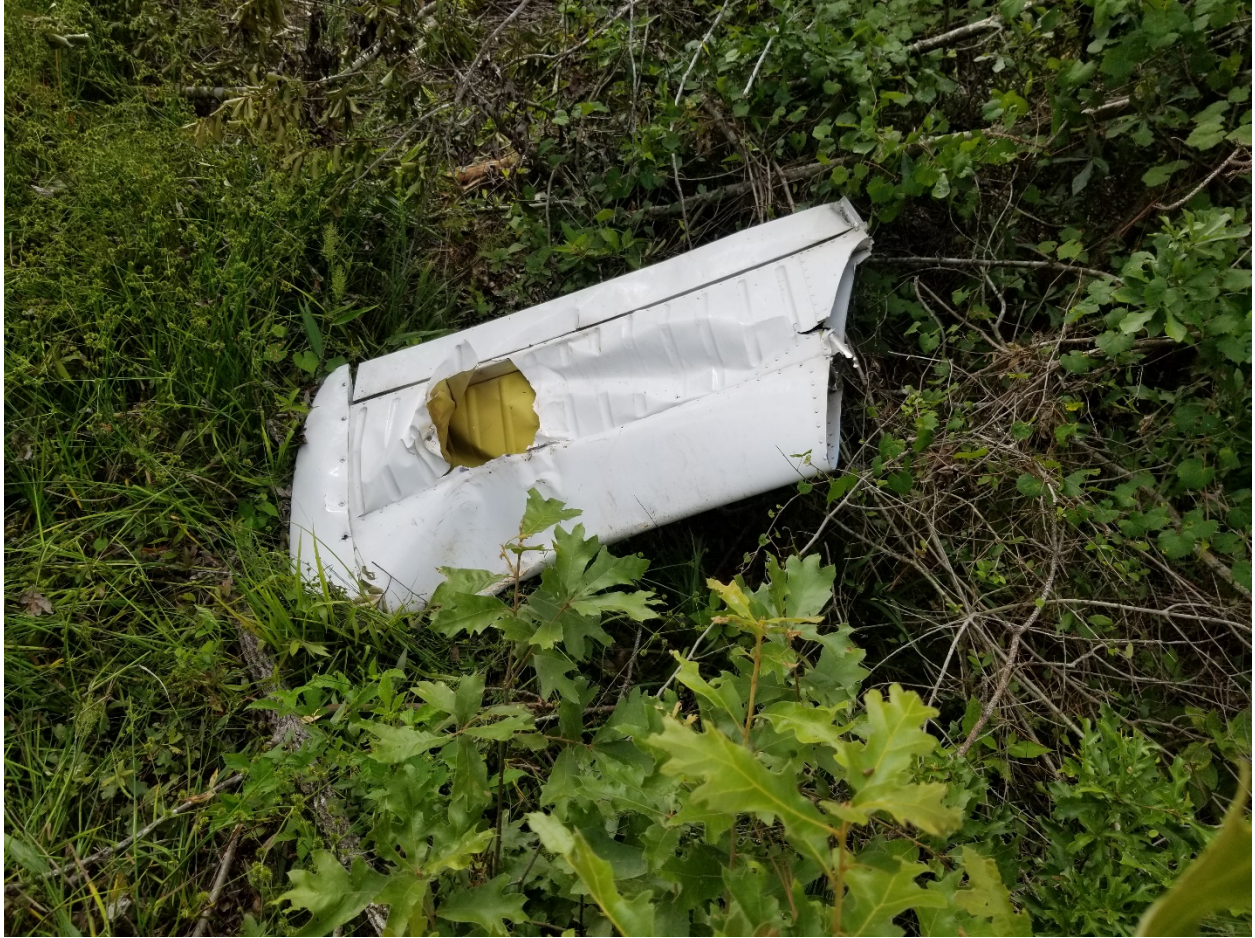
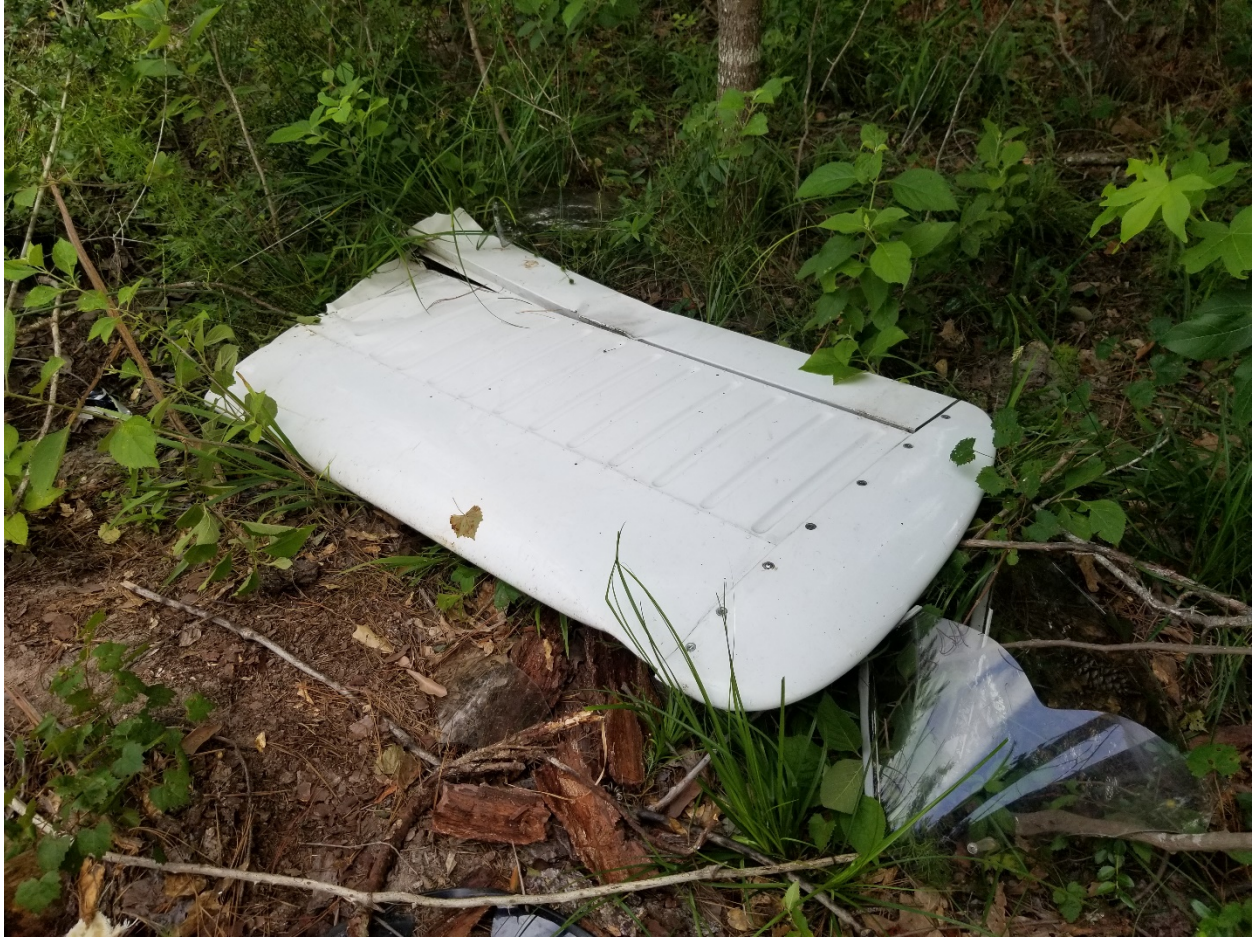
Both stabilator halves separated from the center spar section at the root adjacent to the fuselage. The center portion of the stabilator spar remained attached to the fuselage. One half of the horizontal stabilator came to rest near the right wing. The other half came to rest near the nose of the airplane.

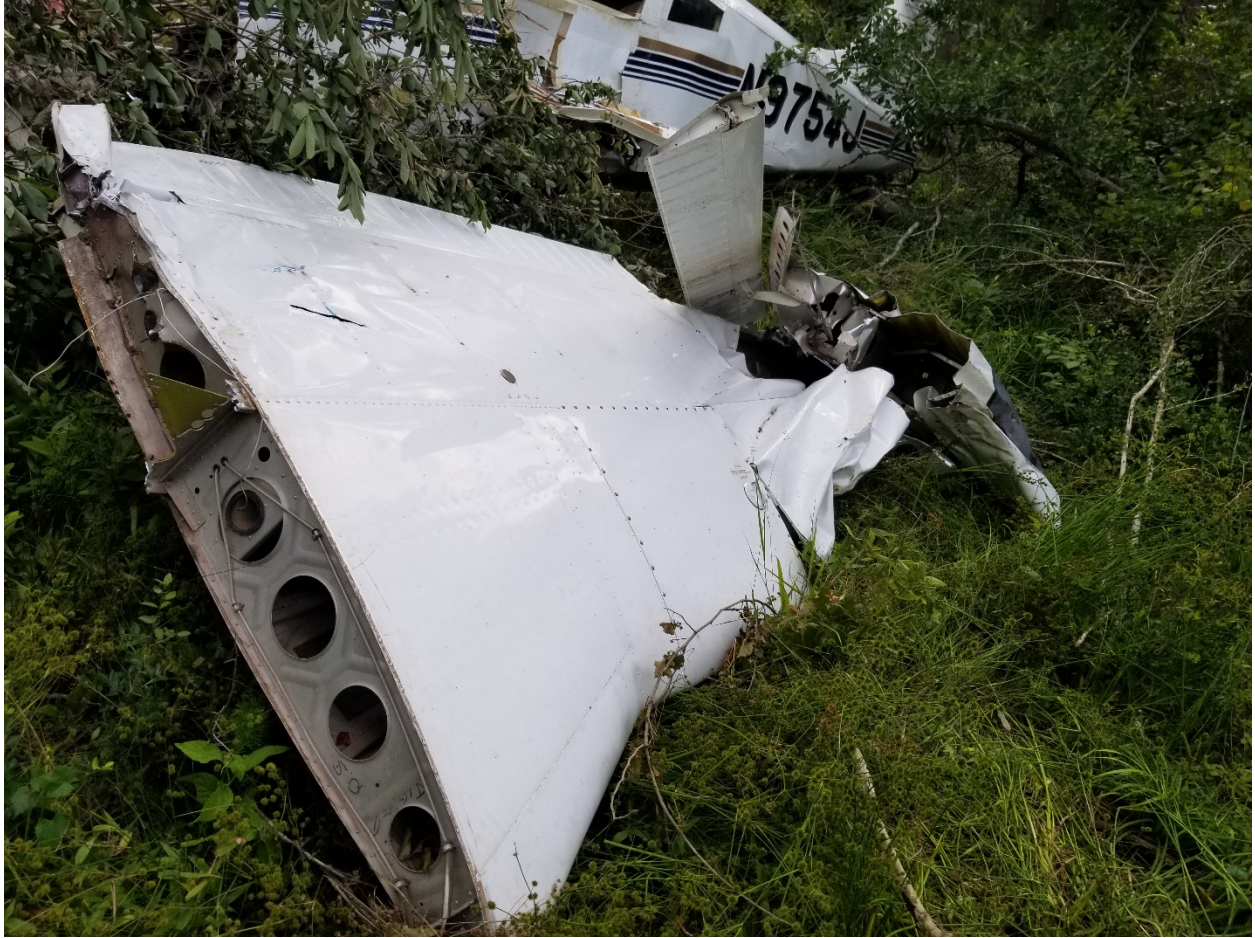
*Figure 6- Left inboard wing*

The left wing was separated from the fuselage at the root and came to rest next to the fuselage. The tank was intact and contained about 1 gallon of fuel, however; the fuel feed line from the wing was separated about 6 inches inside the wing root. The outboard section of the left wing was separated from the inboard section and the outboard section had a semicircular indent consistent with tree impact.

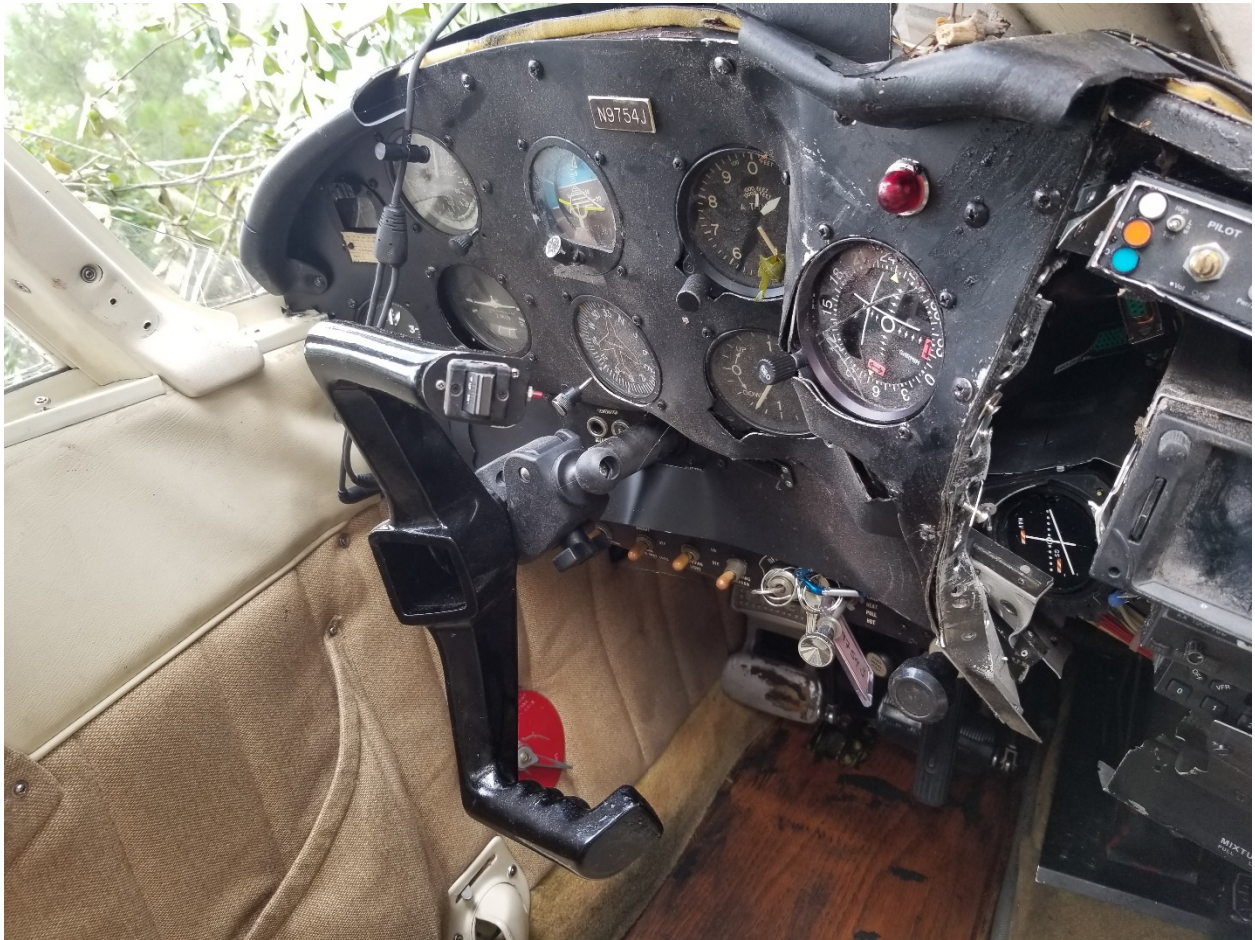
Figure 8- Cockpit view

- Fuel selector valve positioned to the off position
- Magneto switch on both
- Throttle full in
- Mixture control aft (lean)
- Primer – locked
- Carb heat – on (aft)
- Recording tach 4405.11
- Hobbs – either 373.9 or 9262.8 (face was broken and reading may not be reliable)

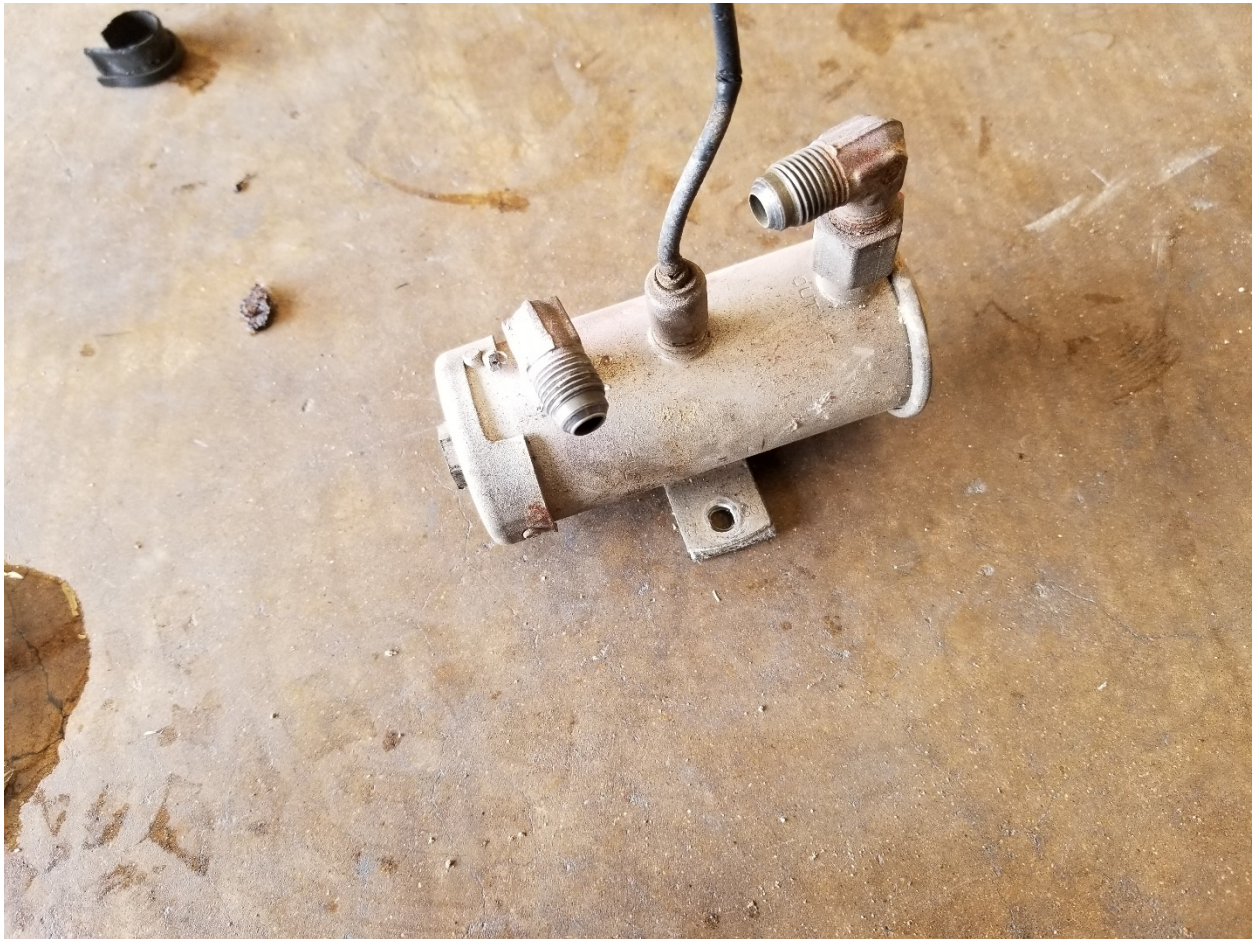
*Figure 10- Electric fuel pump*

The electric fuel pump was removed and connected to a 12V battery. The pump ran and produced suction on the inlet and pressure on the outlet.

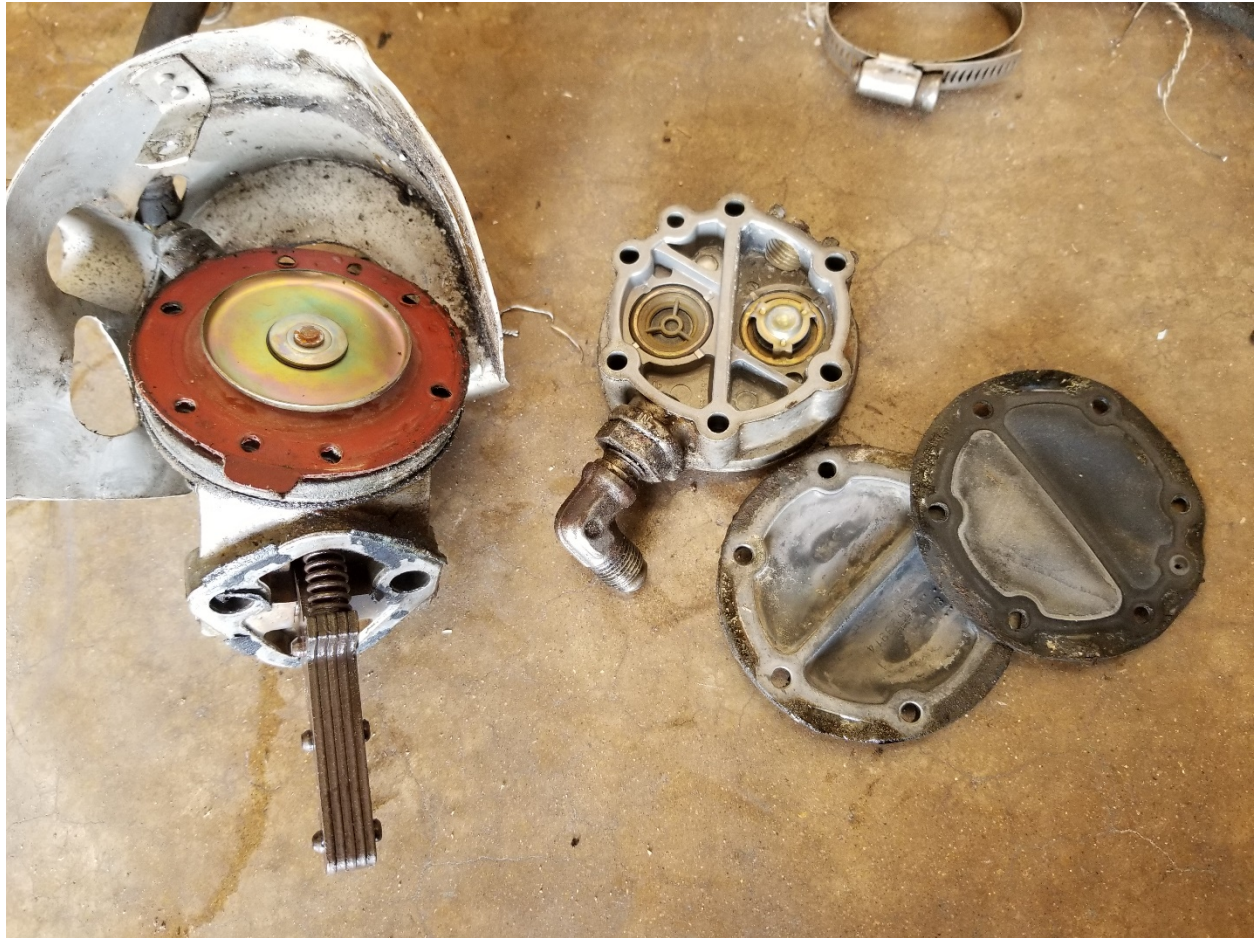
*Figure 11- Mechanical fuel pump*

The mechanical fuel pump was cracked and was removed and disassembled. No anomalies were noted and the diaphragms were intact.
