**NATIONAL TRANSPORTATION SAFETY BOARD**  
Vehicle Recorder Division  
Washington, DC 20594

## **Onboard Image, Audio, and Data Recorder**

**Group Chairman's Factual Report**  
**By Sean Payne**

| NTSB Number: | CEN19FA185 |

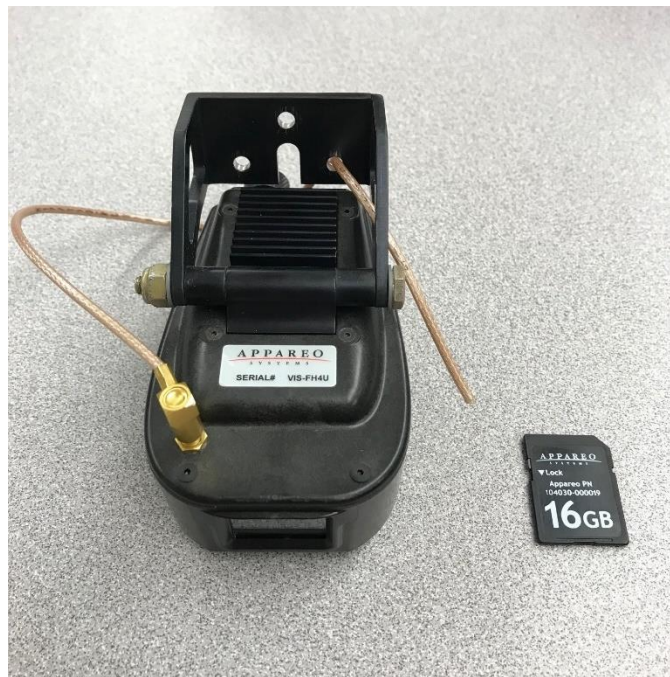
Upon arrival at the NTSB Vehicle Recorder Division, it was evident that the Vision 1000 device had not sustained any obvious damage. The device is pictured below in figure 1 in the condition it was received.

**Figure 1. The Appareo Vision 1000 device and the associated SD card, as received.**

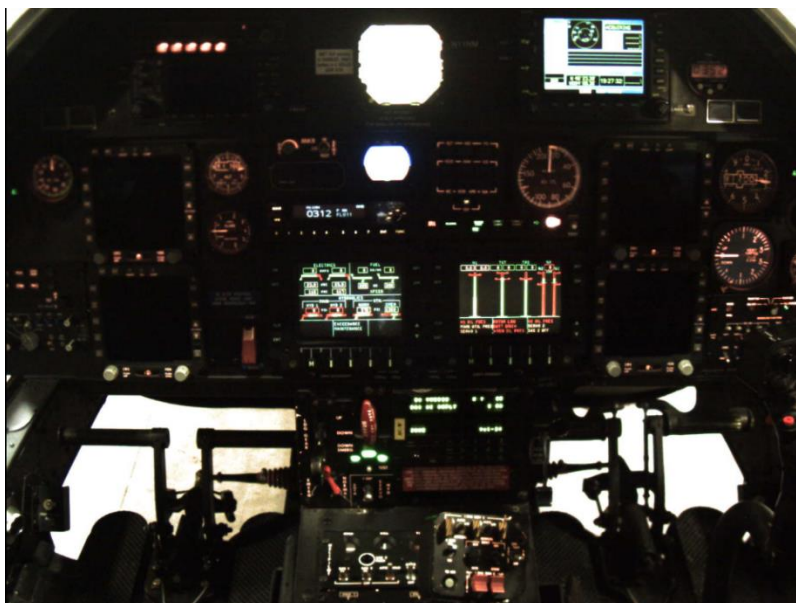
Figure 2 is a screenshot taken from the recorder that shows an example of the camera’s image from a power cycle previous to the accident where the accident pilot was conducting a preflight inspection.

Figure 2. A capture from the Appareo image recorder, serial number VIS-FH4U installed on N11NM.

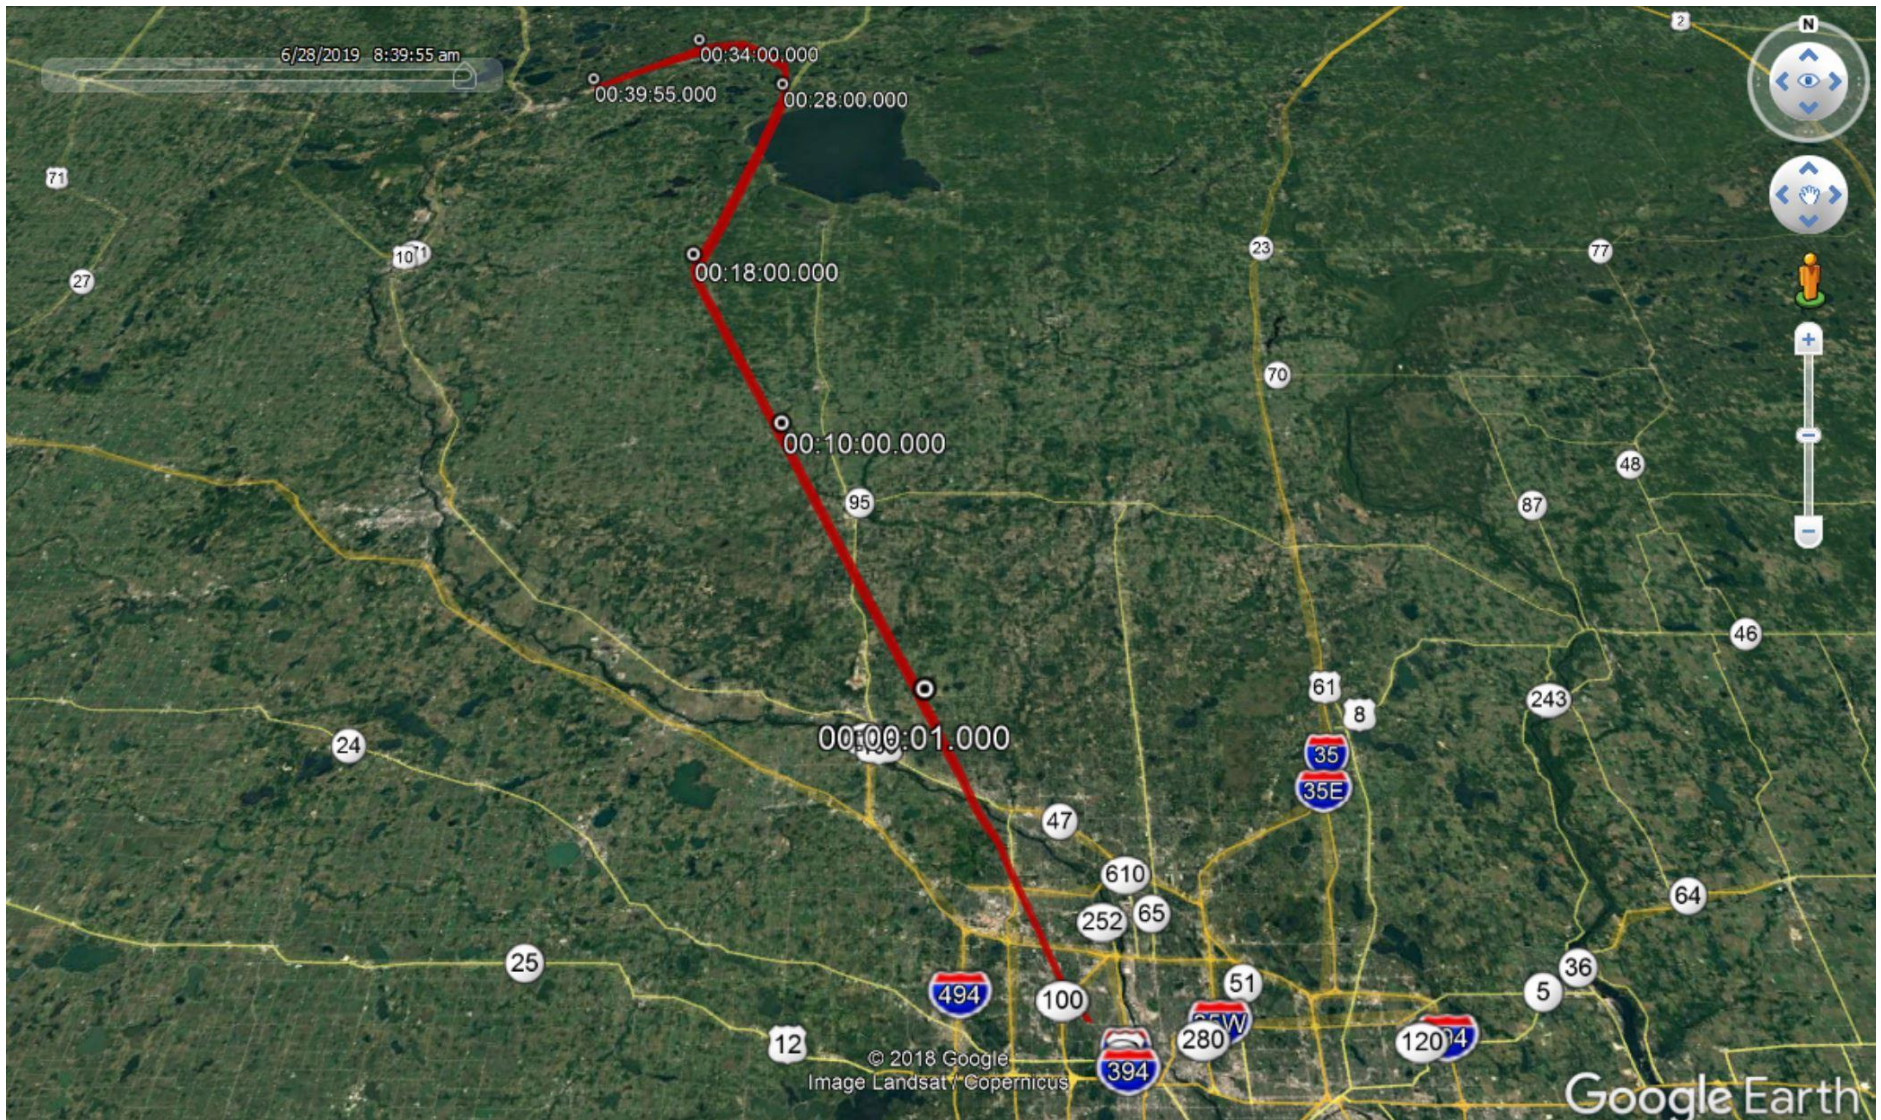
Figure 3 is a Google Earth overlay oriented north-up. The overlay shows the entire accident flight.

Figure 3. A Google Earth overlaying showing recorded GPS data for the entire accident flight. Times are in CDT.

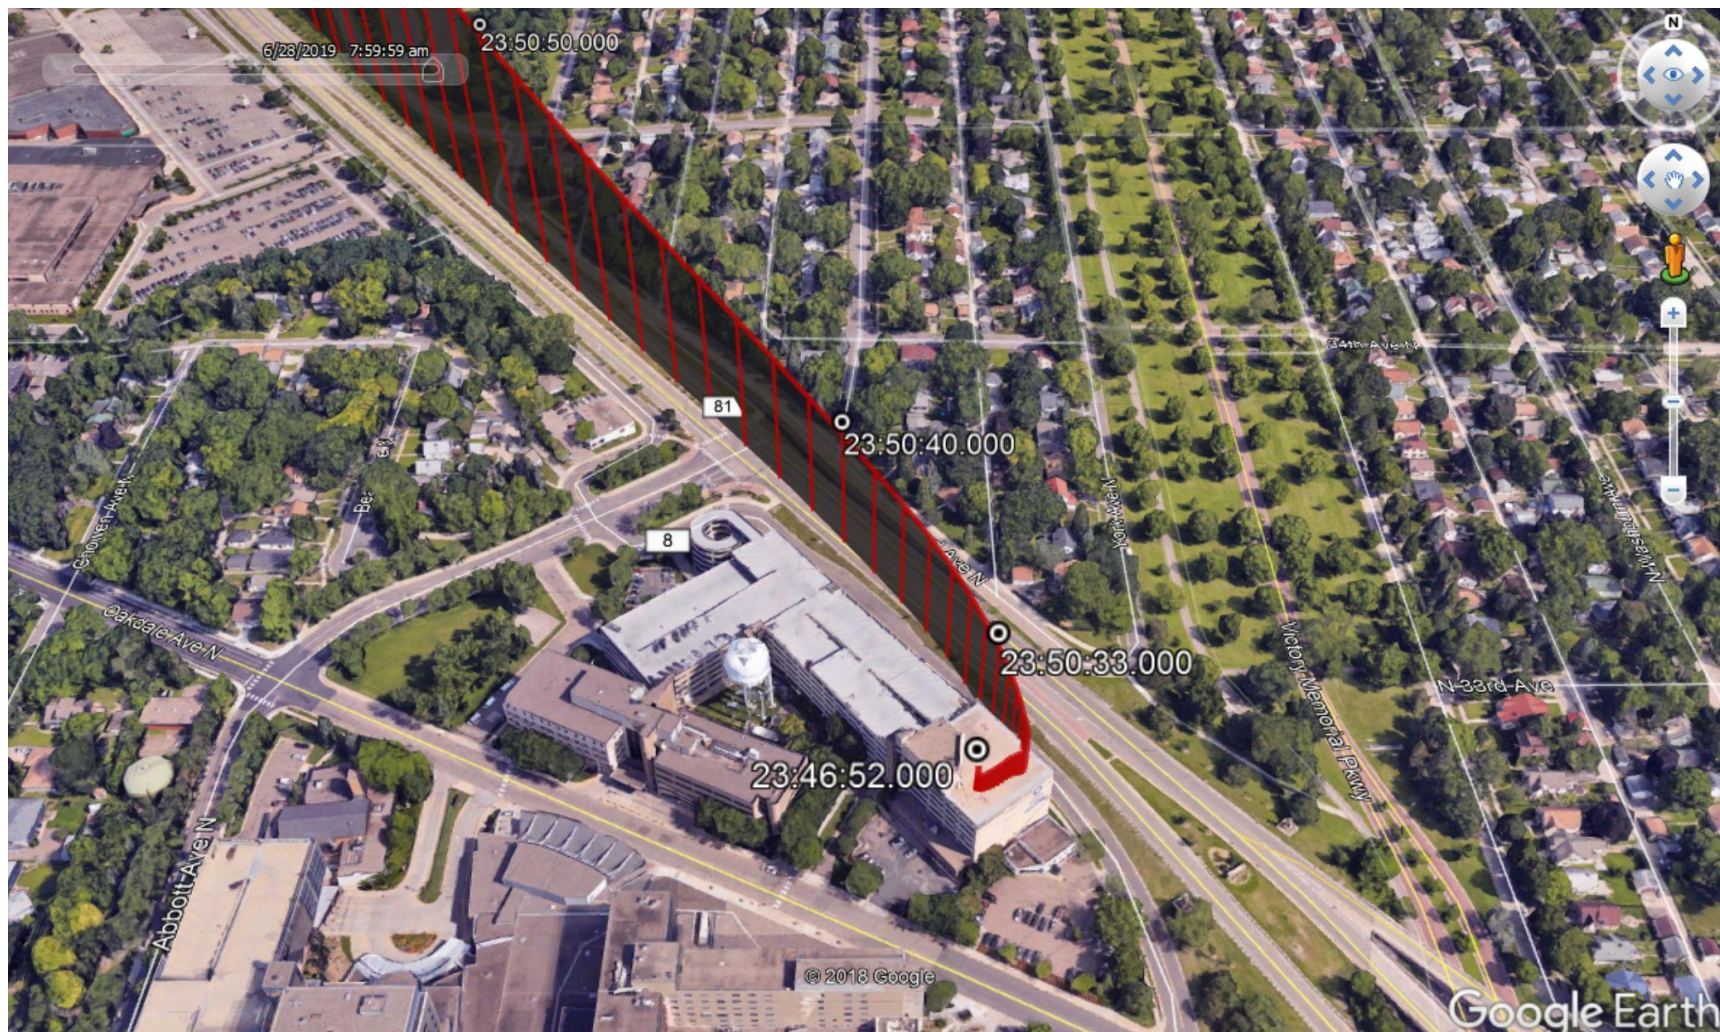
Figure 4 is a Google Earth overlay oriented north-up. The overlay shows the helicopter's departure from MY77.

Figure 4. A Google Earth overlaying showing recorded GPS data for the departure portion of flight. Times are in CDT.

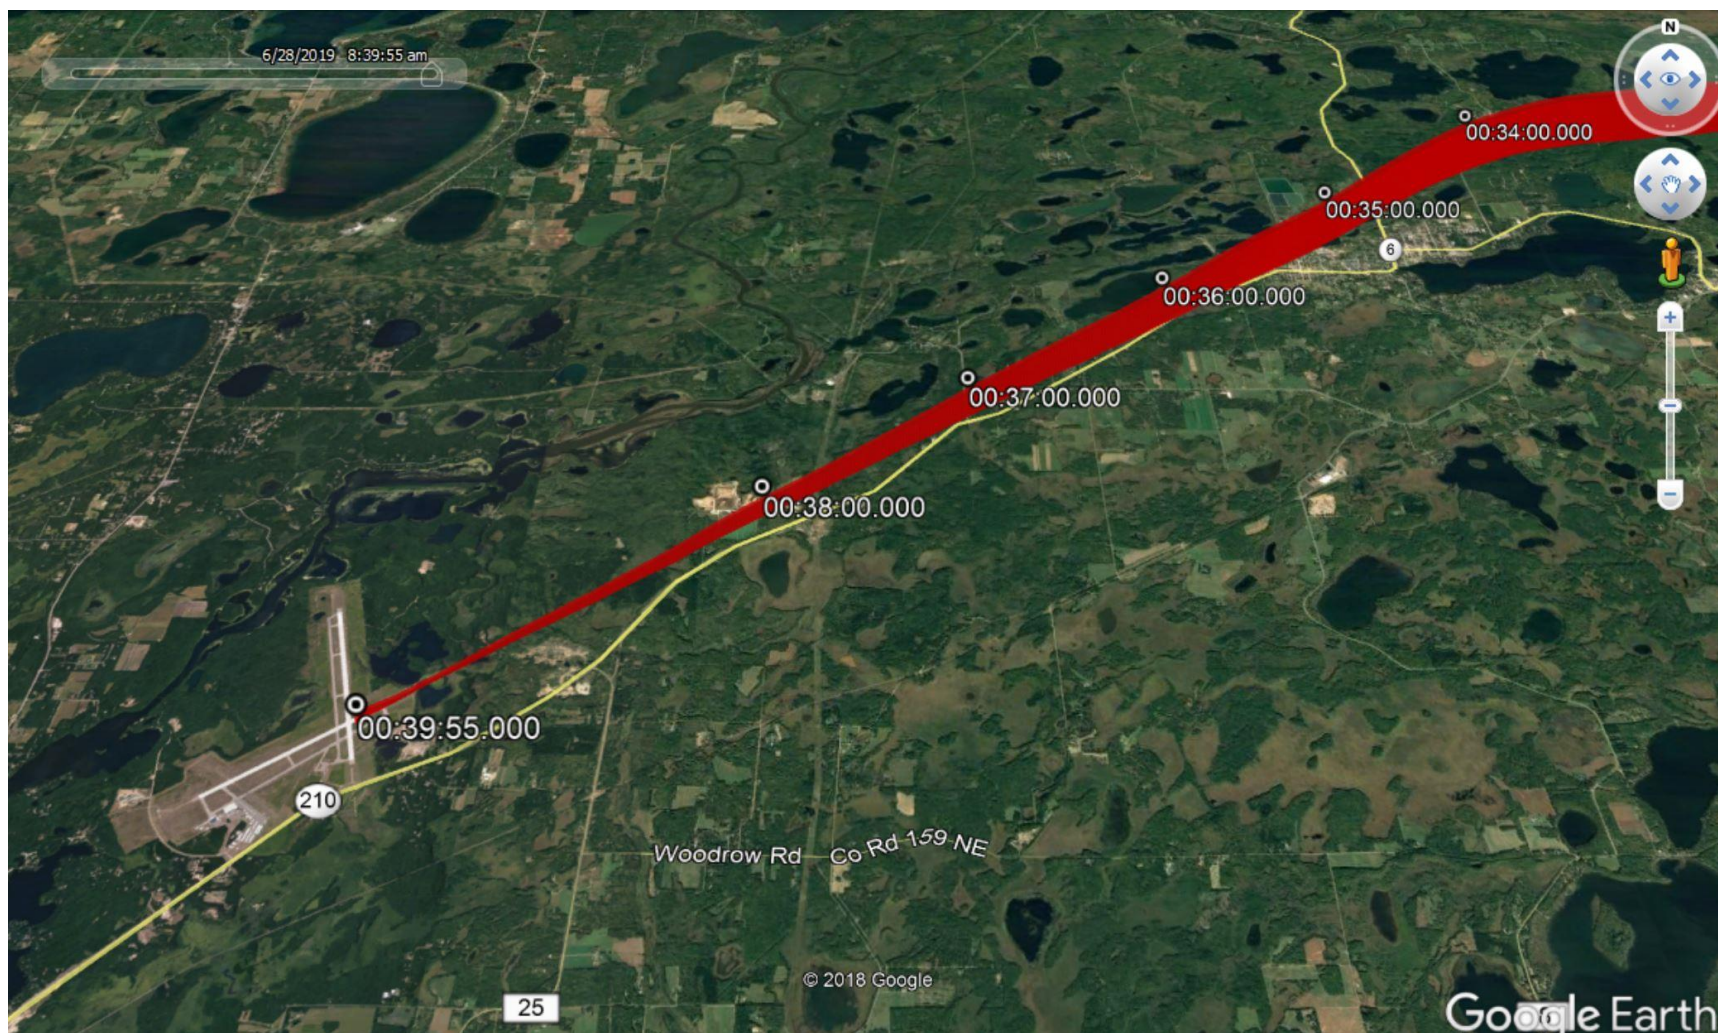
Figure 5 is a Google Earth overlay oriented north-up. The overlay shows the overall vector and approach phase of the helicopter on the ILS 23 at BRD.

Figure 5. A Google Earth overlaying showing recorded GPS data for the overall approach portion of flight. Times are in CDT.

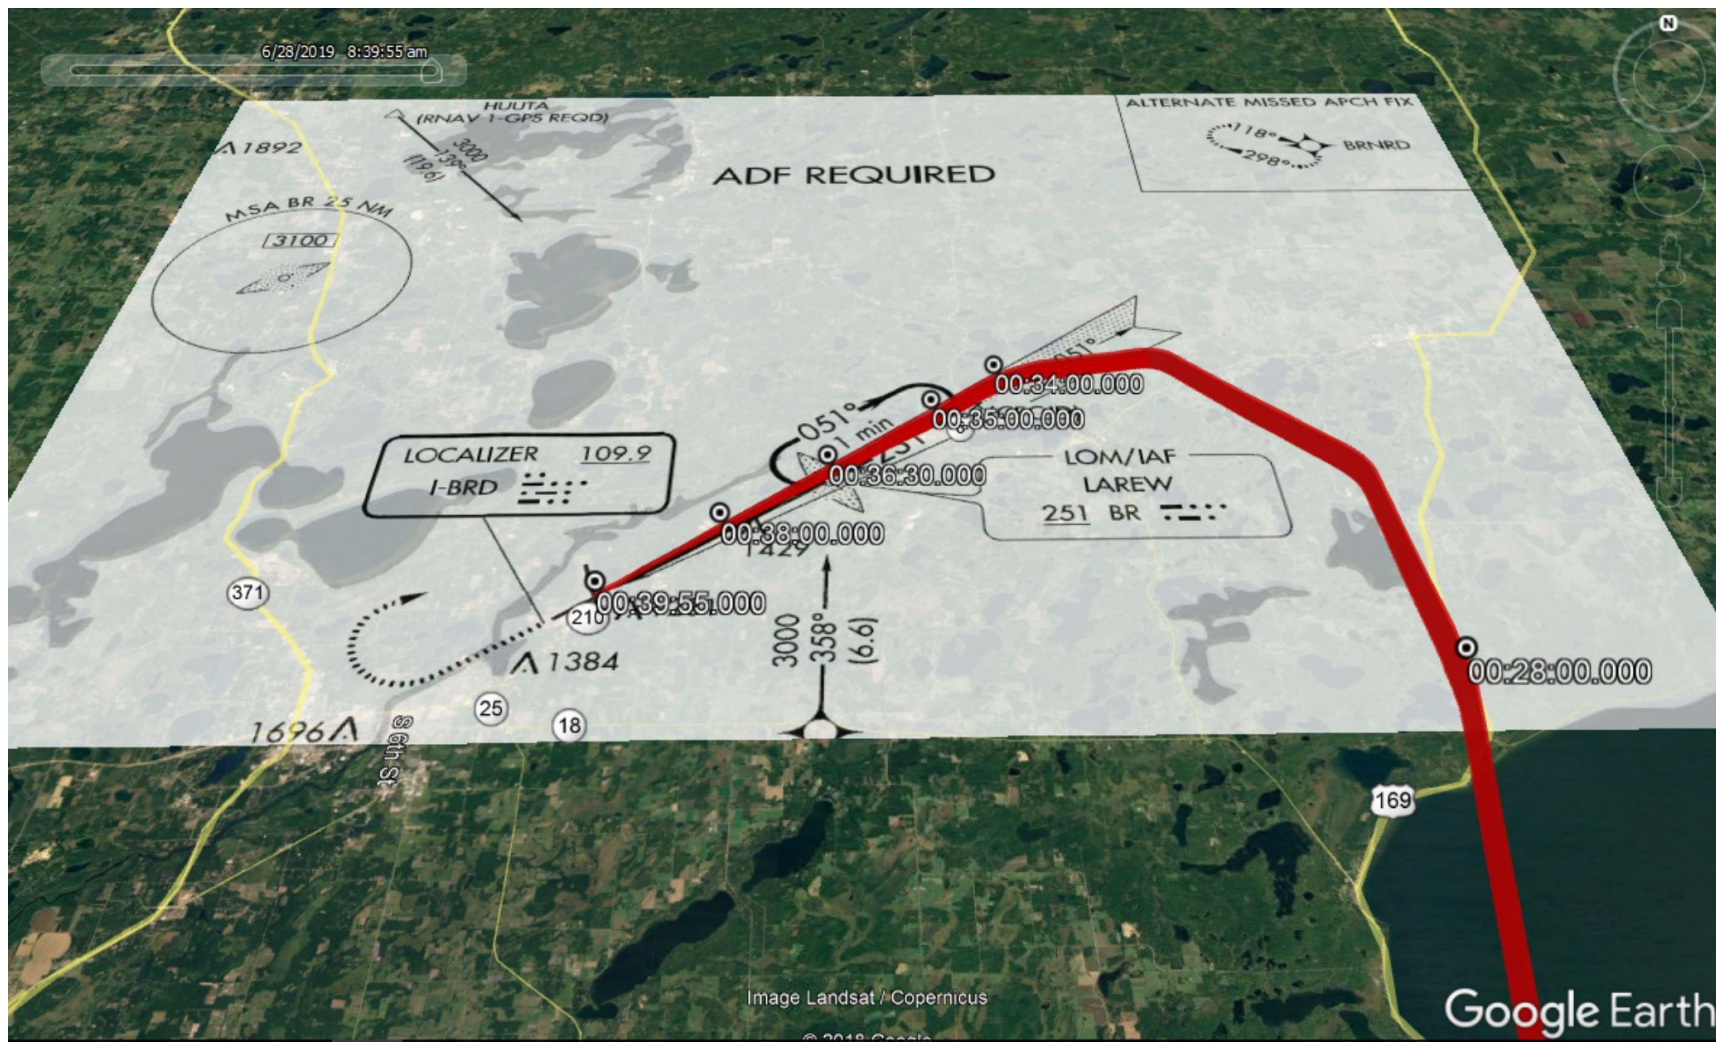
Figure 6 is a Google Earth overlay oriented north-up. The helicopter's GPS tracks are overlaid on the published approach procedure for the ILS 23 approach at BRD.

Figure 6. A Google Earth overlaying showing recorded GPS data overlaid on the ILS 23 Approach Plate for KBRD. Times are in CDT.

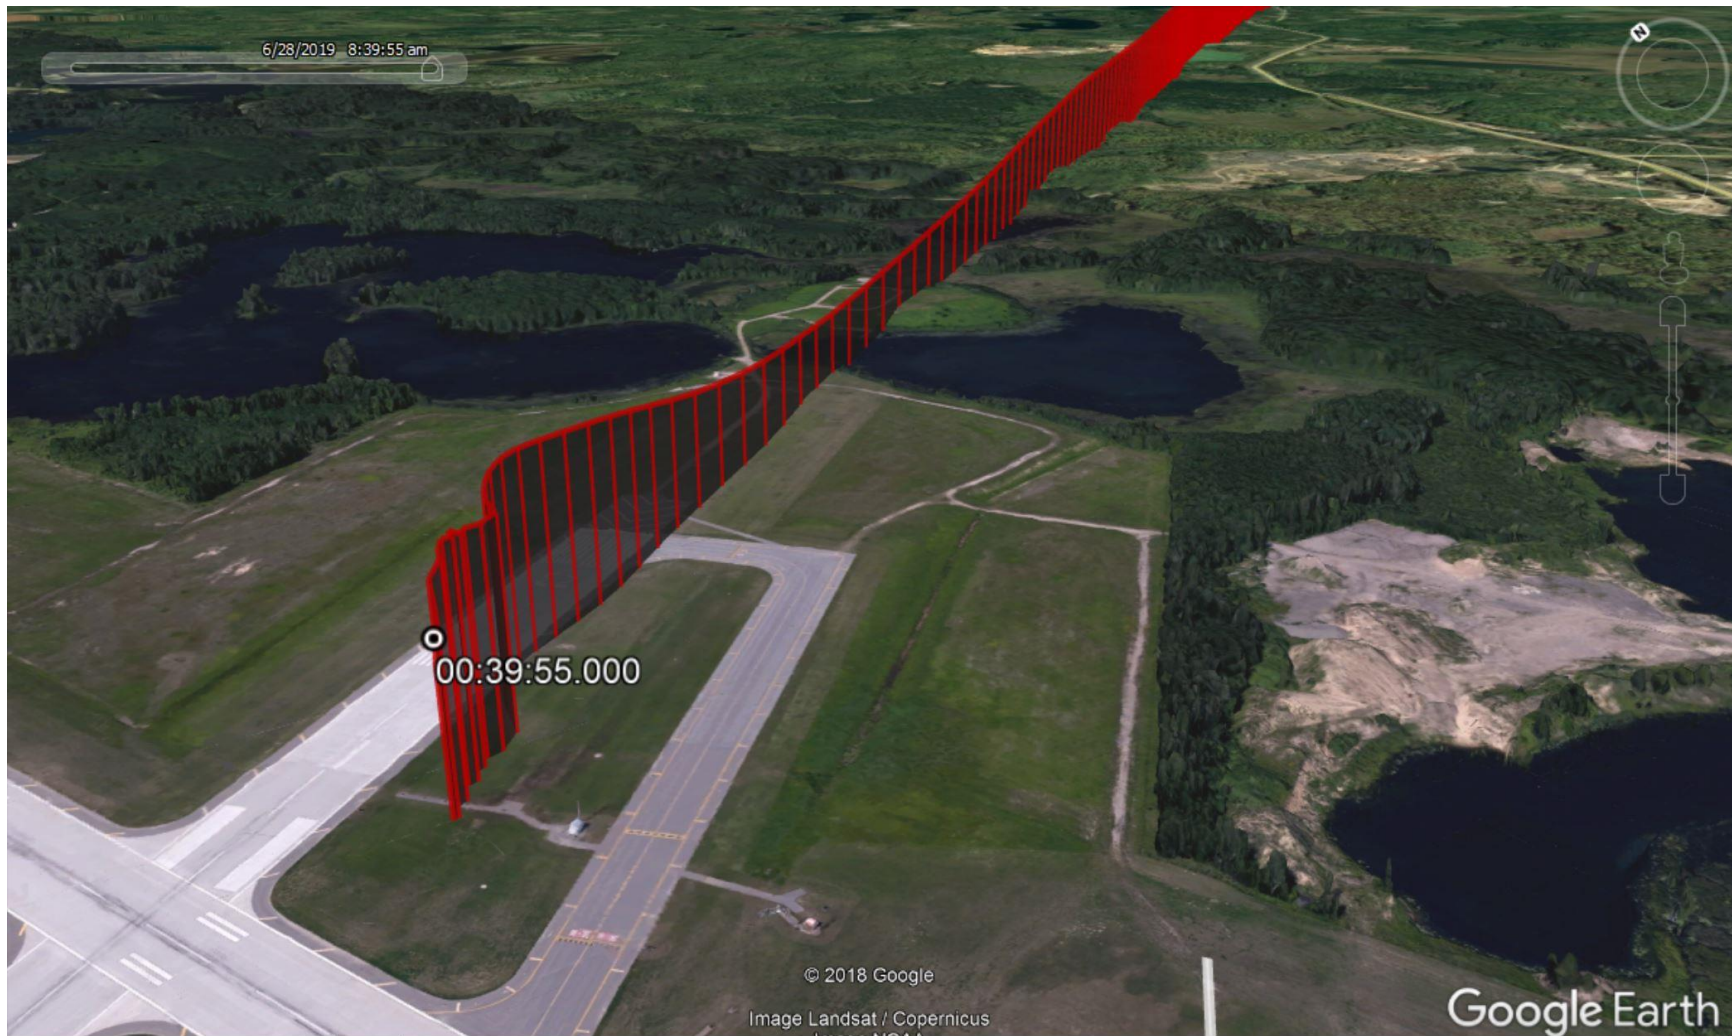
Figure 7 is a Google Earth overlay showing the final portion of the approach phase of flight.

Figure 7. A Google Earth overlaying showing recorded GPS data for the final portion of the approach phase of flight. Times are in CDT.

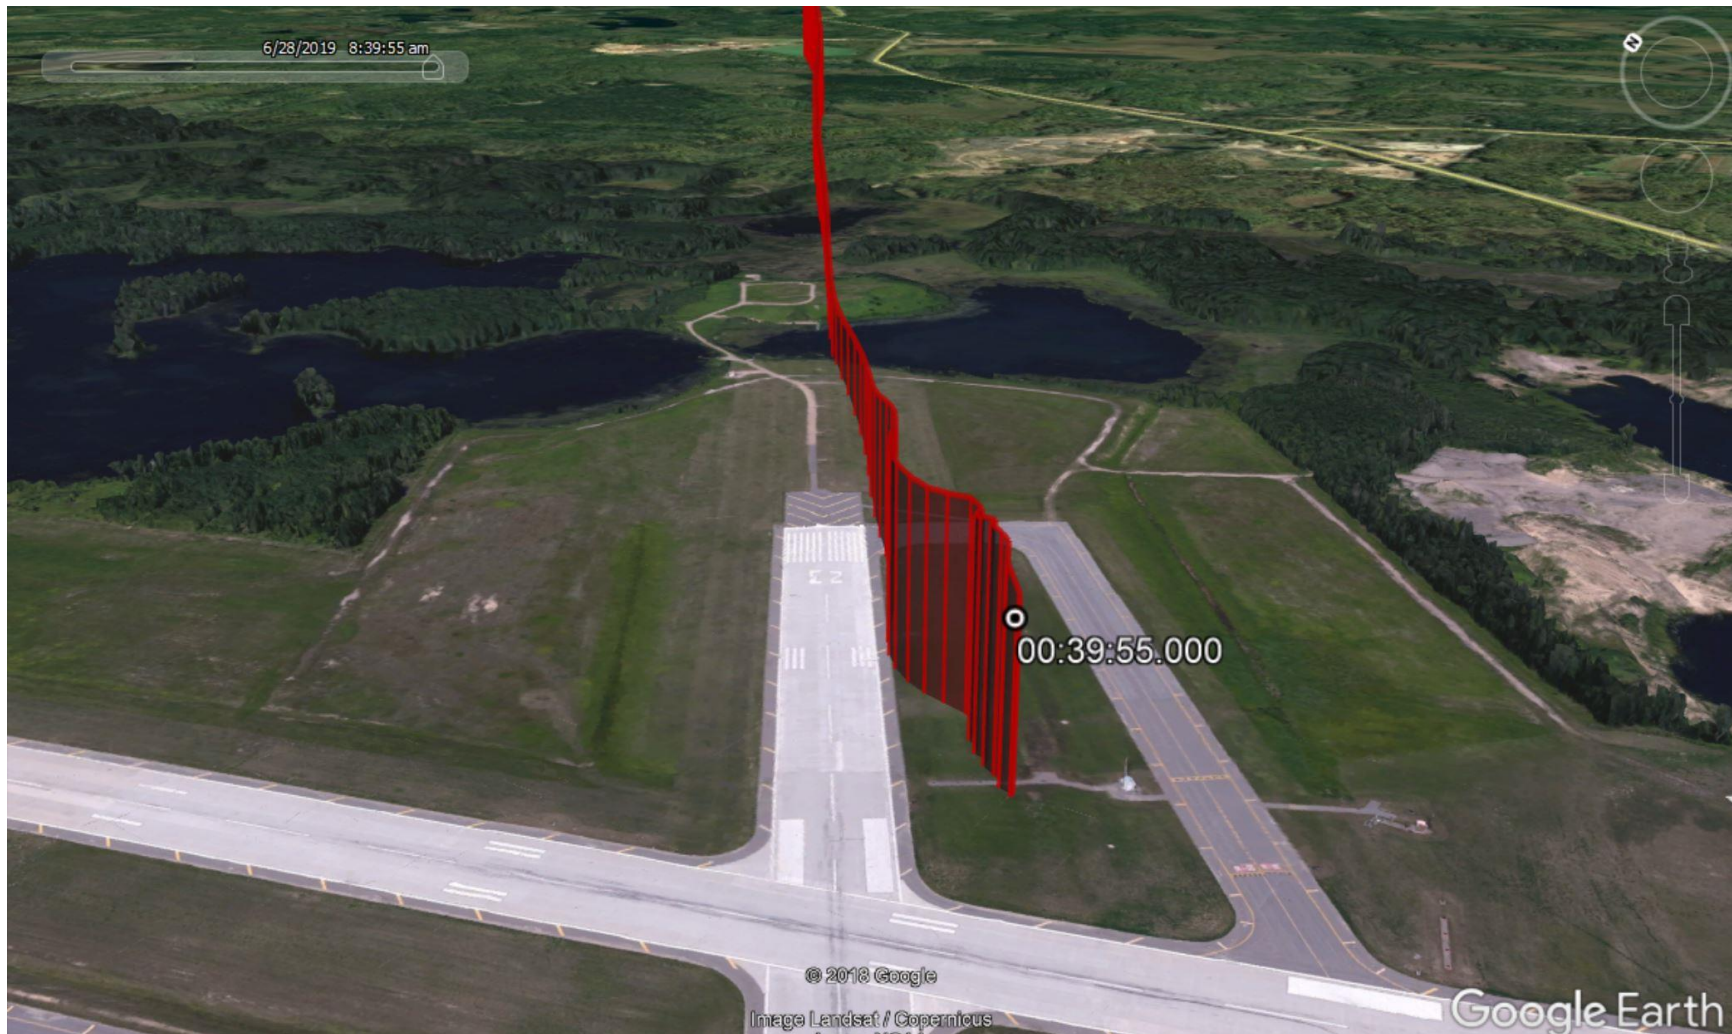
Figure 8 is a Google Earth overlay showing the final portion of the approach phase of flight. The orientation is looking toward the arrival end of runway 23 at BRD.

Figure 8. A Google Earth overlaying showing recorded GPS data for the final portion of the approach phase of flight. The orientation is looking toward the arrival end of Runway 23. Times are in CDT.

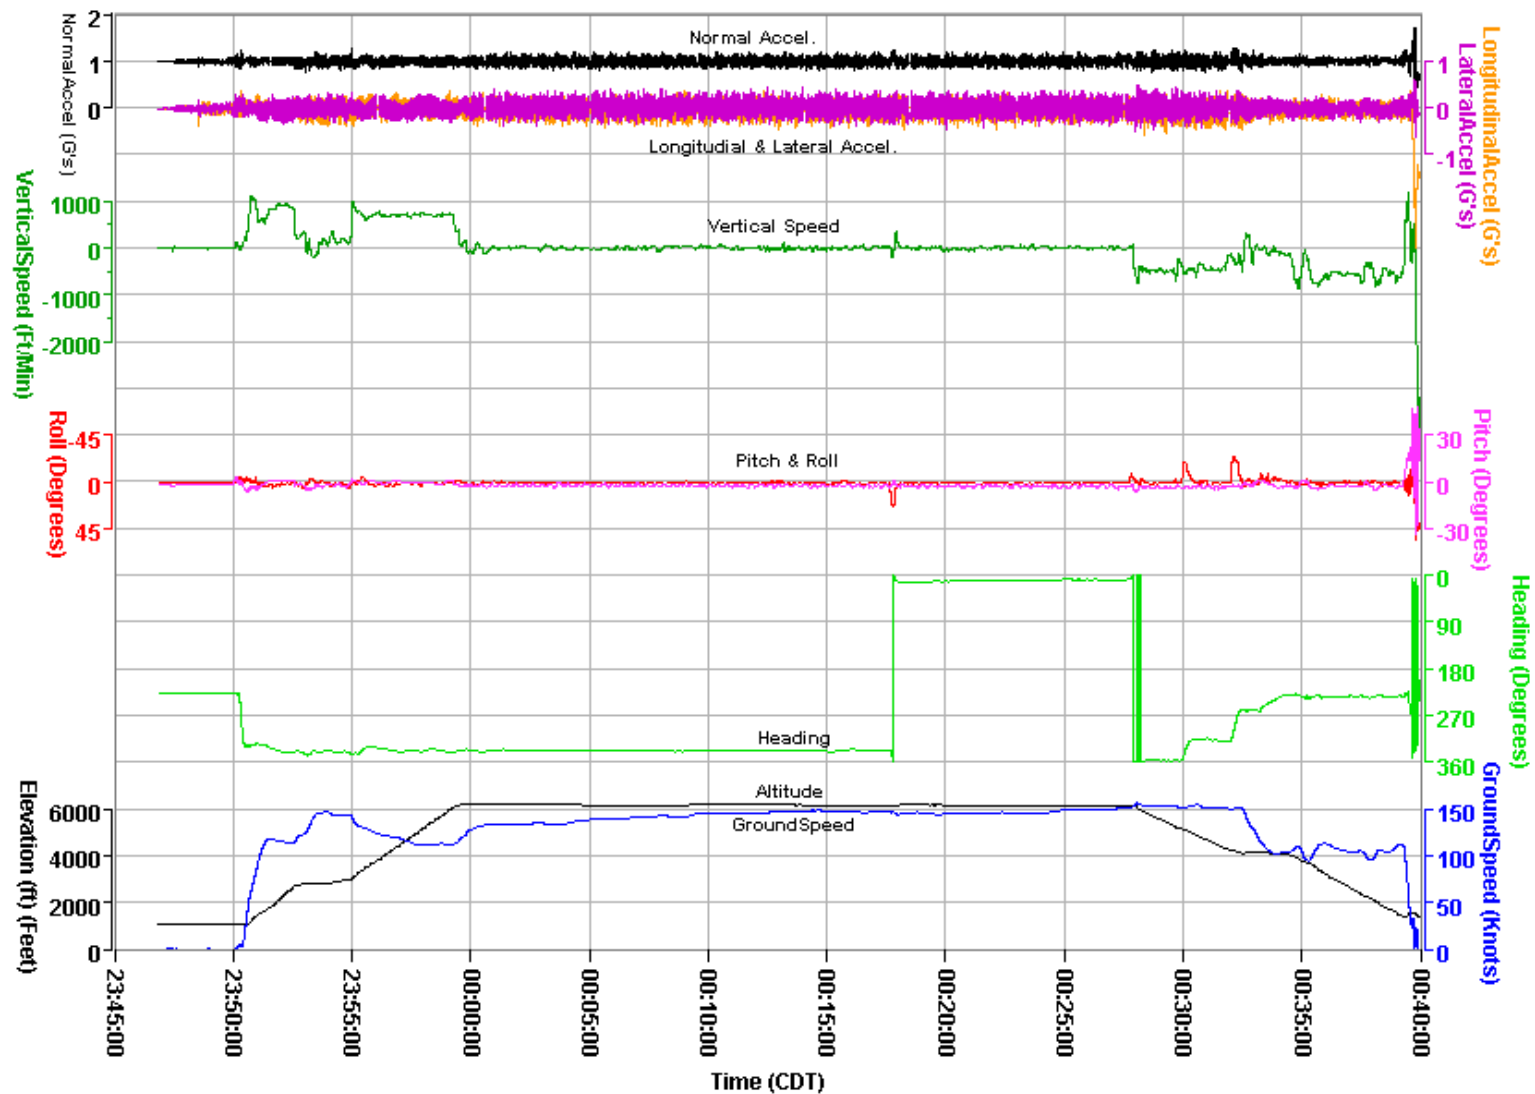
Figure 9 is a plot of all relevant recorded parameters from the Appareo Vision 1000 for the entire flight.

Figure 9. A plot of GPS recorded parameters, GPS derived parameters as well as AHRS recorded parameters for the entire flight.

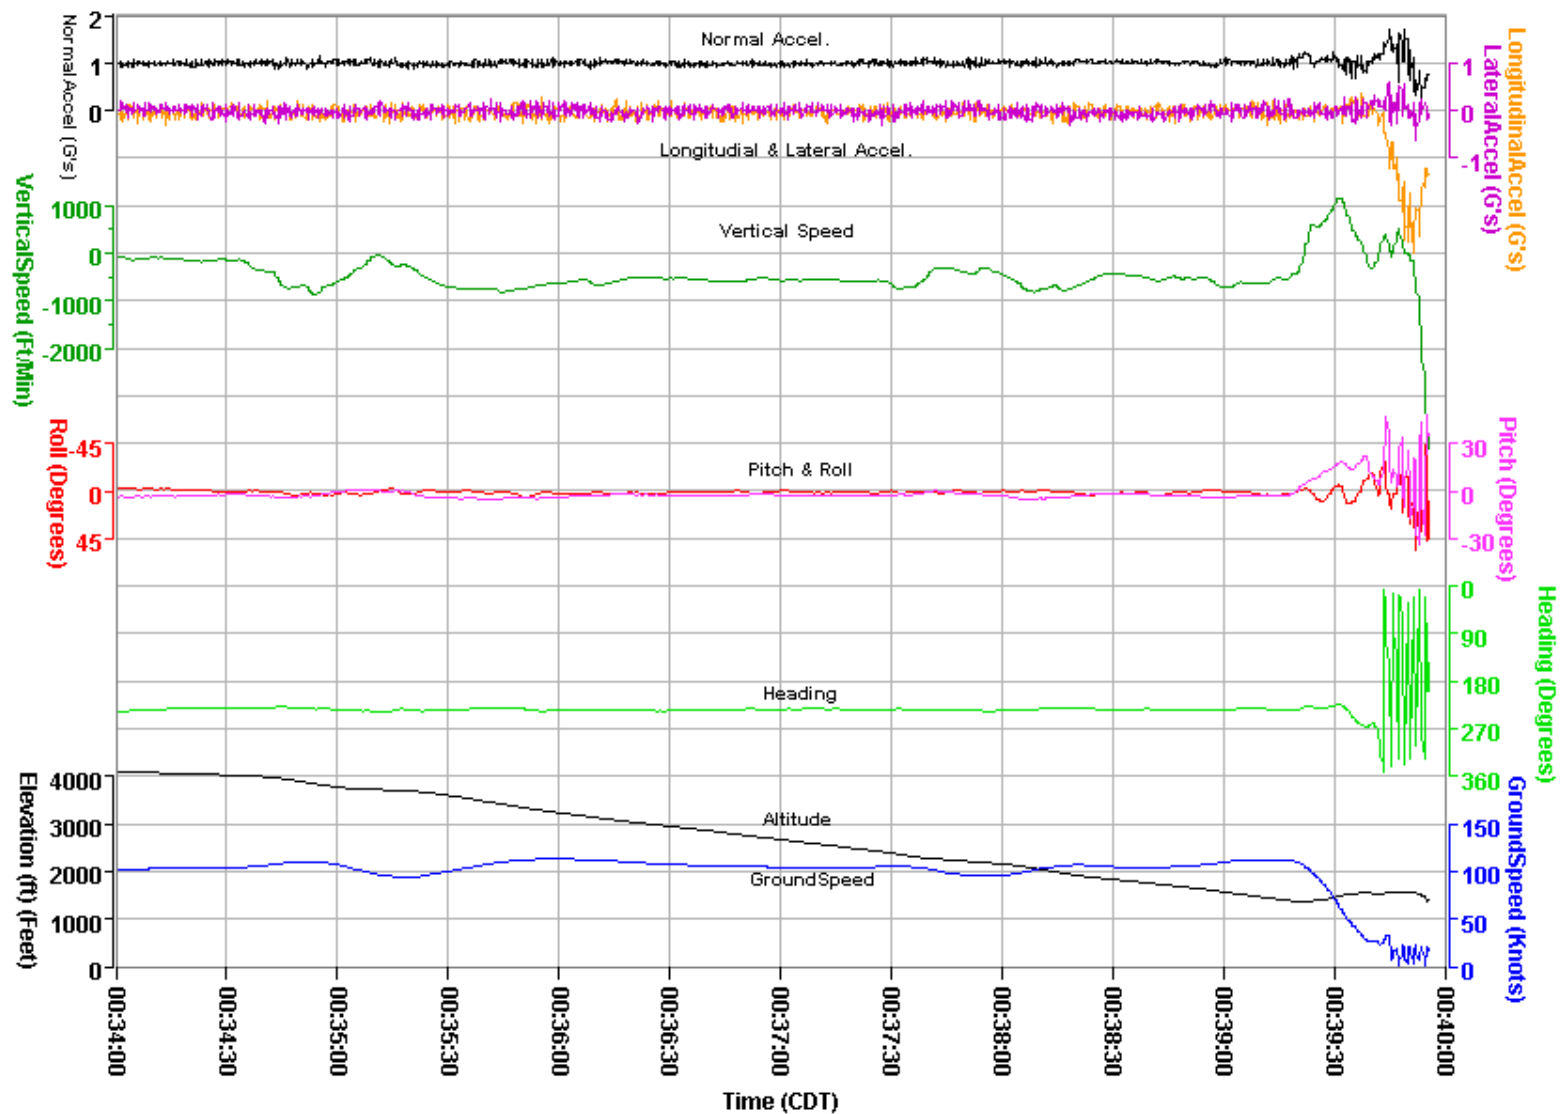
Figure 10 is a plot of all relevant recorded parameters from the Appareo Vision 1000 for the time interval between 00:34:00 and 00:40:00.

Figure 10. A plot of GPS recorded parameters, GPS derived parameters as well as AHRS recorded parameters for the approach phase.

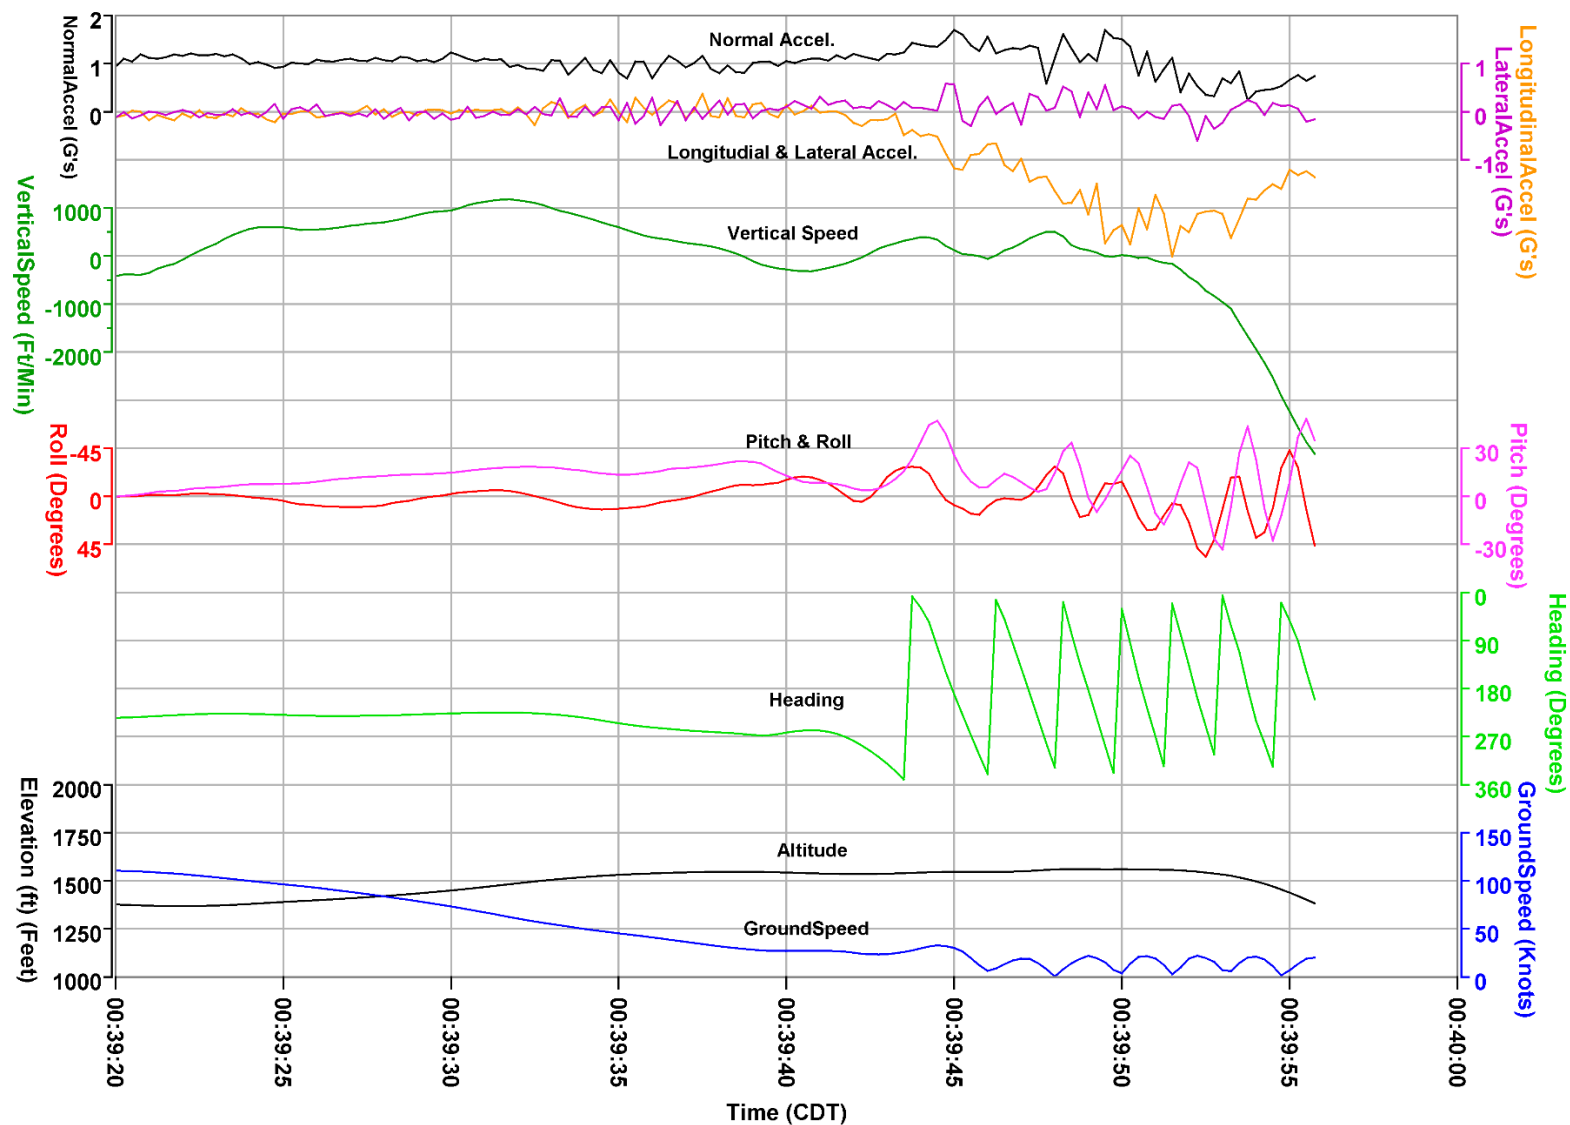
Figure 11 is a plot of all relevant recorded parameters from the Appareo Vision 1000 for the time interval between 00:39:20 and 00:40:00.

Figure 11. A plot of GPS recorded parameters, GPS derived parameters as well as AHRS recorded parameters for the accident portion.
