**NATIONAL TRANSPORTATION SAFETY BOARD**  
**Office of Aviation Safety**  
**Washington, D.C. 20594**

**AIRWORTHINESS GROUP CHAIRMAN'S FACTUAL REPORT**

**NTSB No: CEN19FA185**

Operator: North Memorial Healthcare  
Aircraft: Leonardo A109S, Registration N11NM  
Location: Brainerd, Minnesota  
Date: June 28, 2019  
Time: 0040 central daylight time

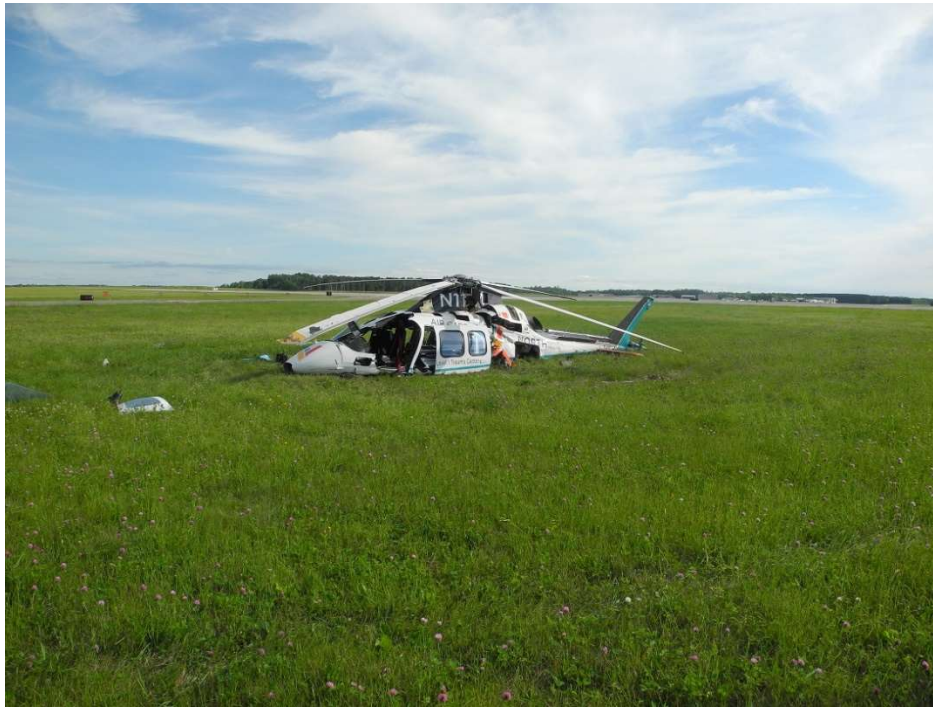
The helicopter came to rest upright at a heading of about 74 degrees magnetic ([Figure 1](#)). The nose cone was separated and found about 73 feet to the northeast of the main wreckage. The tail boom was partially separated from the main fuselage. Both the main fuselage and the tail boom exhibited crushing damage consistent with a primarily vertical impact ([Figure 2](#)). The left and right horizontal stabilizer remained attached to the tail boom. The left horizontal stabilizer’s tip end (winglet) was fractured and found adjacent to the left horizontal stabilizer. The right horizontal stabilizer remained whole.

**Figure 1. A view of the left side of the accident helicopter.**

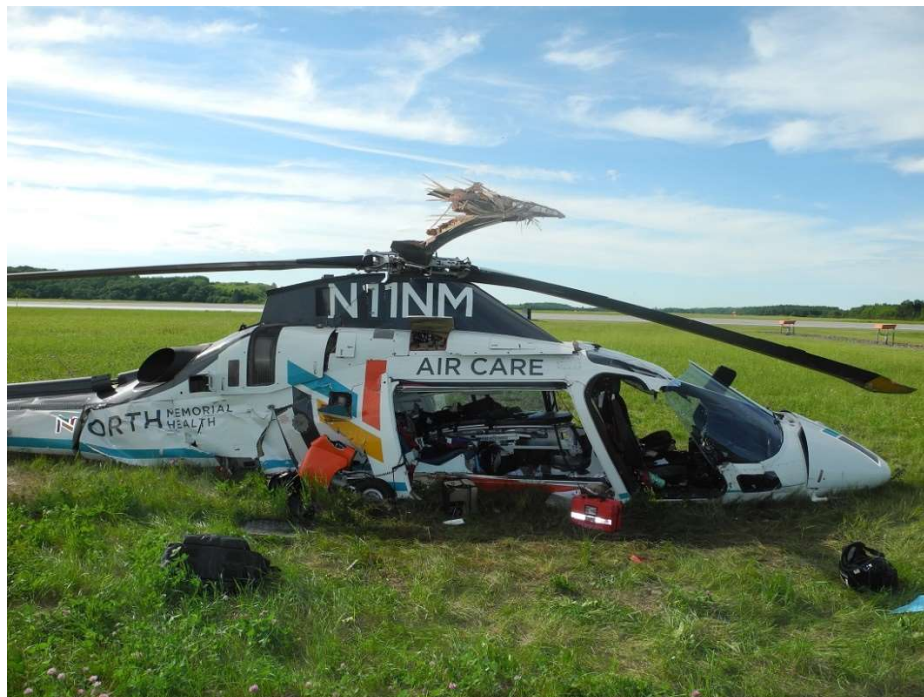
**Figure 2. A view of the right side of the accident helicopter.**

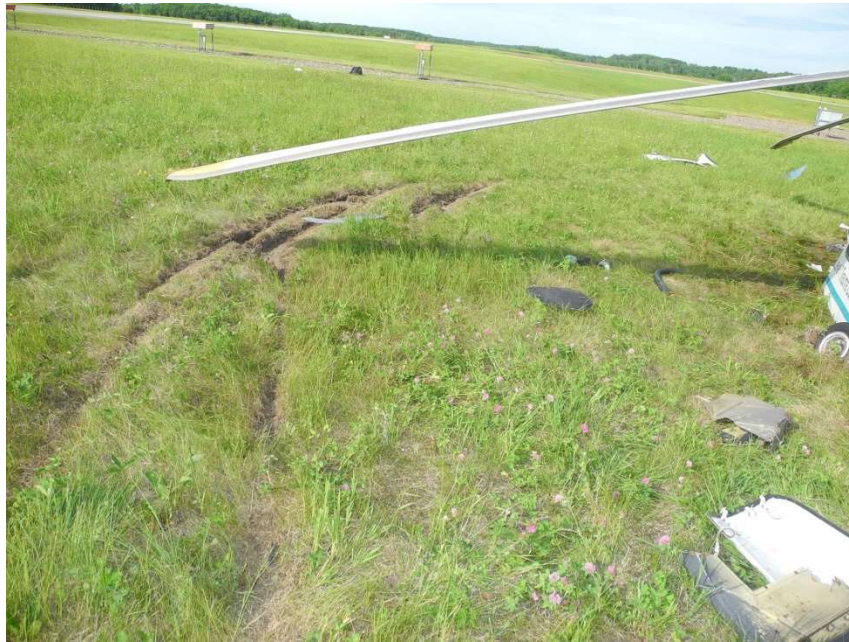
Ground scars were present on the left side of the helicopter, within the area of the main rotor disk (**Figure 3**). The ground scar was an arc that spanned about 90 degrees and was about 6 inches in depth at its deepest point.

**Figure 3. Ground scars to the left of the accident helicopter.**

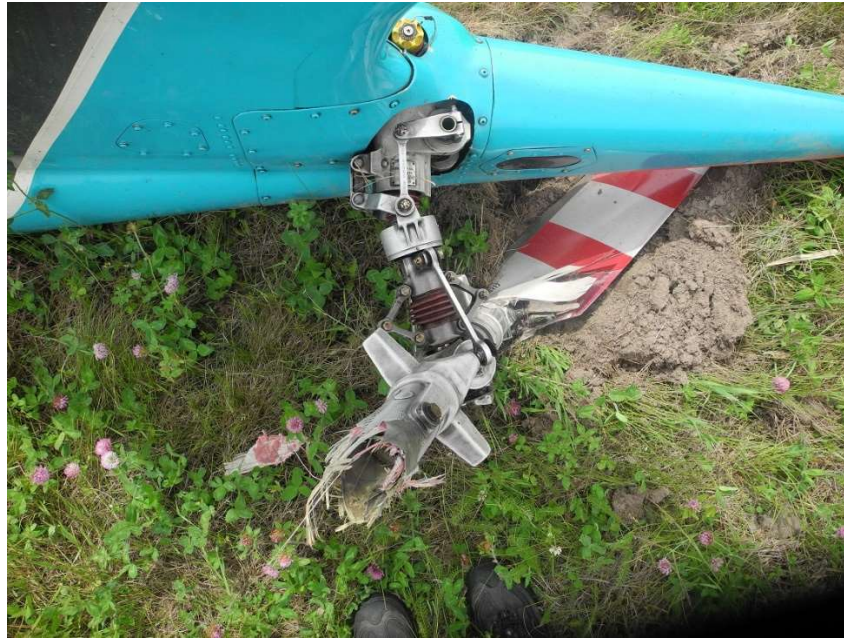
The tail rotor hub remained attached to the tail gearbox (**Figure 4**). The tail rotor blade PCLs and the tail rotor control linkages remained connected. One of the two tail rotor blades was fractured at its root and found about 211 feet to the southwest of the main wreckage; this blade exhibited impact damage near its tip and a broomstraw appearance on its inboard end, but was otherwise whole (**Figure 5**). The second tail rotor blade was partially fractured at its root but remained attached to the tail rotor hub and resting on the ground. Ground scars were found adjacent to the tail rotor and was consistent with multiple tail rotor blade strikes. The ground scars were about 7 inches deep.

**Figure 4. The tail rotor attached to the tail gearbox.**

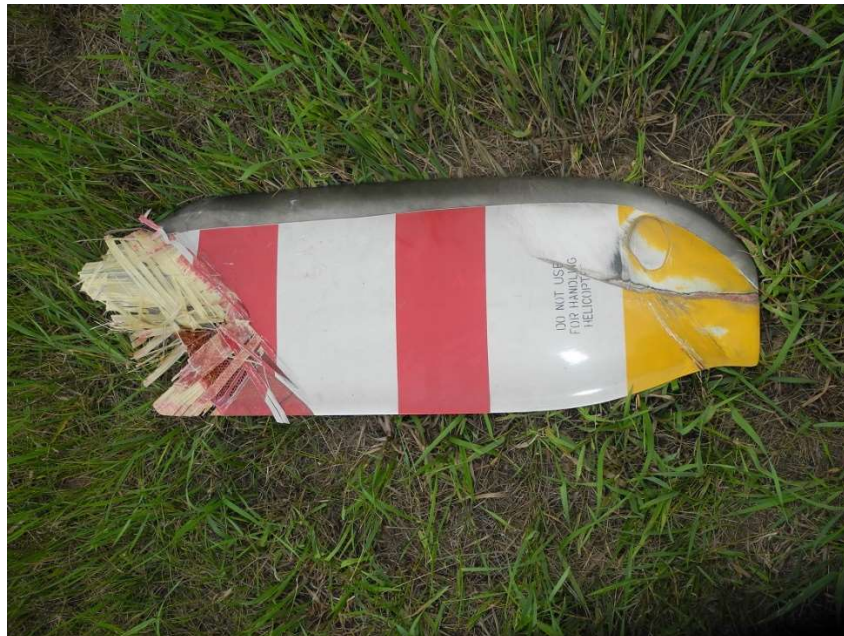
**Figure 5. The separated tail rotor blade, found about 211 feet from the main wreckage.**

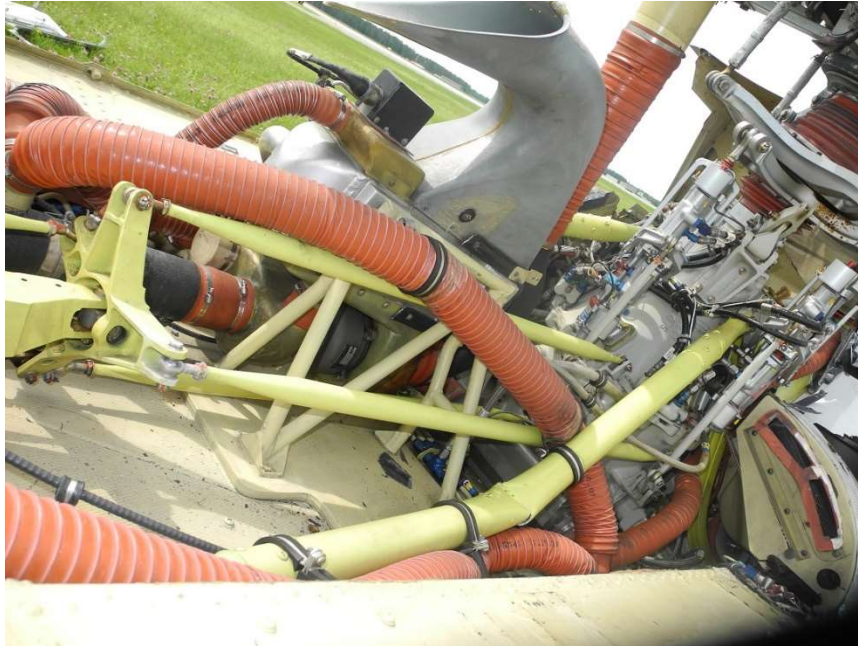
The three main rotor hydraulic actuators remained attached to the stationary swashplate and the main gearbox housing ([Figure 6](#)). The flight control linkages underneath the upper fairing, which included the pitch and roll linear actuators and the

mixing star, showed no evidence of fractures or disconnections with the exception of a fracture observed on the input linkage routing to the right main rotor hydraulic actuator. The rotating and stationary scissors remained connected to their respective swashplates.

**Figure 6. A view of the flight controls from the mixing star to the main rotor hydraulic actuators (only the left and right actuators are visible).**

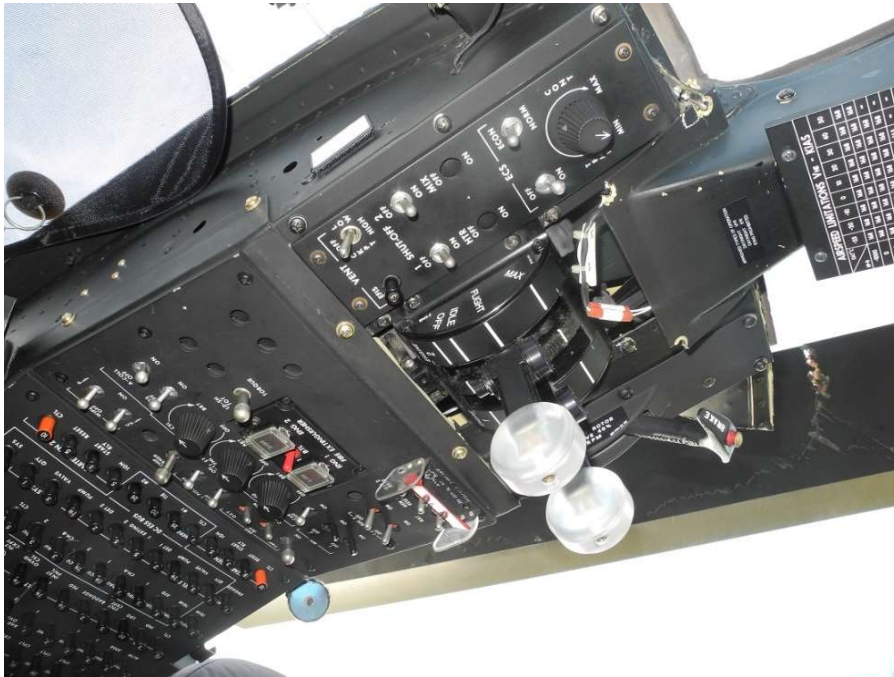
Both engine control levers were found in the “flight” position and the rotor brake lever was stowed (**Figure 7**).

**Figure 7. The engine control levers and rotor brake lever.**

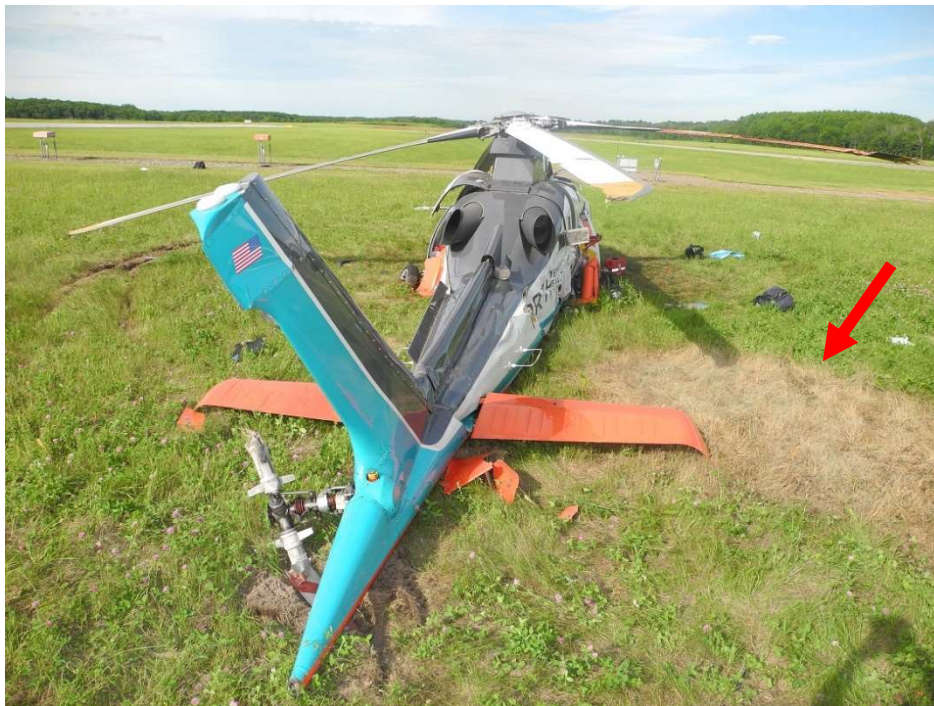
The No. 2 engine remained installed on the engine deck. At the accident site, a patch of grass to the aft of the engine exhaust exhibited a tan-colored discoloration consistent with exposure to hot engine exhaust (**Figure 8**). (A corresponding discoloration of the grass was not present on the No. 1 engine side.)

**Figure 8. A red arrow points to discoloration observed on the grass to the aft-right of the No. 2 engine exhaust.**
