## Air Safety Investigations Aircraft Incident/Accident Technical Report

| Aircraft Incident/<br>Accident Information | Year: 1965 | Make: Beechcraft | Model: 95-B55 |
| Location: Chadron, NE | | Date: 07-24-19 | Time: 1420 MDT |
| Senior Air Safety Investigator: Peter J. Basile | | Report #: ASI-19-BX-T | Report date: 01-21-20 |

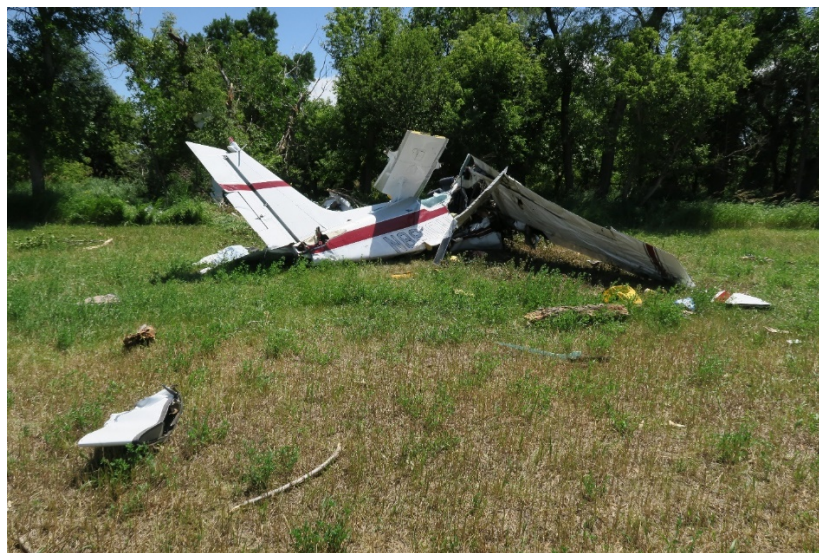
Accident Site

The aircraft descended into a tree line in a left-wing-low, nose-down flight attitude and then impacted a grass covered field approximately 0.25 NM northeast of Runway 20 at KCDR. The right horizontal stabilizer separated from the aircraft and was found approximately 10' AGL in the impacted tree. The right elevator, with elevator trim tab attached, came to rest at the base of the impacted tree. The left wing struck the ground first and the left wing tip, approximately 3' long, separated from the wing. The outboard section of the left wing, containing the left aileron, sustained tree impact damage and was also separated from the aircraft. The inboard section the left wing, with the flap attached, remained attached to the fuselage. The right wing remained in one piece and was attached to the fuselage. The right flap was hanging downward and remained attached at the outboard flap track.

The vertical stabilizer and the rudder remained attached to the tail. The left horizontal stabilizer, with the left elevator attached, remained connected to the tail. The top of the cabin was removed by first responders and the aft cabin roof was bent aft by first responders to facilitate recovery efforts.

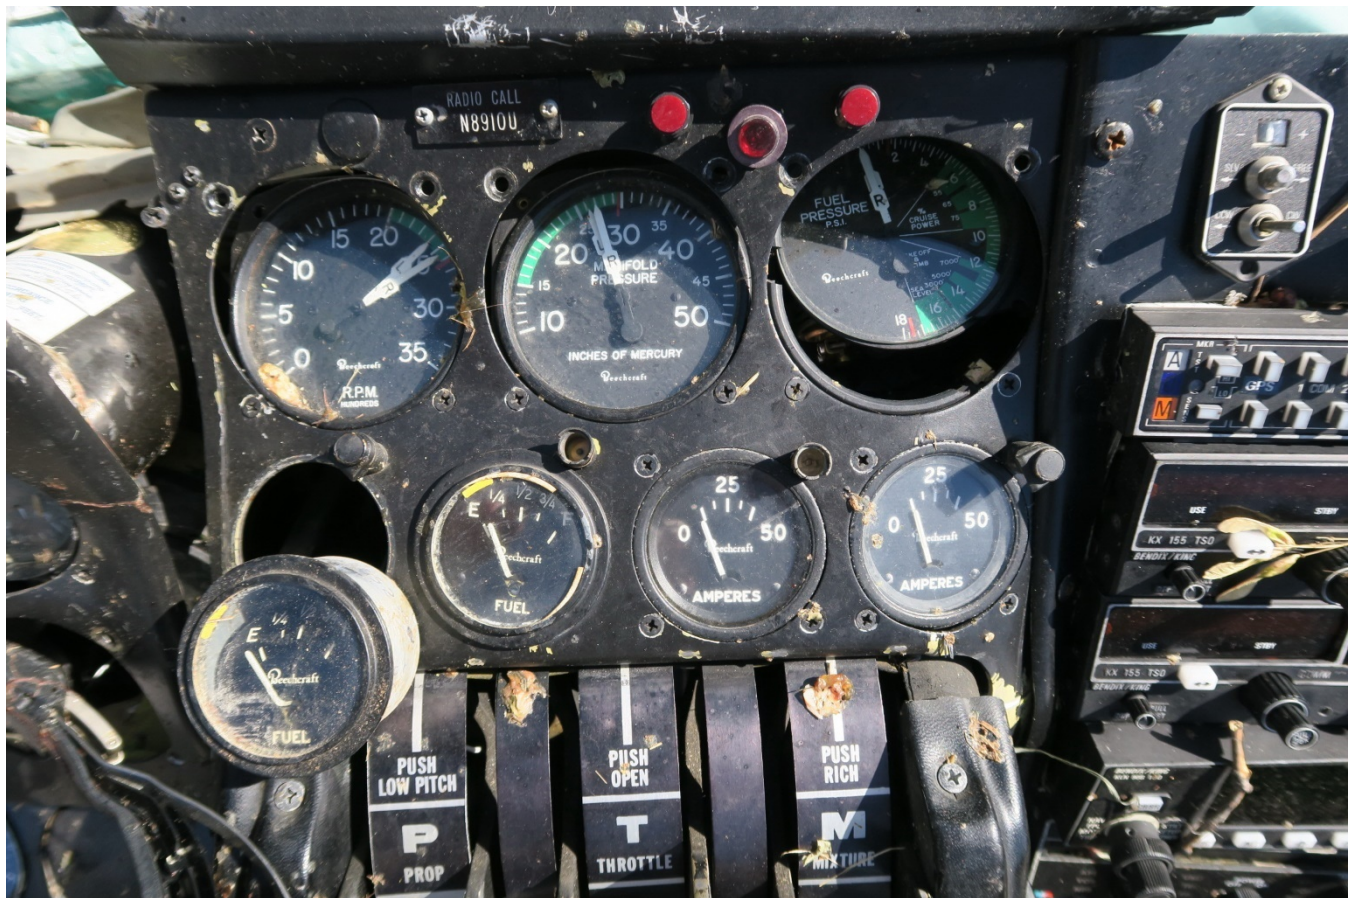
Fuel Gauges

The left fuel gauge was impact separated from the instrument panel and was found in the grass next to the fuselage. The left fuel gauge indicated Empty. The right fuel gauge indicated slightly above Empty.

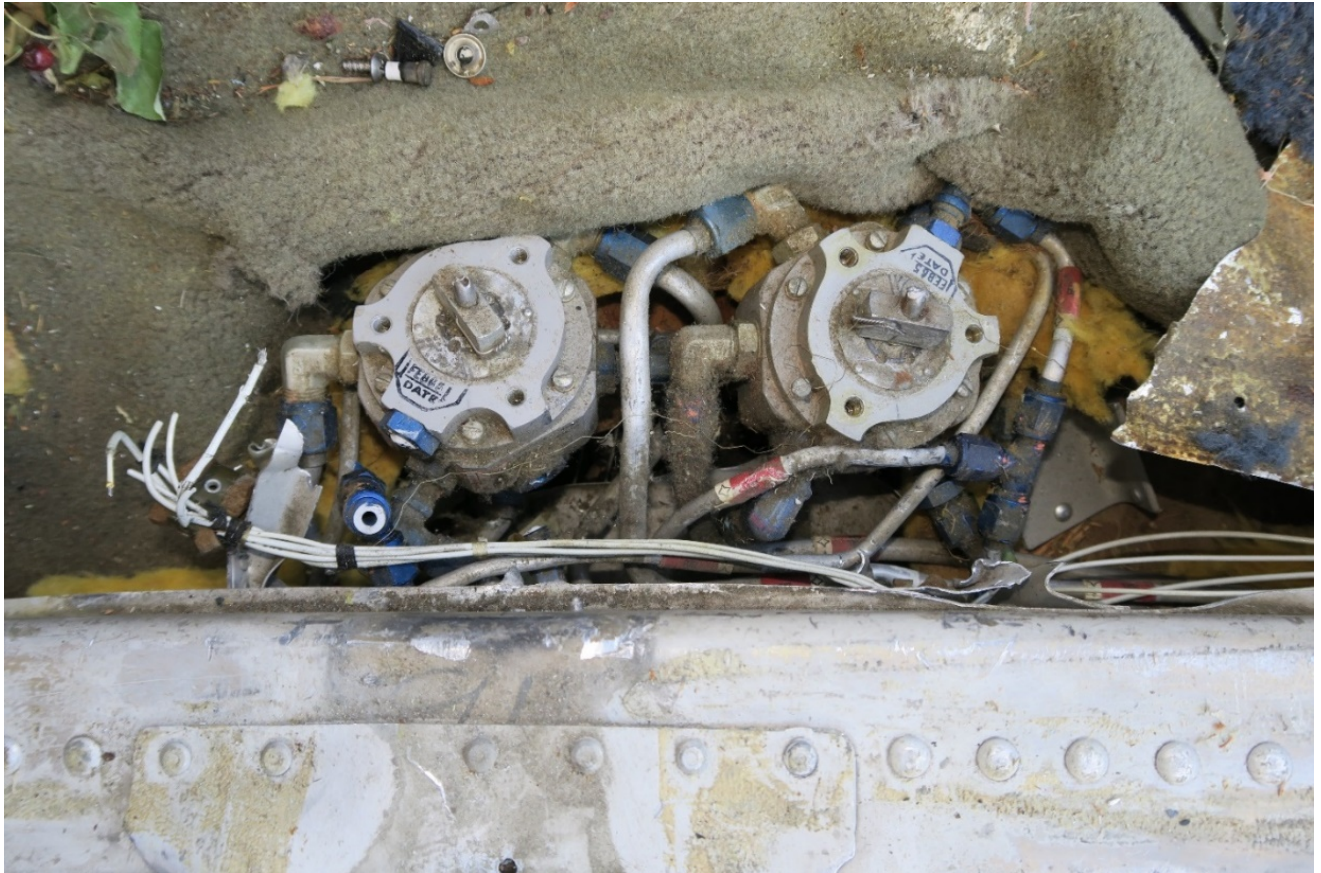
Fuel Selector Valves

The left fuel selector handle was impact separated. The left fuel selector handle fractured roll pin hole was determined to be aligned with the handle being oriented to the left main fuel tank. The left fuel selector yoke on top of the fuel selector valve was turned using a wrench and the left fuel selector valve was determined to be on the left main tank position.

The damaged right fuel selector handle was removed, and the right fuel selector yoke was turned with a wrench. The right fuel selector valve was found to be positioned on the right main fuel tank.

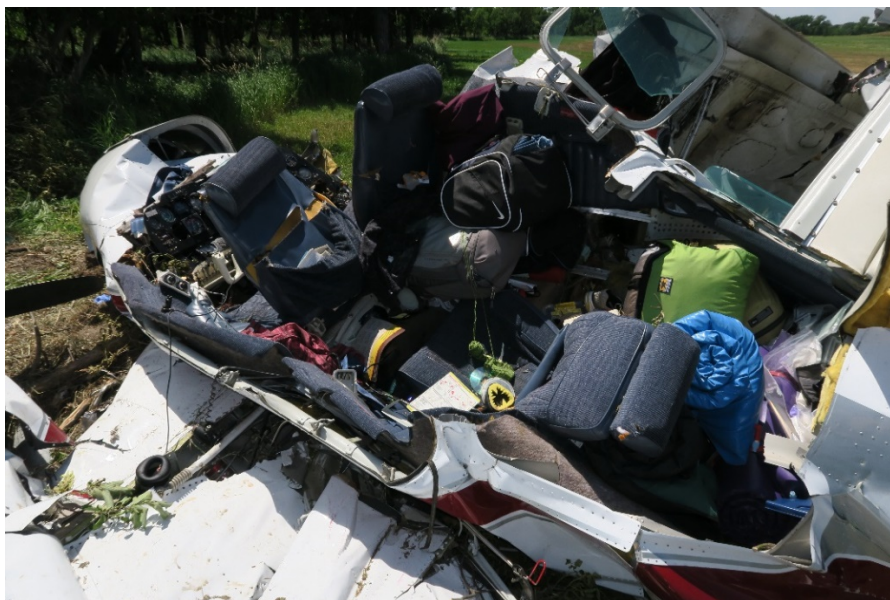
Cargo in Cabin

The seats remained loosely attached to their respective seat rails. Seats 4, 5, and 6 had been removed from the aircraft. The aircraft was packed with camping gear which included, tents, sleeping bags, air mattresses, chairs, clothing, a cooler, and food stuffs. All items were removed from the cabin and nose baggage compartment. The items were weighed using a bathroom scale. The cargo in the cabin weighed 293.6 pounds. The cargo in the nose baggage area weighed 116 pounds.

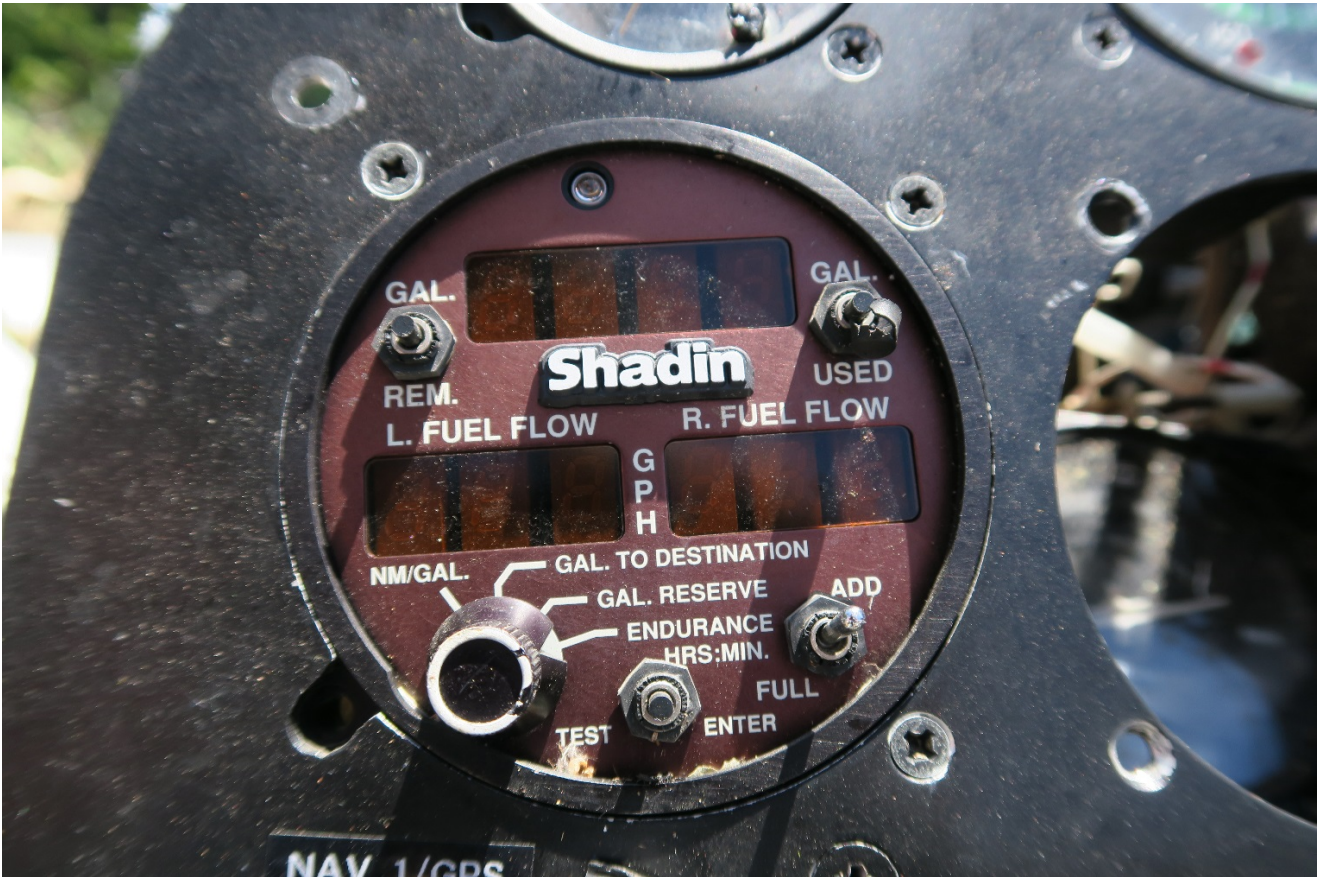
Shadin Fuel Flow Indicator

A Shadin digital fuel flow indicator was removed from the instrument panel and retained by the NTSB-IIC for data analysis. The data analysis had not been completed at the time this report was written.

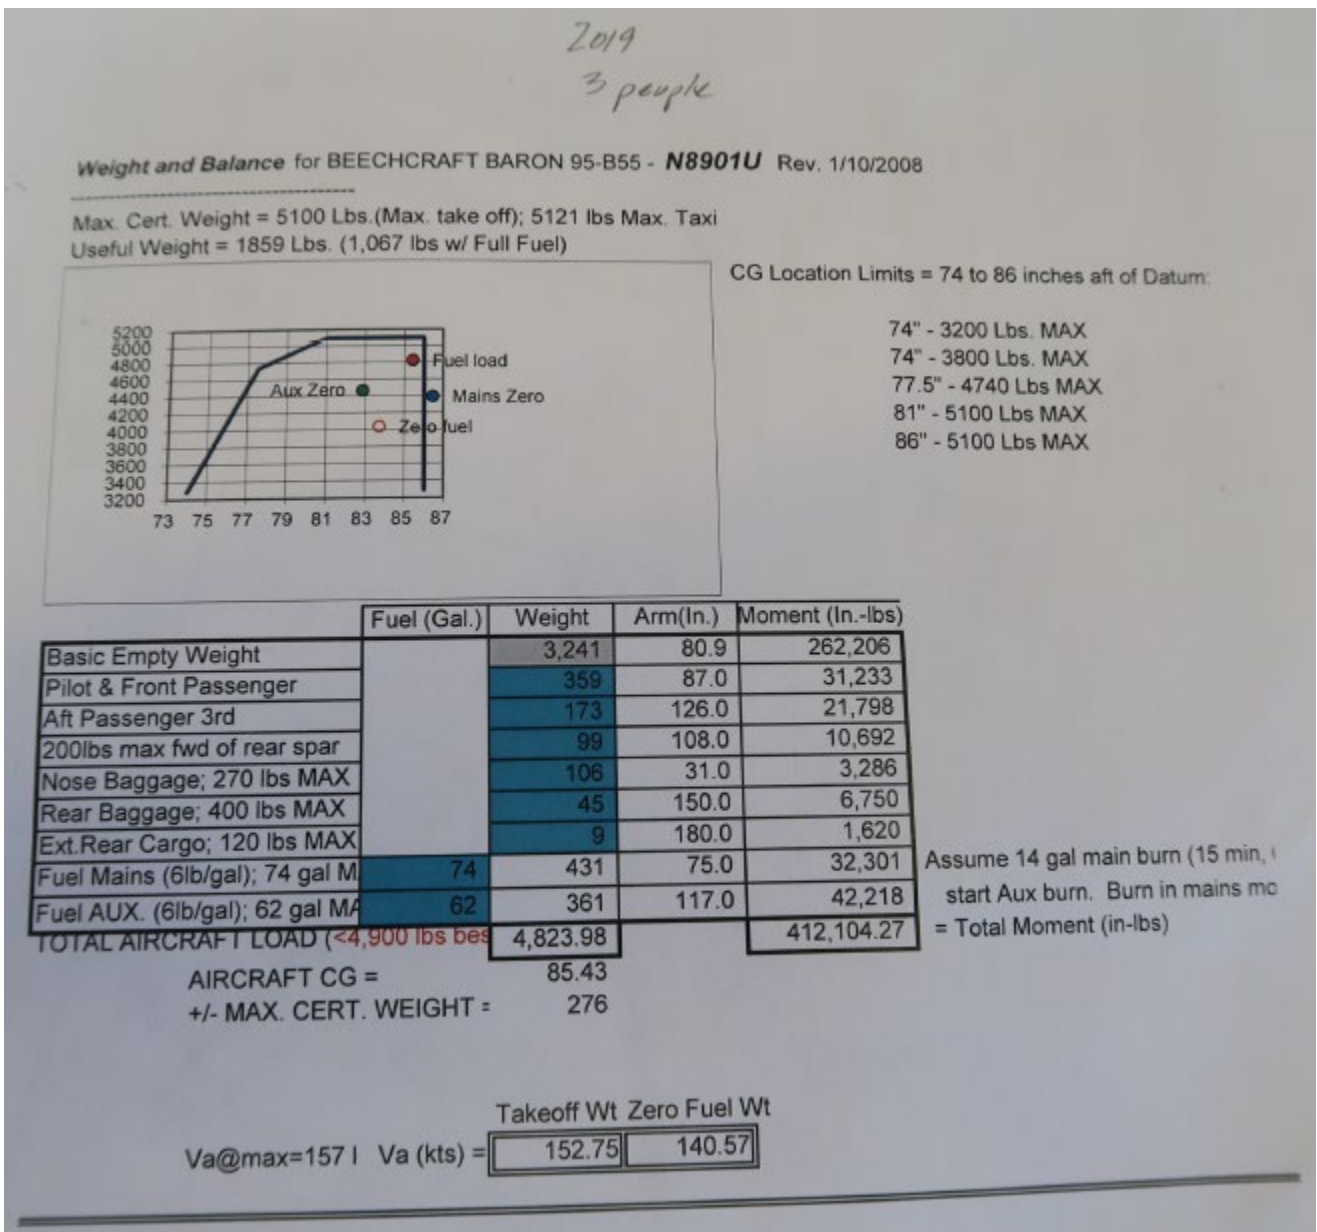
Pilot Calculated Weight and Balance

The pilot calculated weight and balance included a total of 259 pounds of cargo. A total of 409.6 pounds of cargo was weighed in the hangar.
