# NTSB Accident Summary

## Accident Number CEN19FA236

Location: Chadron, Nebraska  
Date: July 24, 2019  
Time: 1420 MDT  
Aircraft: Beech 95-B55 (T42A) - s/n TC-946  
Registration: N8910U

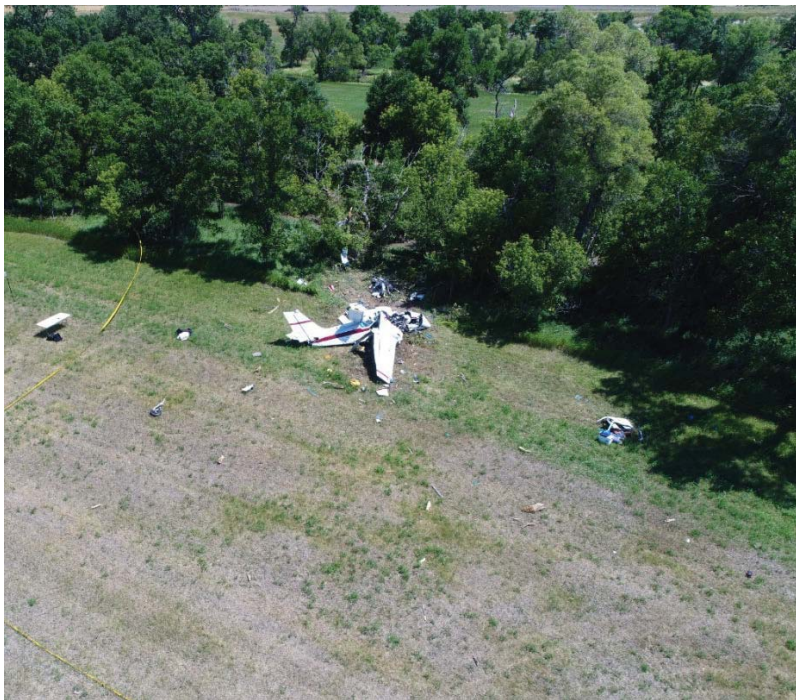
The accident site was located at 42.850178° x -103.084908° - elevation 3,240 ft msl. The site was 0.25 nm north-northeast of the end of runway 21 at CDR and 0.33 nm from the beginning of the displaced threshold.

The airplane descended into a tree line in a left-wing-low, nose-down flight attitude and then impacted a grass covered field approximately 0.25nm northeast of Runway 20 at KCDR. The right horizontal stabilizer separated from the aircraft and was found approximately 10' AGL in the impacted tree. The right elevator, with elevator trim tab attached, came to rest at the base of the impacted tree. The left wing struck the ground first and the left wing tip, approximately 3'-long, separated from the wing. The outboard section of the left wing, containing the left aileron, sustained tree impact damage and was also separated from the aircraft. The inboard section the left wing, with the flap attached, remained attached to the fuselage. The right wing remained in one piece and was attached to the fuselage. The right flap was hanging downward and remained attached at the outboard flap track.
