## RECORD OF CONVERSATION

**Date:** July 31, 2019  
**Person Contacted:** Derek de Bastos, friend of pilot  
**NTSB Accident Number:** CEN19FA236

**NTSB Accident Number:** CEN19LA216

**NTSB Accident Number:** CEN19FA236

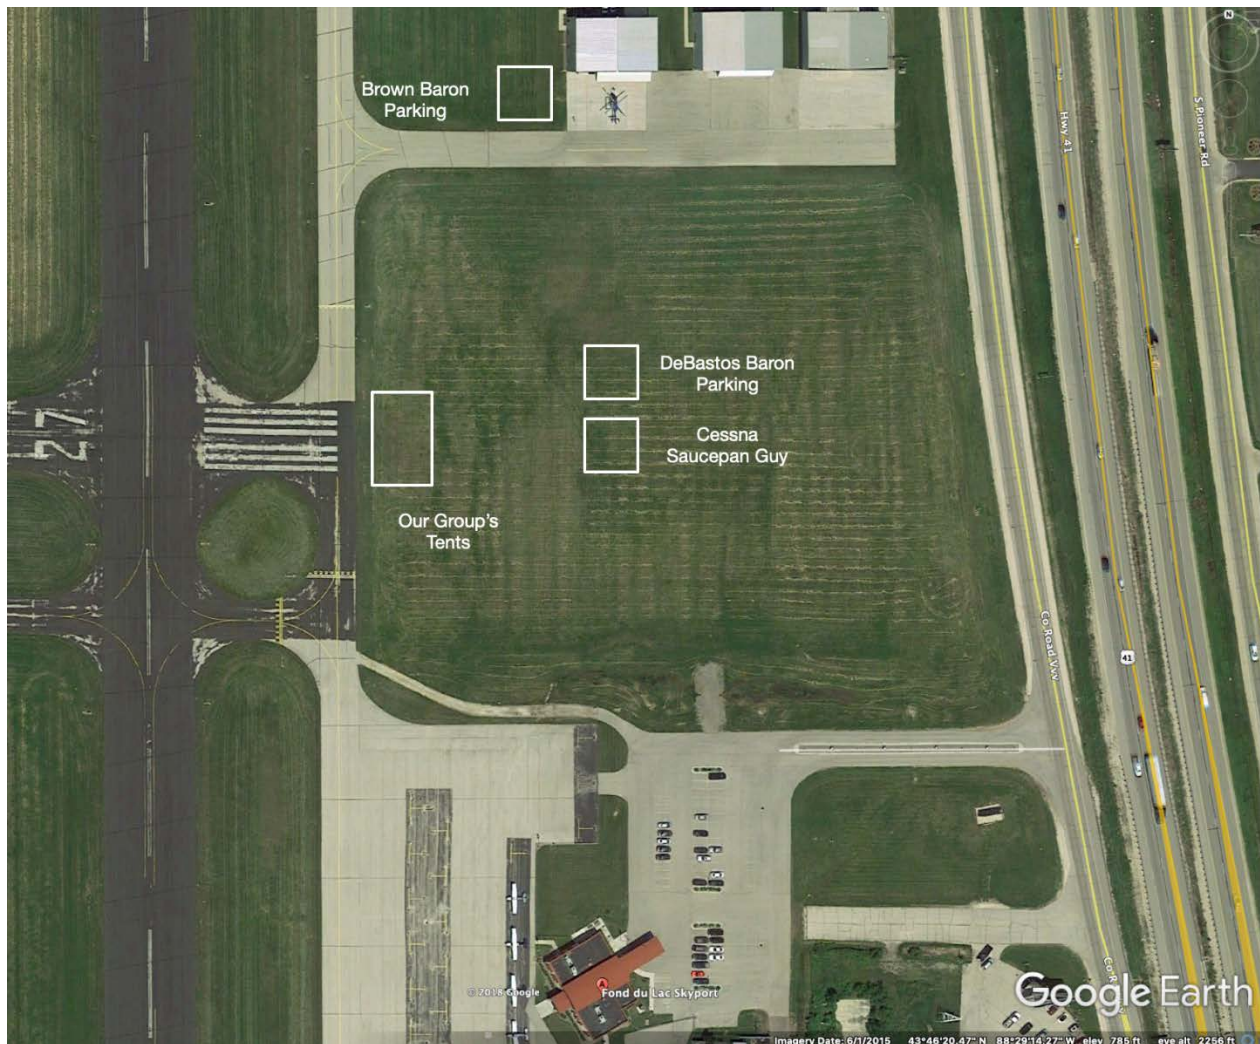
They all had tents together next to Glenn's airplane at FLD. But the Browns airplane was about 60 yards away (see map below created by Glenn and sent to NTSB).

He remembered the Browns were parked by a hangar with Cessna parked next to him. The parking location at FLD was on a downhill slope. AUX may have appeared full when they weren't actually full.
