**NATIONAL TRANSPORTATION SAFETY BOARD  
Office of Aviation Safety  
Washington, DC 20594**

**SUMMARY OF AIRCRAFT EXAMINATIONS**

**-- CEN19FA238 --**

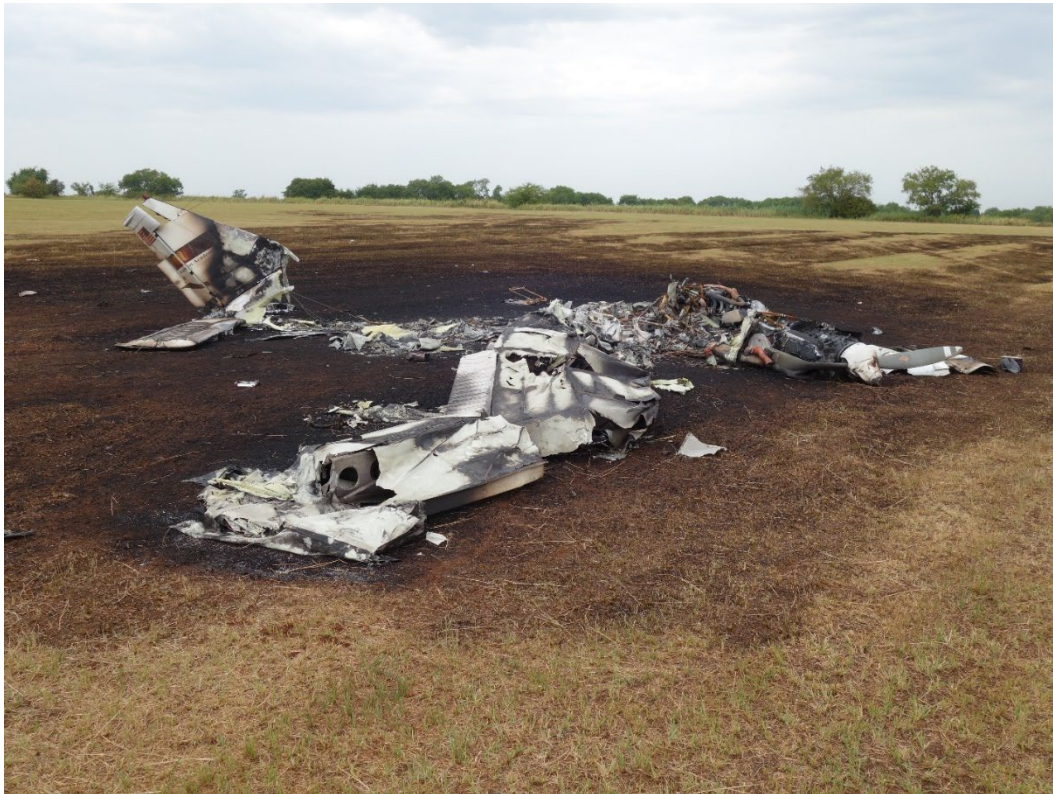
Figure 1: Airplane Wreckage

The airplane impacted the ground with the left wing-low attitude, hitting the nose and nose landing gear next as the fuselage continued to slide until coming to rest in an upright position. The fuselage was consumed by fire from the forward bulkhead to the aft tailcone. The nose landing gear and fragments of the nose baggage cone were observed in the debris field. The main wreckage included both engines, wings, fuselage and tail sections.
