**NATIONAL TRANSPORTATIONS SAFETY BOARD**  
**Office of Aviation Safety**  
**Washington, DC 20594**

**SUMMARY OF AIRCRAFT EXAMINATION**

-- CEN19FA271 --

Location: Chandeleur Sound, Louisiana  
Date: August 18, 2019  
Time: 1330  
Aircraft: Cessna 206; N5364Q

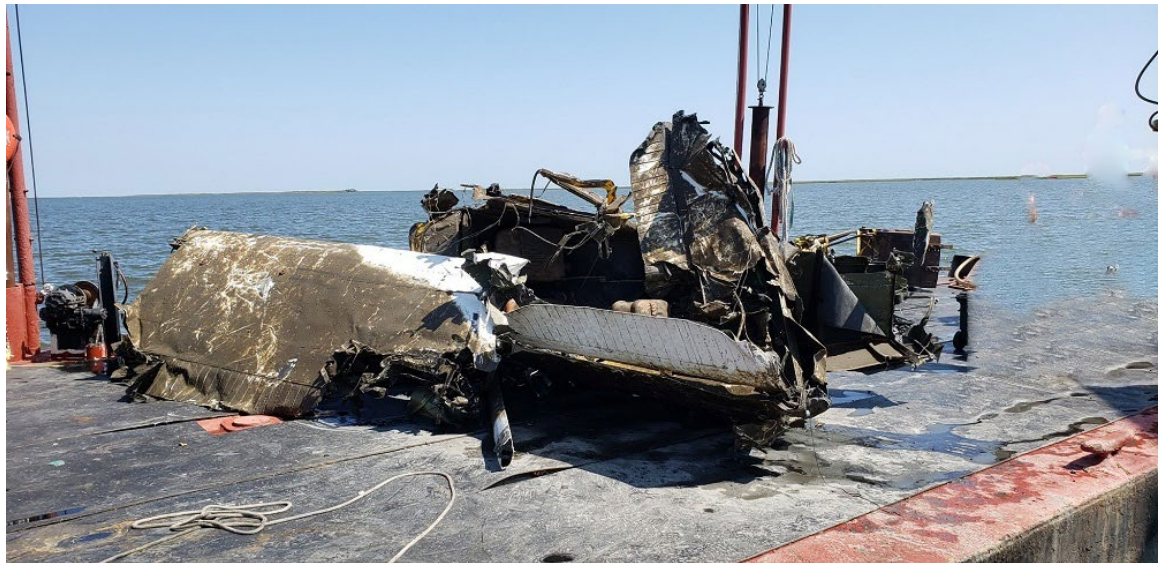
The fuselage included the pilot seat, the right front passenger seat, and one seat aft of the pilot seat. The instrument panel was impact damaged and covered in dirt and barnacles. The engine throttle control, the propeller control knob, and the fuel mixture control knob all appeared to be full forward. The airspeed indicator was partially full of water and the needle sat about 104 mph. The altimeter Kolsman window was set to 29.95. The engine rpm needle sat at zero and the counter read 522.8 hours.
