Covington Aircraft Engines, Inc.

| <b>Work Order:</b> | <b>12637</b> |
| <b>Engine Information: Model:</b> | <b>Pratt &amp; Whitney R-985 AN-14B</b> |

## Engine Report

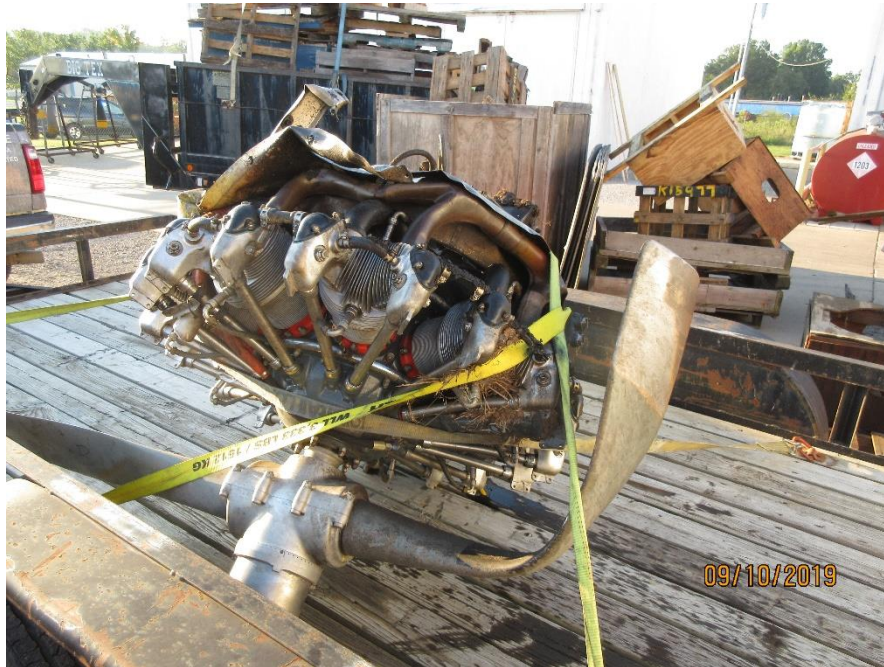
The engine condition as received showed major fire damage to rear section of the engine, with the Accessory section and Magnetos having sustained major fire damage. The Propeller blades were significantly bent and the engine mount was also heavily damaged.

Engine as received (Front)  
Photo # 1

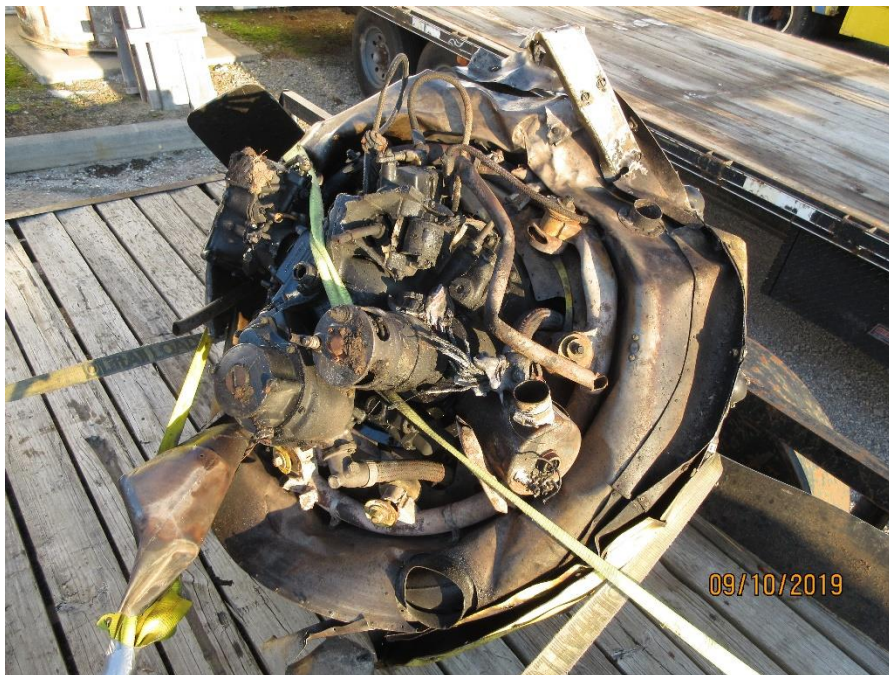
Engine as received (Rear)  
Photo # 2

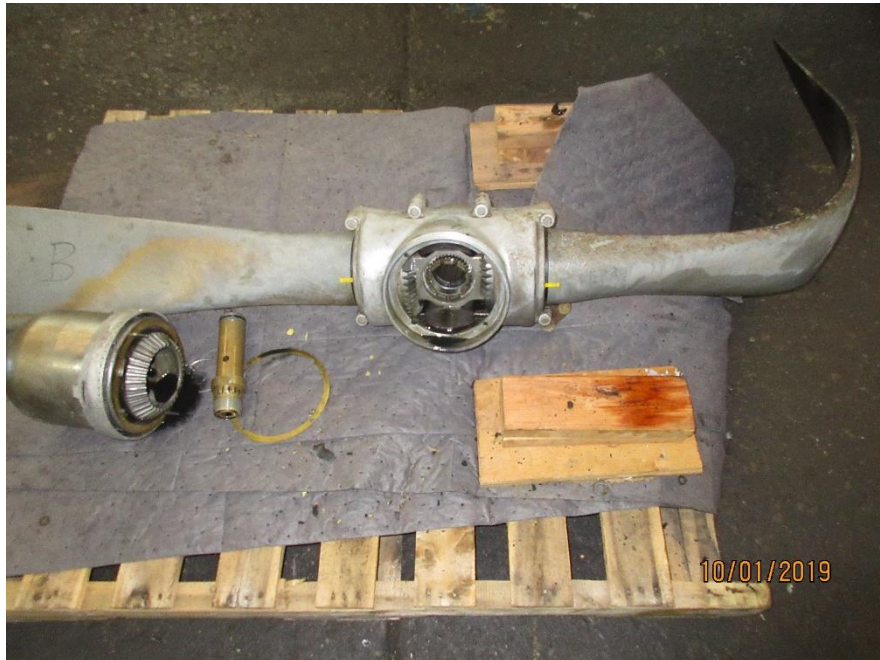
Propeller as removed  
Photo # 3

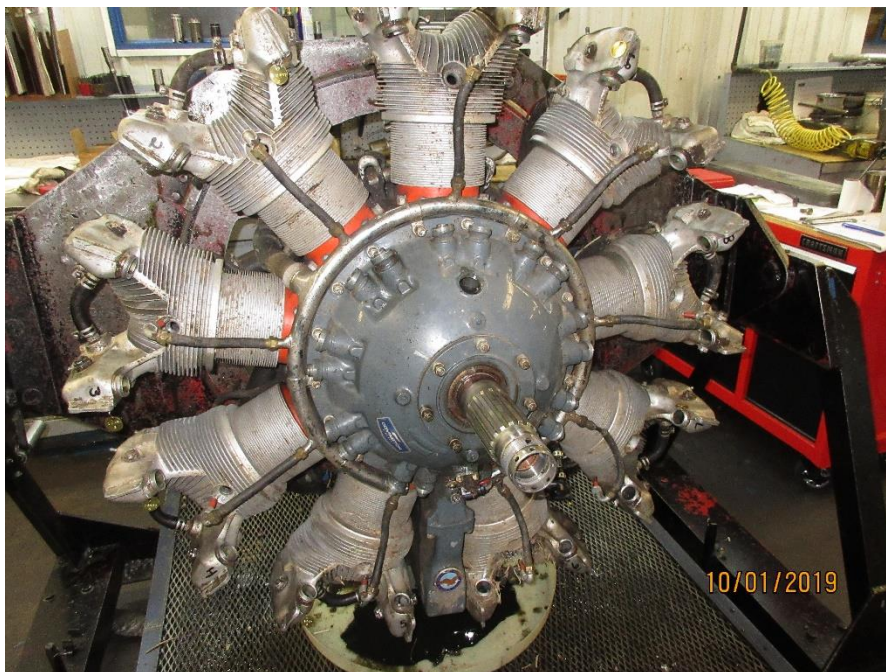
Engine (Front View)  
Photo #4

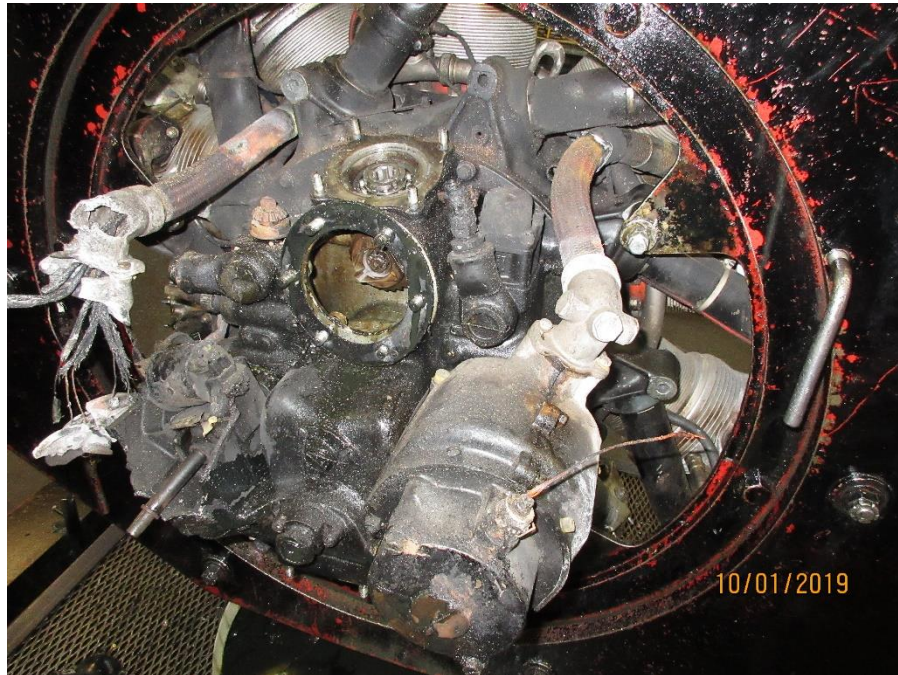
Engine Accessory Case with Magnetos attached (Rear View)  
Photo #5

The engine sustained major damage due to the crash and subsequent fire. Most of the heavy damage was confined to the Blower/Accessory section of the engine. The Blower/Accessory section was heavily damaged with the left Magneto almost totally destroyed due to fire and the right Magneto heavily damaged. The Rear Accessory case sustained impact damage in the area of the Carburetor mount pad on the mid to lower section of the case. Upon initial inspection of the engine, it was noted that the crankshaft could not be turned completely through. This condition was present even after removal of all 9 Cylinders. After removing the crankshaft assembly from the engine, it was noted that the master rod assembly moved freely around the crankpin in a normal manner. The Propeller was removed and the engine was disassembled down to the Blower/Rear section. It was found that the difficulty in turning the engine through was caused by the Blower Gear train. Upon closer inspection, it was found that the 8797 Floating Collector Gear had multiple substantially bent gear teeth. The Carburetor had sustained impact damage and was partially disassembled for inspection. No abnormalities were found in the Carburetor. An additional inspection was made of the magnetos.

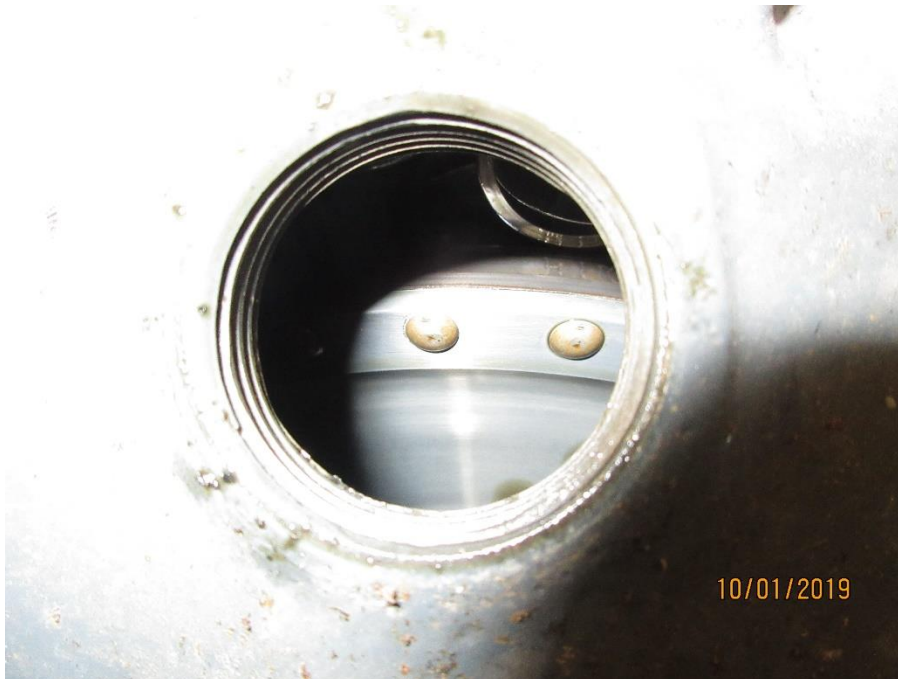
Nose Inspection Port – (\*Note - Cam Hub Rivets intact)  
Photo #6

The Cam Hub assembly was intact with no sign of broken or loose rivets. Additionally, the Intake and Exhaust Cam tracks showed no sign of failure or damage. (Photos 6 and 7)

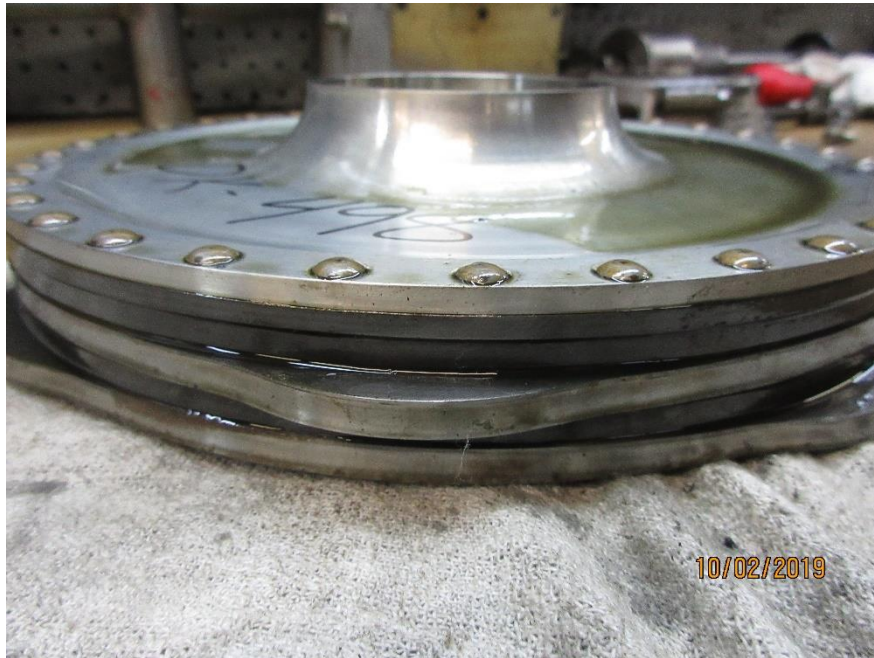
Cam as removed  
Photo # 7

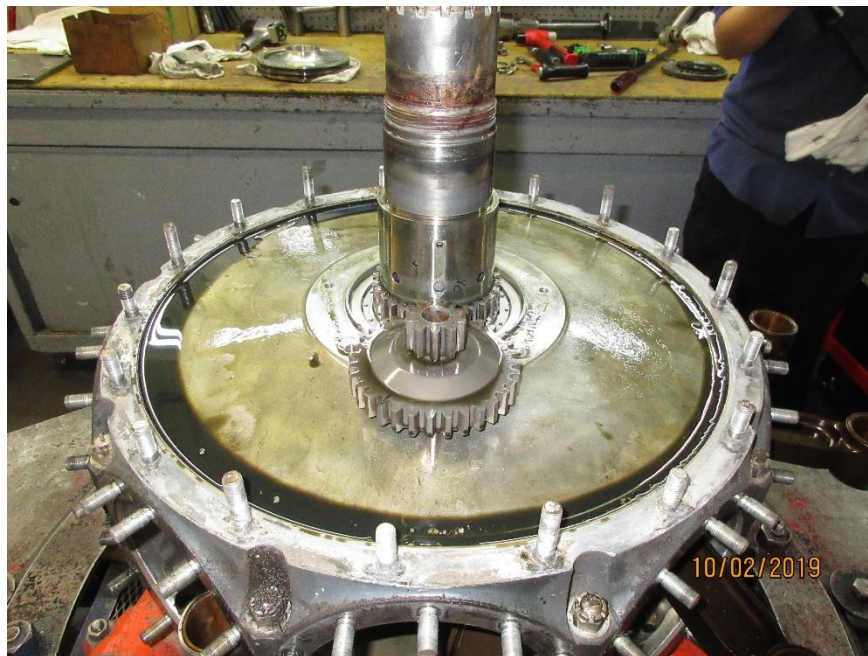
Power Section with Cylinders and Nose Case removed  
Photo # 8

No abnormalities or damage was noted during the disassembly of the Nose/Power section with the exception of the Crankshaft not being able to be fully rotated through.

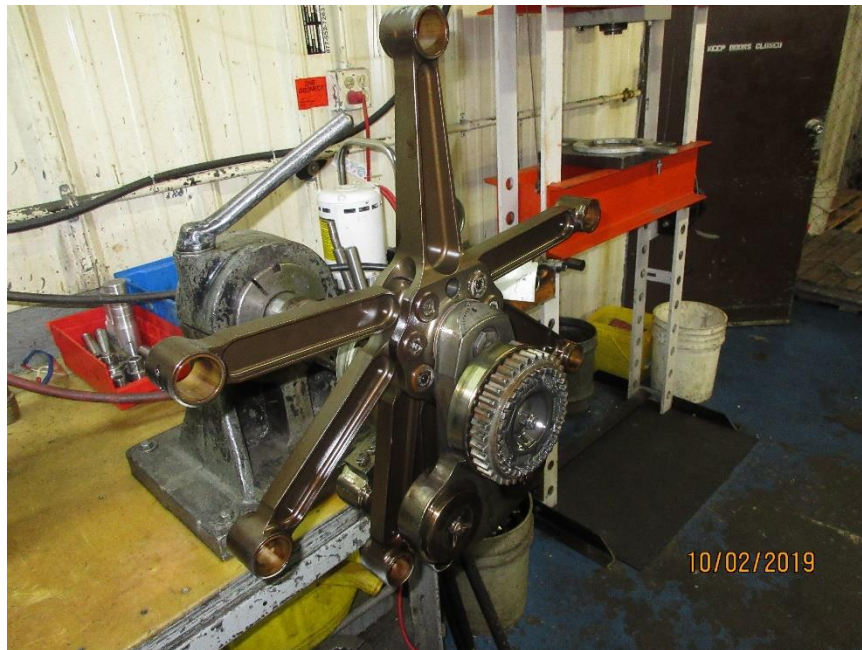
Crankshaft Assembly as removed  
Photo # 9

Although the engine could not initially be rotated completely through, the master rod assembly could rotate freely on the crank pin once removed from the engine. All components of the Crankshaft assembly indicated normal wear with no indications of a failure. Additionally, the lead and silver coating of the Master Rod Bearing I.D. was intact and showed no signs of excessive scoring or de-lamination. (Photos 9 and 10)

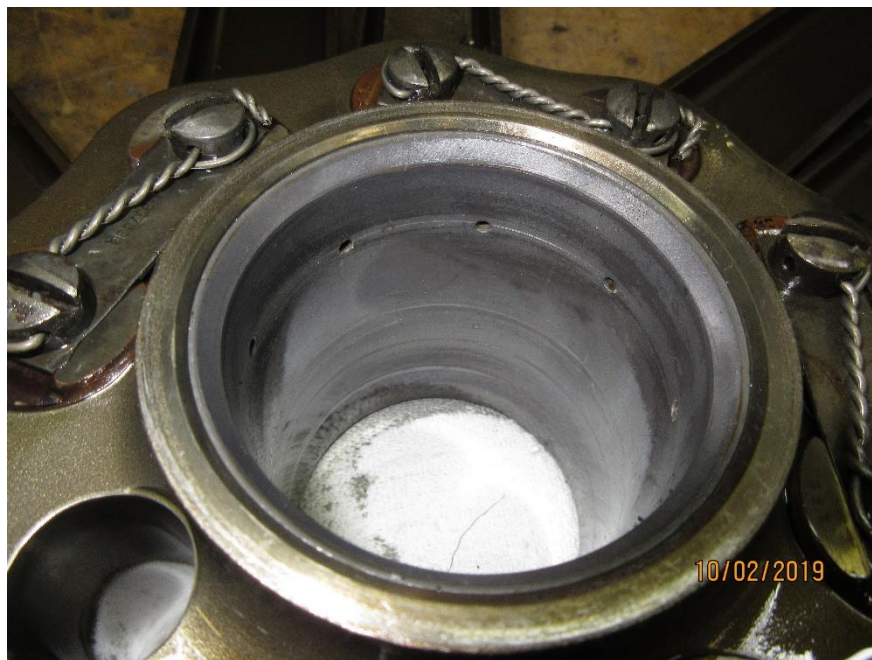
Master Rod Bearing  
Photo # 10

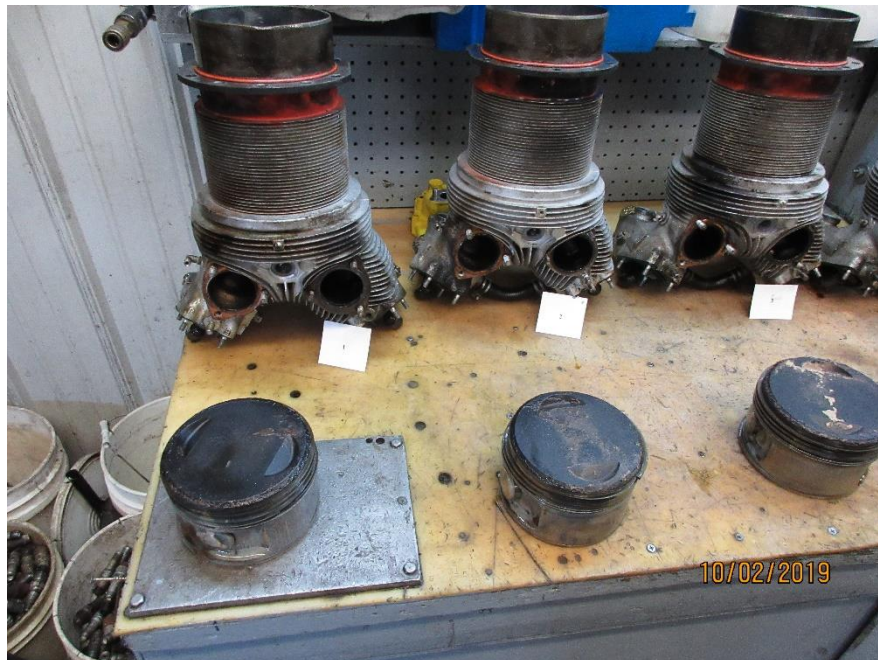
Cylinders and Pistons as removed  
Photo #11

All Cylinders were inspected and no damage was present. A close inspection was made of the Rocker Springs and all were found to be in within specified limits. The pistons were inspected and all rings were intact. No abnormalities were noted with the Cylinders.

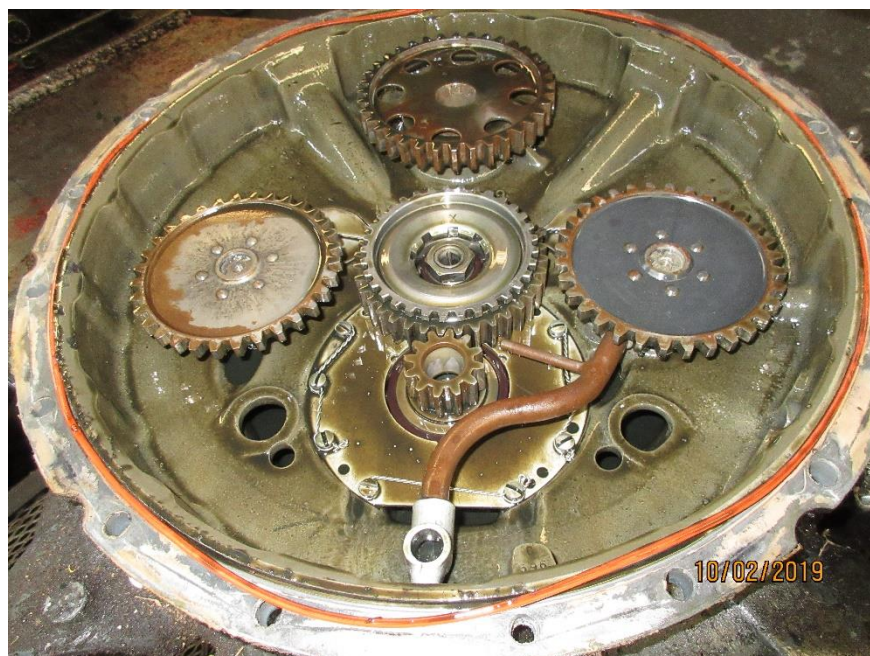
Blower Section as removed  
Photo #12

The Rear Accessory case was heavily damaged from fire and impact during the incident. Upon disassembly of the Blower section, it was found that the 8797-gear contained multiple bent teeth. The nature of the damage to the gear teeth was consistent with a sudden stoppage of the engine. These teeth were bent severely enough to prevent the engine from being fully rotated through.

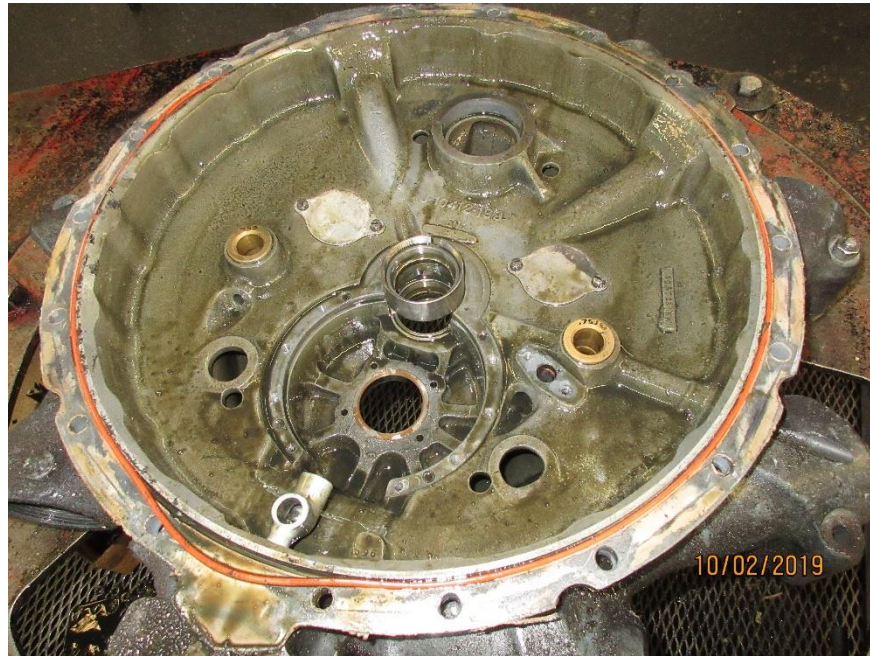
Blower Section as disassembled  
Photo #13

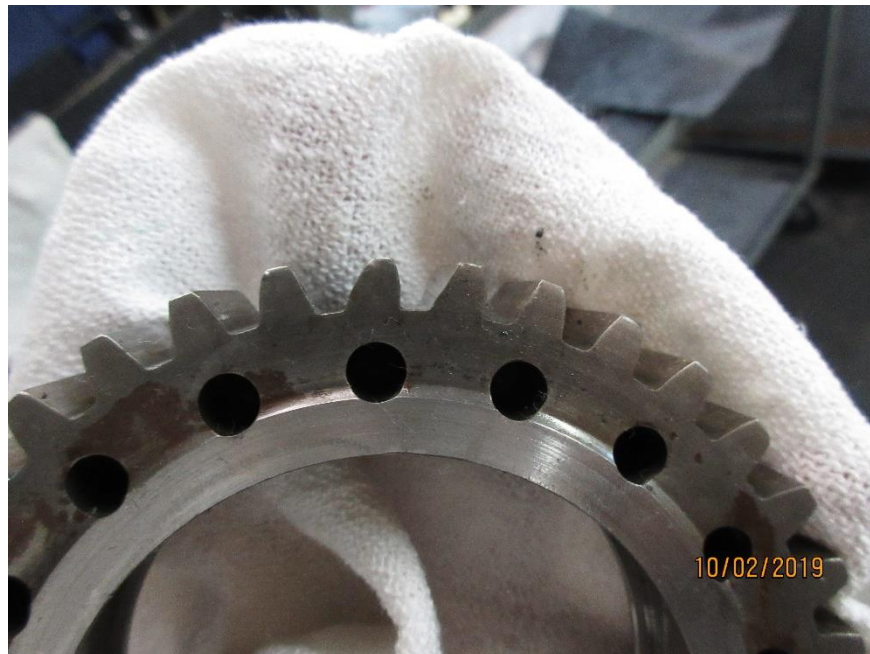
8797 Floating Gear (\*Note damage to teeth)  
Photo #14

No items were found during the inspection of the engine that could be considered as a cause for a partial or total loss of power. Although the engine could not be fully rotated through, it was determined that the root cause of this was the severely bent teeth on the 8797 gear. It is likely that the bent teeth were a result of the Prop Strike/Sudden Stoppage of the engine during the incident. An additional factor that points to a Prop Strike/Sudden Stoppage of the engine is that the 8797 and corresponding gear showed no abnormal signs of wear on the gear teeth which would be present if the engine was operated with bent teeth for a prolonged amount of time.

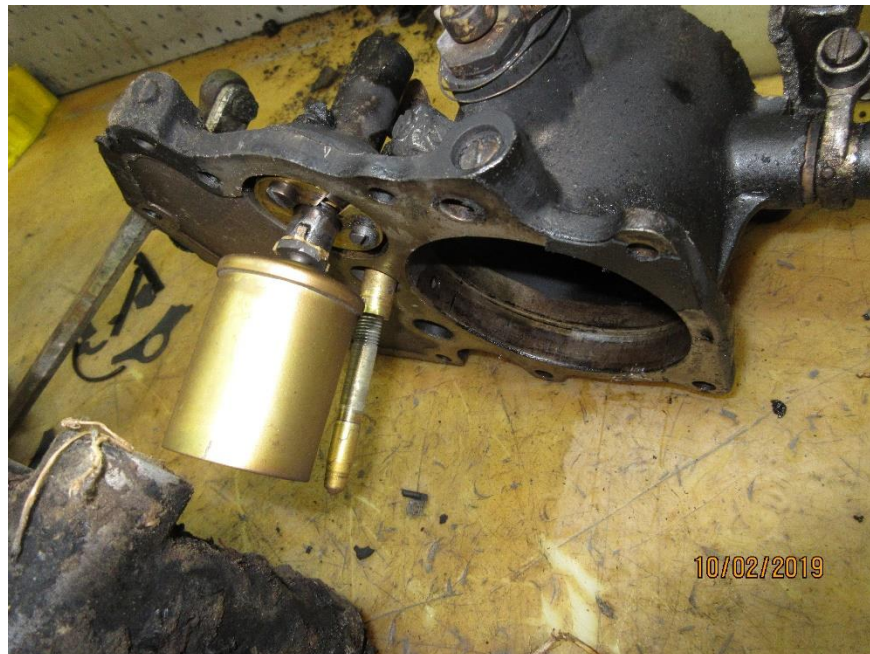
Carburetor (Top half)  
Photo #17

Although heavily damaged from the fire and impact of the engine to the ground, the inspection of the Carburetor did not reveal any abnormalities that would prevent the unit from functioning.

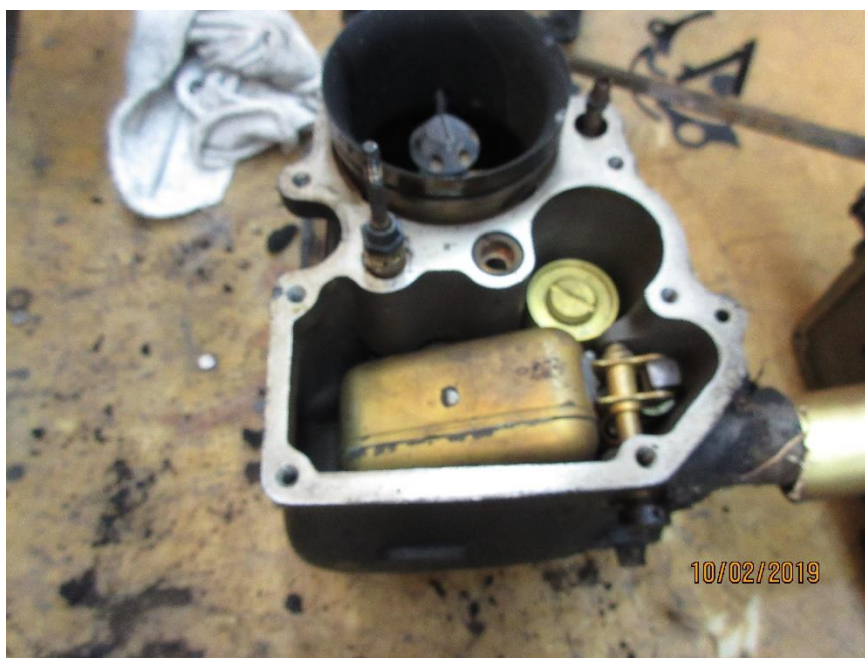
Carburetor (Bottom half)  
Photo #18
