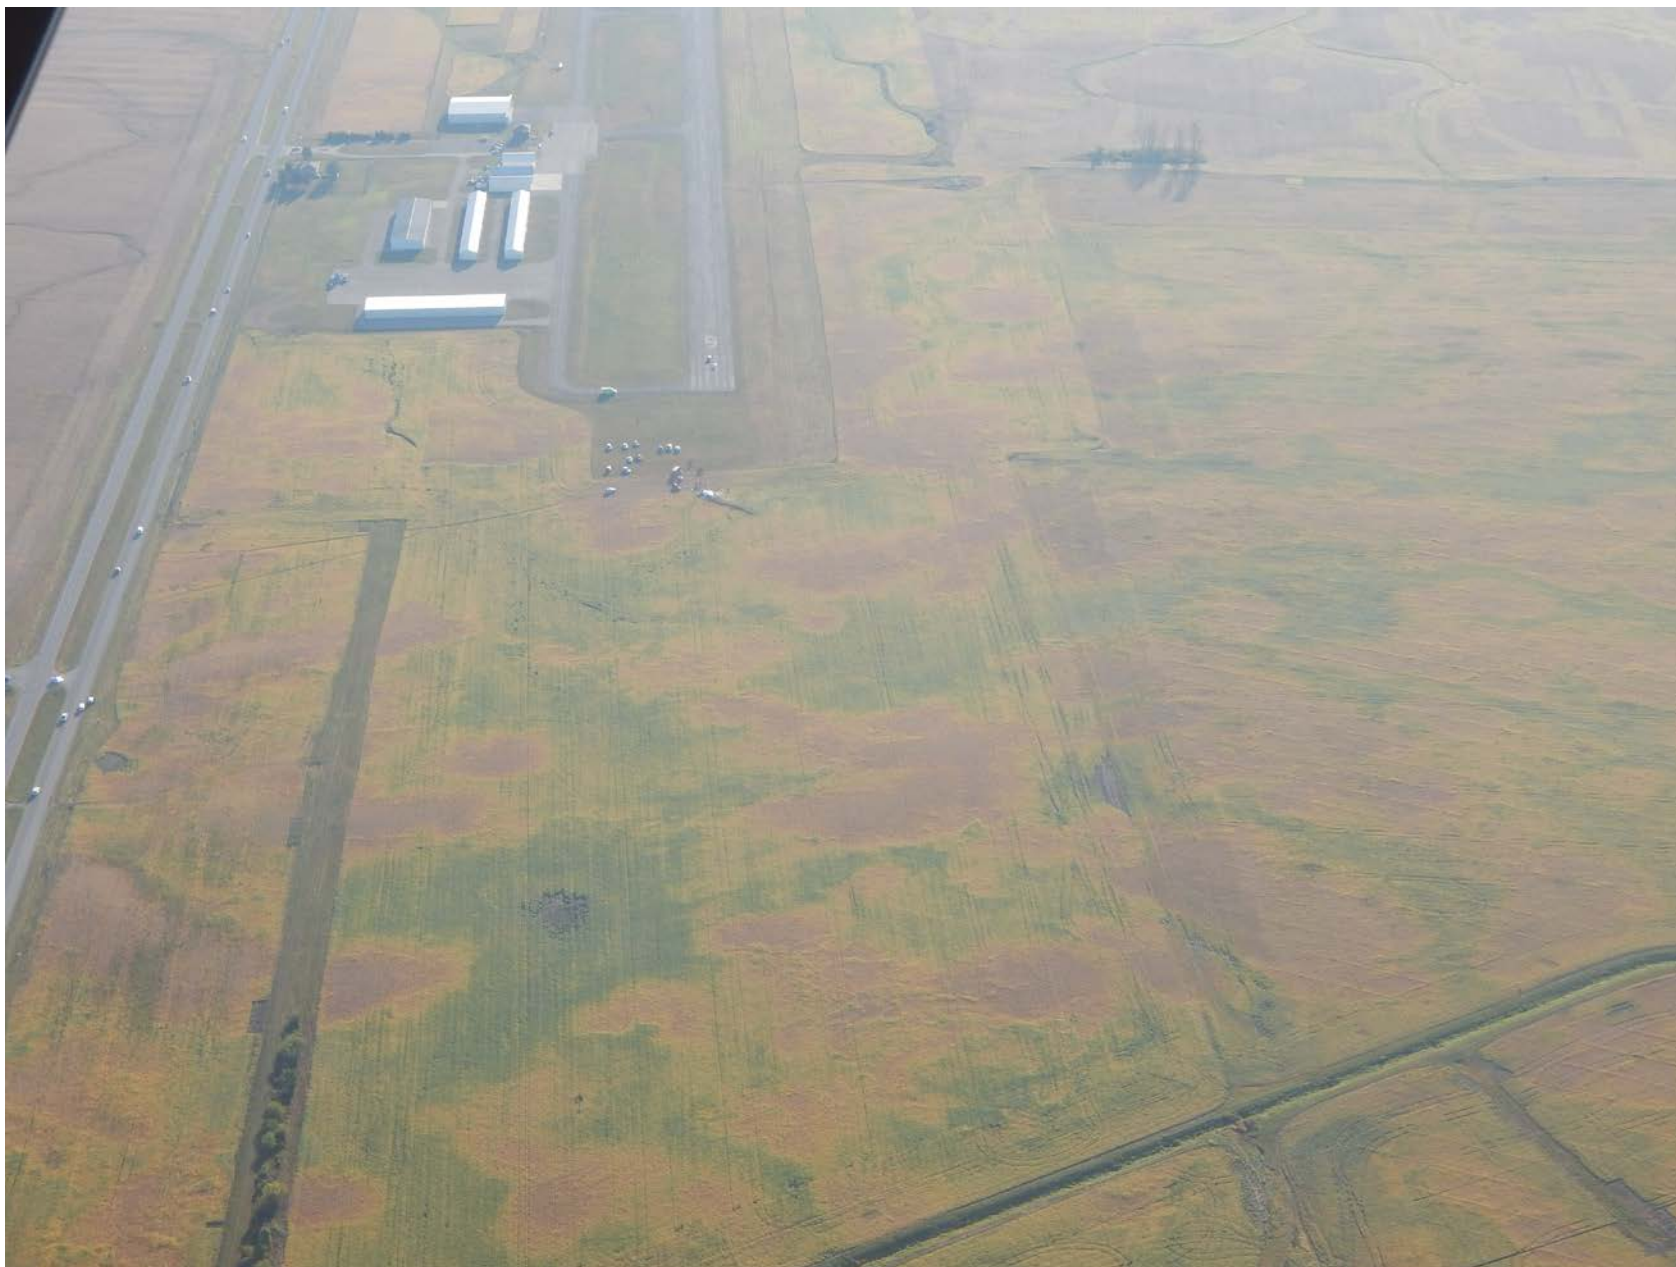
**Photo 1 – View to the east, showing wreckage and its proximity to runway 9 threshold. (Ohio State Police photo)**

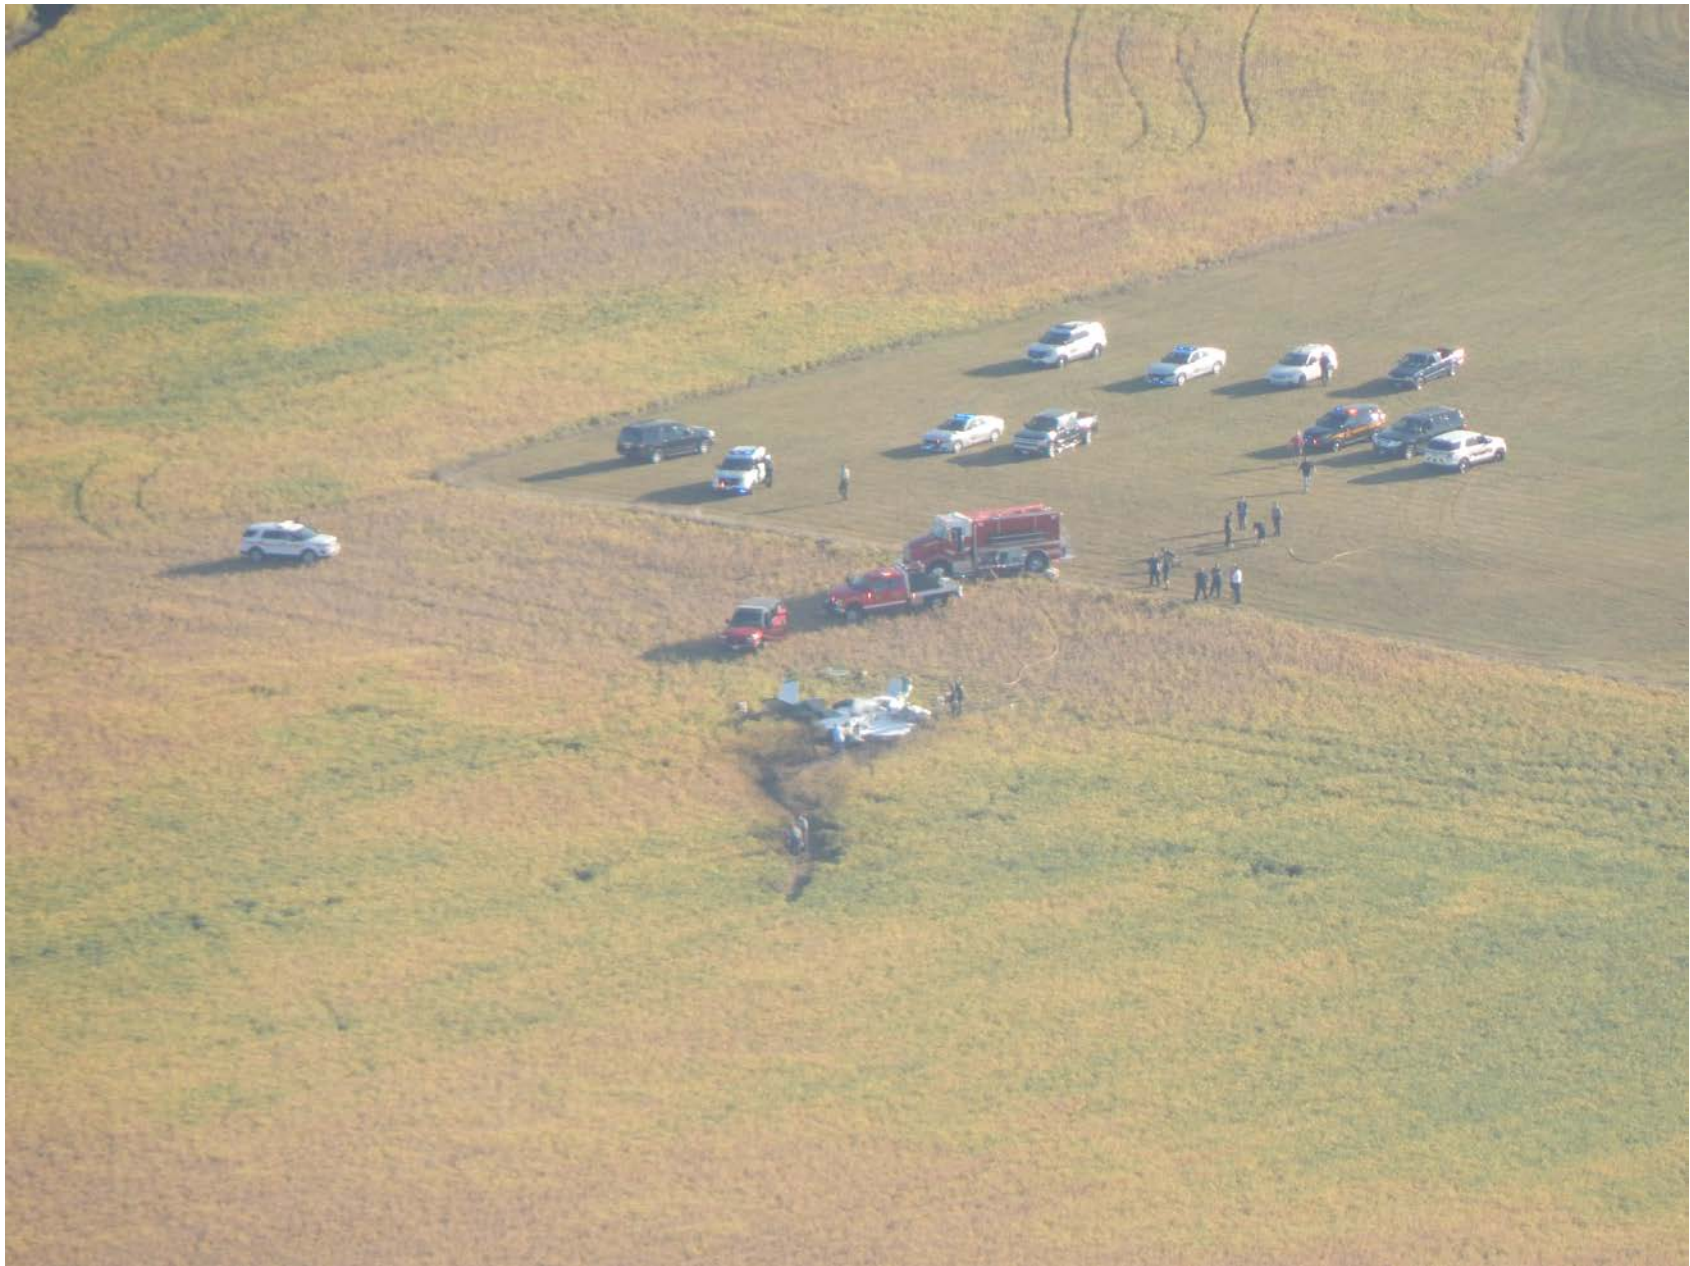
**Photo 2 - Aerial view of wreckage and ground scar. (Ohio State Police photo)**

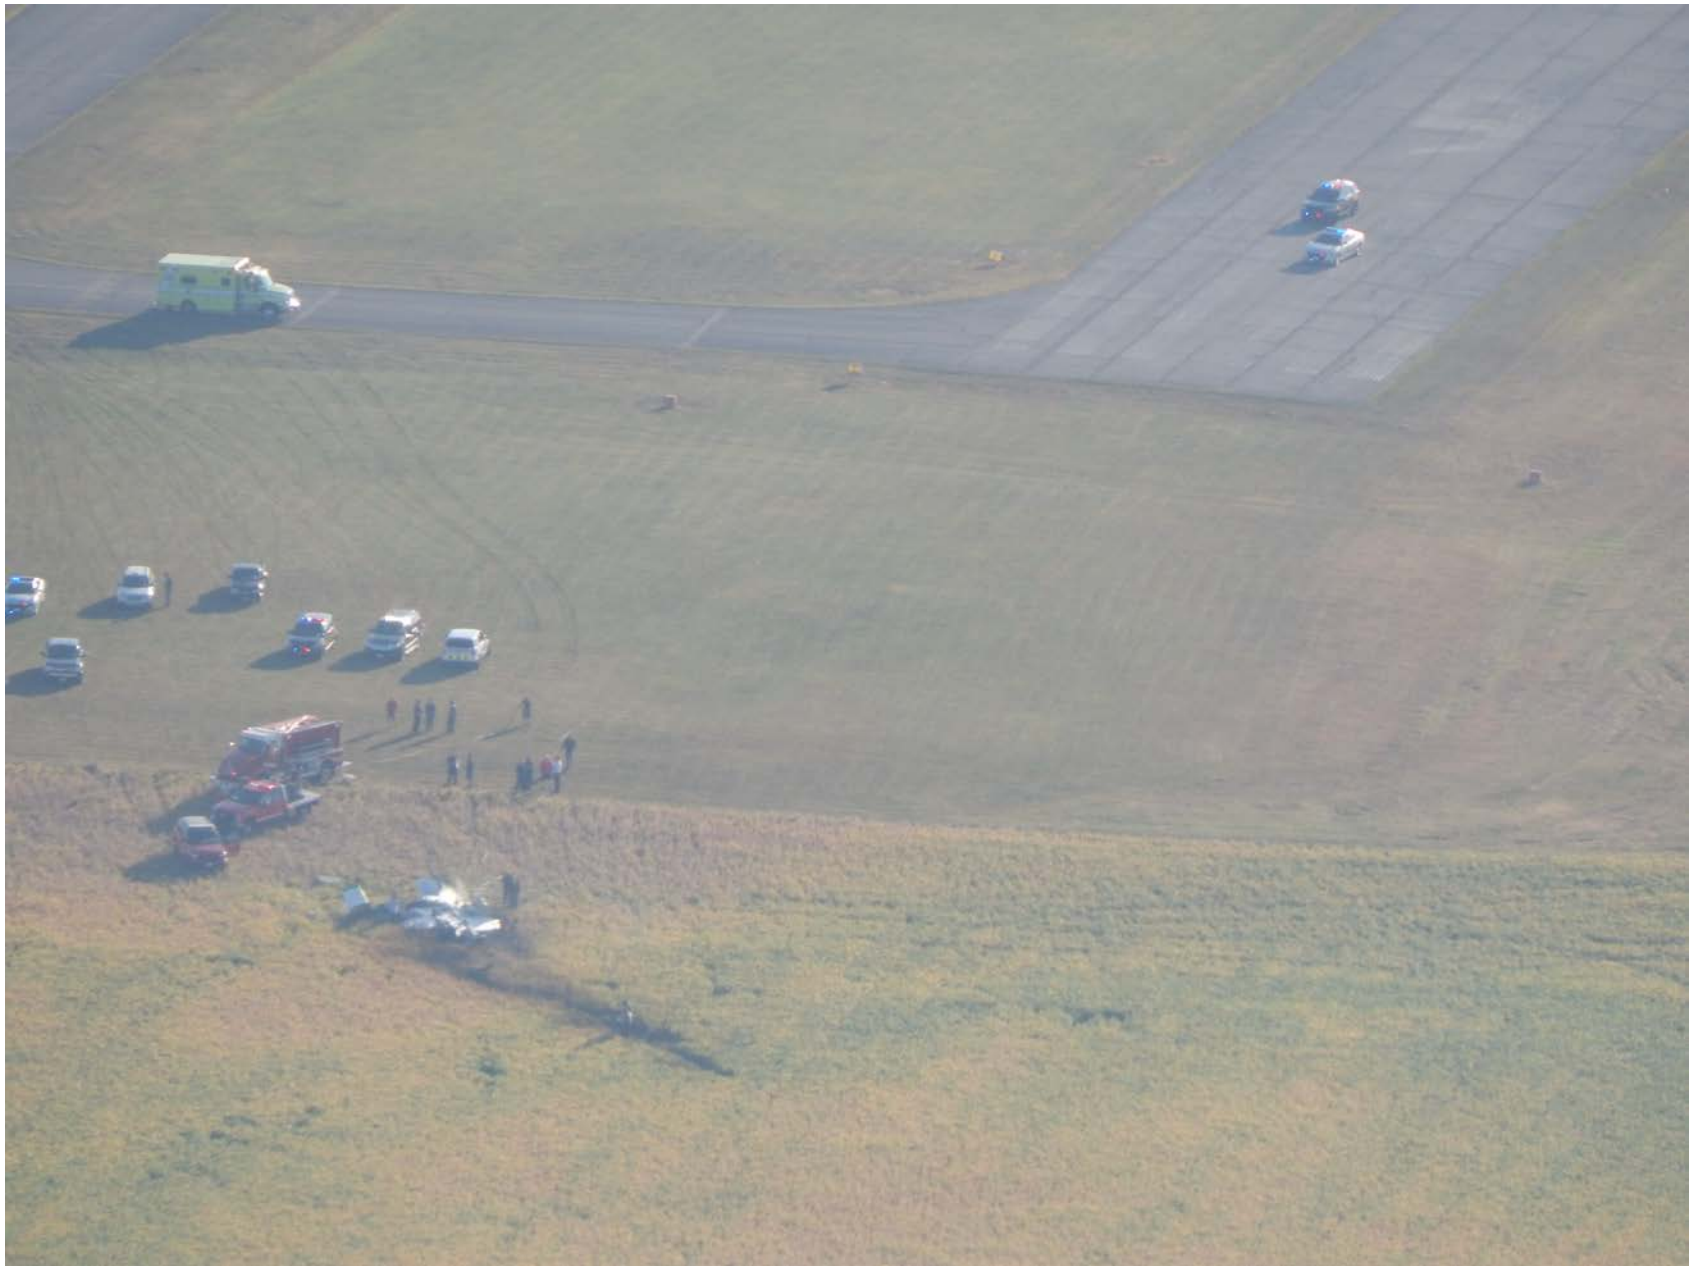
**Photo 3 - View to the northeast at aircraft wreckage and ground scar. Runway 9 threshold is at right. (Ohio State Police photo)**

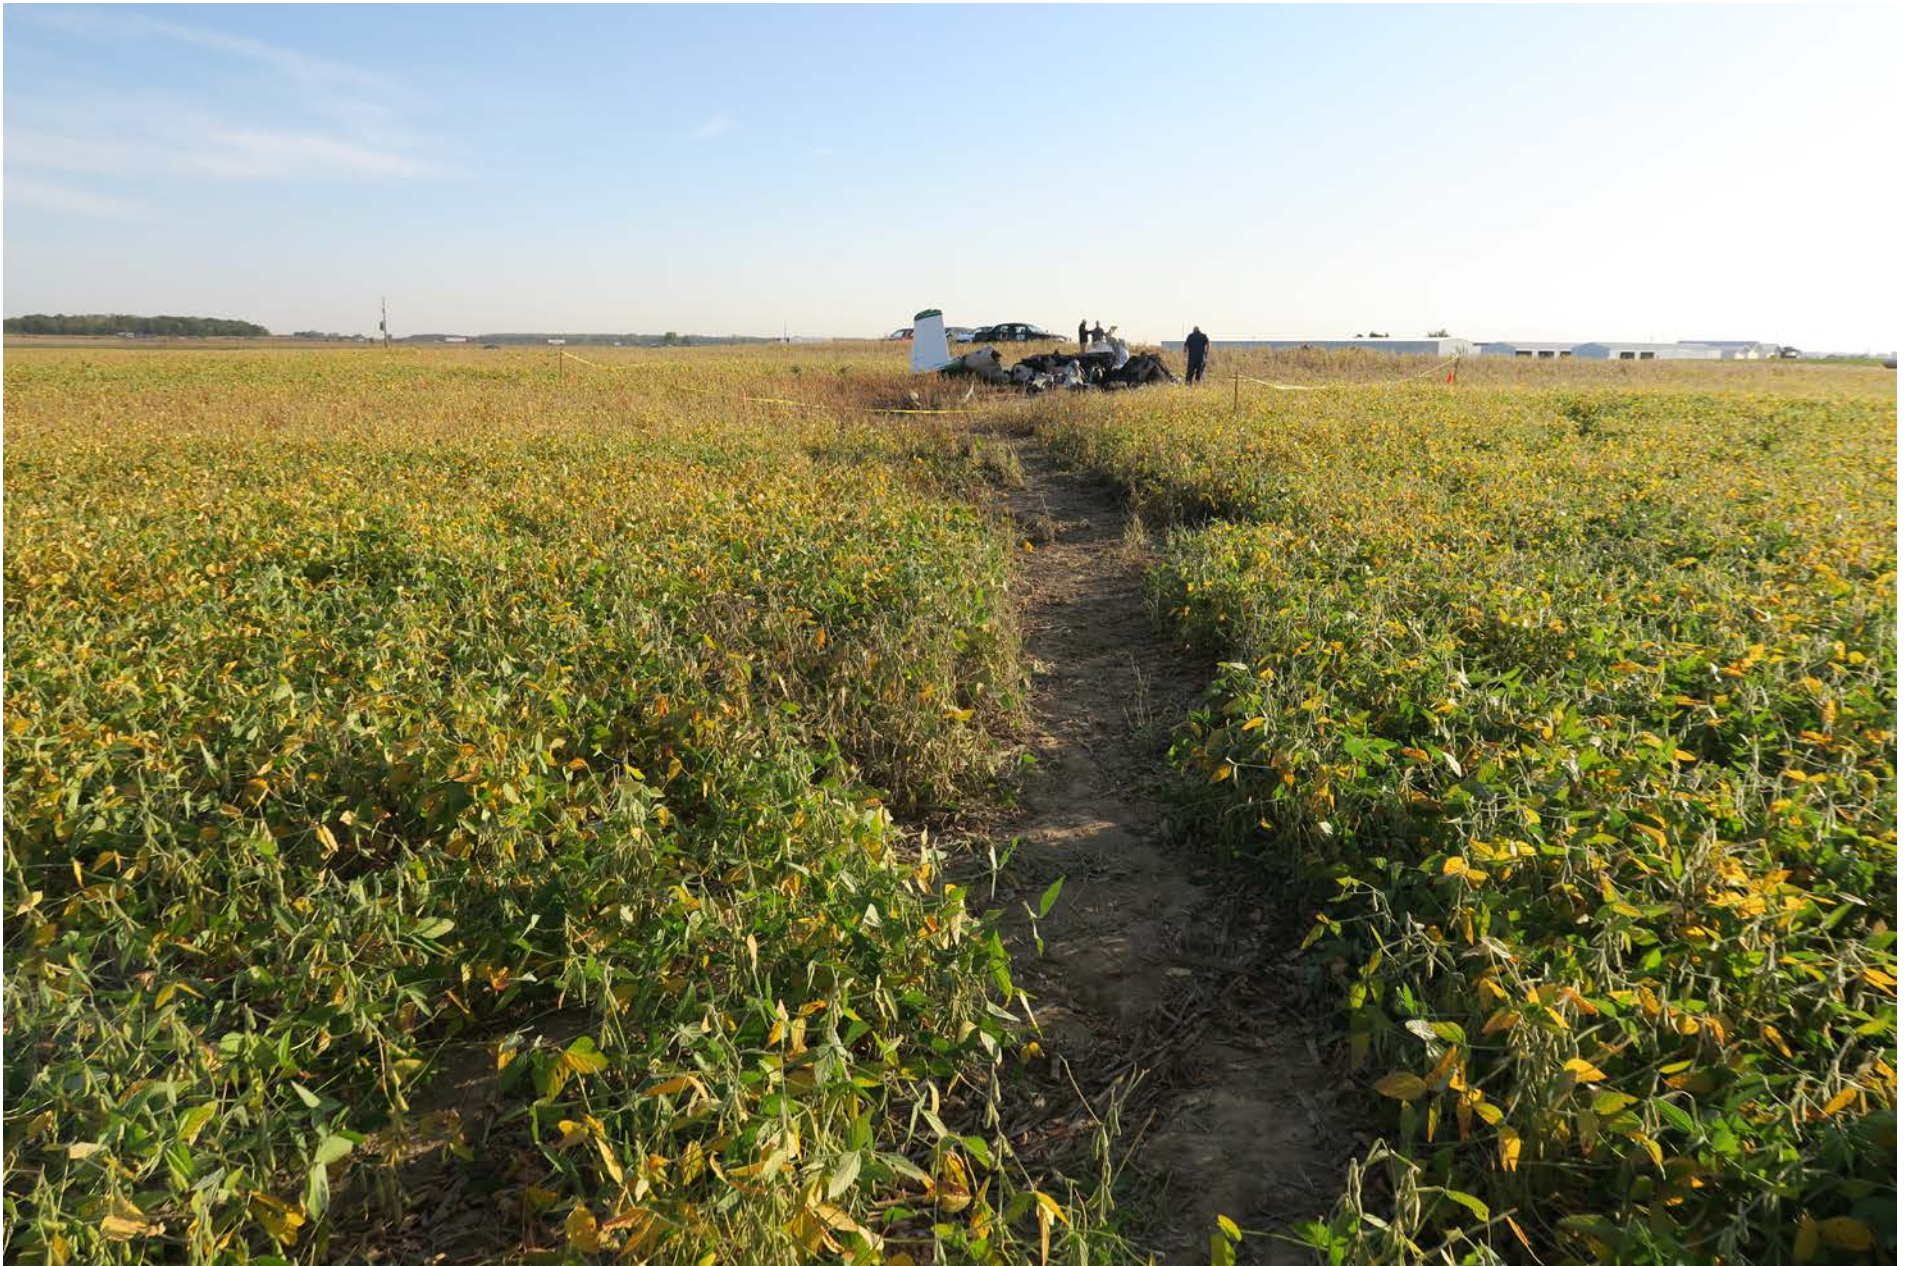
**Photo 4 - Ground scar leading to the wreckage. (Textron photo)**

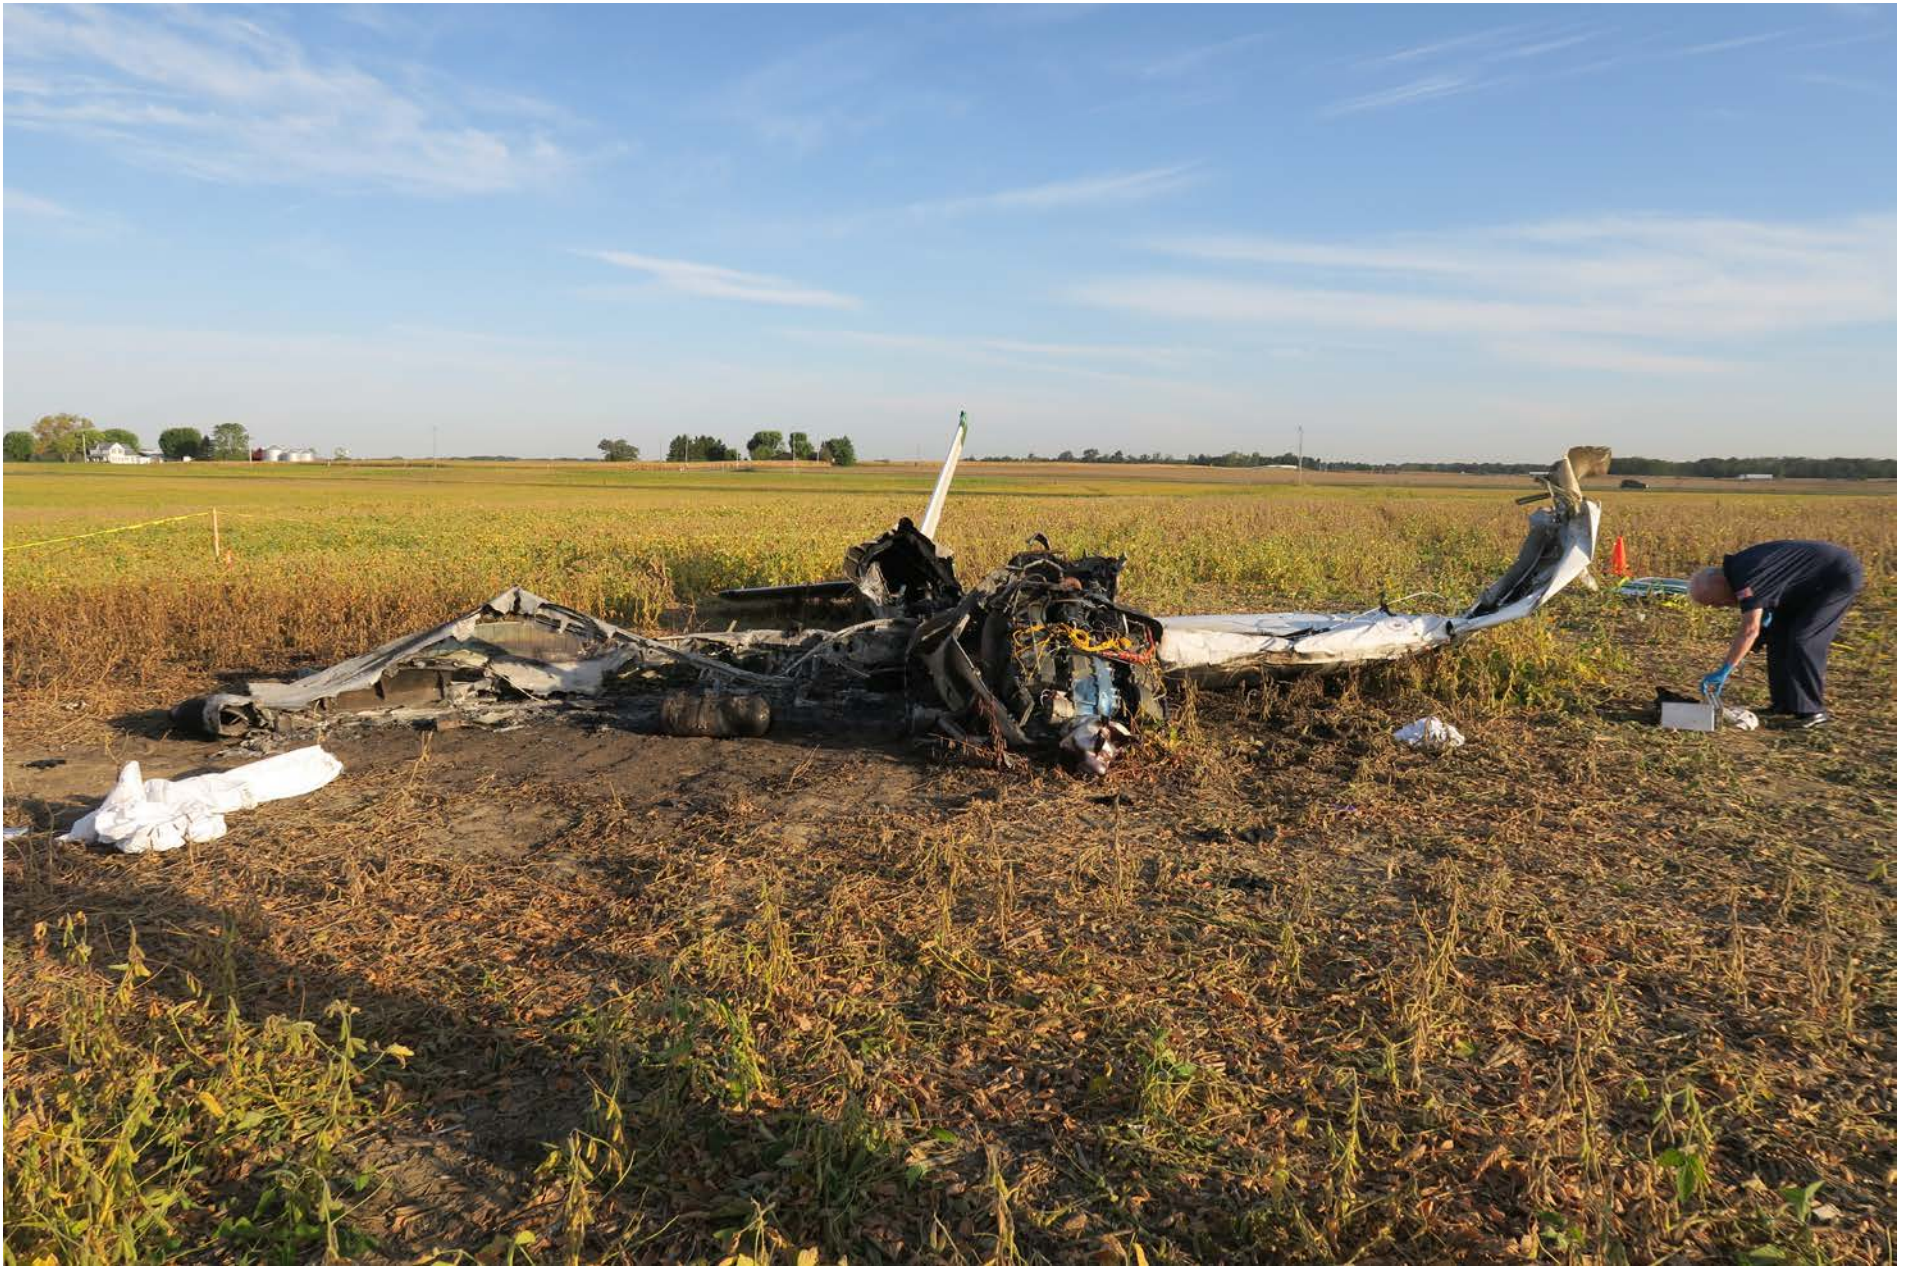
**Photo 5 - Frontal view of aircraft wreckage. (Textron photo)**

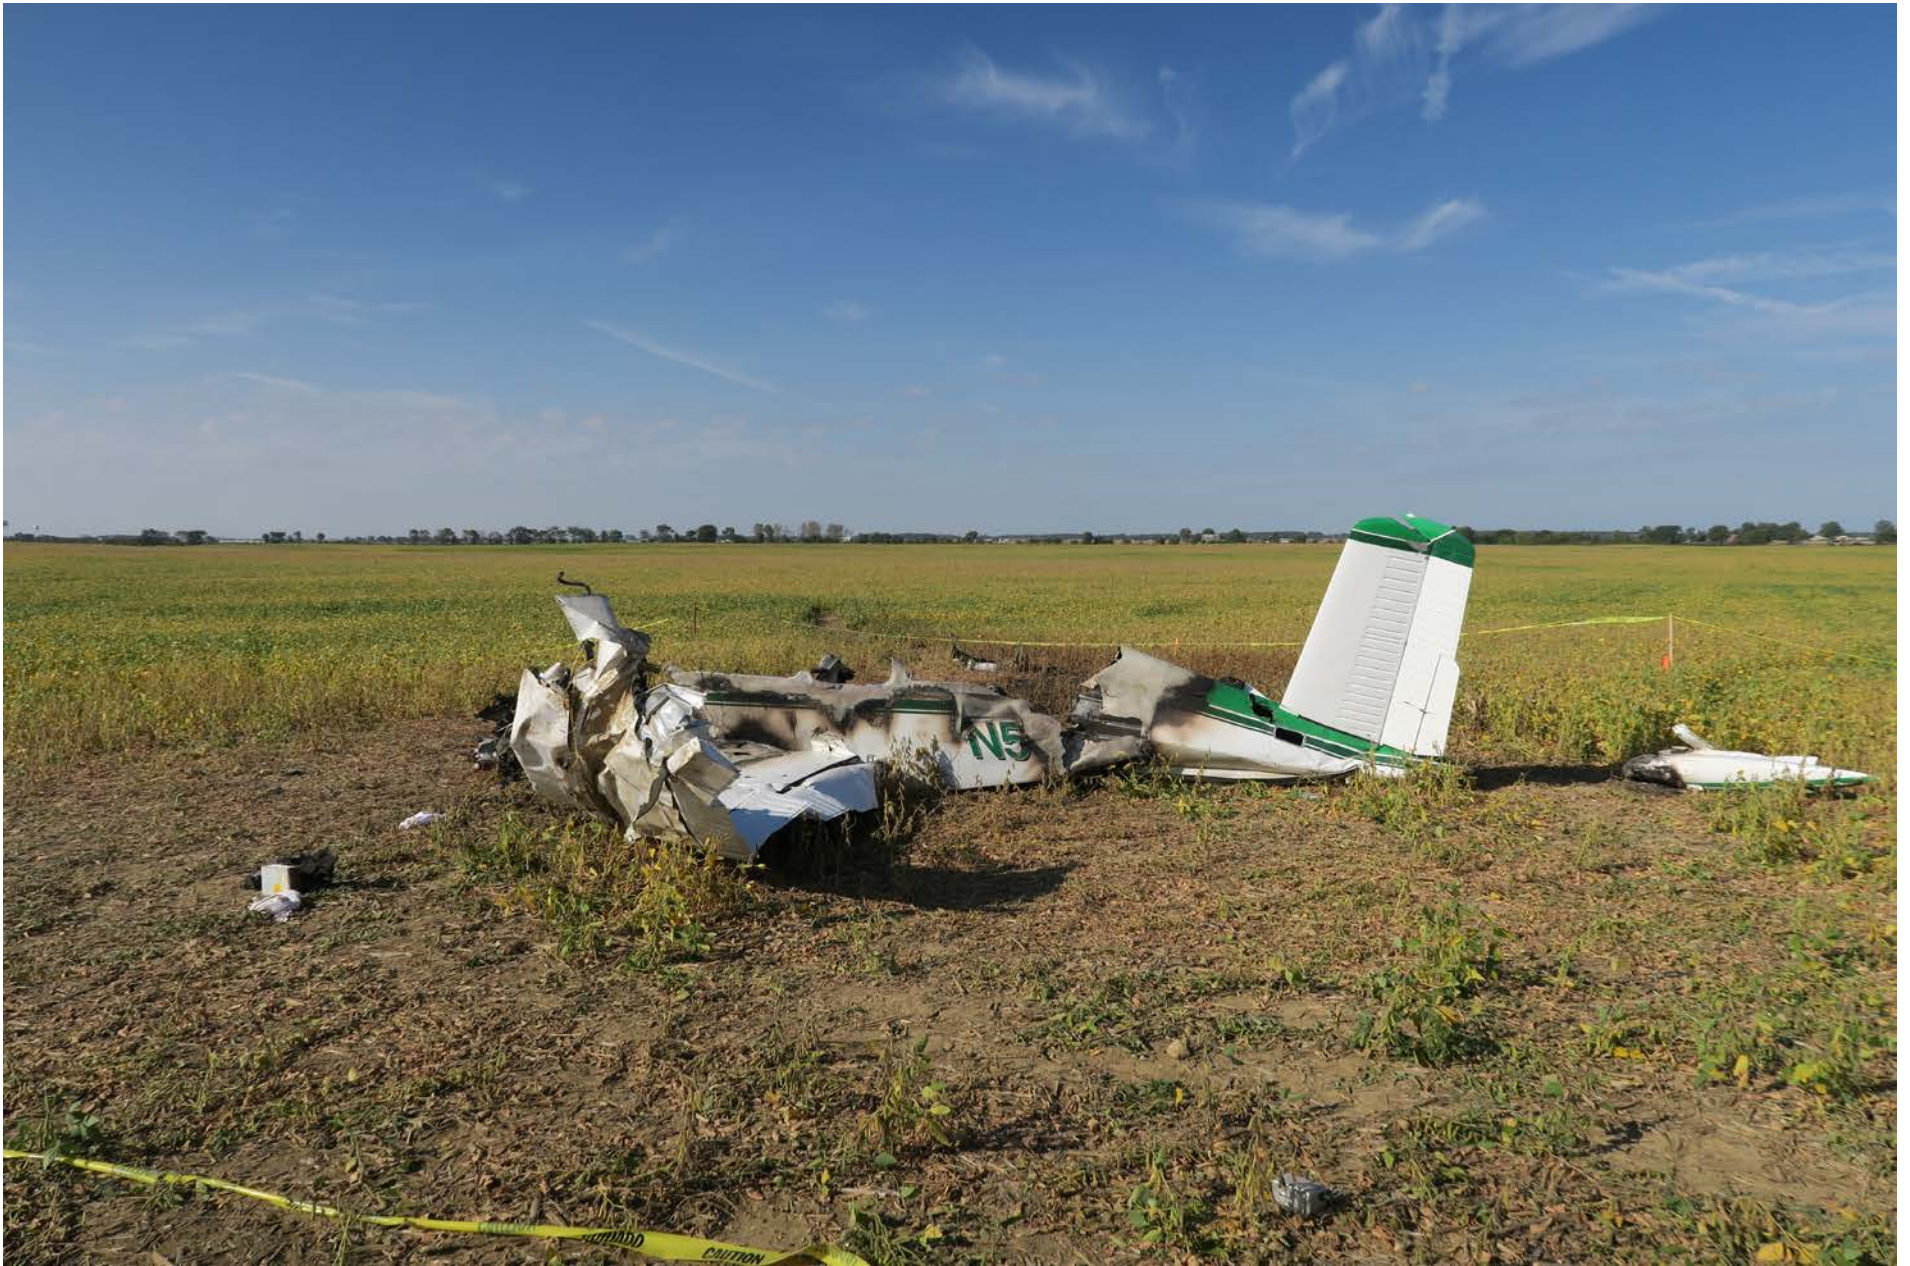
**Photo 6 - Left side of airplane. (Textron photo)**

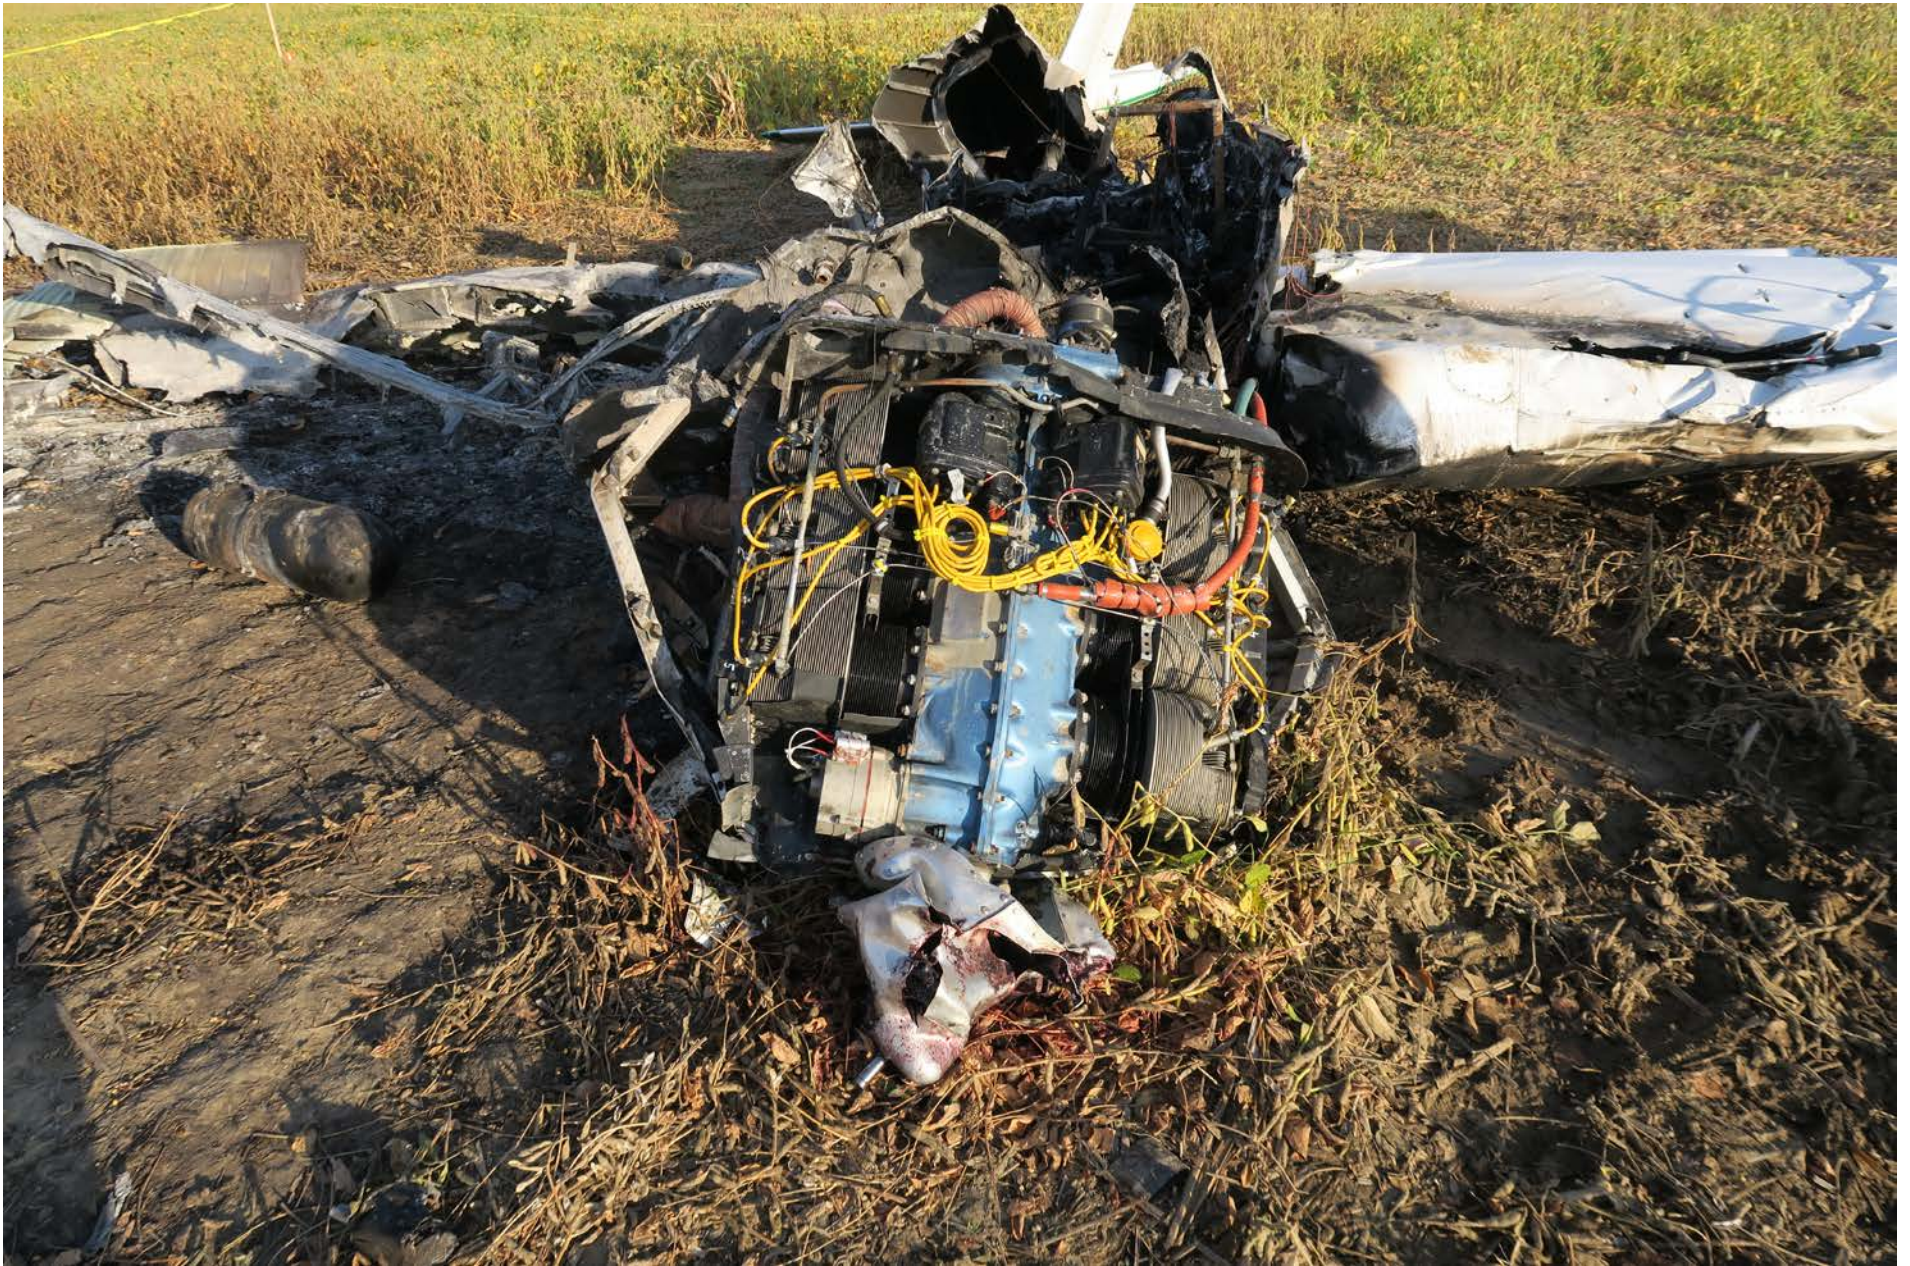
**Photo 7 - The engine. (Textron photo)**

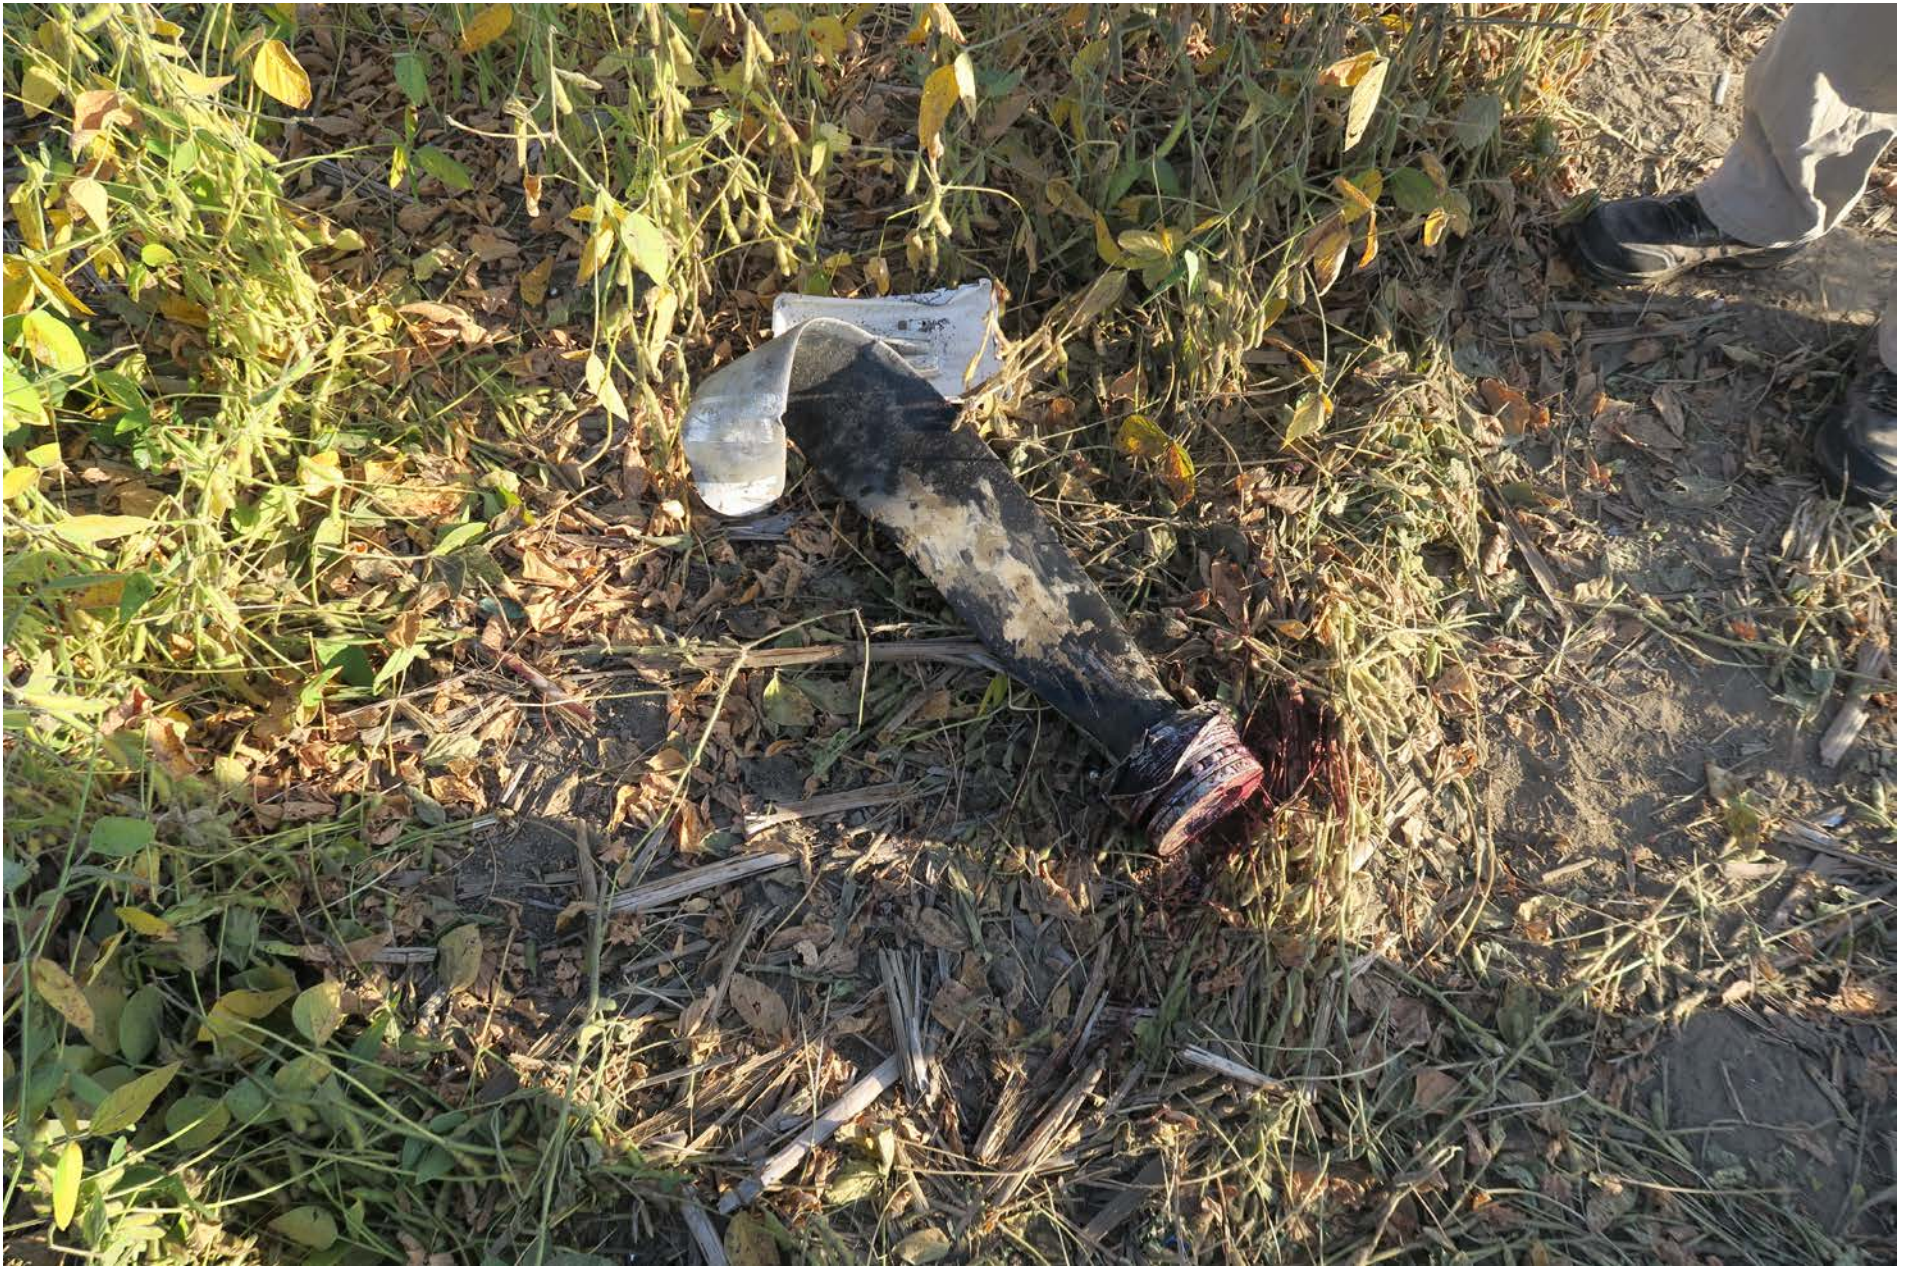
**Photo 8 - Propeller blade A, recovered at crash site. (Textron photo)**

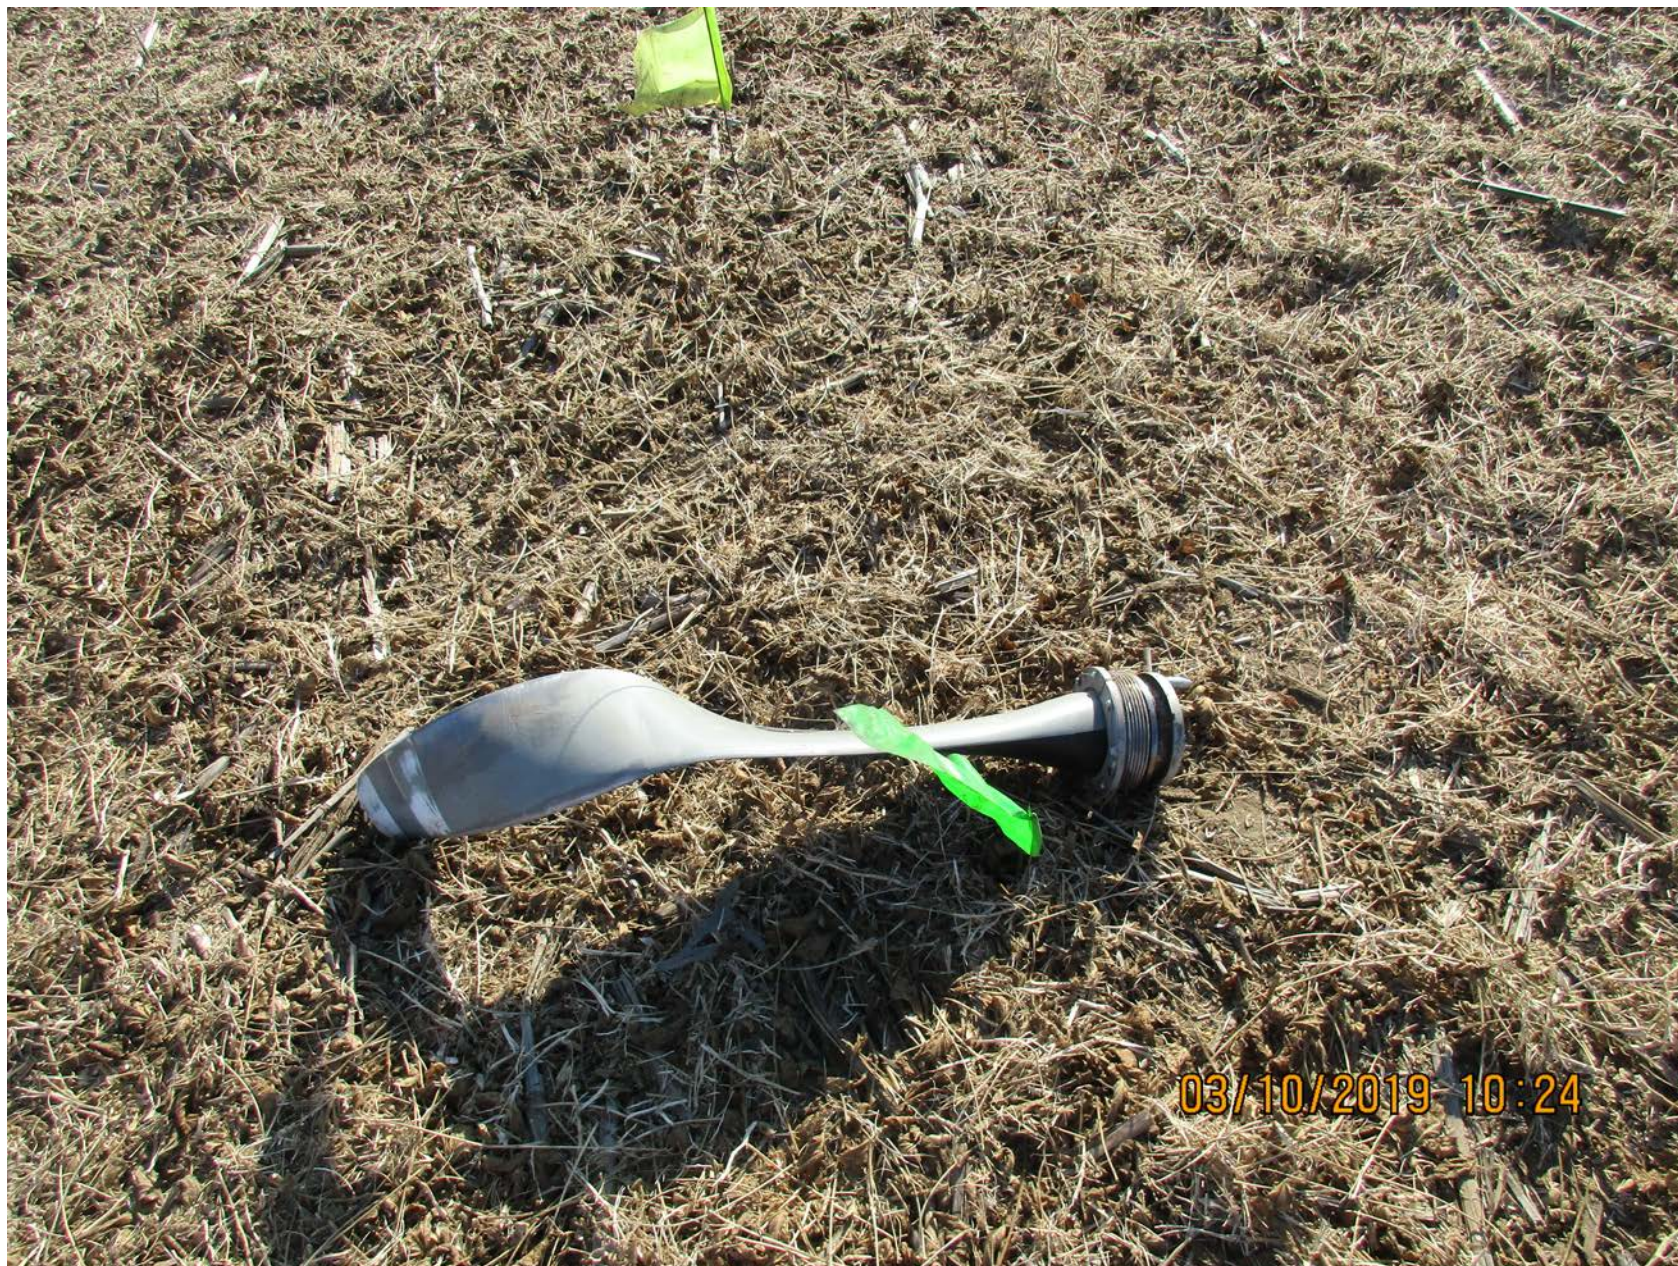
**Photo 9 - Recovered propeller blade B, found by farmer. (FAA photo)**

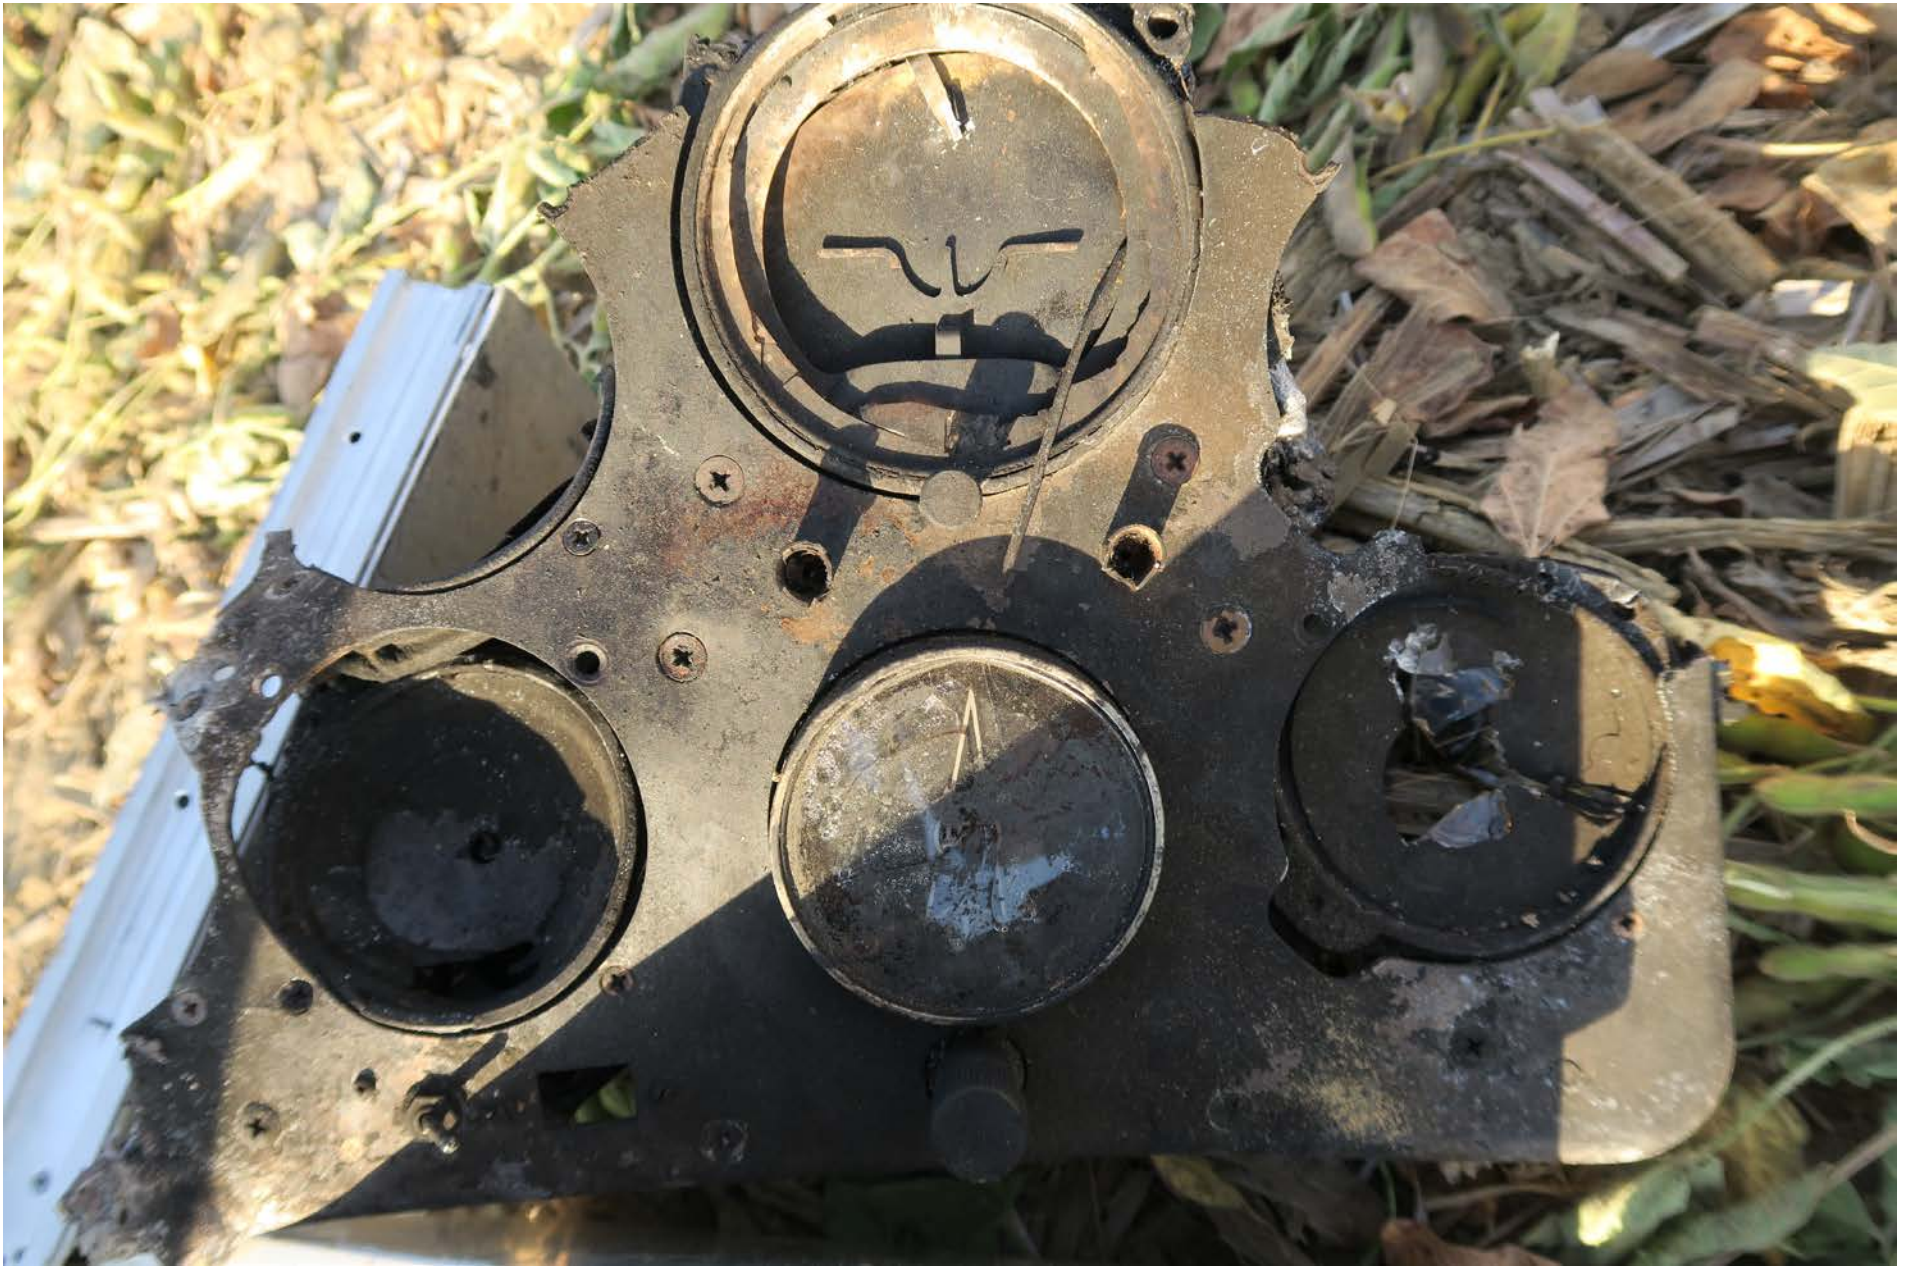
**Photo 10 - Portion of the instrument panel. (Textron photo)**
