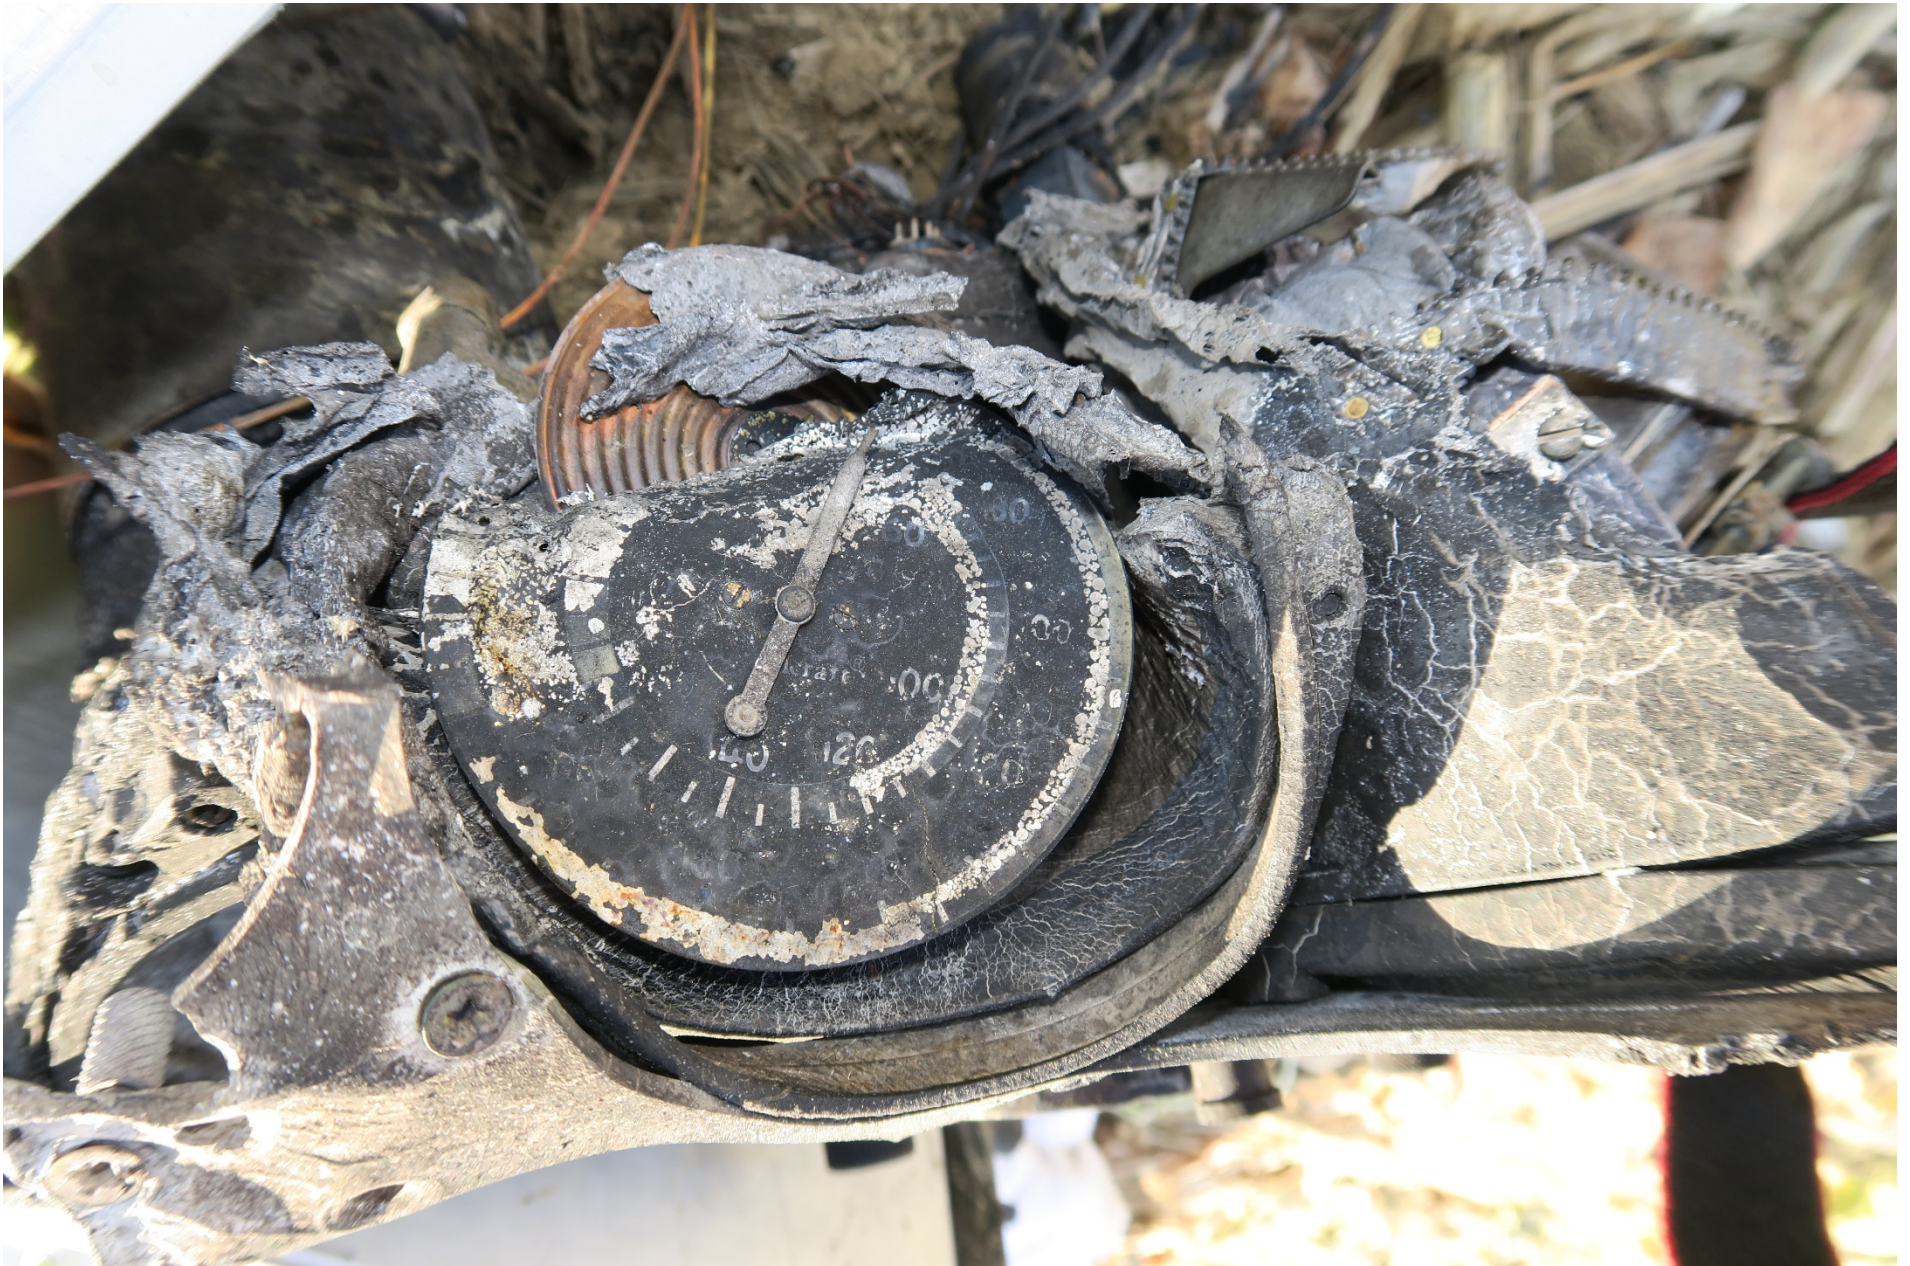
**Photo 11 - Airspeed indicator. (Textron photo)**

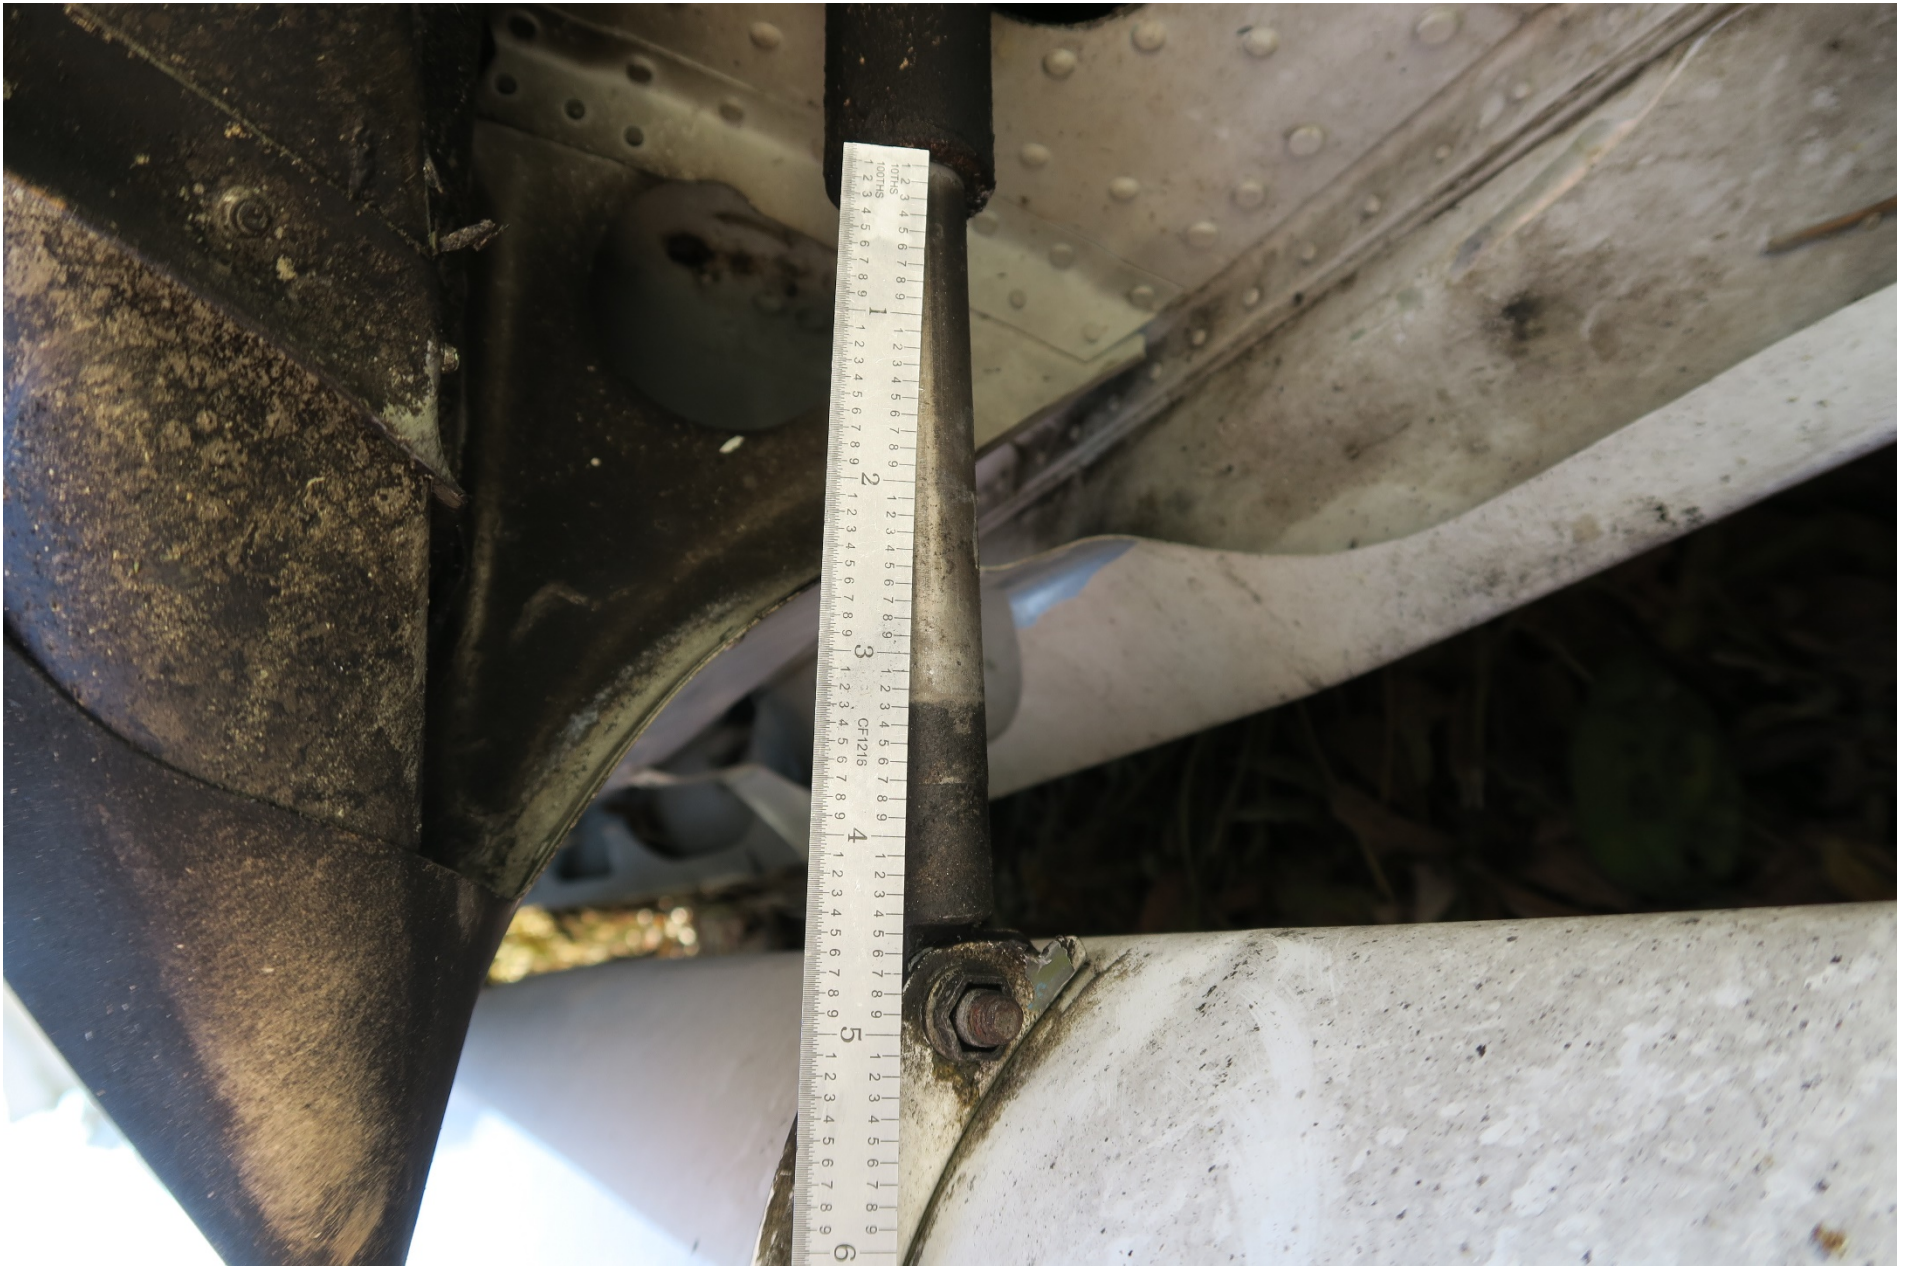
**Photo 12 - Flap actuator measurement. (Textron photo)**
