## ENGINE RUN REPORT

| ENGINE MODEL | IO-520-D30B |
| AIRCRAFT MAKE & MODEL | Cessna A185F |
| FILE NUMBER | 19-100 |

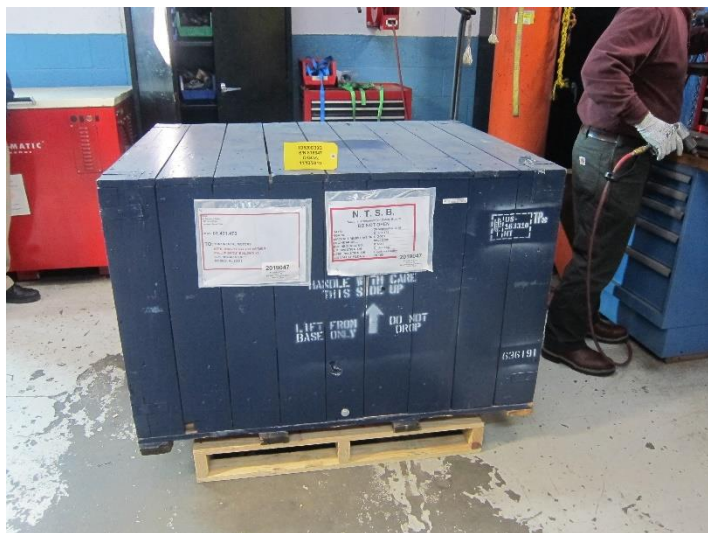
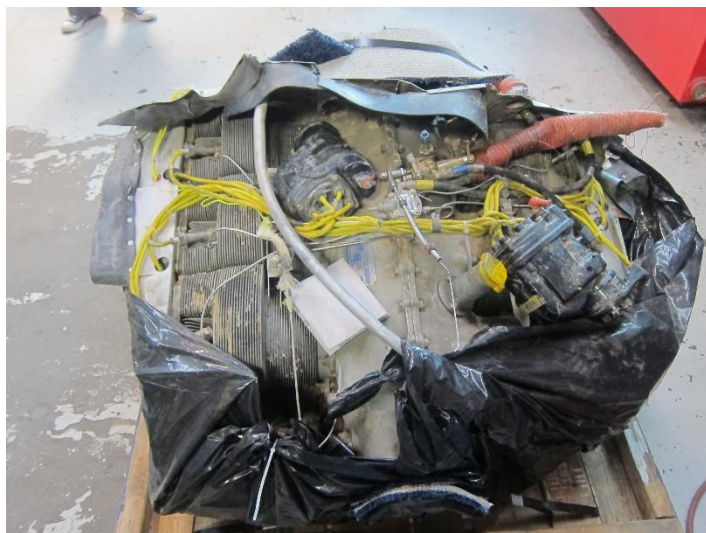
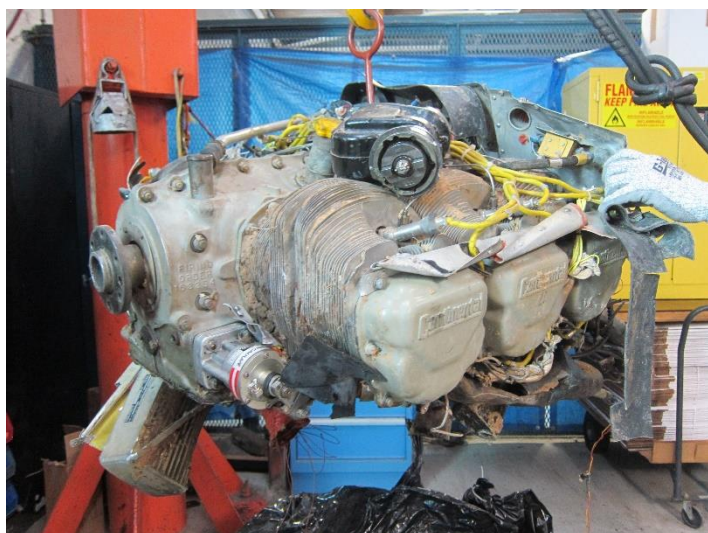
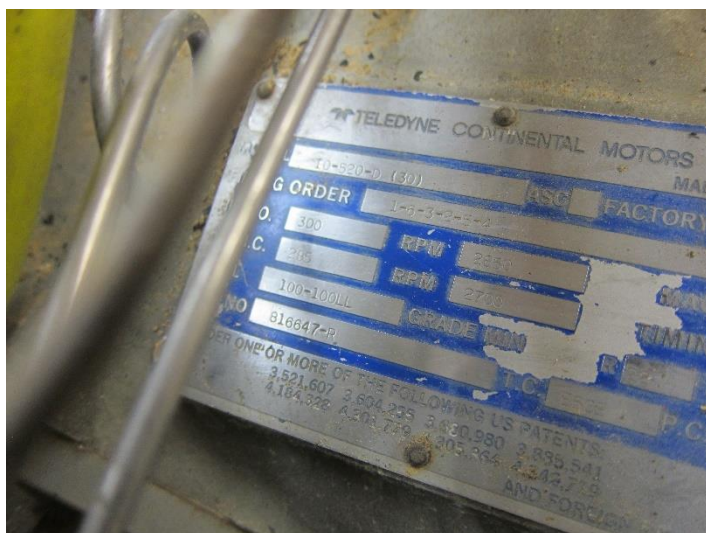
The engine was received in a Continental engine shipping crate. Damage was noted to the oil sump, induction and exhaust systems, the forward left crankcase half and the magnetos were impact separated from their mounts. The oil cooler and adaptor exhibited impact damage as well as some of the cylinder heads.

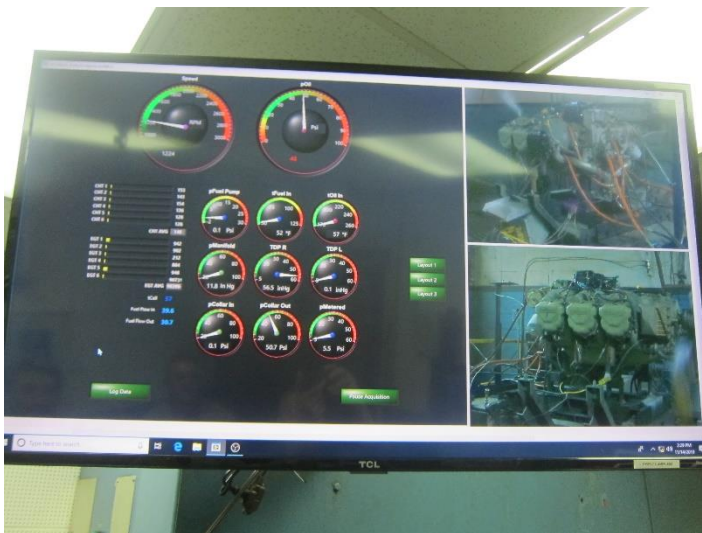
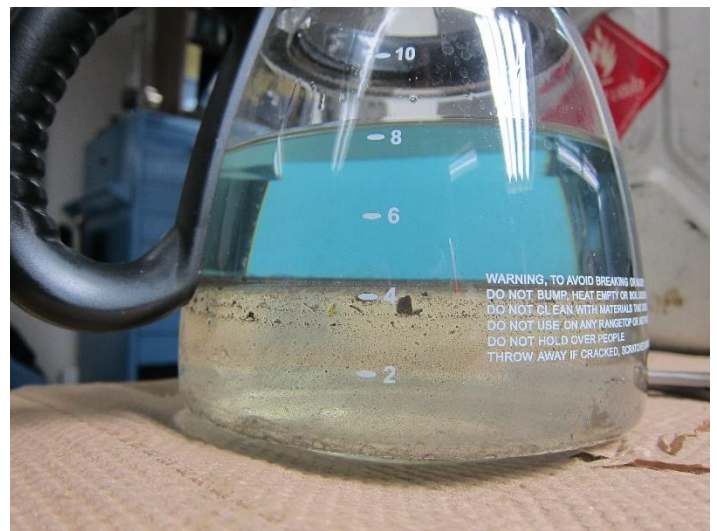
At the request of the NTSB after the engine test cell run, an external fuel supply that was contaminated with water was plumbed into the test cell fuel system. The engine was restarted and the throttle was advanced. When the water was introduced to the engine, the engine abruptly shut down.
