**NATIONAL TRANSPORTATION SAFETY BOARD**

**MATERIALS LABORATORY FACTUAL REPORT**

Report No. 19-082

Place : Watkins, CO  
Date : 12/25/2018  
Vehicle : RV-6  
NTSB No. : CEN19LA048  
Investigator : Courtney Liedler

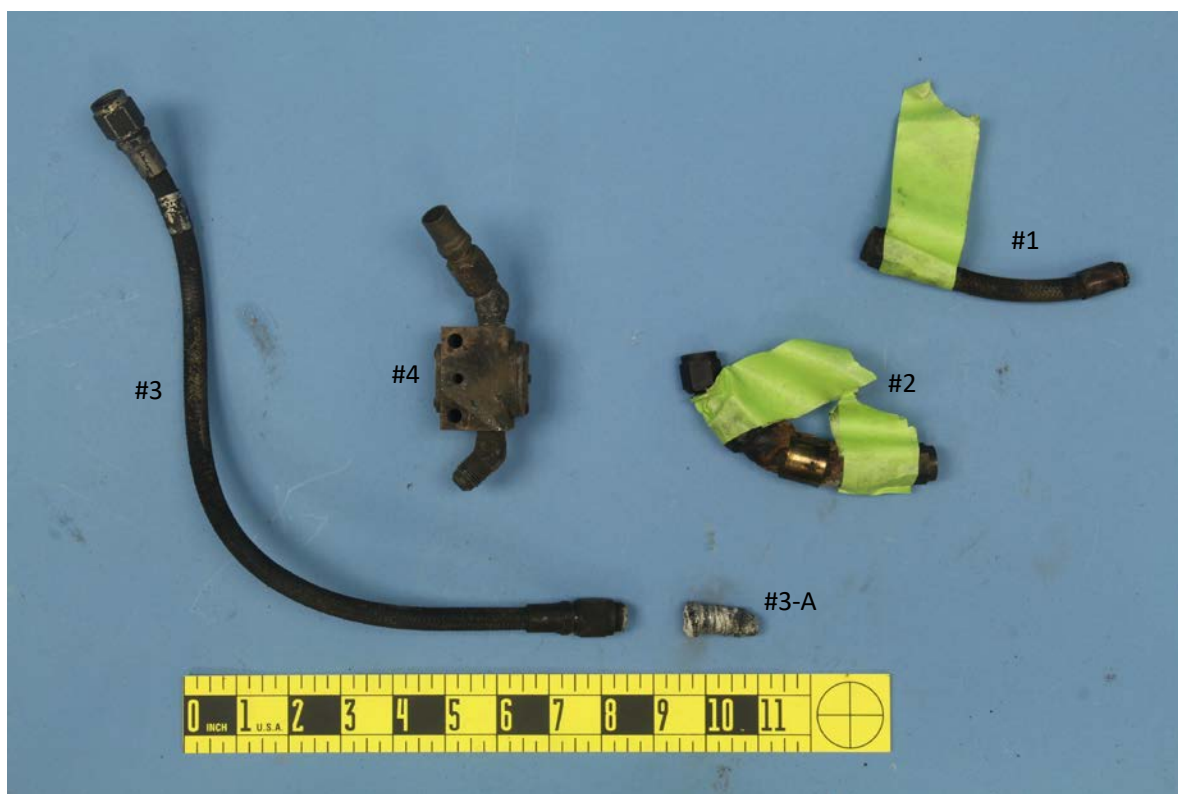
The fuel supply components shown in figure 1 were assigned numbers for reference in the examination. The fuel supply components were examined using a stereo microscope.

Component #1 was a piece of fuel line approximately 3.5-inch-long with a female nut on one end and nothing on the other end. This portion of fuel line was labeled as having been attached to the fuel pump output. The end with no fitting had been connected to the fuel pump output. This portion of fuel line exhibited exposure to a high temperature fire environment. The interior of the fuel line was burnt and no longer present leaving only the braided sheathing. The interior of the female fitting exhibited gold and blue colored oxides consistent with a high temperature exposure. There was no debris inside the fitting and the threads appeared normal.

Component #4 was described as a “fuel transducer between the fuel line from carburetor and pump”. This component exhibited oxidation and staining consistent with exposure to a fire environment.

Figure 1: Fuel system components as received.

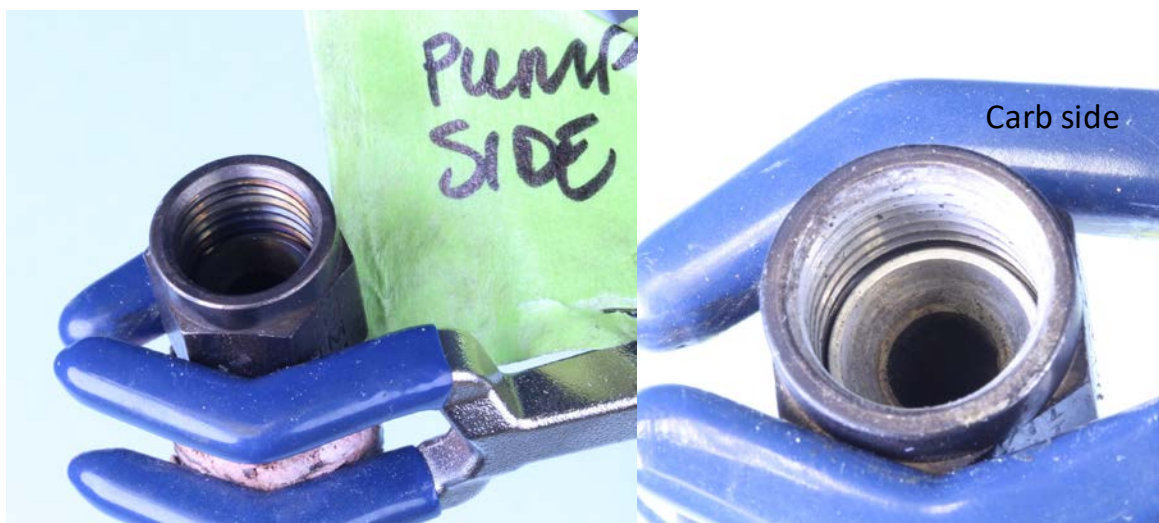
Component #2 was a piece of fuel line approximately 3-inch-long with female fittings on both ends. This piece of fuel line was described as "fuel line from carb (into carb from fuel pump)". The fuel line was soot stained and exhibited thermal damage consistent with exposure to a fire environment. The female fitting labeled as "carb side" did not exhibit colored oxides on the interior or any soot. The threads on this fitting appeared normal. The female fitting labeled "pump side" exhibited gold and blue oxides on the interior consistent with a high temperature exposure (Figure 2). No soot was observed on the interior of this fitting and the threads appeared normal.

Figure 2: Pump side and carb side fittings of component #2.

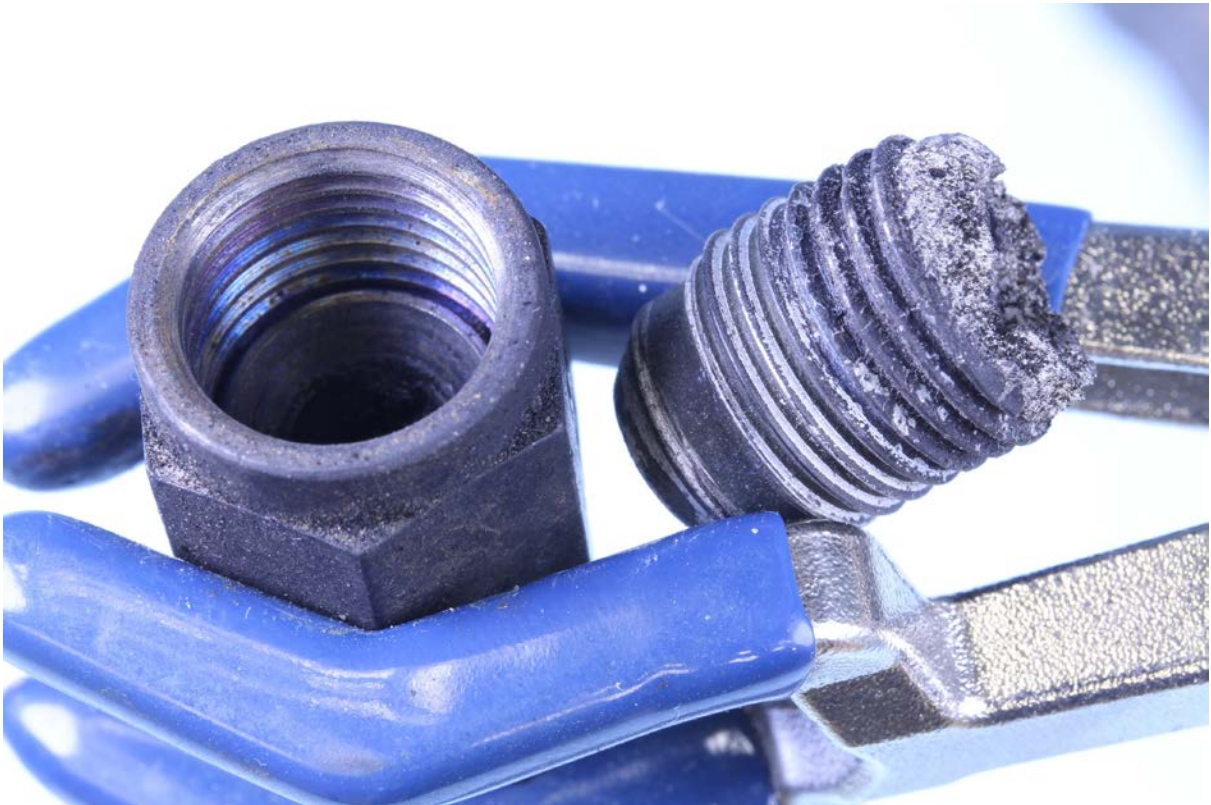
Component #3 was a piece of fuel line with female fittings on both ends. The fuel line exhibited thermal damage and soot on the exterior consistent with exposure to a fire environment. One of the female fittings contained a portion of the nipple it had been attached to (component #3-A, Figure 1). After removing the portion of the nipple remaining within the female fitting, blue and gold colored oxides were observed on the interior (Figure 3). The fitting did not contain any soot and the threads appeared normal.

Figure 3: Fitting from component #3 with oxides from high temperature exposure.

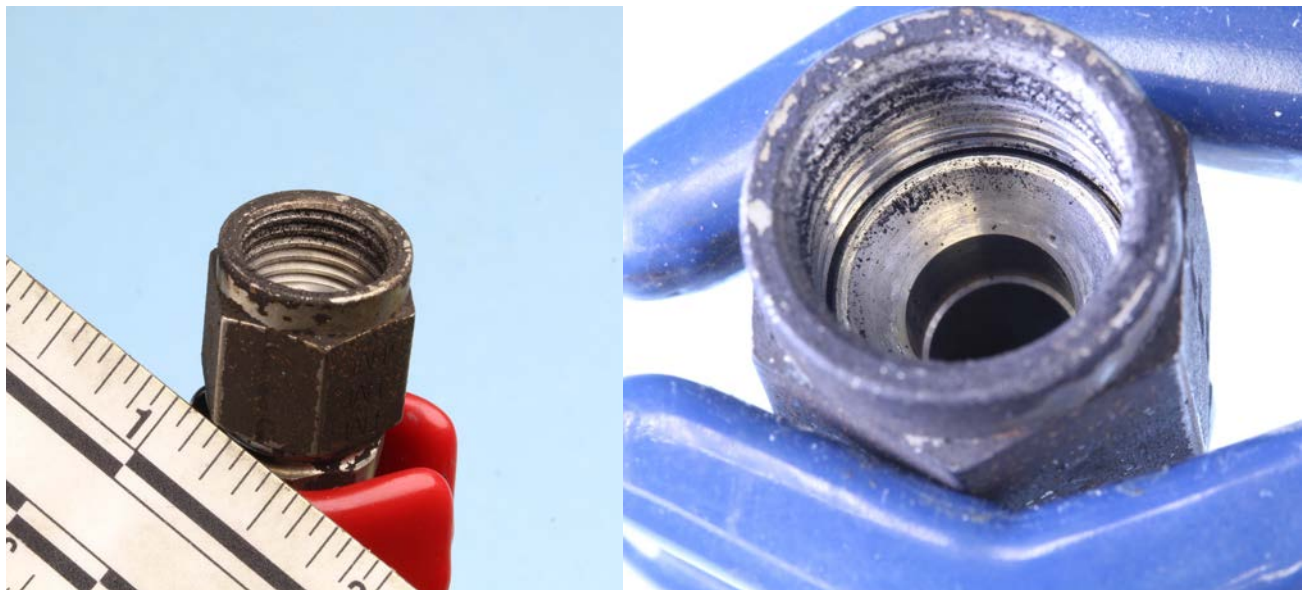
The fitting on the other end of this fuel line did not exhibit colored oxides on the interior but it contained soot deposits for the first 3 threads into the fitting (Figure 4).

Figure 4: Fitting from component #3 with soot deposits inside. Two views of the same fitting.
