## **NATIONAL TRANSPORTATION SAFETY BOARD**

### **Enhanced Ground Proximity Warning System (EGPWS) Download**

**CEN19LA054**

Location: Uvalde, TX  
Date: 1/12/2019  
Aircraft: Canadair CL-600-2A12, Registration Number: N813WT  
NTSB IIC: David Bowling

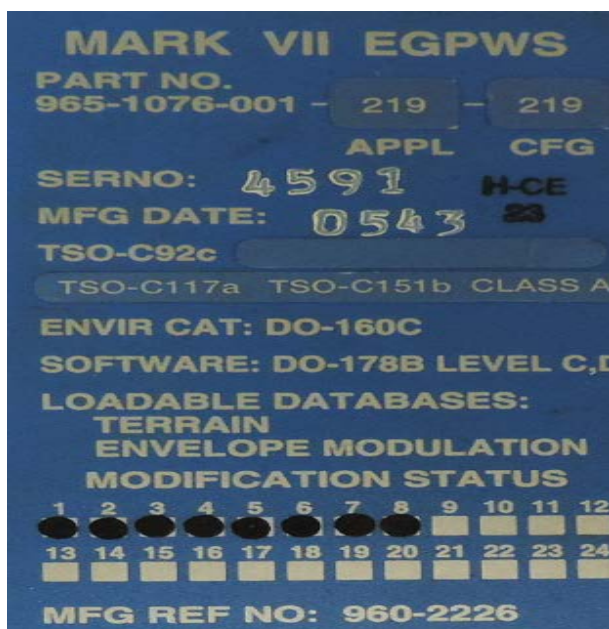
Figure 1: Photo of data plate

No impact damage or deformation to the outer assembly was noted. The main data interface connector, and all connection ports appear to be intact.

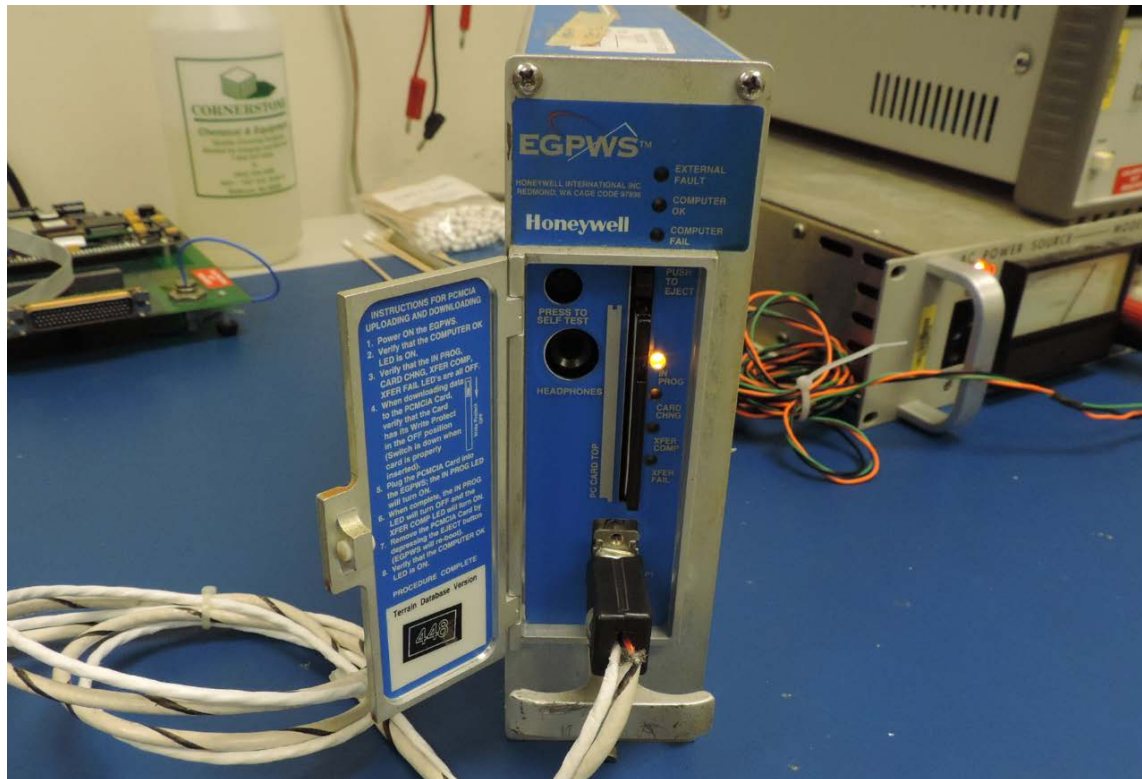
Power to the EGPWS established through normal means and appeared to be fully operational and downloadable, visual amber light indicating power to the EGPWS observed, depicted in figure 2. Download of data from the last operational use was successful. Flight Leg 1545 established as the last flight leg that was recorded.

Figure 2: Download
