**NATIONAL TRANSPORTATION SAFETY BOARD  
Office of Research and Engineering  
Vehicle Recorder Division  
Washington, D.C. 20594**

**SPECIALIST'S FACTUAL REPORT OF INVESTIGATION**

**CEN19LA054**

## **Cockpit Voice Recorder**

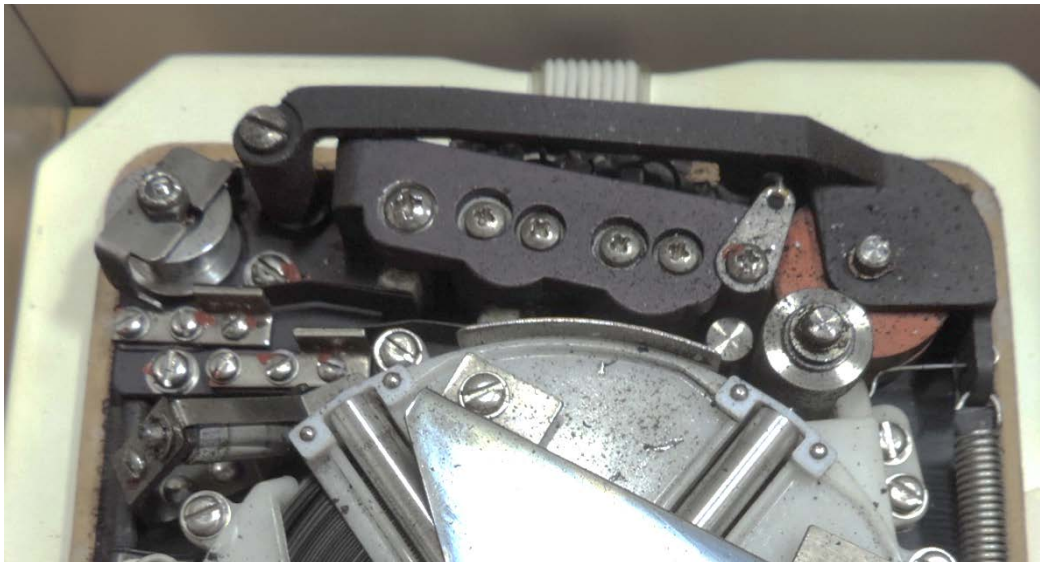
Upon opening the CVR to extract the magnetic tape recording medium for readout, the tape was found to be broken. A significant amount of degraded magnetic material was also found flaked from the tape and deposited in the area around the recording heads.

**Figure 1. Internal view of tape transport from the GA-100 (s/n 1021).**

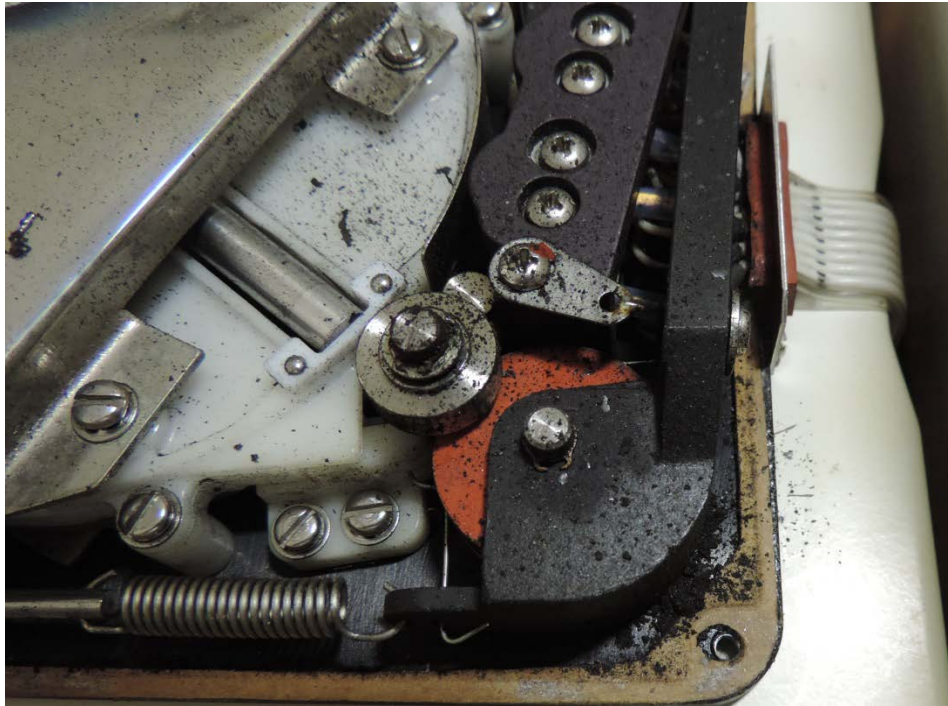
**Figure 2. Closeup of tape transport from the GA-100 (s/n 1021).**
