# NATIONAL TRANSPORTATION SAFETY BOARD

## MATERIALS LABORATORY FACTUAL REPORT

Report No. 20-013

Place : Fredericksburg, Texas  
Date : January 17, 2019  
Vehicle : Beech A36, N2021T  
NTSB No. : CEN19LA055  
Investigator : Craig Hatch, AS-CEN

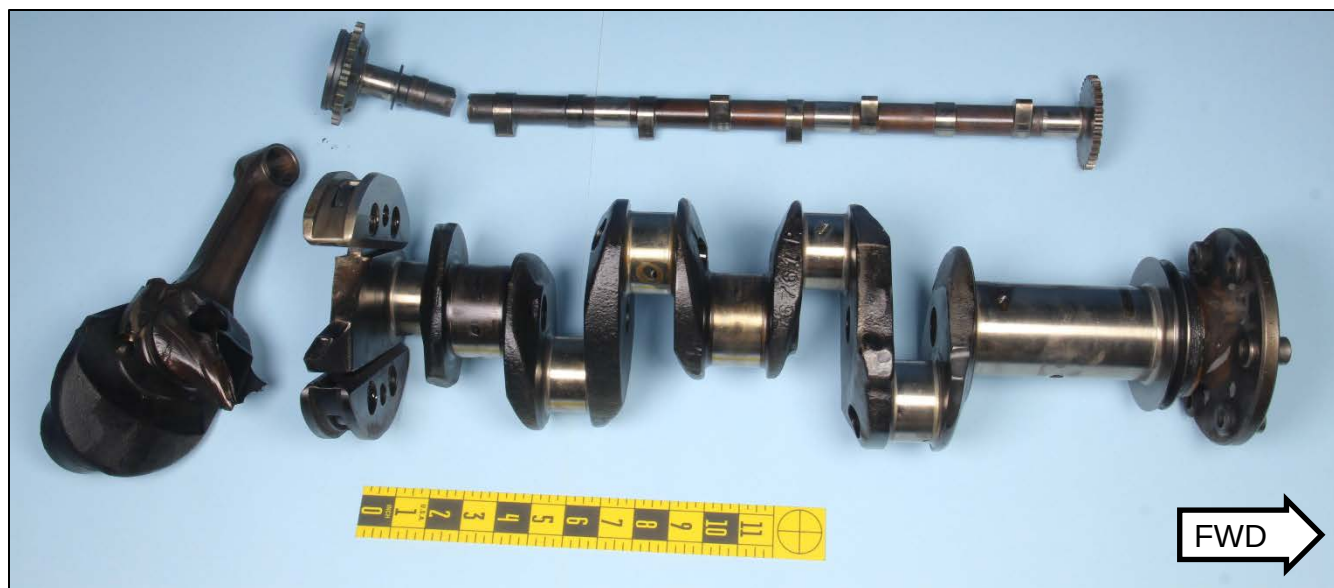
An overall view of the submitted camshaft and crankshaft are shown in figure 1. The crankshaft was fractured at the forward fillet area of the number 6 connecting rod journal, and the number 6 connecting rod assembly and counterweights remained attached to the fractured crankshaft. The camshaft was fractured between the lobes for actuating the number 6 cylinder valves. The accident engine was a Lycoming TIO-540-J2BD engine, and the components had been exposed to a post-crash fire.

The fracture in the camshaft was oriented in the transverse plane. The area adjacent to the fracture showed deformation and impact marks consistent with overstress fracture due to impact from an adjacent engine component.

Figure 1. Overall view of the submitted camshaft and crankshaft pieces with attached connecting rod and counterweights.

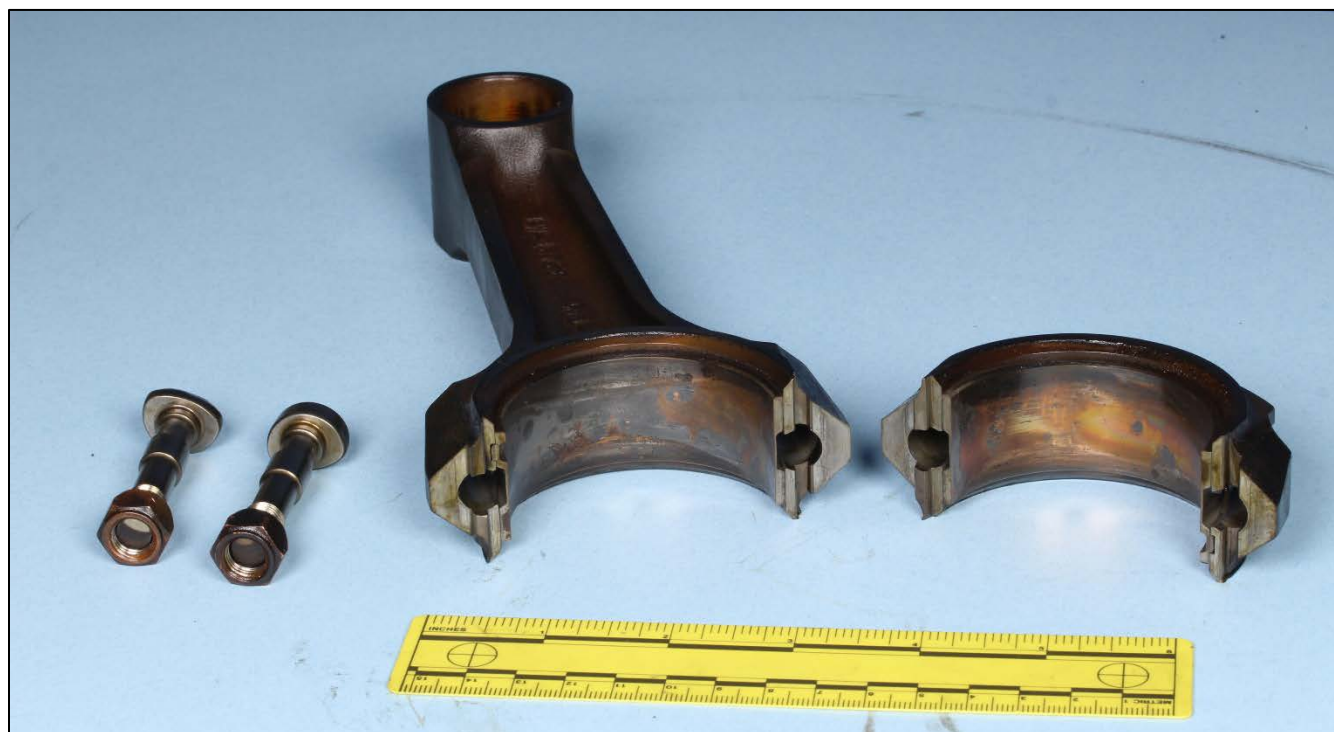
After an initial visual examination, the number 6 connecting rod was disassembled from the aft crankshaft piece, and the disassembled connecting rod is shown in figure 2. The connecting rod had a uniform darkened appearance with coked oil on the surface consistent with exposure to heat from the post-crash fire. The connecting rod bearing halves showed heat tinting, and Babbitt material was missing from more than half of the interior surface. The underlying copper layer showed limited scoring (the connecting rod was found free to rotate on the crankshaft as-received). The forward and aft faces of the connecting rod showed rub damage consistent with sliding contact with the crankshaft fillet radius and cheeks at the forward and aft end of the number 6 journal. Corresponding rub contact damage was observed on the crankshaft fillets and cheeks for the number 6 journal as noted in figure 3.

Figure 2. Number 6 connecting rod assembly after disassembly from the crankshaft.

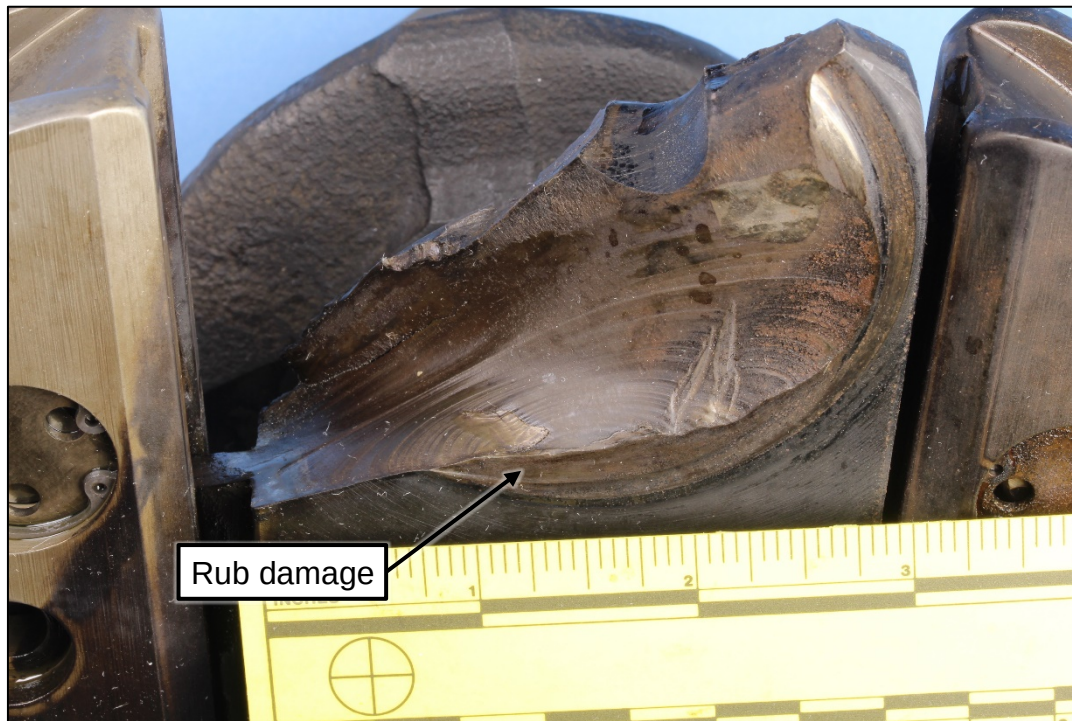
The fracture in the crankshaft as shown in figure 3 had curving crack arrest marks consistent with fatigue. The fatigue region extended across most of the thickness of the cheek and into the counterweight attachment flange. However, the total extent of the fatigue region could not be absolutely determined due to post-fracture damage. The fatigue features emanated from an origin area at the surface of the cheek at the forward end of the number 6 connecting rod journal. Origin areas on both the forward and aft sides of the fracture were damaged by post-fracture contact, but the fracture surface on the forward side of the fracture had relatively less damage. Therefore, the images used in this report focus on the forward fracture face.

Figure 3. Overall view of the forward side of the fracture after the crankshaft was cut through the number 3 main journal and before the fracture surface was cleaned.

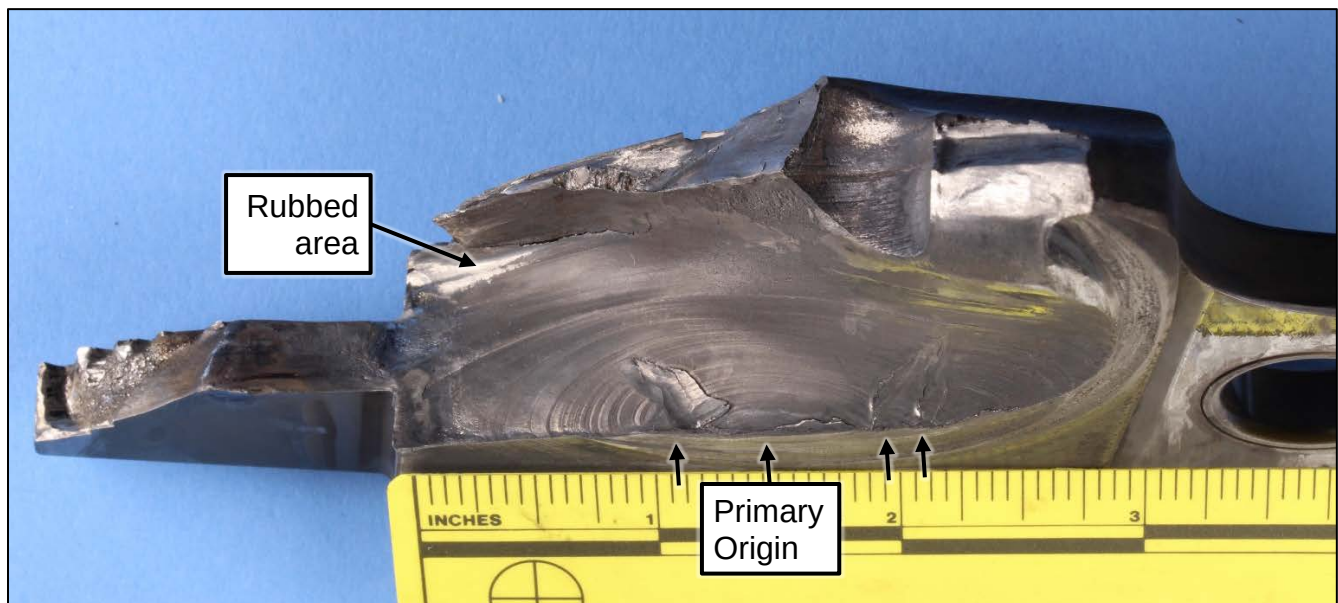
A view of the crankshaft fracture surface after disassembly, sectioning, cleaning, and deoxidizing is shown in figure 4. The fatigue features emanated from a primary origin as indicated in figure 4 and shown at higher magnification in figure 5. Secondary origins were located adjacent to the primary origin, as indicated with unlabeled arrows in figure 4. Ratchet marks<sup>2</sup> were observed radiating from the origin area, consistent with multiple origins. More crack arrest lines were observed emanating from the primary origin relative to the secondary origins, indicating that the secondary origins developed later as the crack progressed from the primary origin. Unlabeled arrows in figure 5 indicate crack arrest lines that were associated only with the primary origin.

Using both optical and SEM images of the fracture surface, the number of crack arrest lines was counted from the primary origin to a rubbed area at the forward end of the fracture surface (see figure 4). In most cases, a light and dark portion of the wavy pattern was observed between each crack arrest line, particularly near the middle portion of the fracture, consistent with a change in reflected light (optical images) or reflected secondary electrons (SEM images) due to the change in slope associated with each wave-like feature. The total number of observed crack arrest lines was 46.

Figure 4. Overall view of the forward side of the fracture after the counterweights were disassembled and the crankshaft cheek was cut to facilitate further examination of the fracture features. The fracture surface is shown after cleaning and deoxidation.

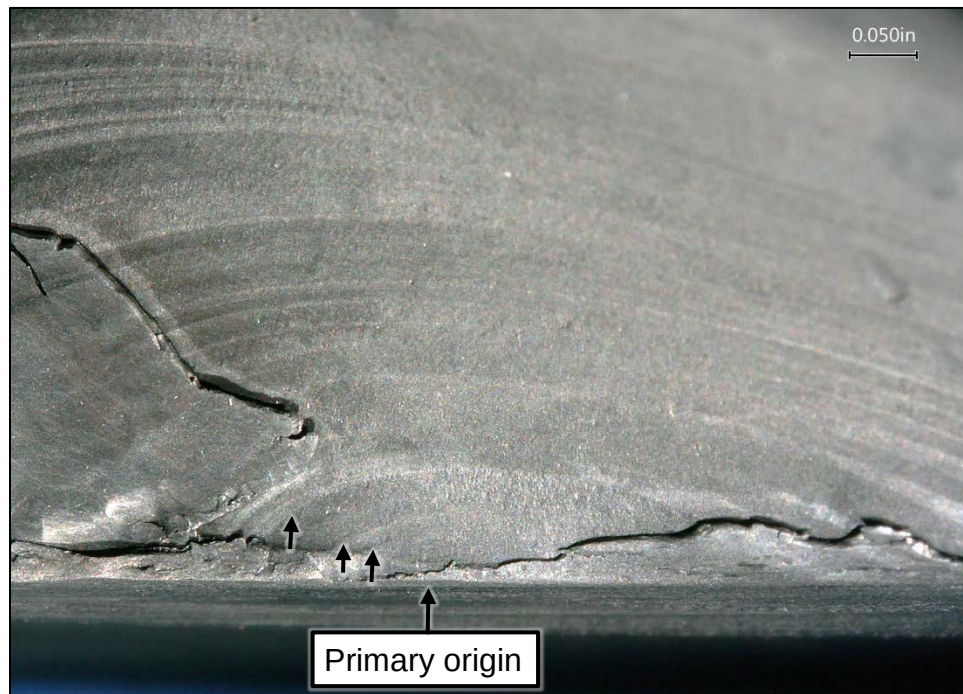
Relatively prominent crack arrest lines were observed close to the origin as shown in figure 5 and across much of the fracture as shown in figure 6. Crack growth appeared to progress in a wavy pattern, which were highlighted by side-lighting to show an alternating light and dark pattern when viewed optically as shown in figure 6. The fracture surface was further examined using a scanning electron microscope (SEM). An SEM image of the primary origin area is shown in figure 7, and an image of crack arrest lines near the middle of the fatigue region is shown in figure 8. The images shown in figure 7 and 8 are at relatively low magnification. The fracture surface was examined at higher magnification, but fine fracture features had been mostly obliterated by post-fracture rubbing damage and oxidation.

Figure 5. Optical image of the primary origin after cleaning and deoxidation. Unlabeled arrows indicate several crack arrest lines near the origin.

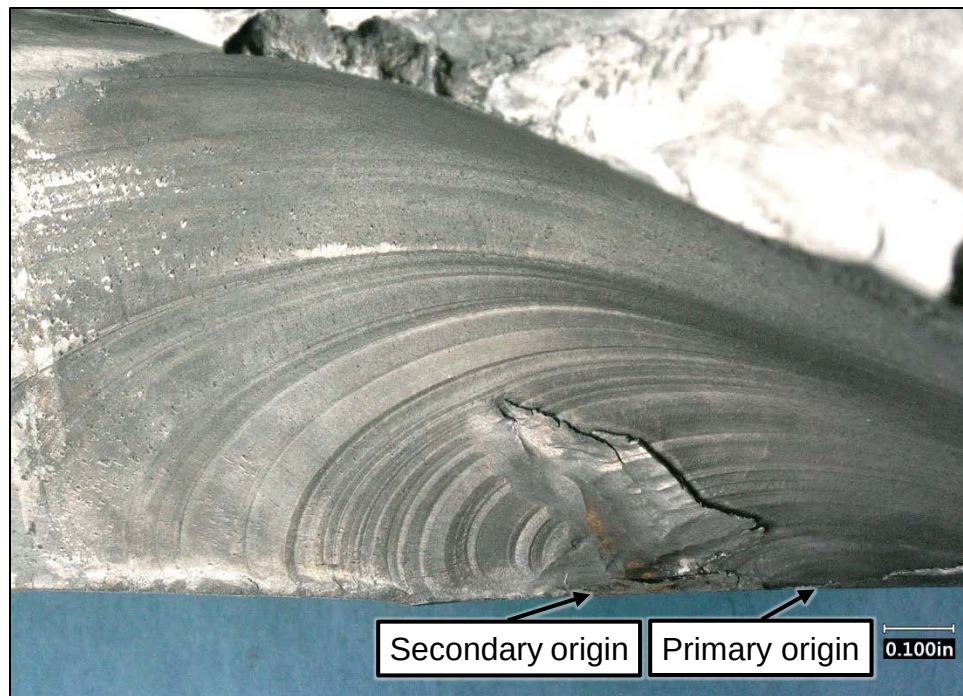
Figure 6. Optical image of the cleaned and deoxidized fracture surface showing crack arrest lines emanating from the primary and secondary origins.

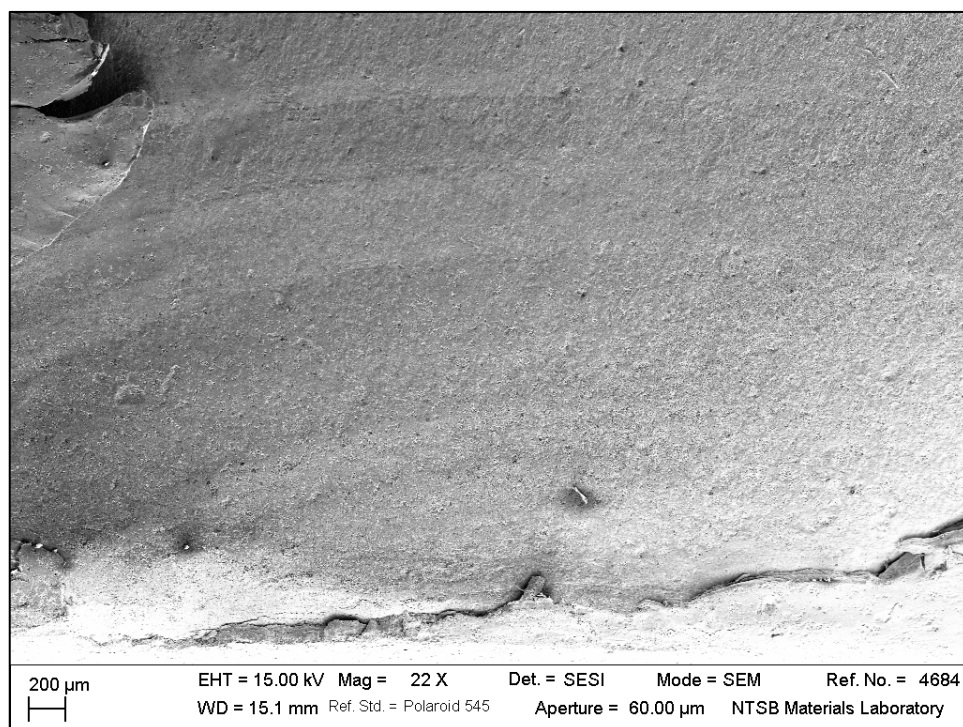
Figure 7. SEM image of the primary origin area.

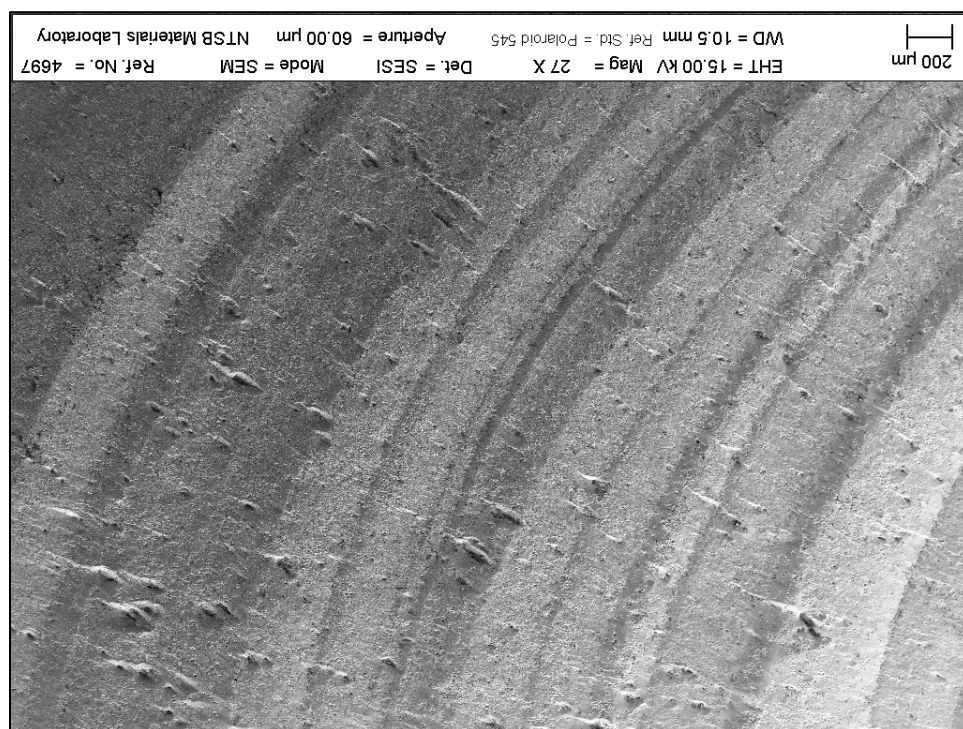
Figure 8. SEM image of crack arrest lines in the middle portion of the fatigue region.
