## Stinson 108 aircraft accident, aircraft evaluation.

On January 24, 2019 I traveled with inspector Joe Saunders to Shawano WI to perform an evaluation of a Stinson 108 aircraft after it was involved in an accident where it was reported that the engine lost power and stopped running prior to the crash. As a result of the crash the aircraft ended up inverted in a ditch alongside a road. The aircraft was moved from the accident site to a hangar at the Shawano airport prior to our arrival and was left in the inverted position.

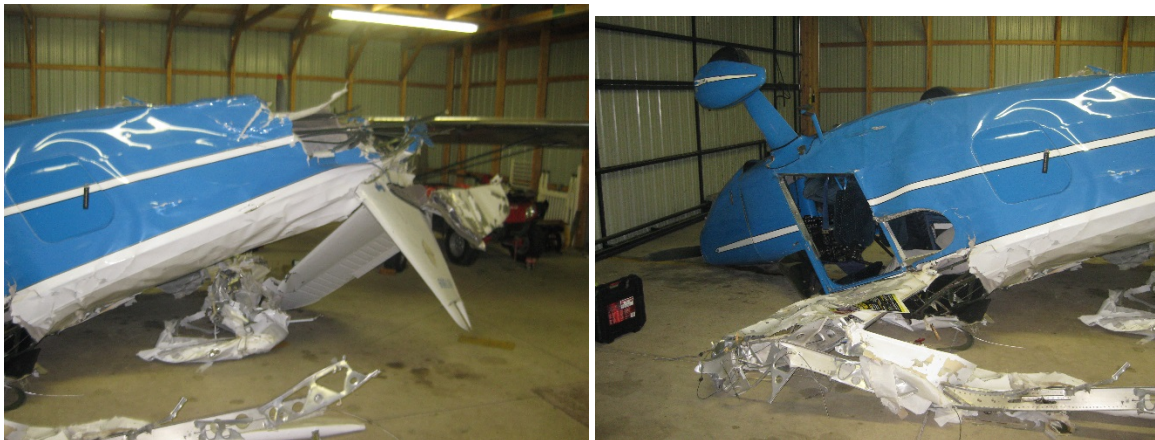
Upon arrival at the Shawano airport we were met by hanger owner Bruce who escorted us to the hangar. We were also joined by a deputy Sheriff from the county who assisted during the evaluation. We began our evaluation with a walk around of the aircraft taking photos and general inspection of the aircraft. We noted that airframe sustained very substantial damage to both wings and the tail section. The fuselage is also bent and twisted. Tail surfaces are substantially damaged. The left side landing gear is crushed and the prop is bent slightly.

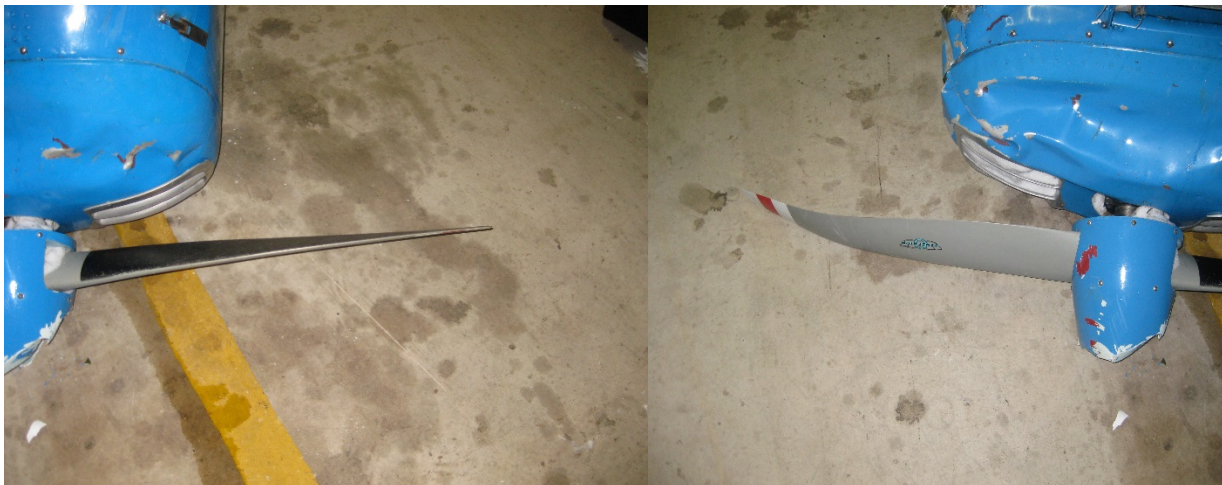
Inspection of the prop indicated that the engine was not likely operating at the time of impact.

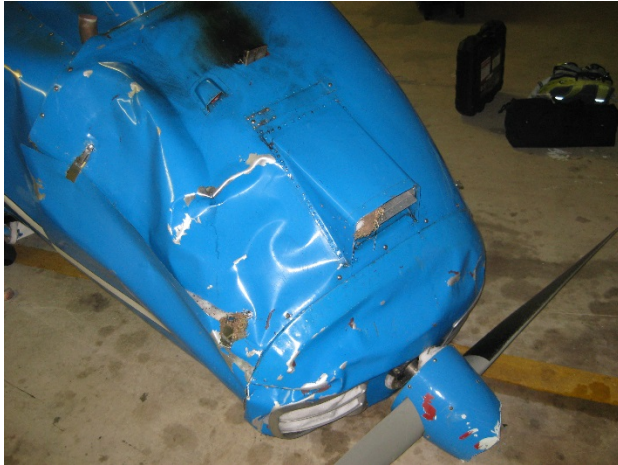
We then focused on the engine for a teardown evaluation. Since the aircraft was still inverted we started by removing the bottom cowl from the airframe.

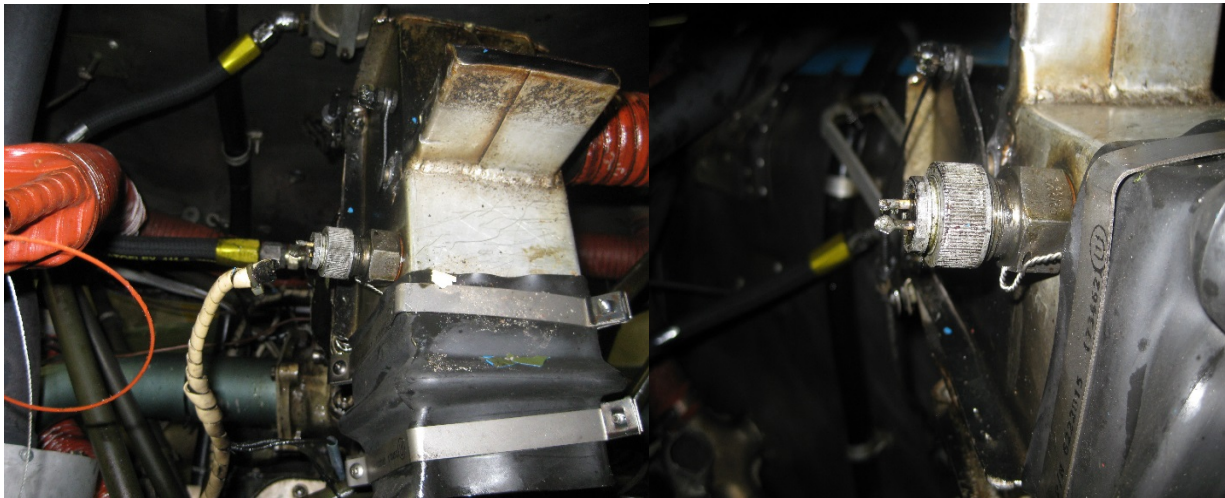
Upon removal we noticed that there was a wire harness that should have been connected to the carburetor air box temperature bulb that were broken off.

Prior to leaving the hangar we removed temperature bulb from the carburetor air box as well about 10 inches of the wires that were broken off the cannon plug connector. Examination of those items is not conclusive that they were broken off before the crash but their general condition would lead us to believe they were not operational.

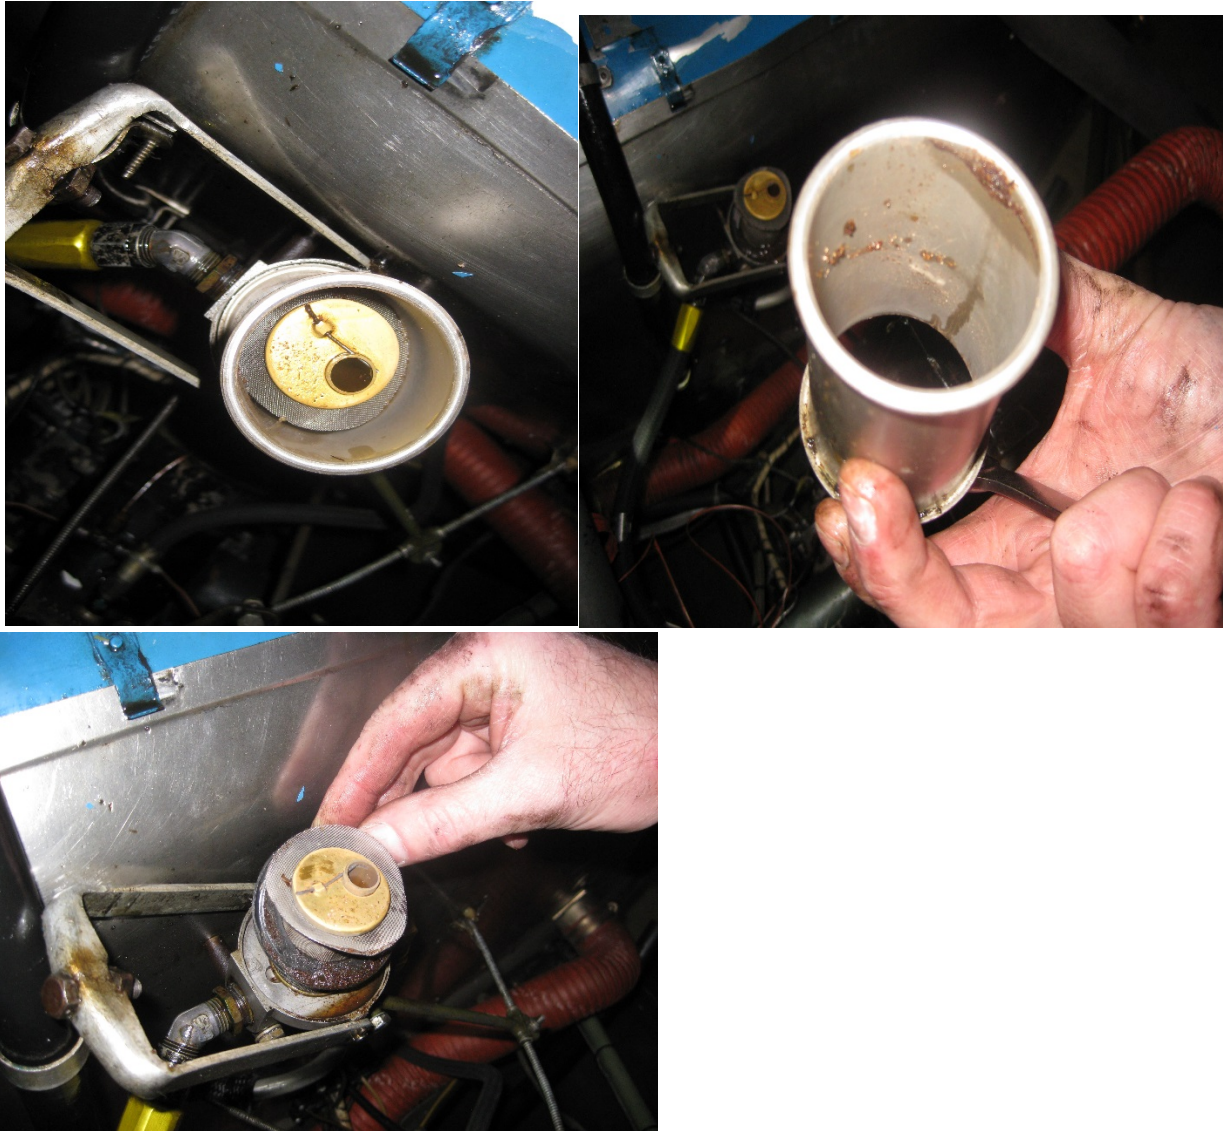
We didn't notice anything else out of place inside the engine. We established continuity to the throttle and carb heat from the appropriate knobs on the instrument panel. We then proceeded to drain fuel from the fuel filter mounted on the firewall into a glass jar for examination, approximately 1 cup was removed. The fuel was taken from the outlet of the fuel filter assembly. The fuel was mostly clear with a slight blue tint.

No water was noted in the fuel and there was minor presence of dirt or debris. We took apart the filter assembly. There was some minor dirt and debris found within the filter but no signs of disruption of fuel flow.

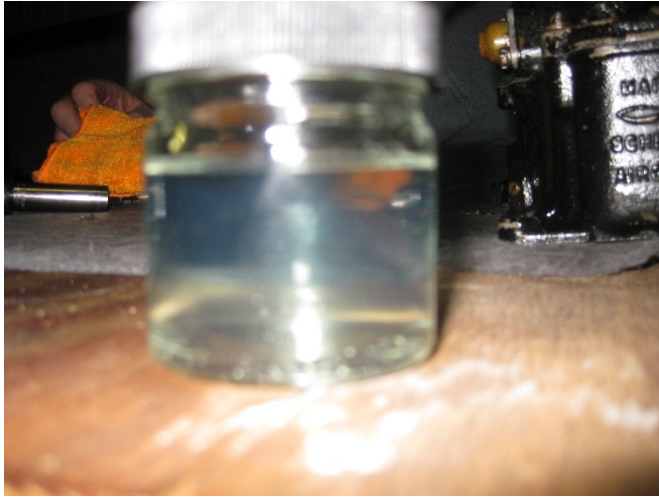
We then removed the carburetor from the engine and took it apart on a bench. Prior to disassembly we drained the remaining fuel from the float bowl into a glass jar, approximately  $\frac{1}{4}$  cup was drained. The

fuel was clear with a slight blue tint color, no debris or water was noted in the fuel.

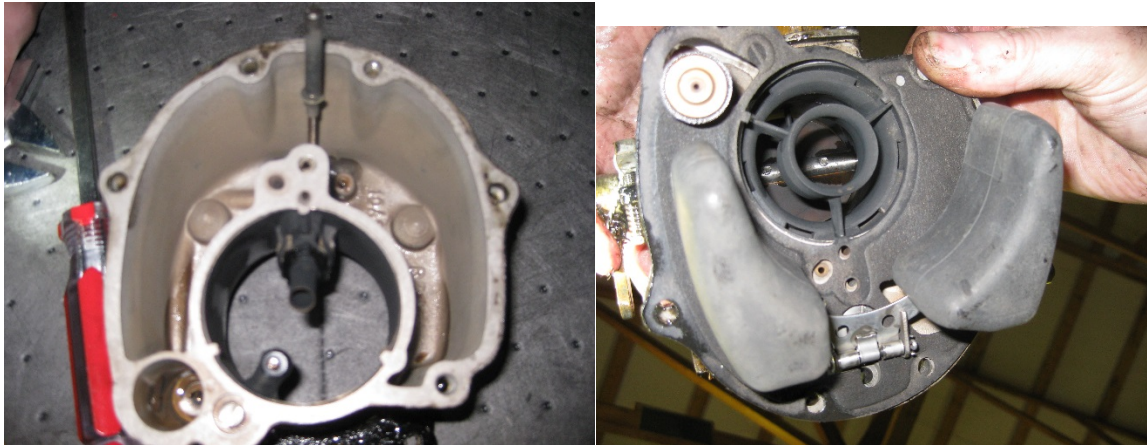
Note that intake manifold had some fuel puddles in it in it, likely fuel drain out of the carb from being in an inverted position. We disassembled the carburetor. There was no abnormalities found during the disassembly. The needle and seat operated normally. No obstructions were noted in the carb inlet. No dirt or debris was found in the float bowl. We removed the main jet from the carb body, no debris was noted in the jet, air could be easily blown through the jet.
