# The National Transportation Safety Board

Office of Aviation Safety  
Central Region  
Memorandum for the Record  
Carburetor Icing Probability,  
Carburetor Airbox  
Evaluation, and Engine  
Examination Findings  
CEN19LA071  
Beechwood Wisconsin

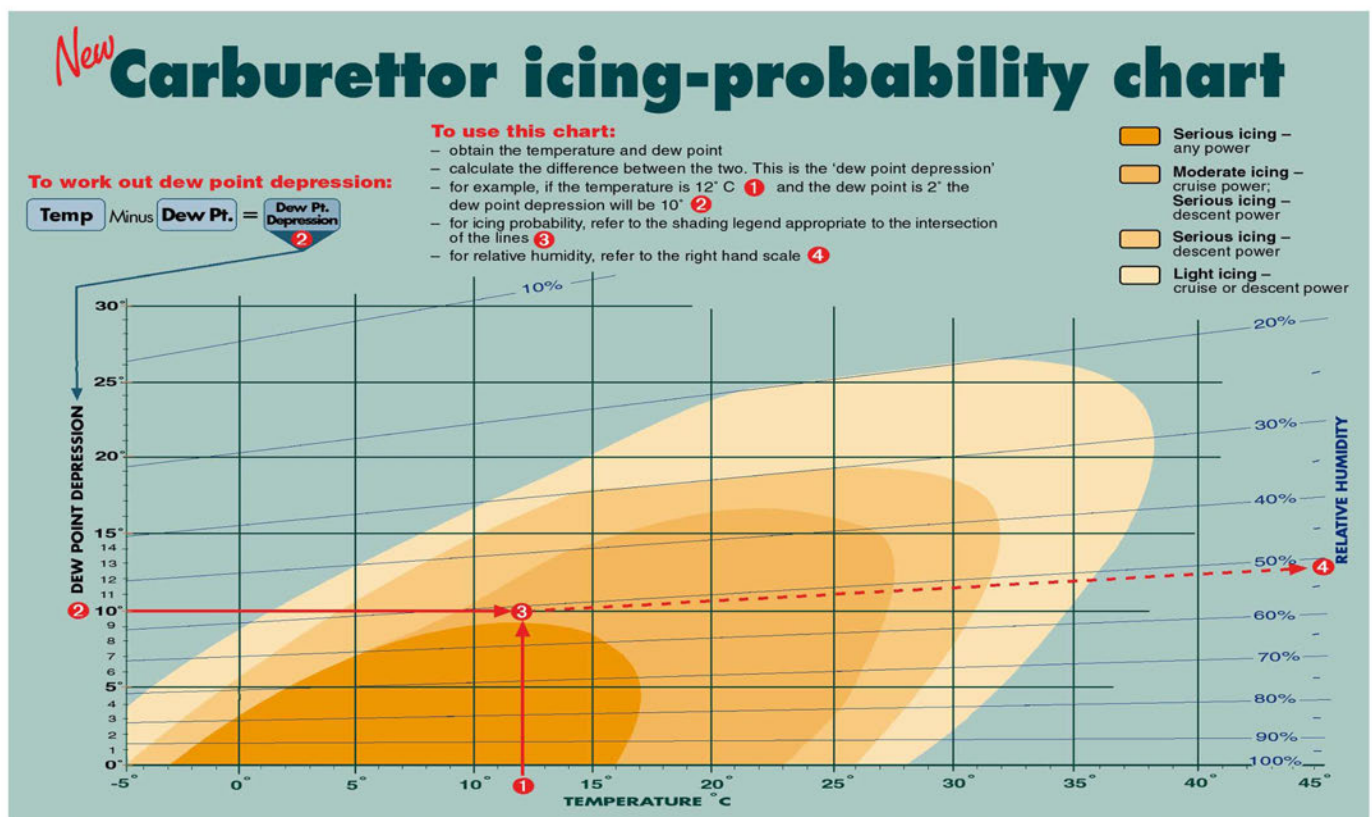
According to the carburetor icing probability chart, with a temperature of -7 degrees C and a dew point of -14 degrees C (-7 dew point depression), it could not be determined if the airplane's carburetor could have been subjected to icing, because the dew point depression was not within the charts matrix.

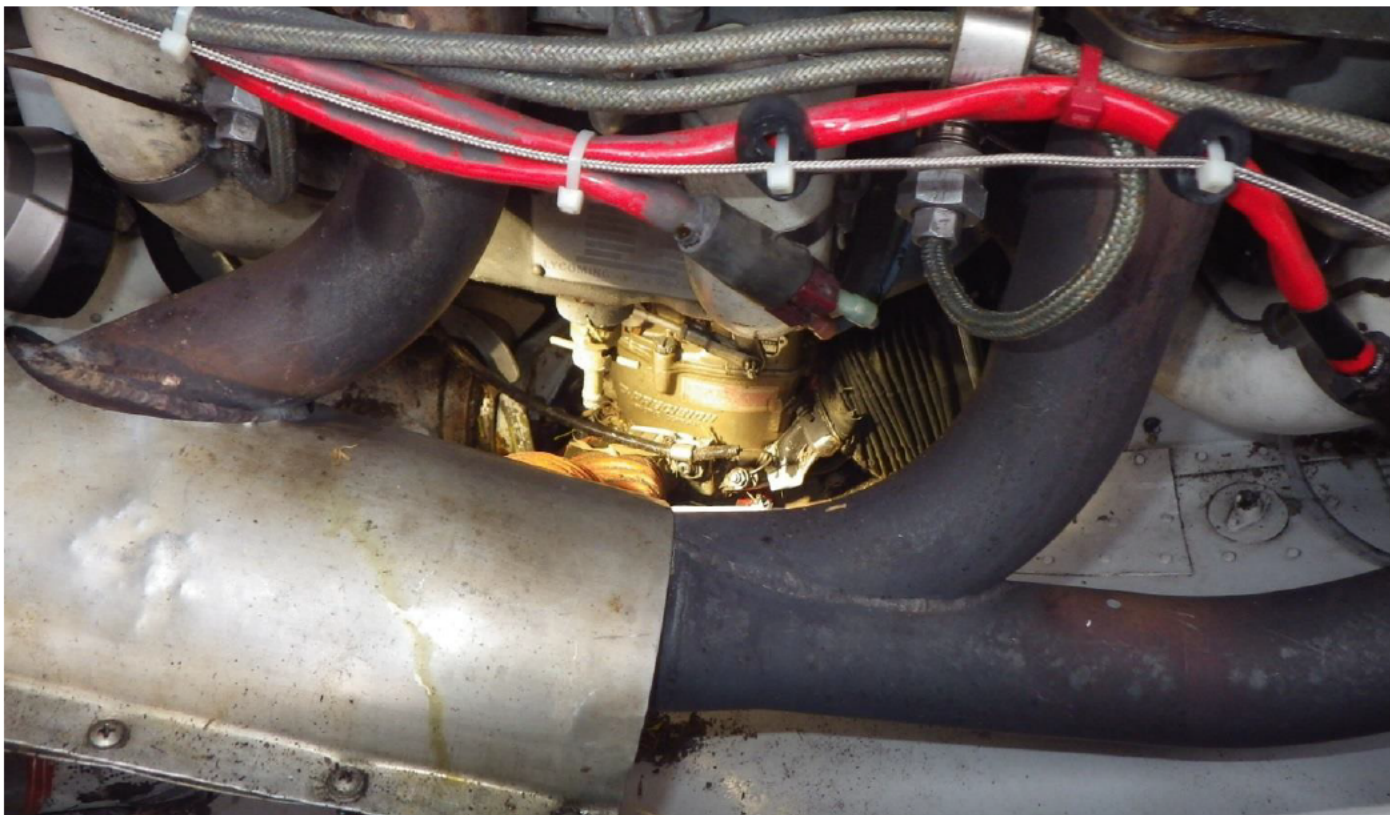
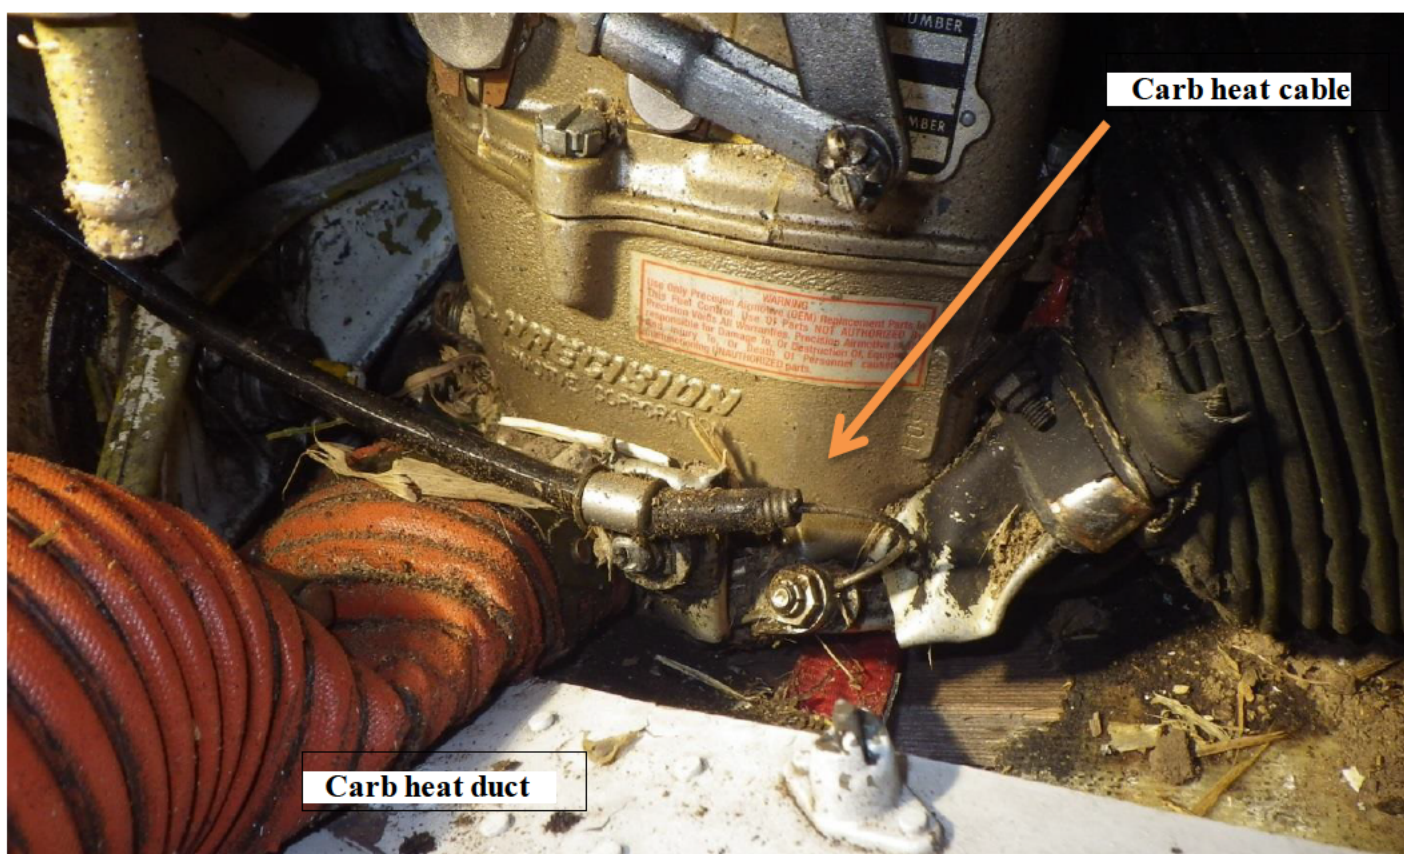
An examination of the carburetor air box rigging the and carburetor heat valve assembly was performed. Opening the cowl to gain access to the carb heat ductwork and valve assembly revealed that both have been crushed by the impact of the gear-up landing. In the cockpit, the carb heat control was in the forward position. Due to the carb heat valve assembly being crushed, it was not possible to determine if the rigging was correct

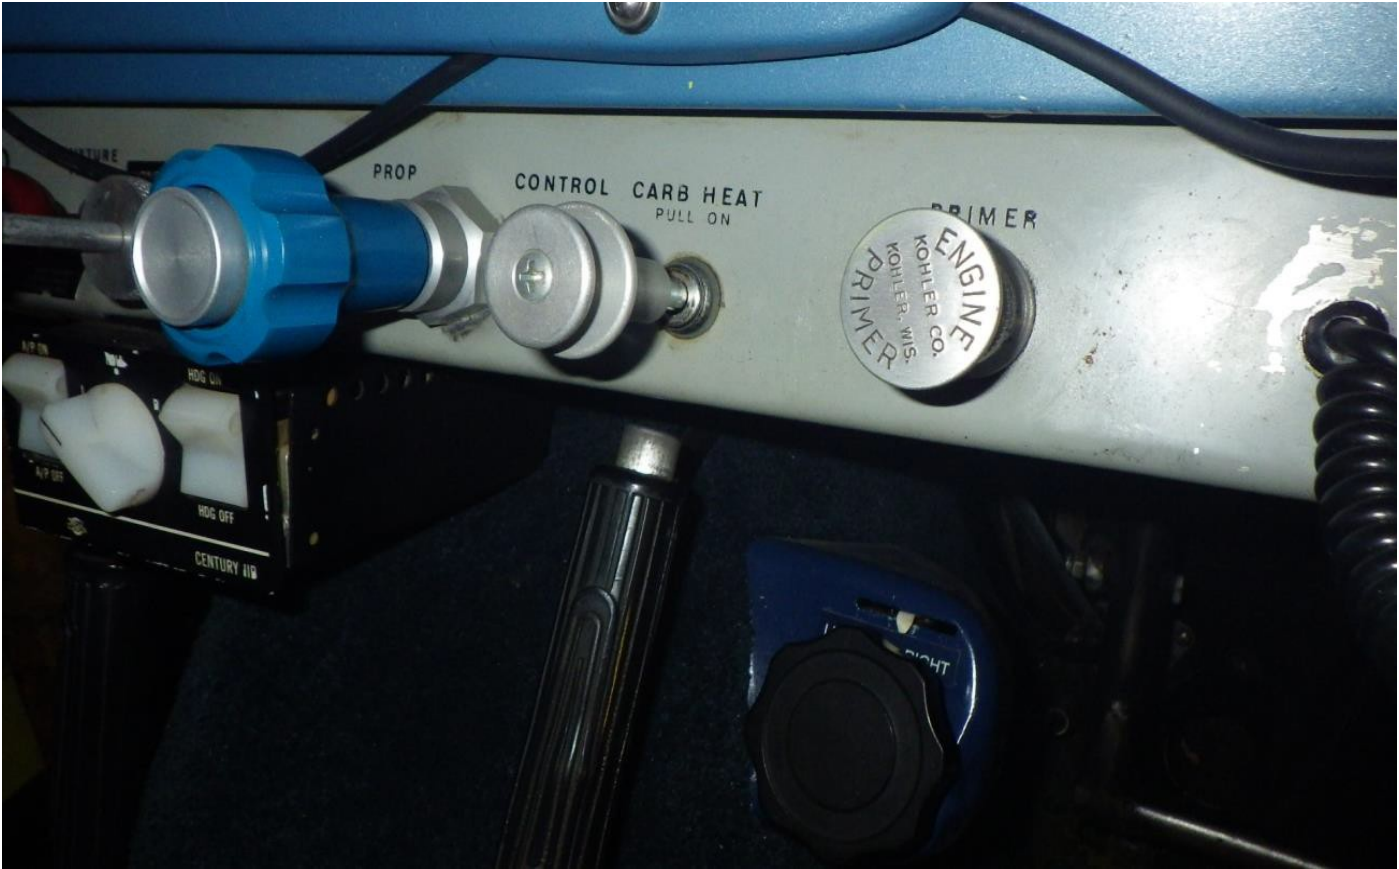
In the cockpit, the carb heat control was found in the forward (OFF) position.
