## Factual Narrative

### HISTORY OF FLIGHT

On January 27, 2019, at 1514 central daylight time, a Piper PA-32RT-300T airplane, N39650, suffered a partial loss of engine power resulting in an off-field landing near Pflugerville, Texas. The pilot received minor injuries and the airplane was substantially damaged. The airplane was registered to -Stew Industries, LLC., and was operated by the pilot as a Title 14 *Code of Federal Regulations* Part 91 personal flight. Day visual meteorological conditions prevailed, and the flight was not operated on a flight plan. The flight originated from the Austin Executive Airport (EDC), Austin, Texas, with an intended destination of Taylor Municipal Airport (T74), Taylor, Texas.

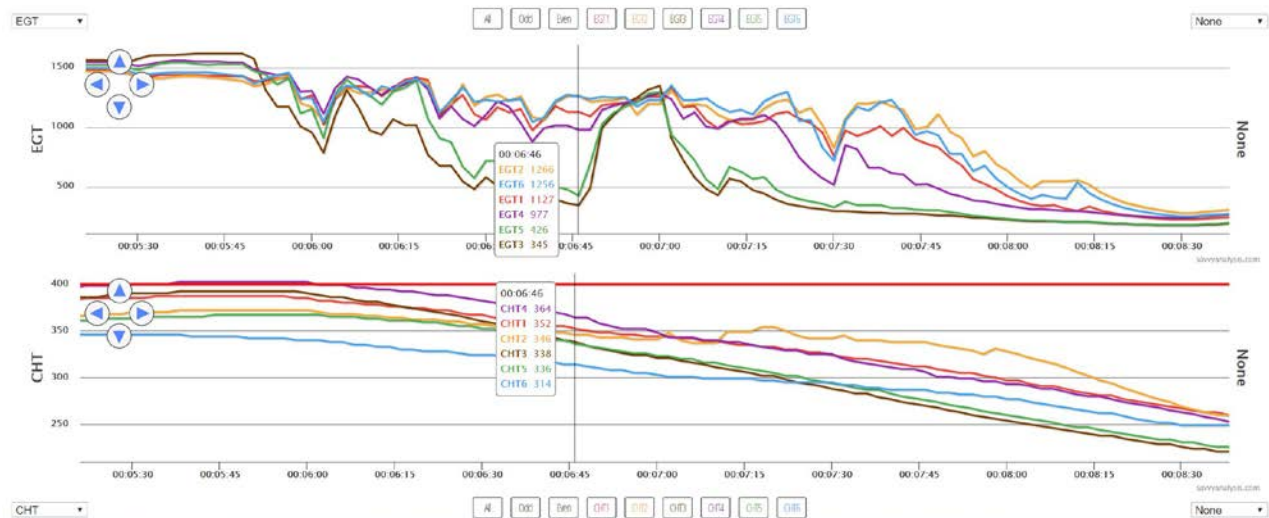
Figure 1 – Final Minutes of Accident Flight JPI Data

Data associated with the accident flight showed a consistent decrease in CHTs during the final 3 minutes of flight. EGT data showed a series of decreases and increases in temperatures during the same period. (Figure 1)

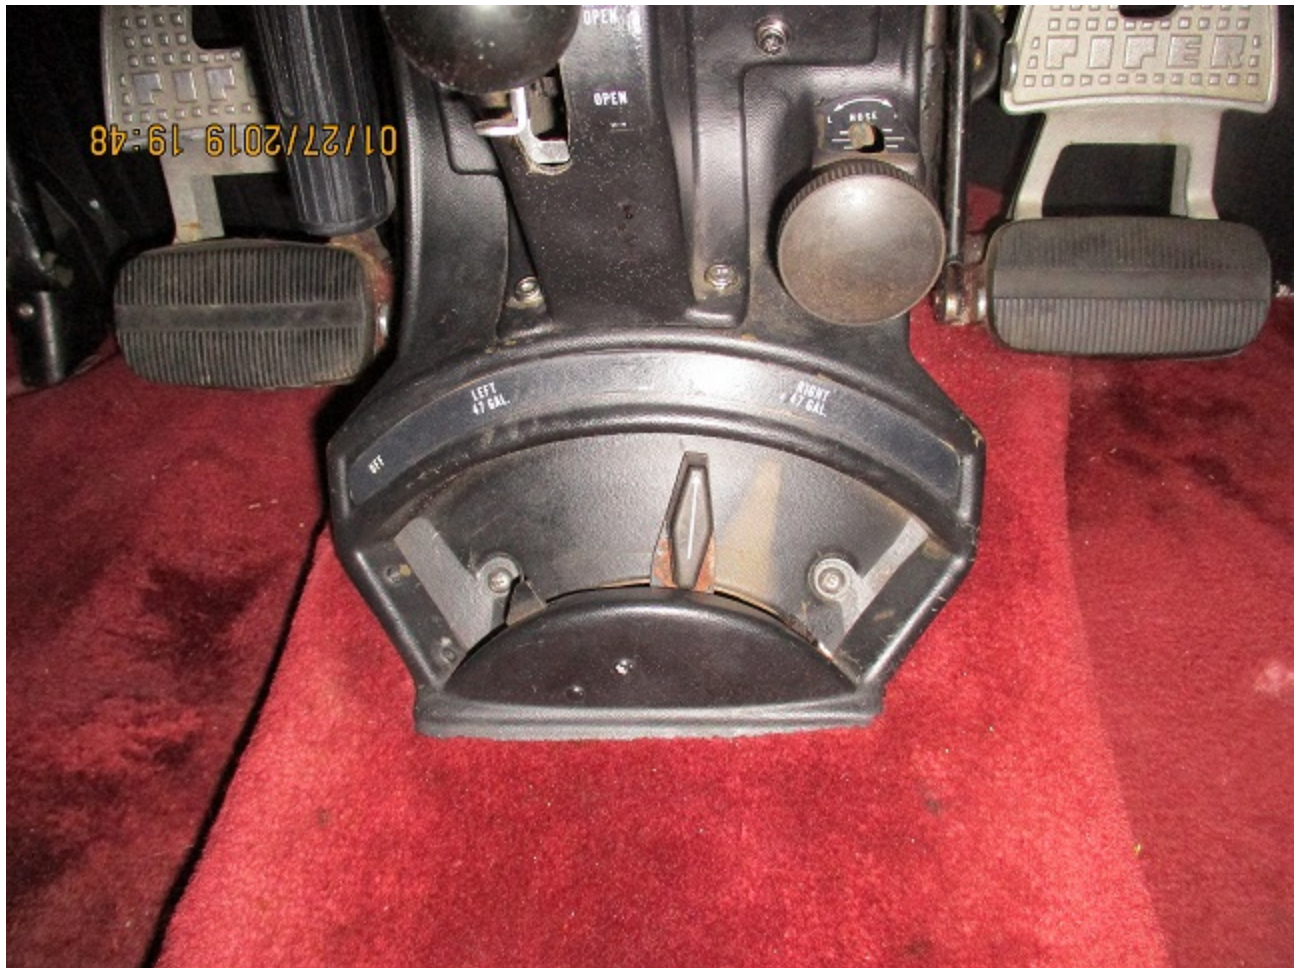
Figure 2 - Fuel Selector Position

The inboard right wing tank did not contain any fuel and the right fuel cap was secure on the wing when viewed at the accident scene by Federal Aviation Administration (FAA) inspectors. The right tank fuel lines were compromised where the wing separated from the fuselage during the accident, and the right outboard fuel tank was ruptured where leading edge impact damage had occurred. Little-No evidence of fuel leakage from the right wing tanks was evident at the accident scene and no fuel was found in the right wing tanks by recovery personnel. FAA inspectors documented the fuel selector handle in a position about 1 to 2 inches past center towards the right tank position (see figure 2).
