# NATIONAL TRANSPORTATION SAFETY BOARD

## MATERIALS LABORATORY FACTUAL REPORT

Report No. 20-022

Place : Waterloo, Illinois  
Date : March 12, 2019  
Vehicle : Piper PA-32R-300, N750R  
NTSB No. : CEN19LA098  
Investigator : Tim Sorensen, AS-CEN

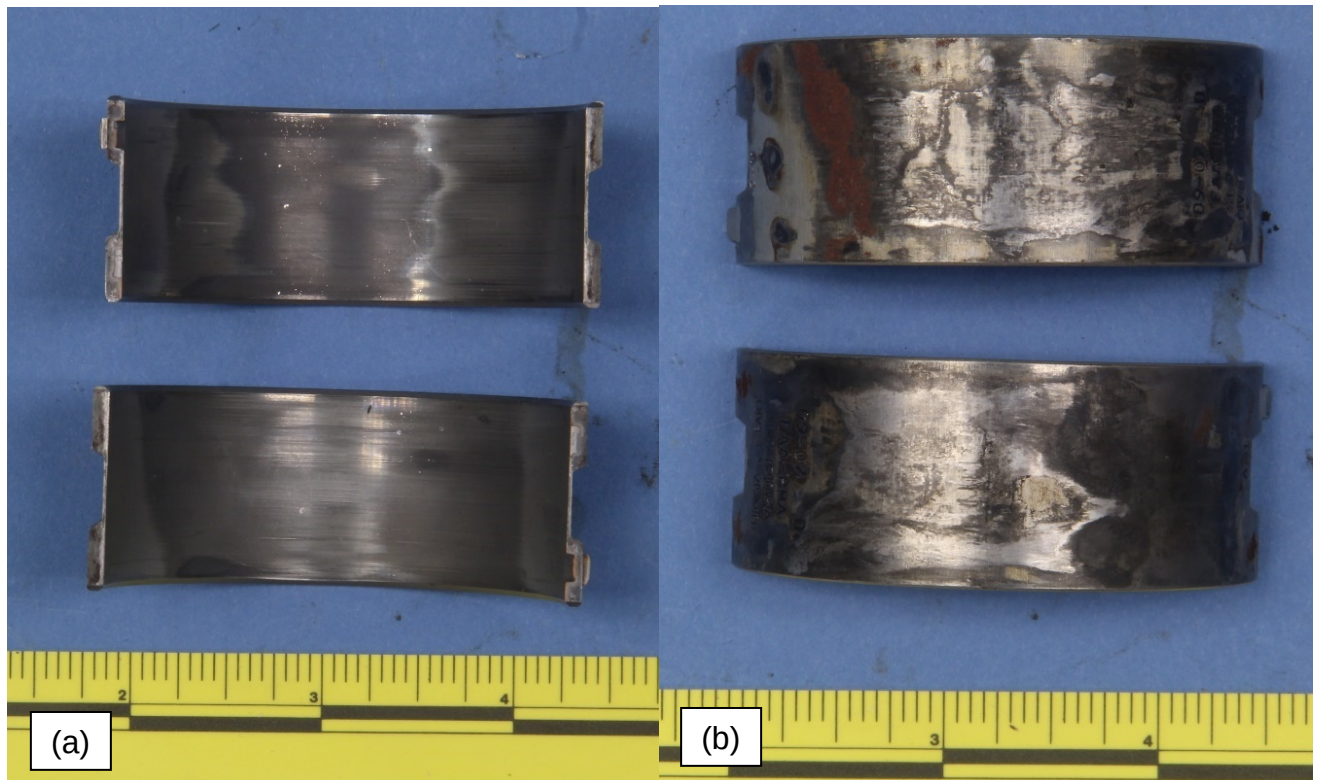
Figure 3 shows the bearings from the #3 connecting rod assembly, viewed from the inside and outside surfaces. While the bearings did not exhibit any gross plastic deformation, there were no visible indications of wear or gouging on the inner surfaces, such as typified with scratching or material spalling. The wear patterns on the inner bearing surfaces showed clustered wear scars, consistent with localized contact and movement. On the exterior surfaces, one of the bearings exhibited three circular-shaped protrusions. These marks matched those on the #3 connecting rod bearing surface, as shown in Figure 4. These marks were consistent with material trapped between the external bearing and connecting rod surfaces.

Figure 3 – The (a) inner and (b) outer surfaces of the #3 bearing.

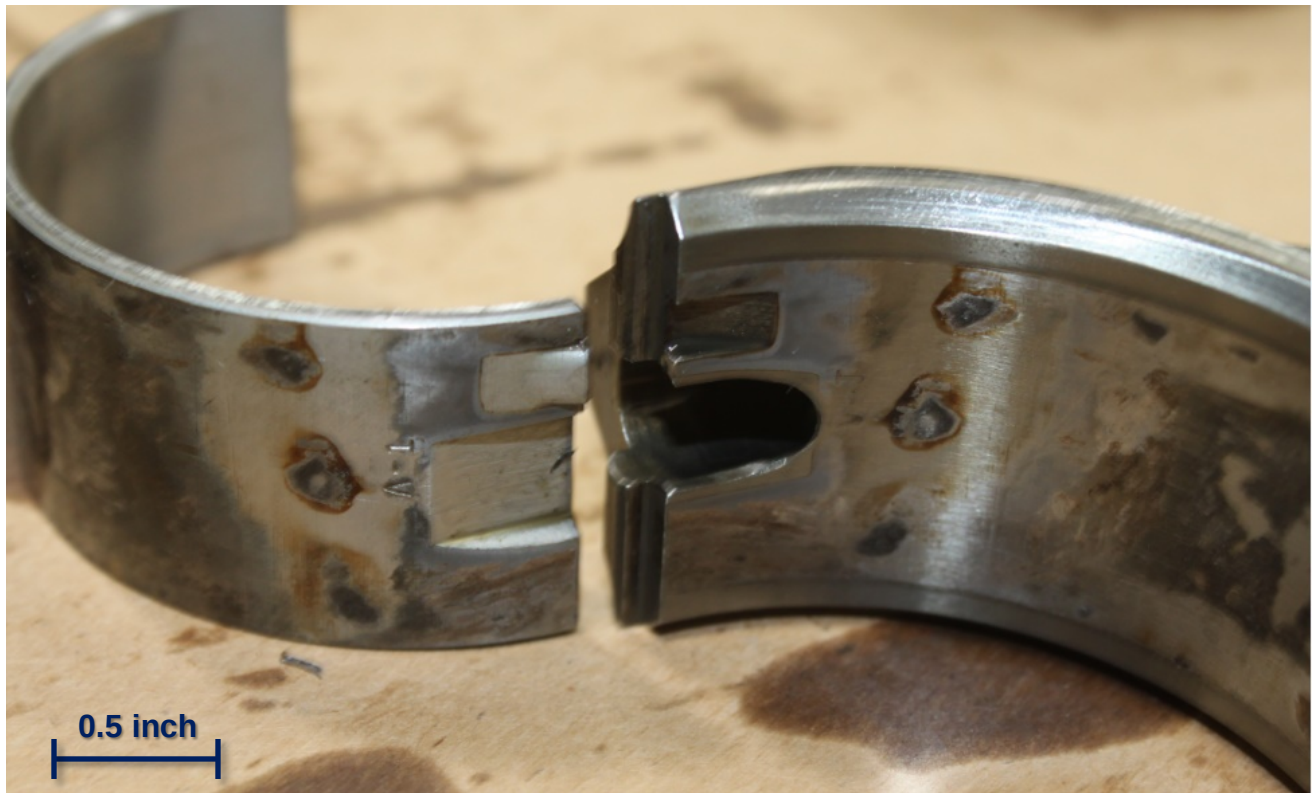
Figure 4 – View of the mating bearing surfaces of the #3 connecting rod surface and the outer bearing surface, showing three matching marks (courtesy Tim Sorensen, AS-CEN).

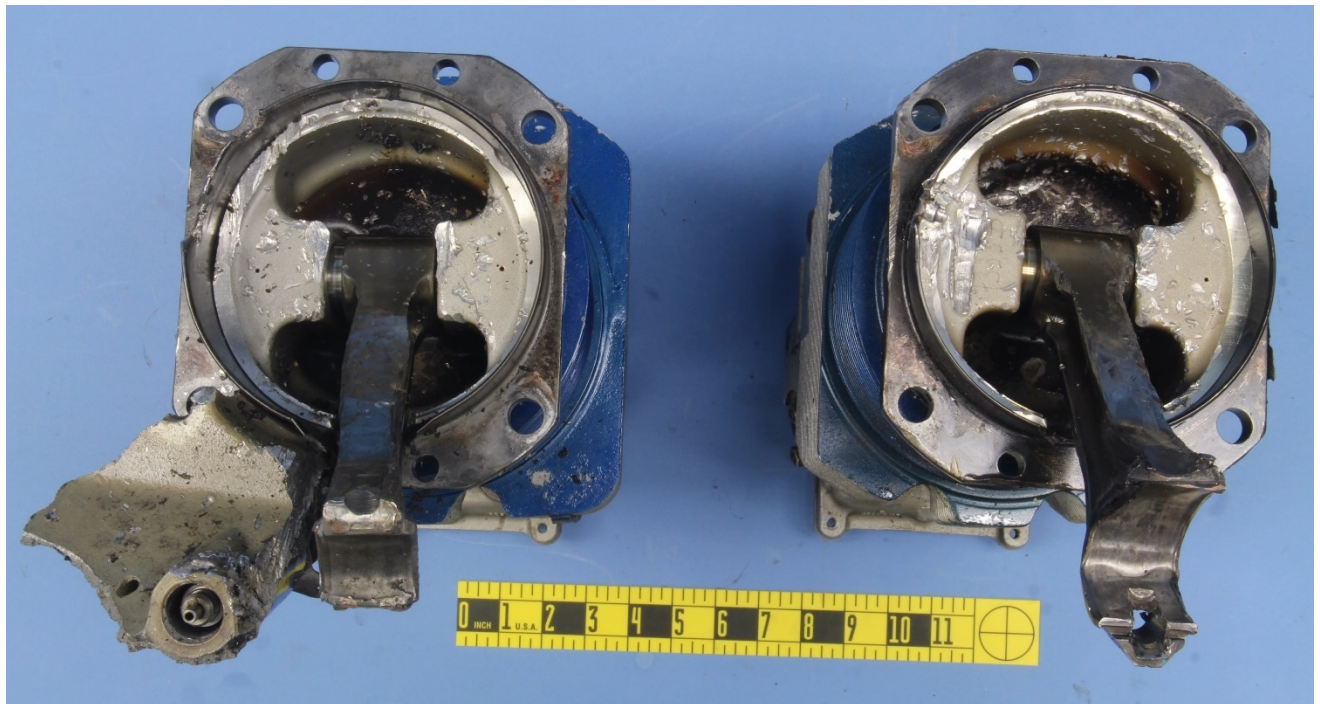
Figure 5 shows the crankshaft sides of the #4 and #6 cylinder assemblies. These assemblies were intact on the upper portions (where the rockers, retainers, and upper stems of the valves were located), and had not yet been disassembled. The lower portions, facing the reader in Figure 5 through Figure 8, were open. The #6 cylinder flange was connected to a fractured remnant of the engine case (shown in the lower left in Figure 5 and Figure 6).

Both cylinder assemblies had their respective pistons lodged inside the cylinder cavity, and they were unable to be moved. As shown in Figure 5 and Figure 6, the lower skirts of both pistons exhibited gouging consistent with impact damage from smaller parts. The connecting rod remnants were still affixed to their respective pistons by piston pins. The rods could be readily rotated about the pins.

5, the connecting rods fit within the damaged grooves in the skirt flange. This damage pattern was consistent with the rods being forced against the cylinder wall skirt in a rapid manner or impact.

Figure 5 – View of the connecting rod sides of the cylinder assembly remnants from the #4 and #6 cylinders.

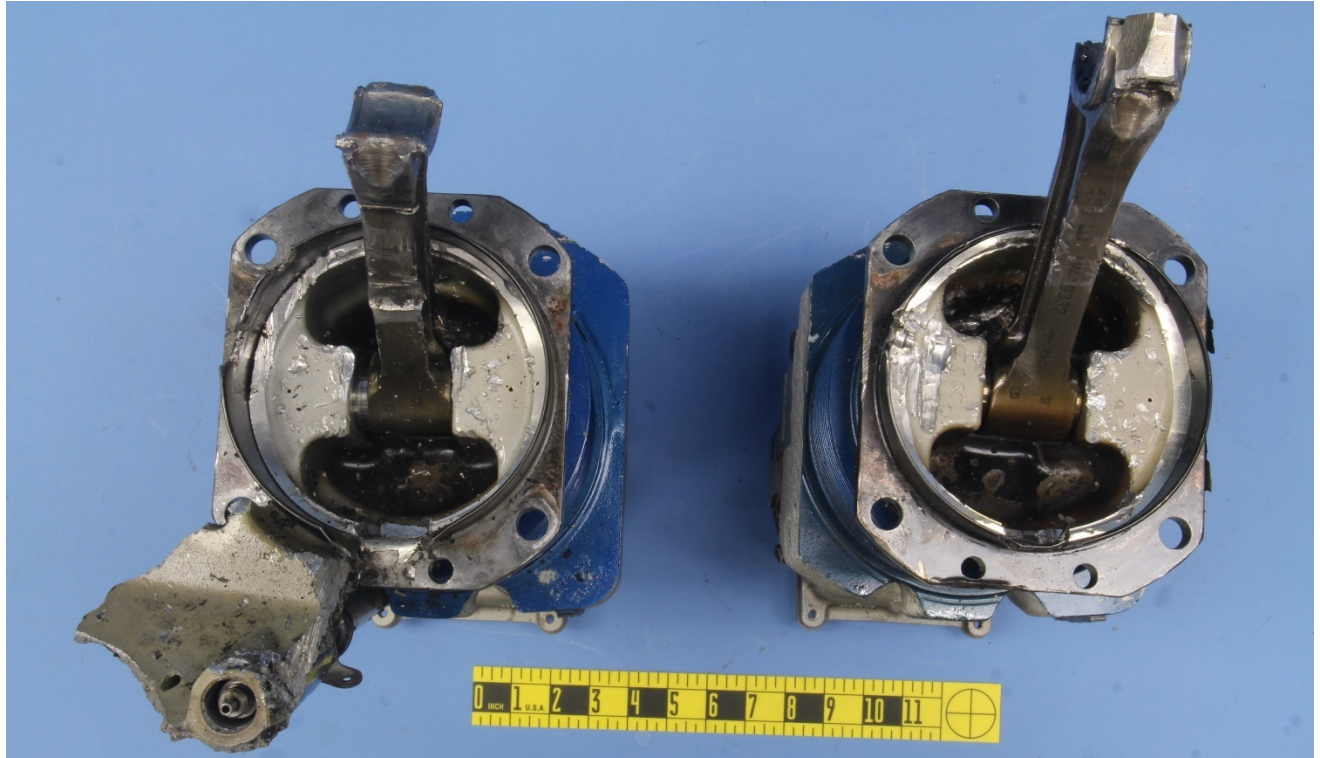
Figure 6 shows the connecting rods moved upward to reveal damage to the lower cylinder skirts. This damage, manifest as plastic deformation and cutting of a portion of the skirt, was proportional to the width of the connecting rods. As demonstrated in Figure

Figure 6 – View of the connecting rod sides of the cylinder assembly remnants from the #4 and #6 cylinders, with the rods moved upward from Figure 4, showing cylinder damage.

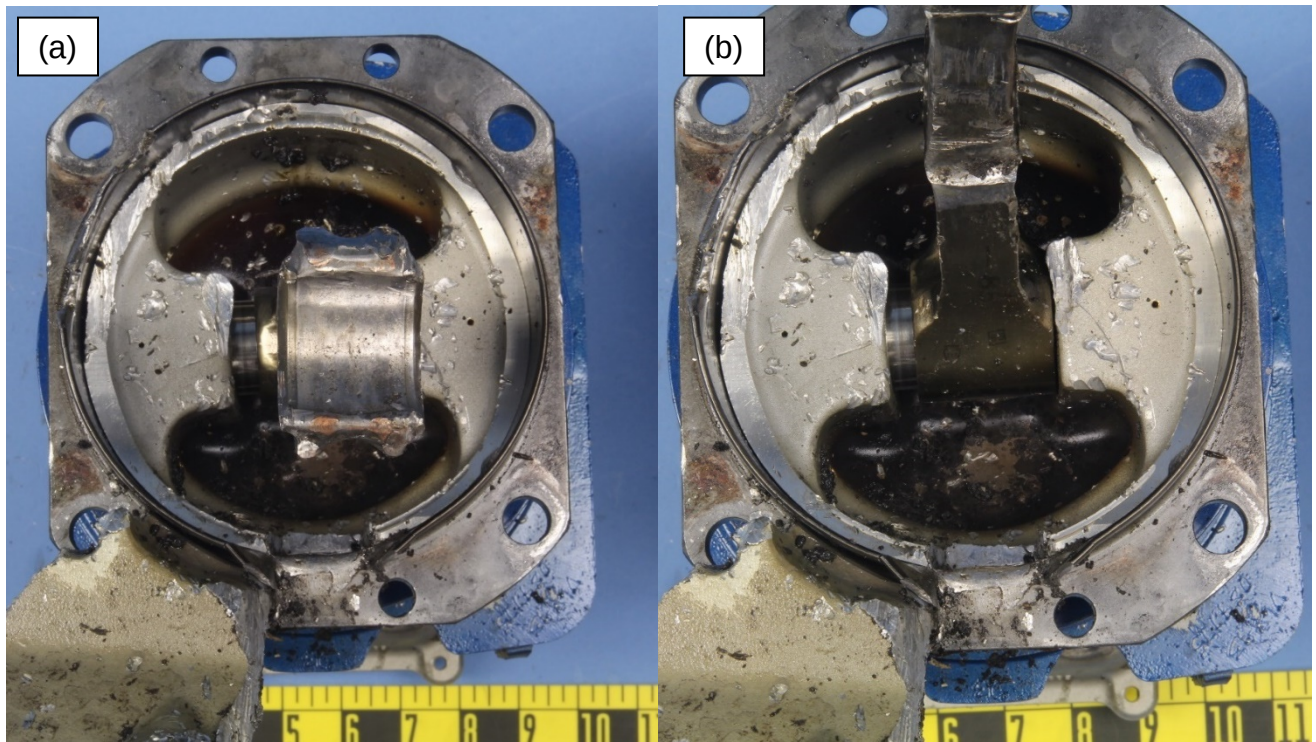
Figure 7 shows a closer view of the #6 cylinder, highlighting the #6 connecting rod bearing surface towards the respective crankshaft journal. On this connecting rod surface, there were no apparent fracture surfaces or areas of missing material. In addition, the bearing surface exhibited some circumferential wear scars and minor ( $< 0.04$  inches or 1 mm deep) impact marks. As shown in Figure 7b, the lower face of the shank of the connecting rod had been inward, consistent with impact with the respective cylinder wall skirt.

Figure 7 – Closer views of the #6 position assembly remnants showing (a) the rod bearing surface and (b) the rod moved to show the impression in the cylinder wall.

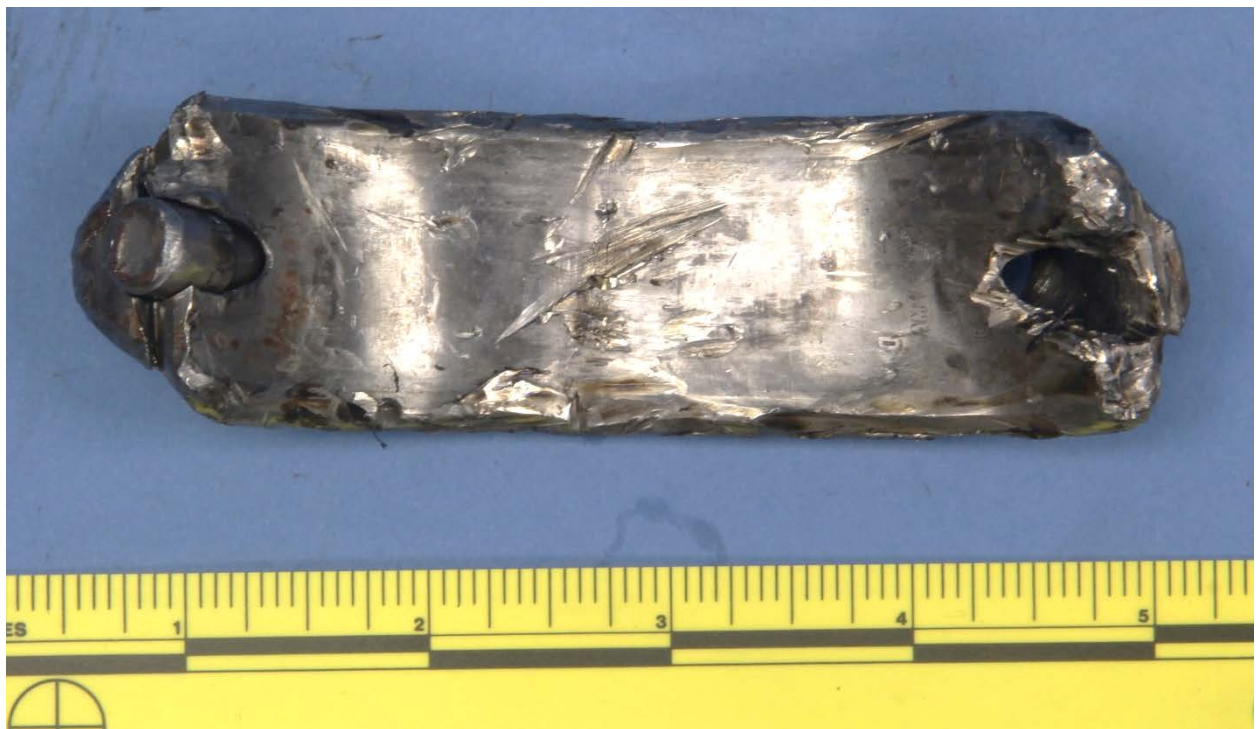
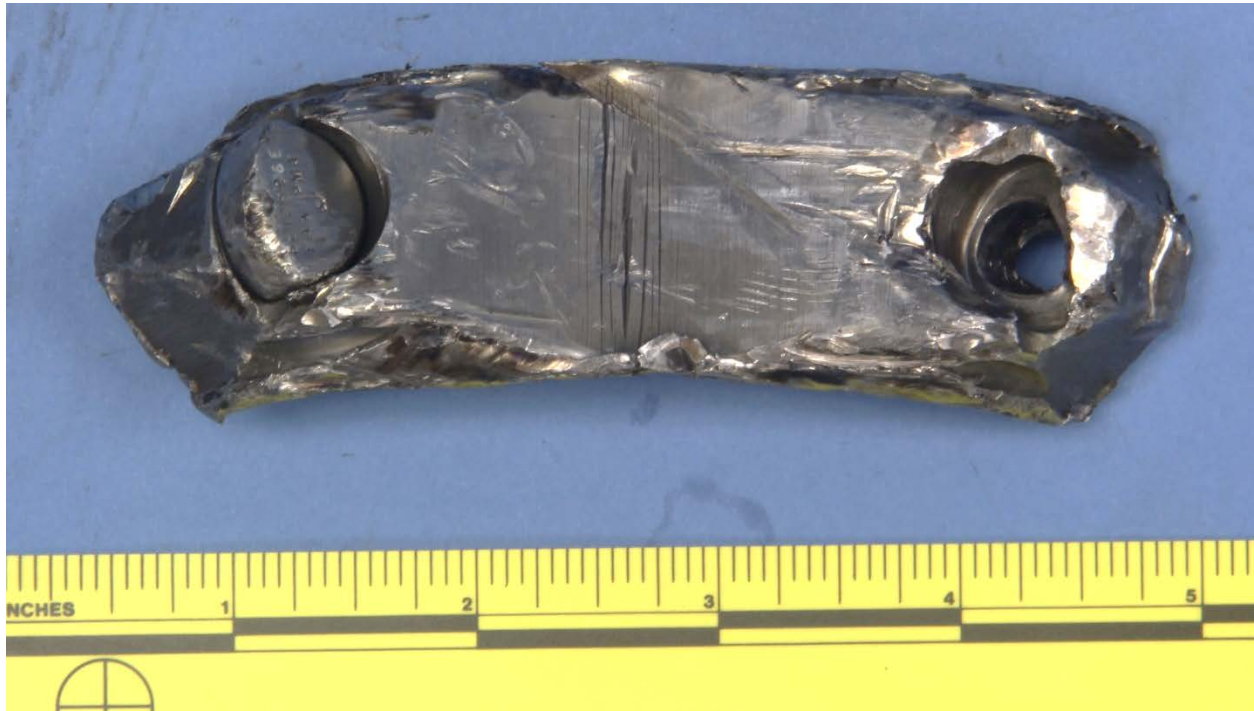
Figure 8 and Figure 9 show the intact loose connecting rod cap remnant, from the inner bearing and outer surfaces, respectively. This cap was identified as being from the #6 connecting rod. As shown on the left in both figures, there was a remnant of the attachment bolt still in place in one of the cap bolt holes. The remnant was that of the bolt head. While intact (i.e., not through-fractured), the cap remnant had been flattened, exhibiting vertically-oriented tear marks on the outer surface (Figure 9). The inner (bearing) surface exhibited gouge marks and smearing, consistent with repeated impacts with an adjacent component.

The bolt remnant fracture surface exhibited smearing and deformation on the edges, consistent with post-fracture damage. The small undamaged portion of the bolt fracture surface, along the bolt centerline, exhibited a rough fibrous texture and dull luster. These features were consistent with overstress fracture of the #6 attachment bolt remnant.<sup>3</sup>

Figure 8 – View of the loose and intact #6 connecting rod cap remnant from the inside surface.

Figure 9 – View of the loose and intact #6 connecting rod cap remnant from the outside surface. There was a bolt remnant in the cap remnant.

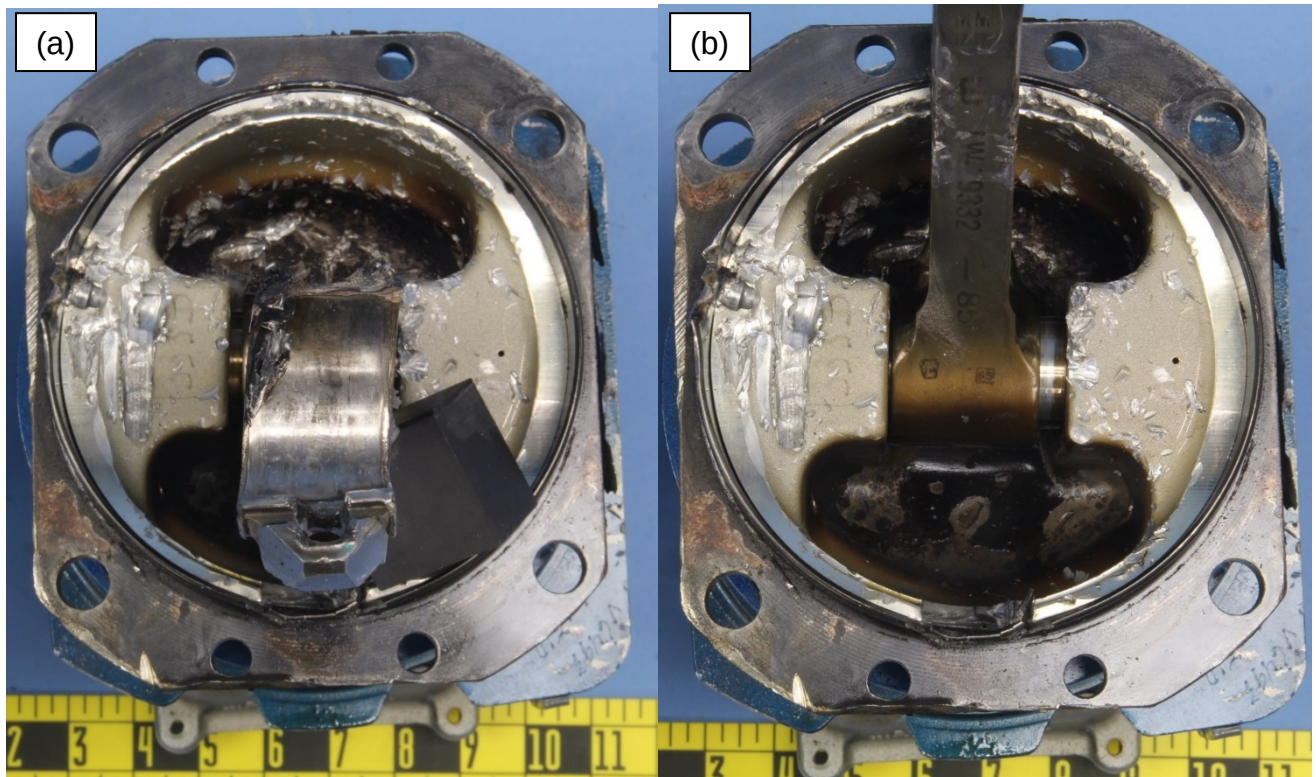
Figure 10 shows the #4 cylinder assembly remnant. As with the #6 cylinder, the cylinder wall skirt exhibited sharp impact damage, consistent with impact from the connecting rod shank face. The left side of the piston skirt in the figures exhibited an angled outward-oriented gouge mark, consistent with an impact in that direction from another component. There was also an upward gouge on the left side of the piston, consistent with the material being pushed upward in Figure 10b.

The #4 connecting bearing surface facing the reader in Figure 10a had fractured through the upper rod yoke. Much of the adjacent material to the connecting rod fracture surface exhibited a darker color and was plastically deformed back towards the bearing surface.

Figure 10 – Closer views of the #4 position assembly remnants showing (a) the rod bearing surface and (b) the rod moved to show the impression in the cylinder wall.

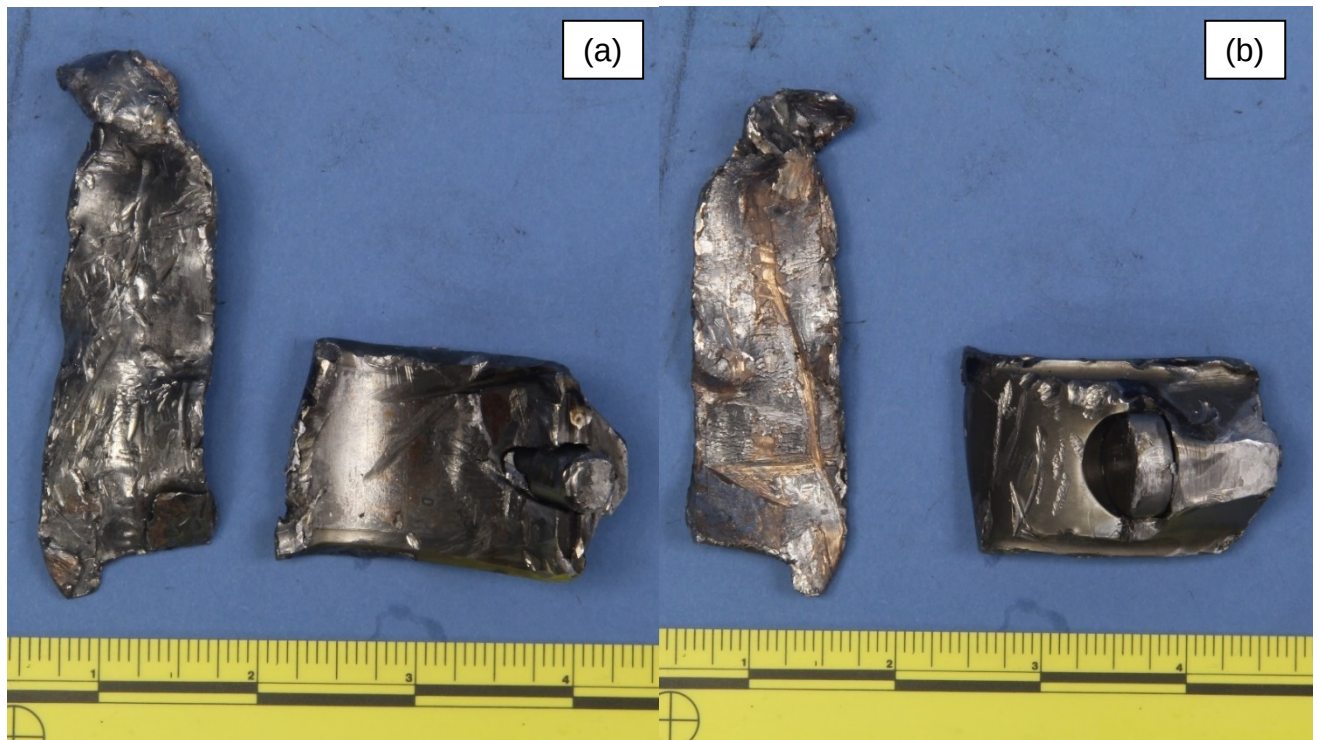
Figure 11 shows two pieces from the #4 connecting rod—one of the bearings and a remnant of the connecting rod cap. The bearing had been deformed exhibiting indications that it had been twisted. The remnant exhibited multiple impact and gouge marks, revealing the underlying copper-based layer. The fracture surface of the cap

remnant in Figure 11 had been obliterated—plastic deformation of the surface showed material pushed from the outer surface inward, bending over the absent fracture surface.

Figure 11 – Remnants of the #4 bearing and a cap fragment viewed from (a) the inner and (b) outer surfaces.

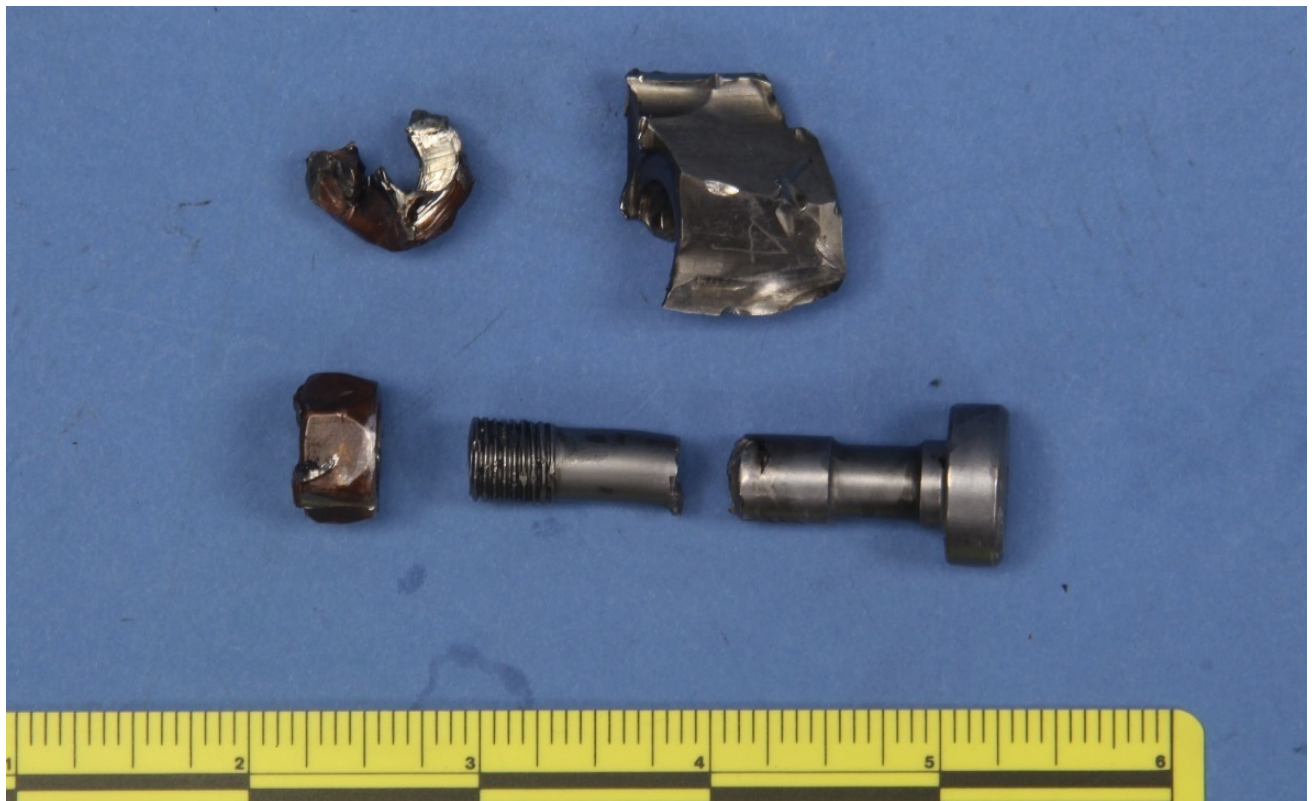
Figure 12 shows another connecting rod remnant, as well as two fractured pieces from an attachment bolt, along with two nut remnants. Much of the area of one of the remnant fracture surfaces displayed in Figure 12 had been obliterated by smearing, consistent with post-fracture damage. The opposite fracture surface is shown in Figure 13. This surface exhibited a rough-textured, layered fibrous morphology, with a dull luster. These features were consistent with overstress fracture of this remnant surface.

Figure 12 – Remnants of the #4 connecting rod cap, with remnants of an attachment bolt and two nuts.

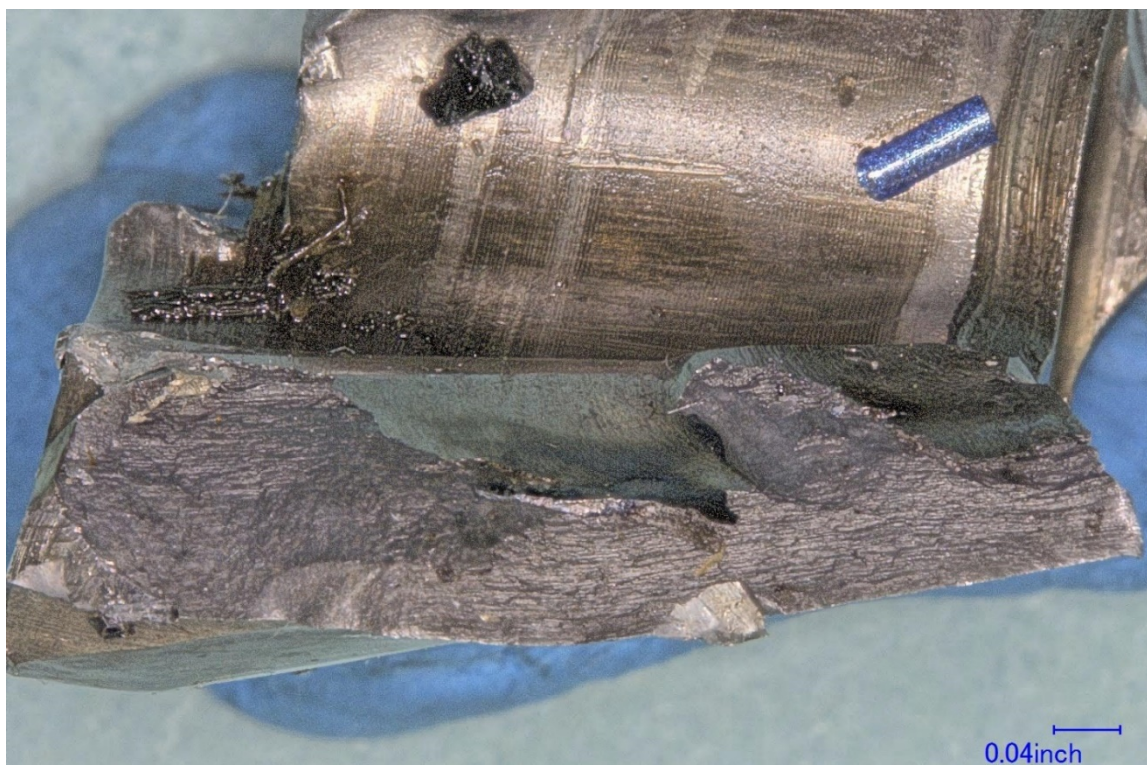
Figure 13 – View of the undamaged area of the fracture surface from the remnant in Figure 12.

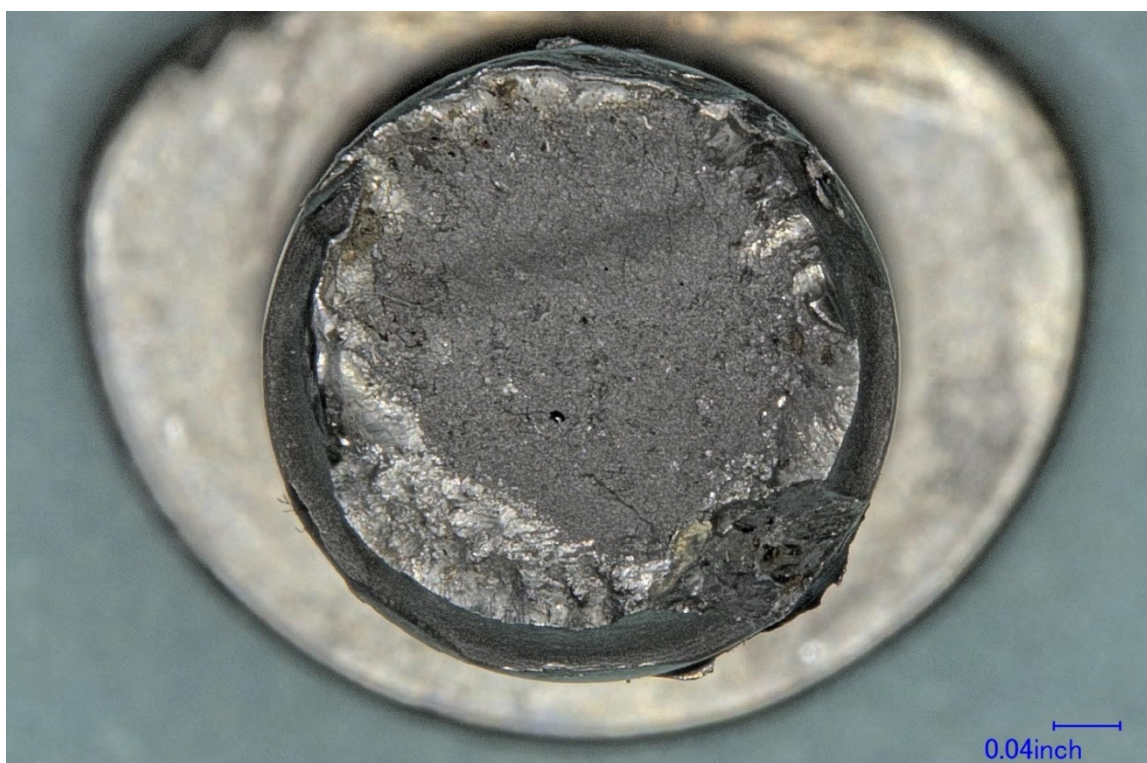
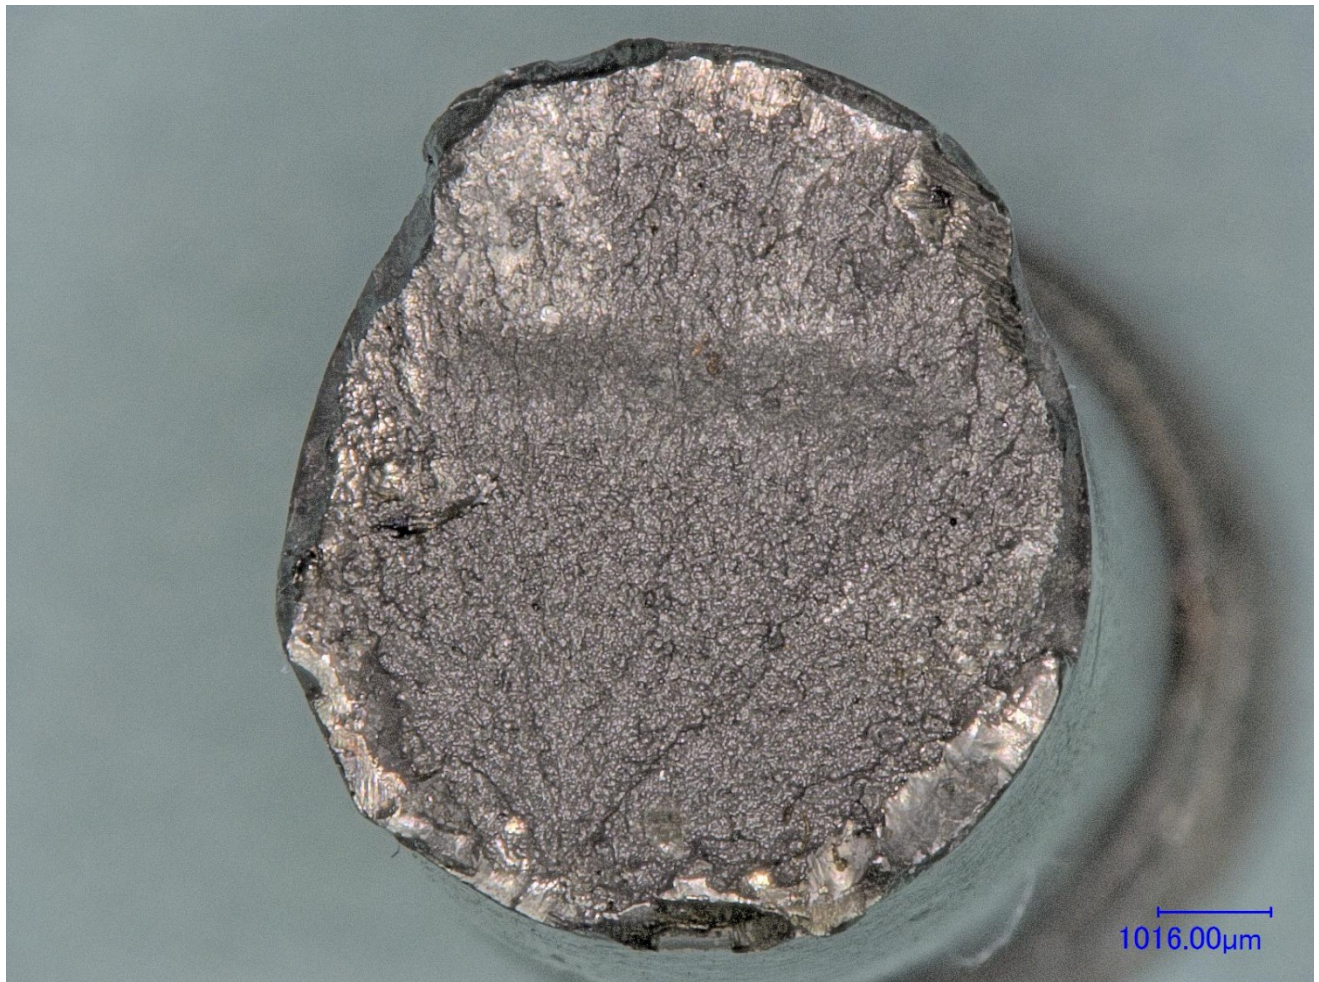
The mating fracture surfaces of the bolt shown in Figure 11 are highlighted in Figure 14 and Figure 15 from the head and nut sides, respectively. The upper fracture surface had been damaged consistent with post-fracture impact, but the lower mating fracture surface was relatively undamaged. This fracture surface exhibited two regions, one flatter and oriented perpendicular to the bolt direction, and an angled, protruding region. Flow lines ran from a damaged edge of the flatter portion towards the angled protruding region. Both regions exhibited a general dull luster and rough surface texture.

Figure 14 – View of the upper mating face of the bolt fracture surface.

Figure 15 – View of the lower mating fracture surface of the fractured attachment bolt.

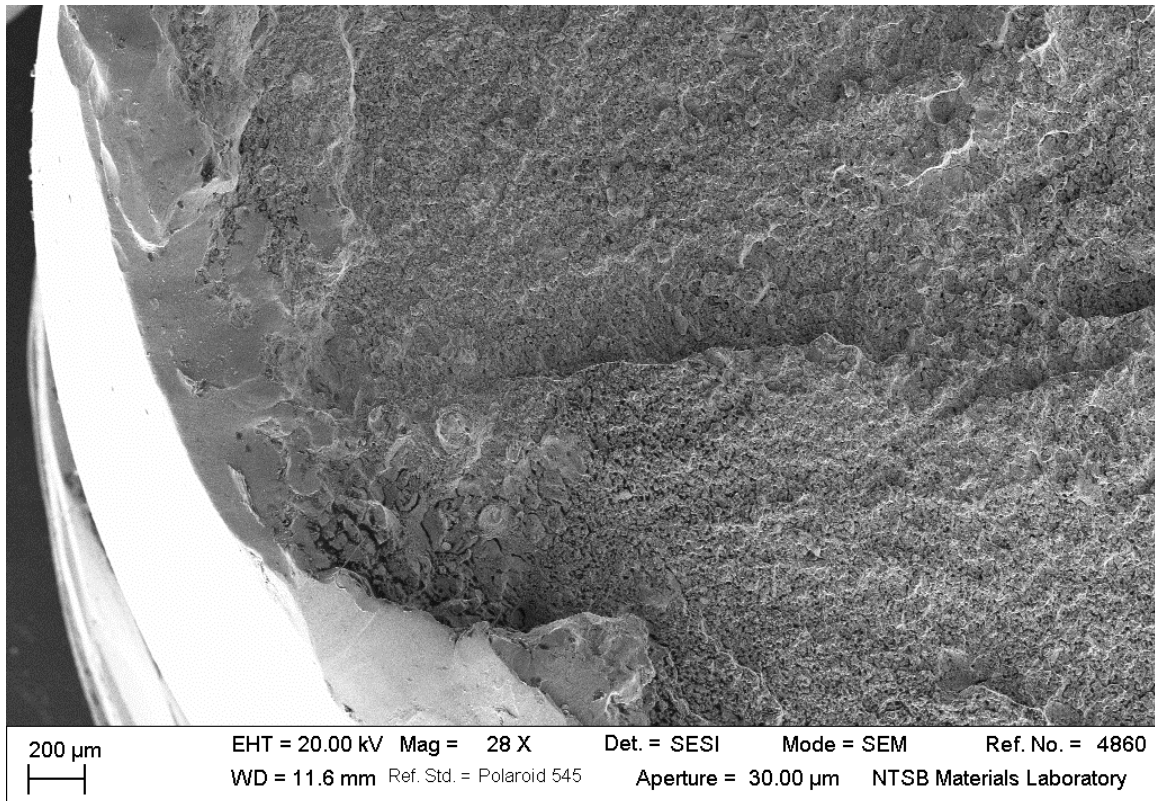
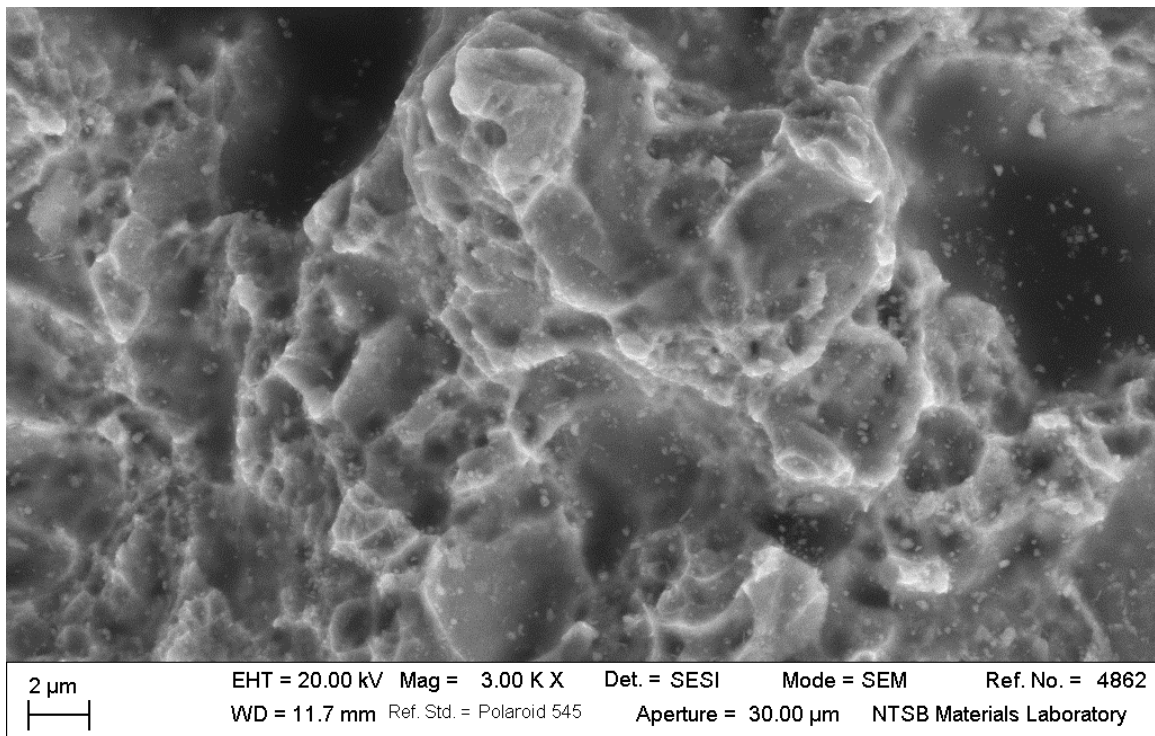
The bolt fracture surface was examined using a scanning electron microscope (SEM). Figure 16 shows the damaged edge on the flatter side, showing flow marks emanating from the edge. A closer view of the area revealed dimpled rupture, consistent with overstress fracture (see Figure 17). No features consistent with other fracture modes were found on the bolt. The features on the bolt fracture surface were consistent with overstress fracture in bending.

Figure 16 – Secondary electron (SE) micrograph of the beginning of the bolt fracture surface.

Figure 17 – SE micrograph of a closer view of the bolt fracture surface, showing dimpled rupture.

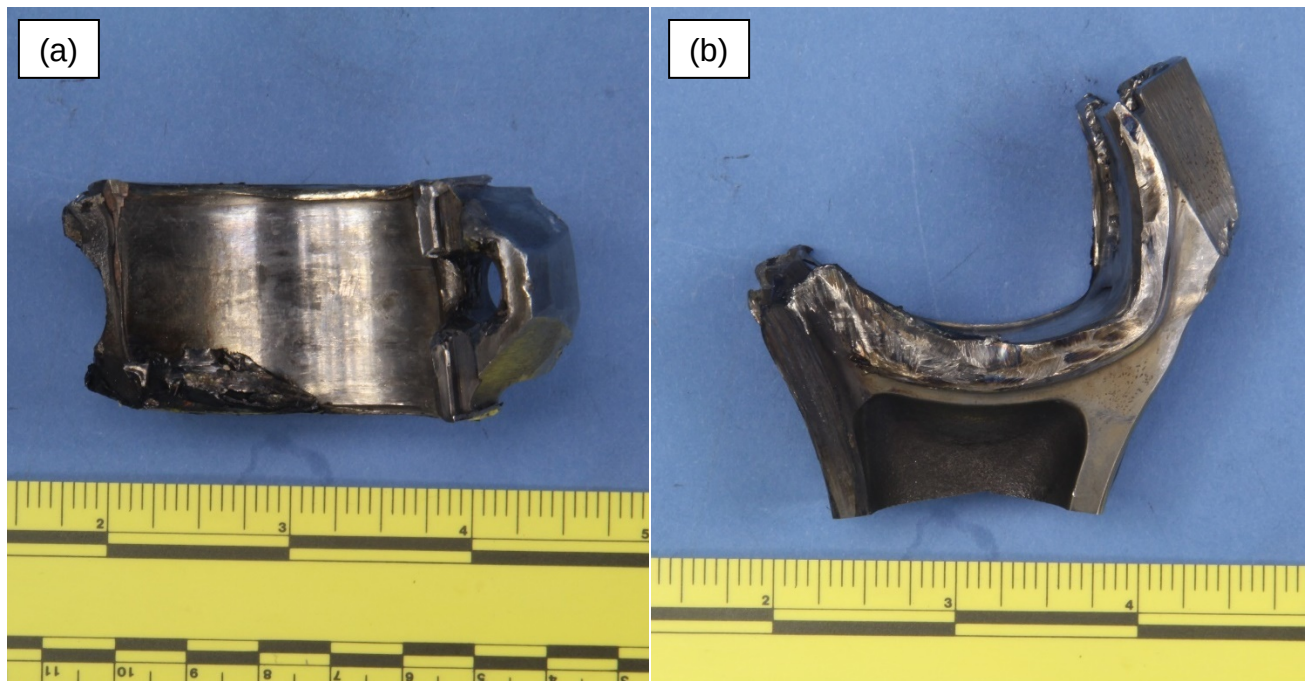
The #4 cylinder was disassembled, and the piston and connecting rod were removed. The bearing surface of the rod was sectioned 1.25 inches from the bearing surface using an abrasive saw. This rod section is highlighted in Figure 18 from the bearing surface and the side. As shown in Figure 18b, the rod yoke had fractured approximately 0.75 inches from the mating cap surface. The opposite yoke side, shown on the right in Figure 18b, exhibited some outward material deformation, consistent with inward bending of the side (towards the left in the figure).

Figure 18 – The sectioned #4 sectioned connecting rod crankshaft-side bearing surface, after sectioning and viewed from (a) the bearing surface and (b) the side.

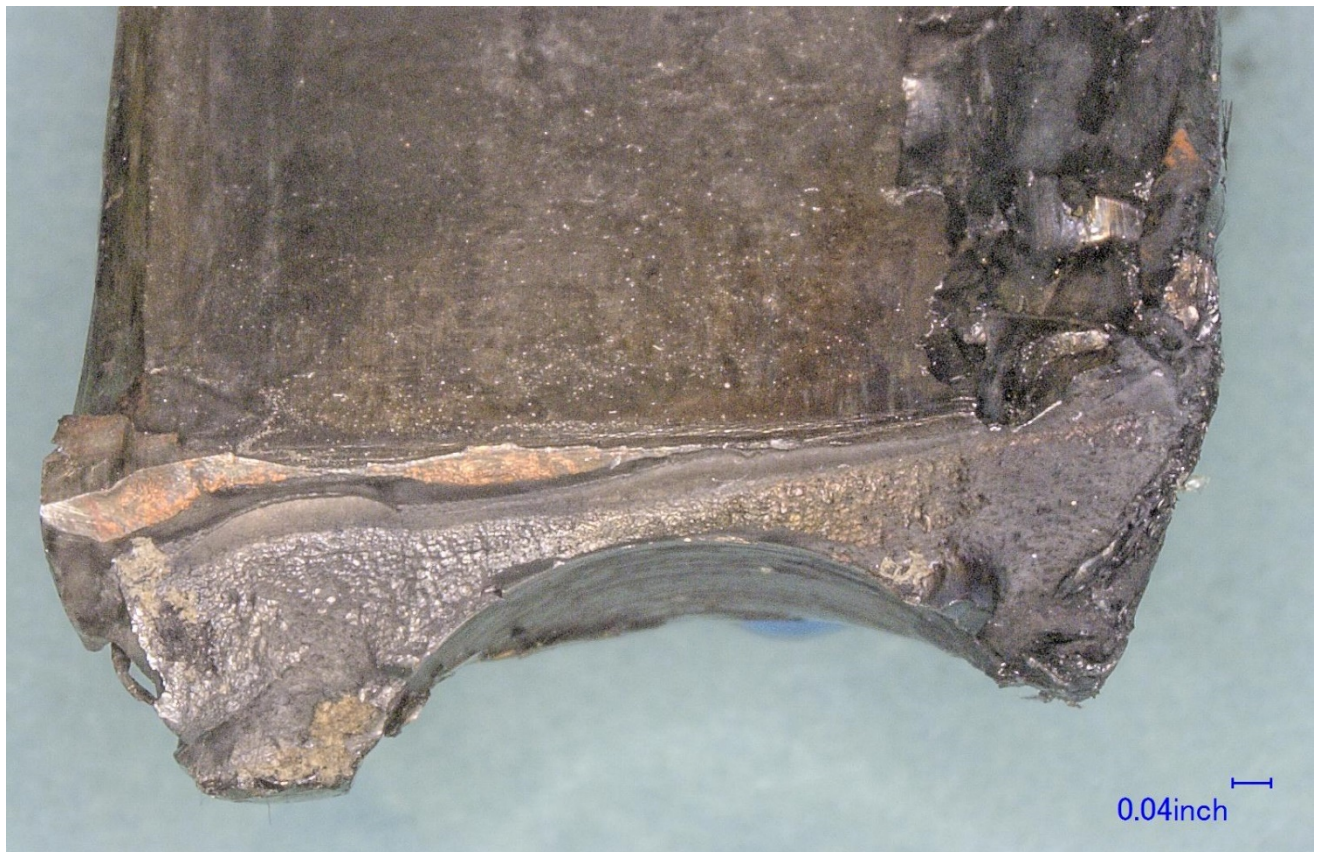
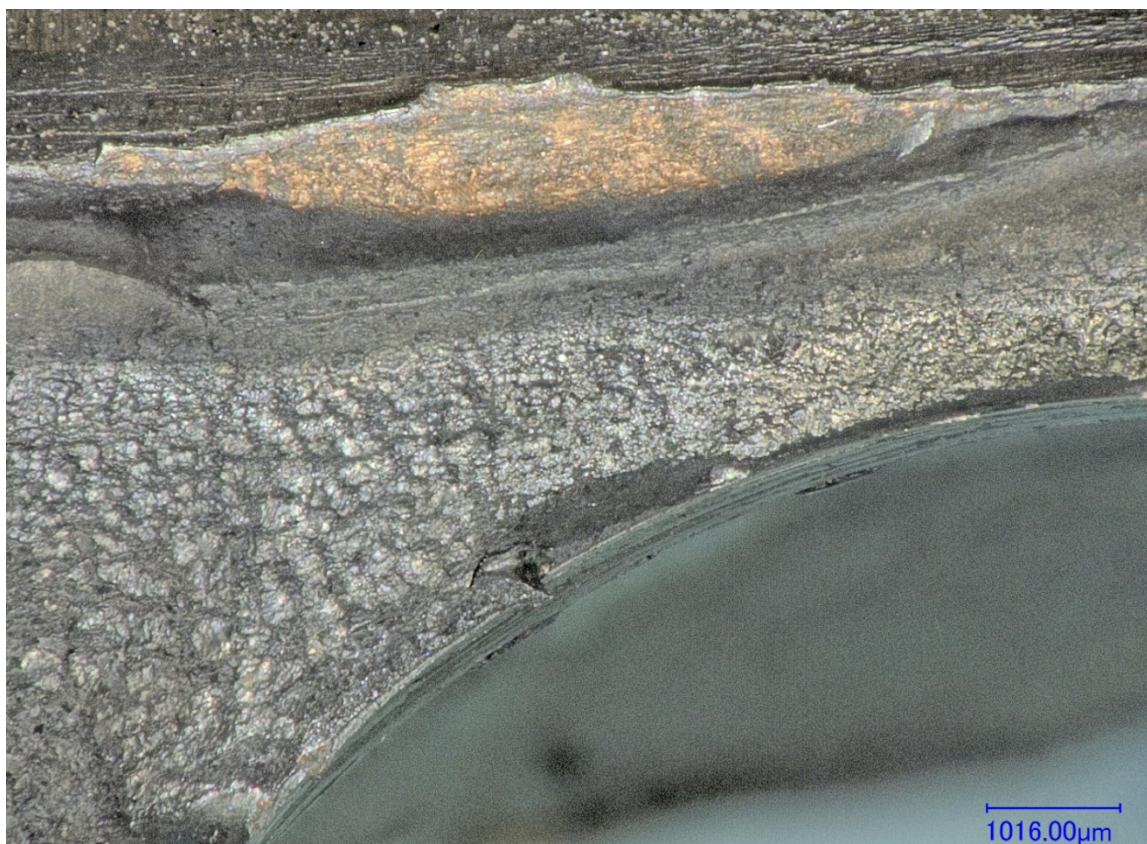
The fracture surface of the sectioned #4 rod is shown in Figure 19, after sectioning and cleaning using acetone. The fracture surface exhibited a banded morphology, with the bands parallel to the outer surface contour. The upper portion of the fracture surface was adjacent to protruding lips. The lower edge exhibited areas of blocky regions, with vertically oriented marks (see Figure 20). This area was examined using a SEM.

Figure 19 – View of the less damaged area of the fracture surface of the #4 connecting rod.

Figure 20 – Closer view of the #4 connecting rod surface in Figure 19.
