# NATIONAL TRANSPORTATION SAFETY BOARD

## MATERIALS LABORATORY FACTUAL REPORT

Report No. 20-022

Place : Waterloo, Illinois  
Date : March 12, 2019  
Vehicle : Piper PA-32R-300, N750R  
NTSB No. : CEN19LA098  
Investigator : Tim Sorensen, AS-CEN

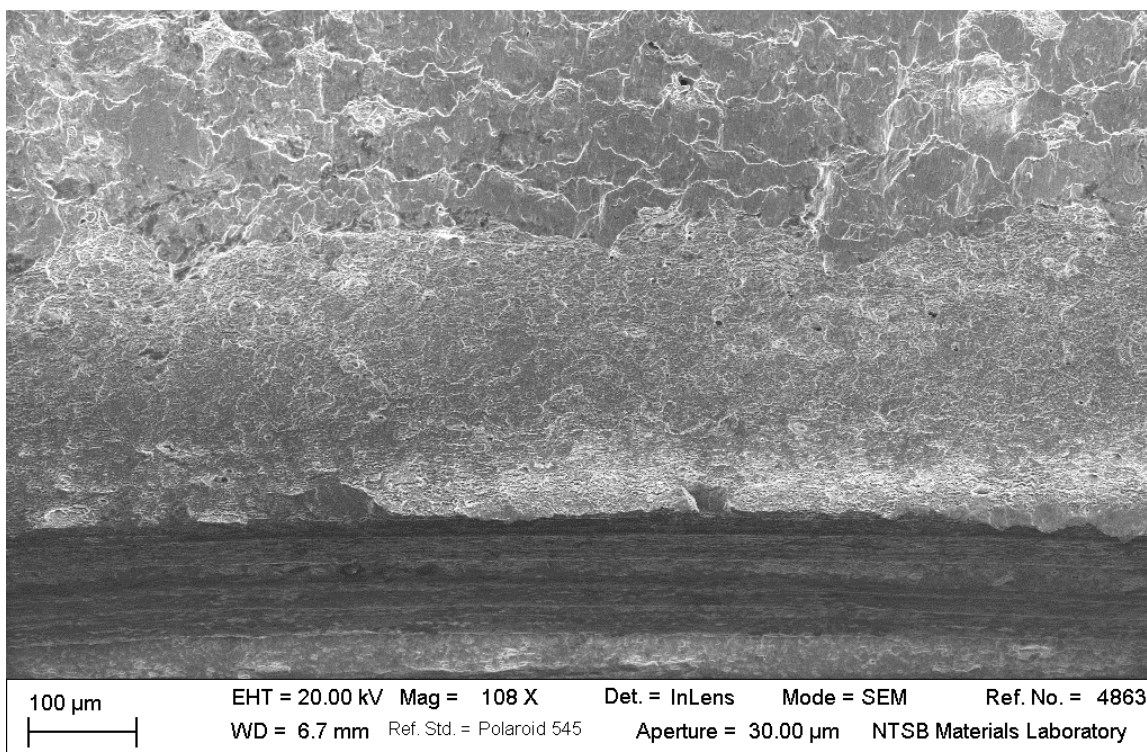
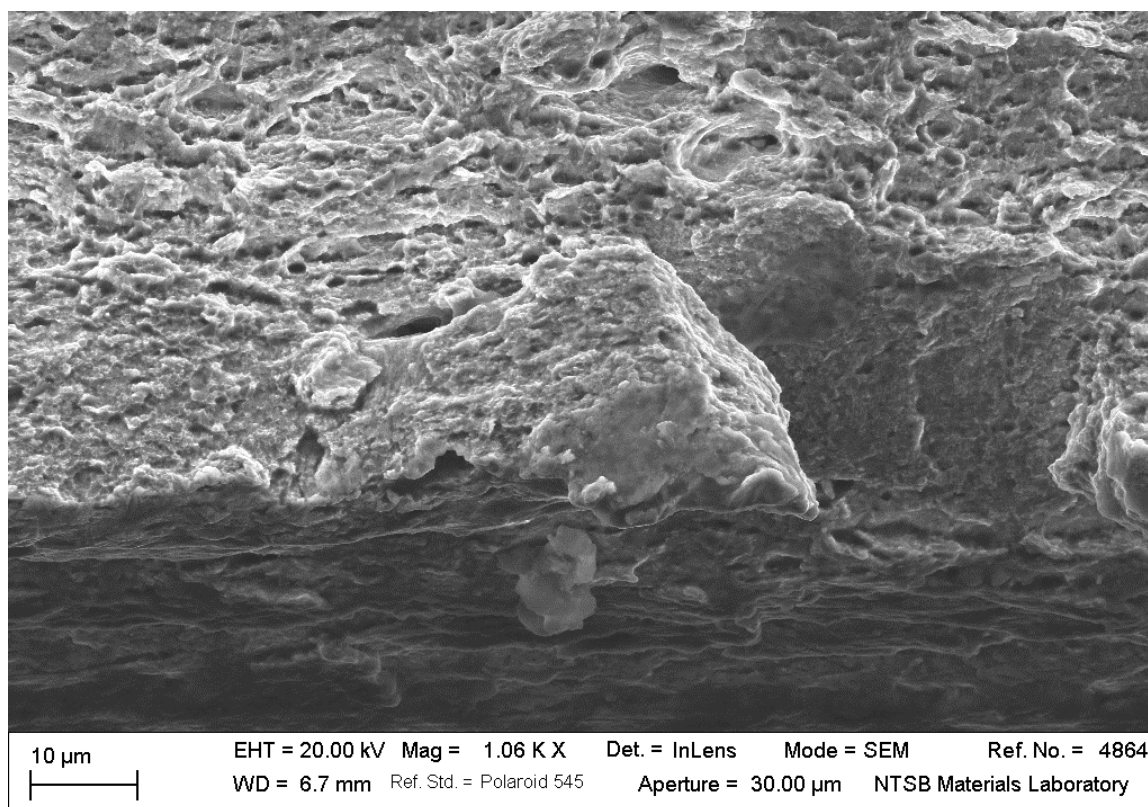
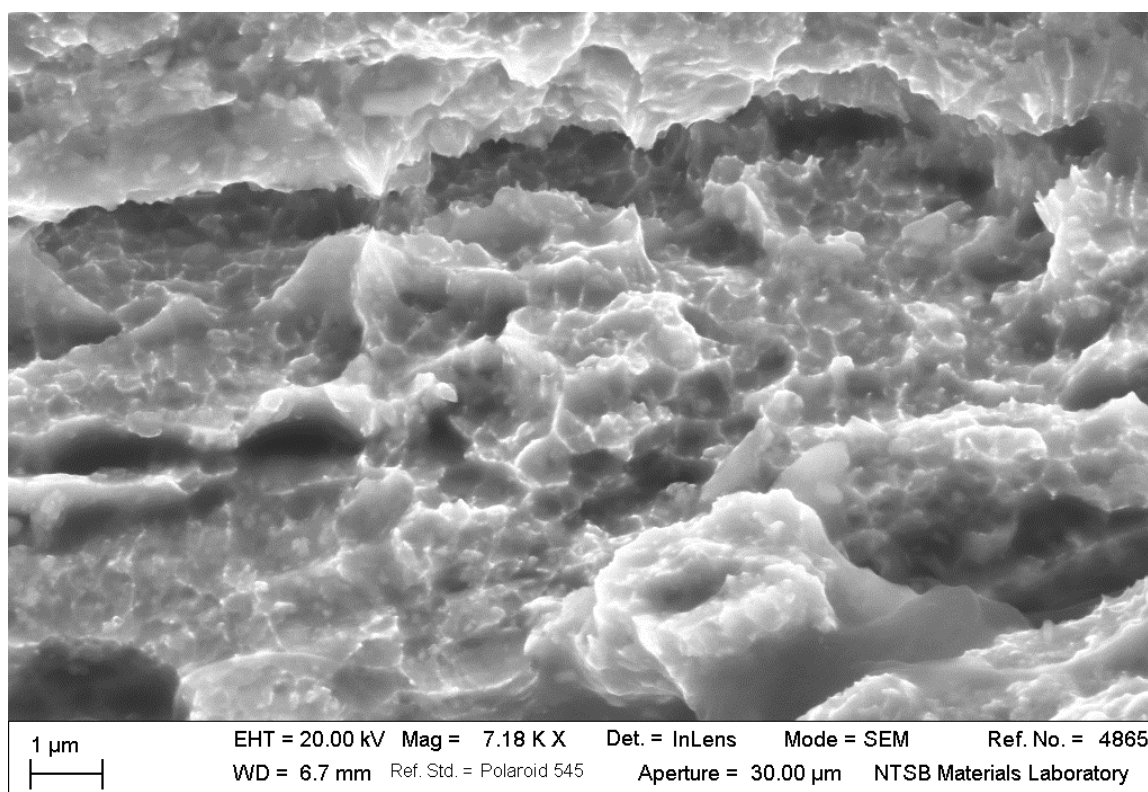
Figure 21 shows the edge of the rod fracture surface, revealing a generally rough texture, along with an upward-oriented mottled region in the upper half of the figure. A closer view of the blocky area along the edge revealed it to be an area of missing material (Figure 22). Repeating horizontally tears were present, oriented parallel to the outer rod surface contour. A closer view of this area, shown in Figure 23, revealed dimpled rupture, consistent with overstress fracture. No features consistent with other fracture modes were found in this area of the fracture surface.

Figure 21 – SE micrograph of a portion of the #4 rod fracture surface edge.

Figure 22 – SE micrograph of a closer view of the stepped edge in Figure 21.

Figure 23 – SE micrograph of edge dimpled rupture of the #4 rod fracture surface.

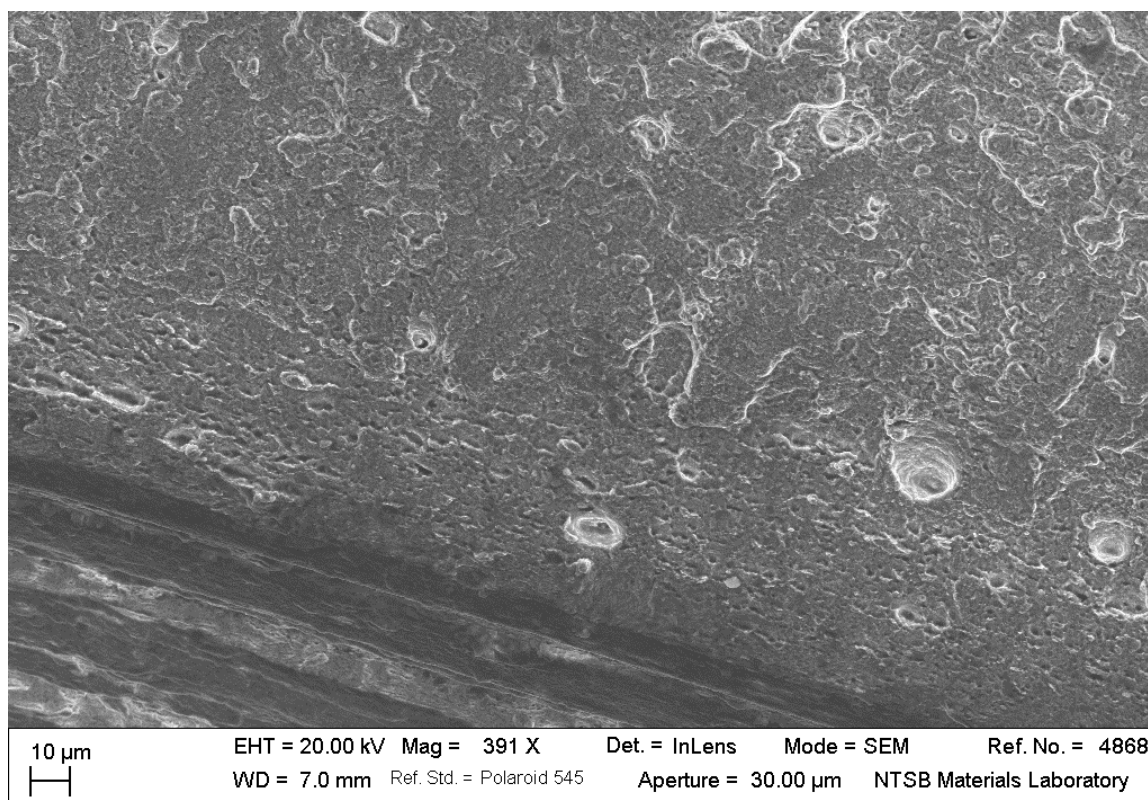
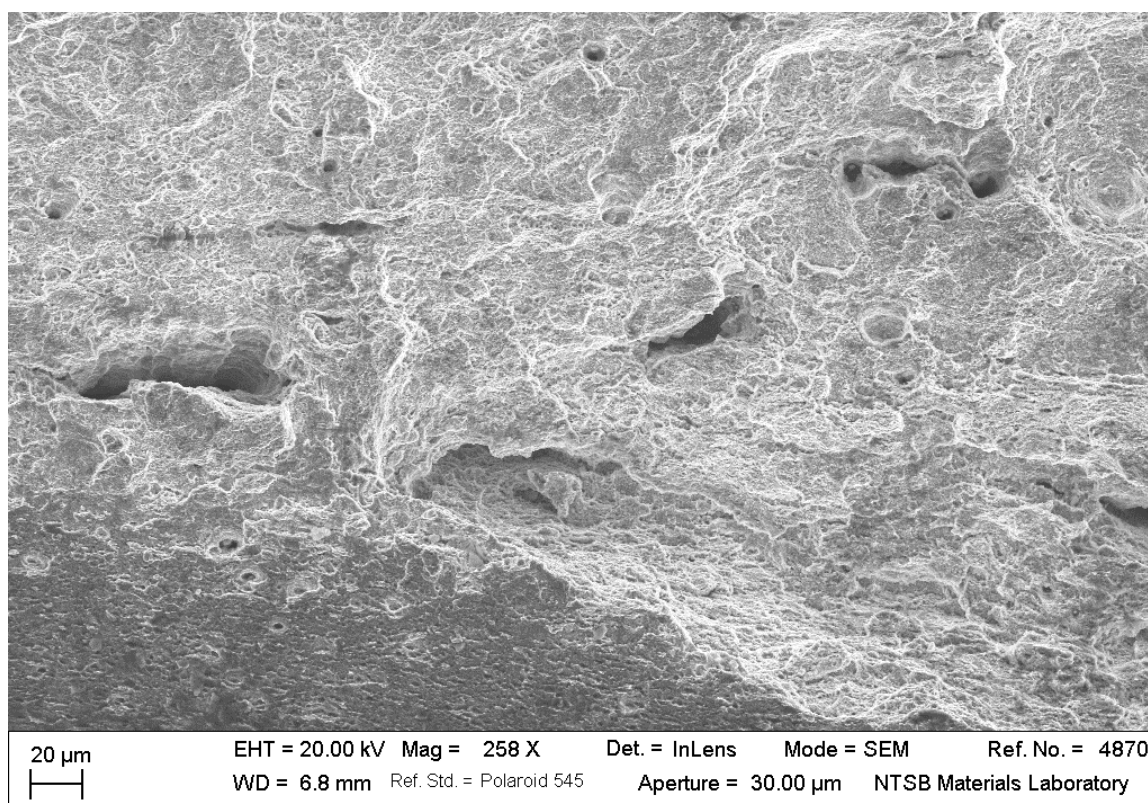
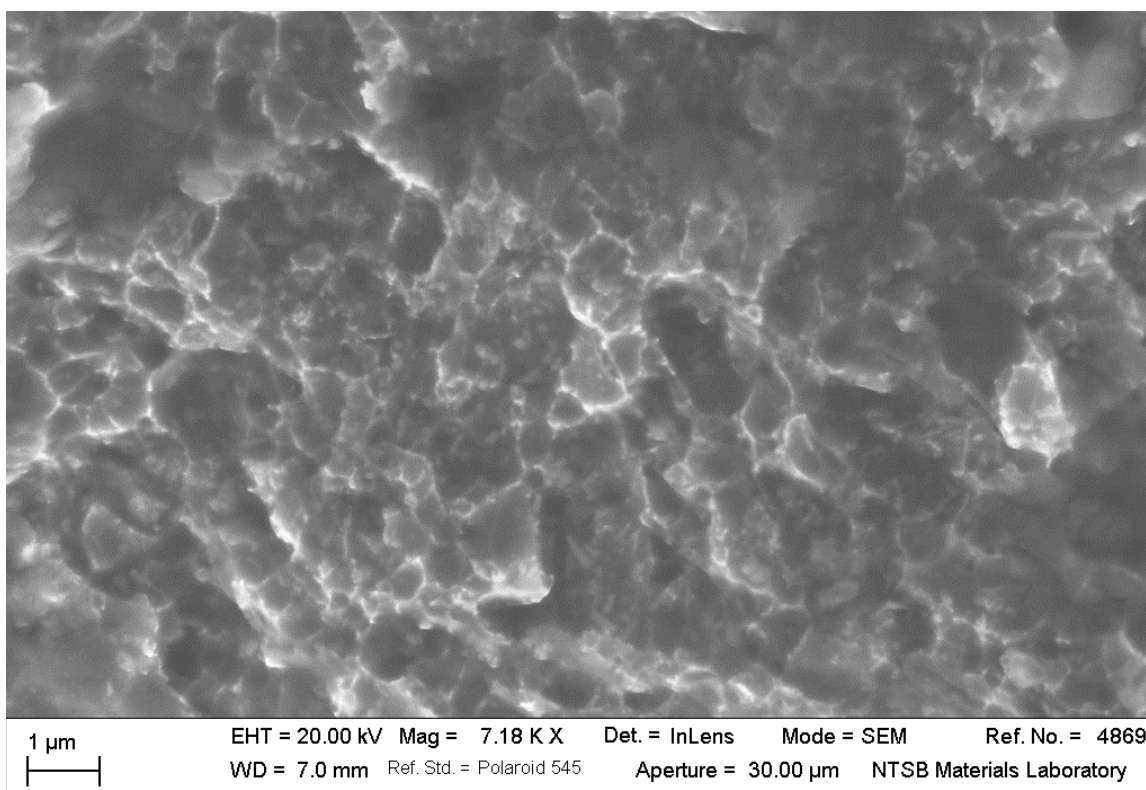
The right side of the fracture surface in Figure 19 was examined using a SEM and is shown in Figure 24. The surface exhibited multiple divots or depressions in the fracture surface. As shown in Figure 25, a closer view of this divots revealed them to be ovoid-shaped tears perpendicular to the fracture surface. The only fracture feature observed in this area was dimpled rupture, as typified in Figure 26.

Figure 24 – SE micrograph of the other side of the #4 rod fracture surface.

Figure 25 – SE micrograph of divot-shaped tears in the #4 rod fracture surface.

Figure 26 – SE micrograph of dimpled rupture in Figure 25.

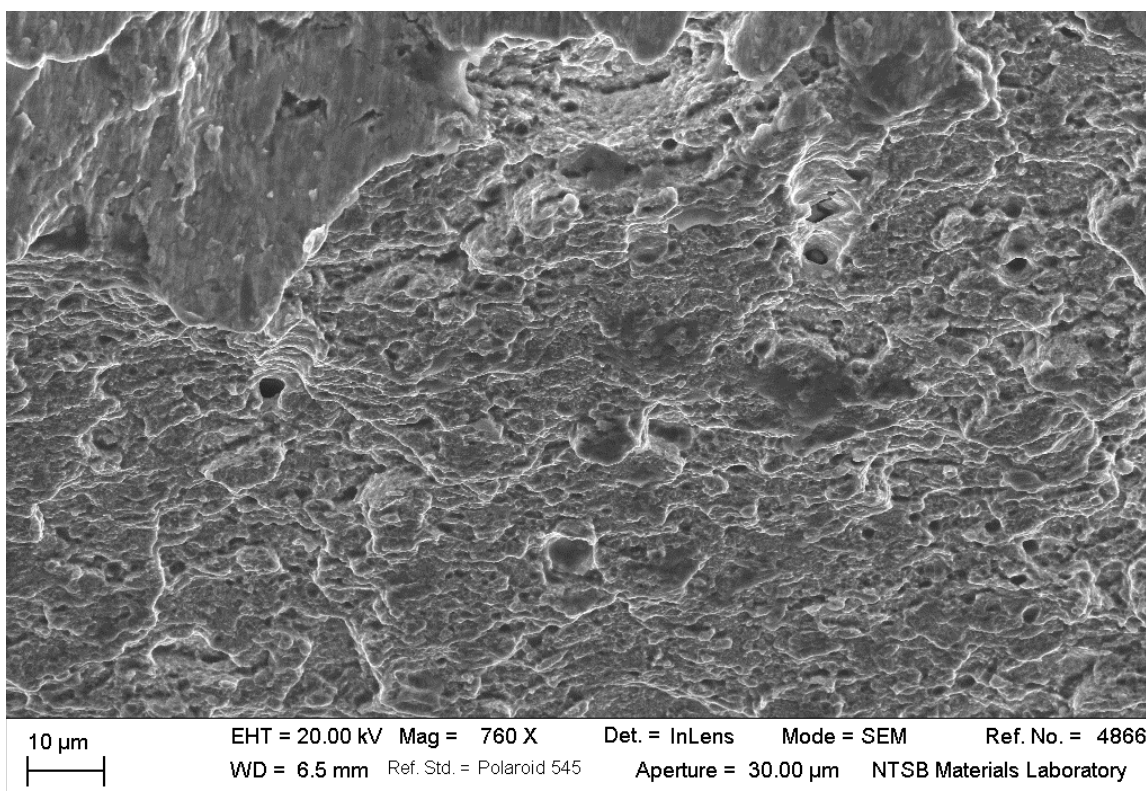
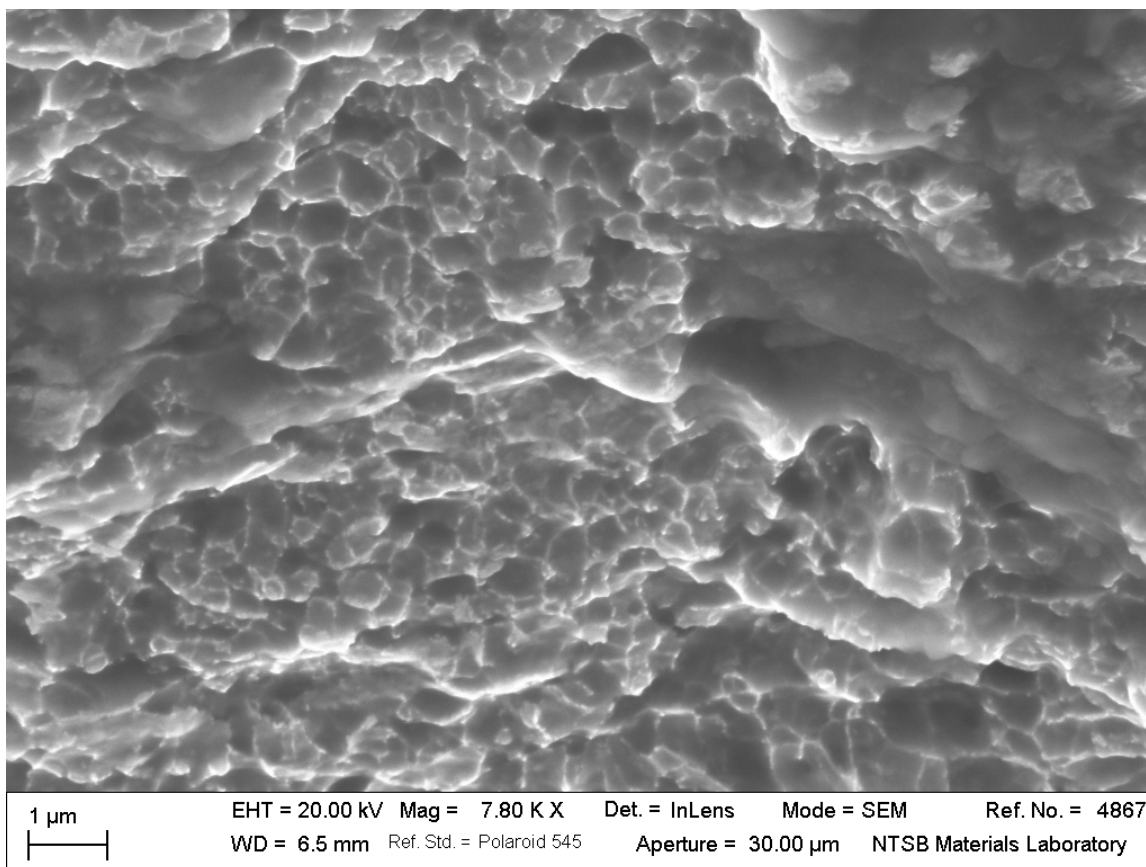
The upper portion of the undamaged rod fracture surface near the protruding lip was examined, as shown in Figure 27. This region exhibited similar characteristics as those examined closer to the exterior edge of the fracture surface. Examination of this portion of the fracture surface revealed dimpled rupture, as typified in Figure 28. No other features consistent with other fracture modes or pre-existing defects were found on the undamaged fracture surfaces of the #4 connecting rod or cap remnants. All other surfaces had been obliterated by post-fracture damage.

Figure 27 – SE micrograph of the innermost part of the #4 rod fracture surface.

Figure 28 – SE micrograph showing a closer view of dimpled rupture from Figure 27.
