# NATIONAL TRANSPORTATION SAFETY BOARD

## MATERIALS LABORATORY FACTUAL REPORT

Report No. 19-040

Place : Sheldon, Missouri  
Date : April 26, 2019  
Vehicle : Beech E50  
NTSB No. : CEN19LA127  
Investigator : Mike Hodges, AS--CEN

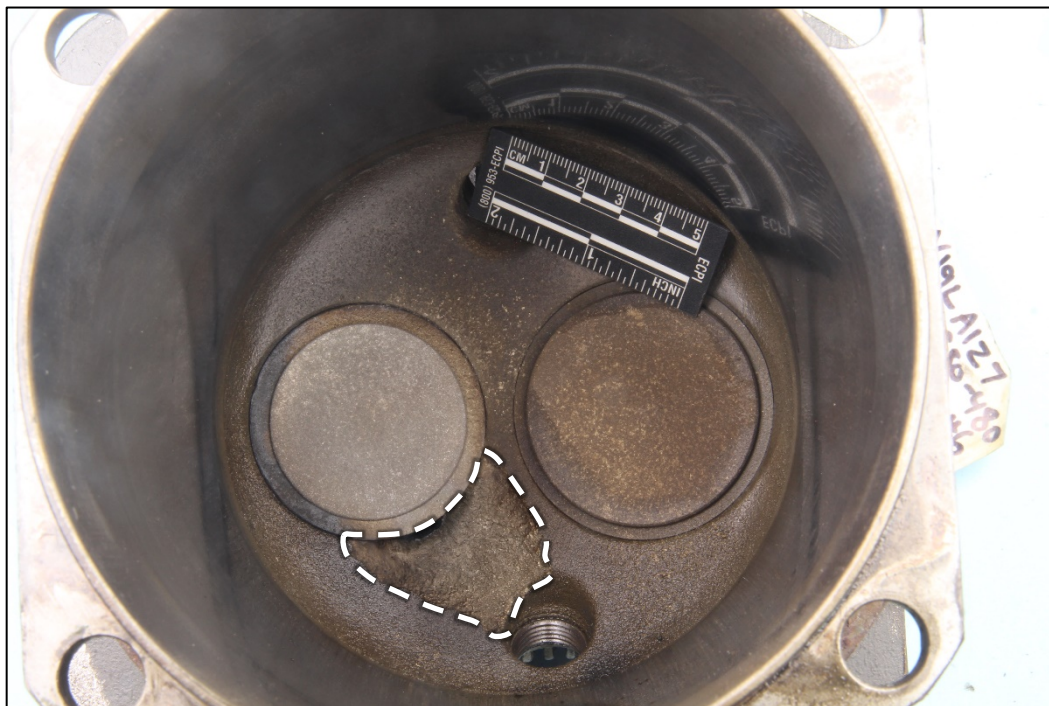
An overall view of the submitted components is shown in figure 1. The components were from each of the two Lycoming GSO-480 engines installed on the accident airplane. The cylinder head on each of the submitted cylinder assemblies had similar damage with material fractured and missing from the head between the exhaust valve and one of the spark plug ports. Photographs of the interior of the cylinders are shown in figures 2 and 3, and the damaged area is outlined with a dashed line. Material was also fractured and missing from the side of the number 4 piston assembly from the left engine as shown in figure 4, and a dashed line in figure 4 outlines the area of damage. The piston compression rings and oil rings were also fractured, and pieces were missing. The damage to the piston and cylinder assemblies was consistent with detonation damage.

Figure 2. Interior of the number 6 cylinder assembly from the left engine. A dashed line indicates an area of missing cylinder head material between the exhaust valve and one of the spark plug ports.

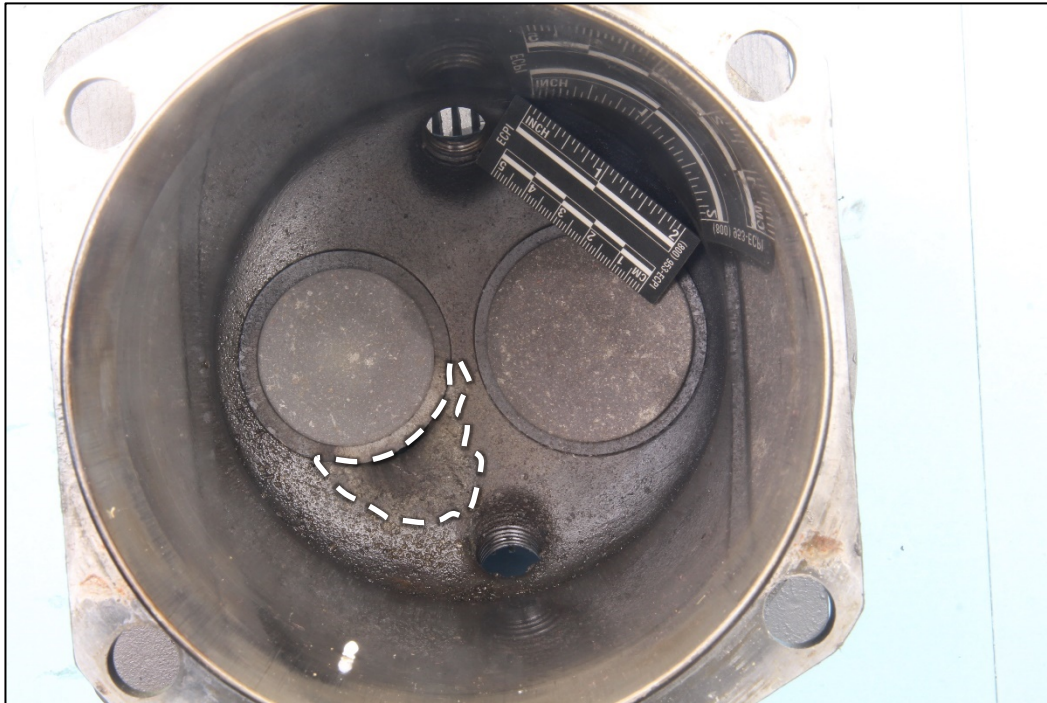
Figure 3. Interior of the number 2 cylinder assembly from the right engine. A dashed line indicates an area of missing cylinder head material between the exhaust valve and one of the spark plug ports.

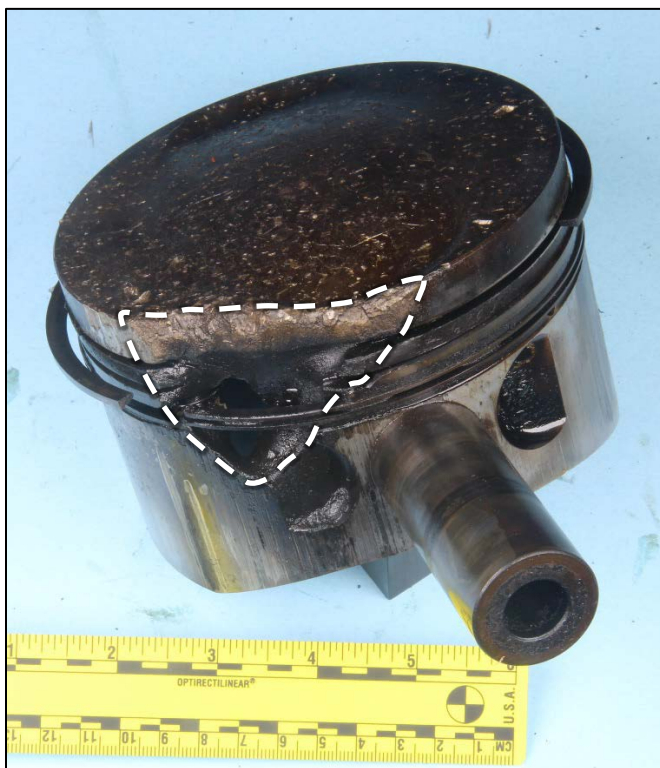
Figure 4. Number 4 piston assembly from the left engine. A dashed line indicates an area of missing piston material and fractured piston rings.

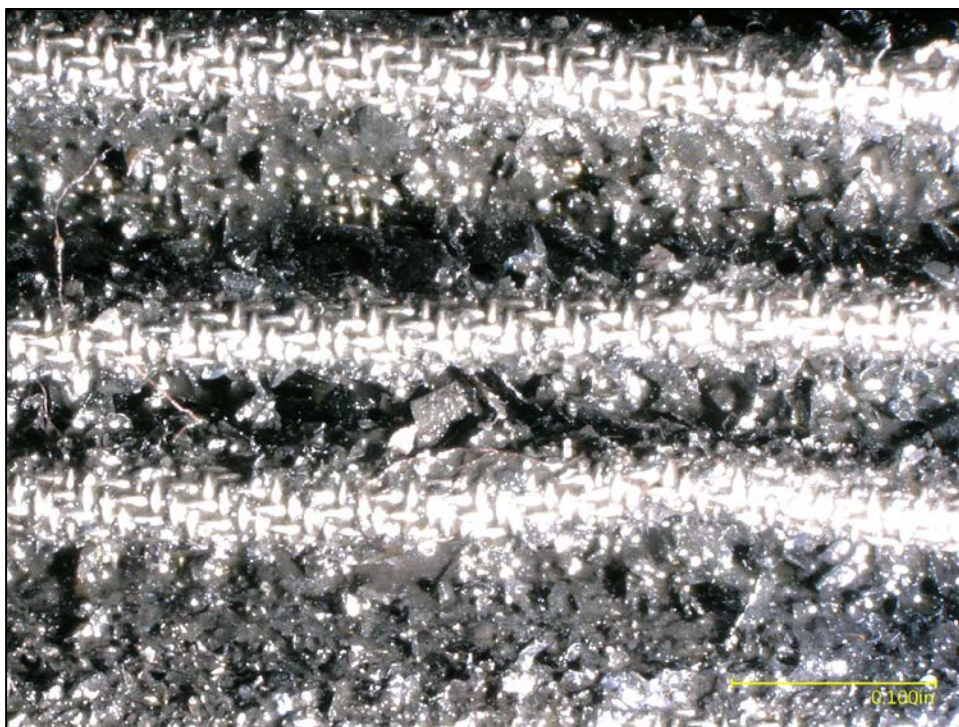
Oil-covered particles were observed in the grooves of the oil screens from the left and right engines. A close view of the oil screen from the left engine is shown in figure 5 and is representative of debris observed in both the left and right oil screens. Particles were removed from each oil screen using a scalpel while viewed under an optical stereomicroscope. The particles were mostly oil-covered thin flakes with angular edges. A view of several typical particles removed from the left engine oil screen is shown in figure 6 where unlabeled arrows indicate the oil-covered particles. A sample of particles from each oil screen was placed into respective beakers of acetone and then placed in an ultrasonic cleaner. After cleaning, the particles had broken into smaller pieces. The particles were dried and placed onto carbon-coated aluminum stubs for analysis using energy-dispersive x-ray spectroscopy (EDS) in a scanning electron microscope. Approximately 6 particles from each oil screen sample were analyzed. Particles from both oil screens had EDS spectra with high peaks of carbon, oxygen, bromine, and lead and a relatively small peak of iron. A peak of aluminum was also detected on the largest

Figure 5. Close view of particles in the oil screen from the left engine.

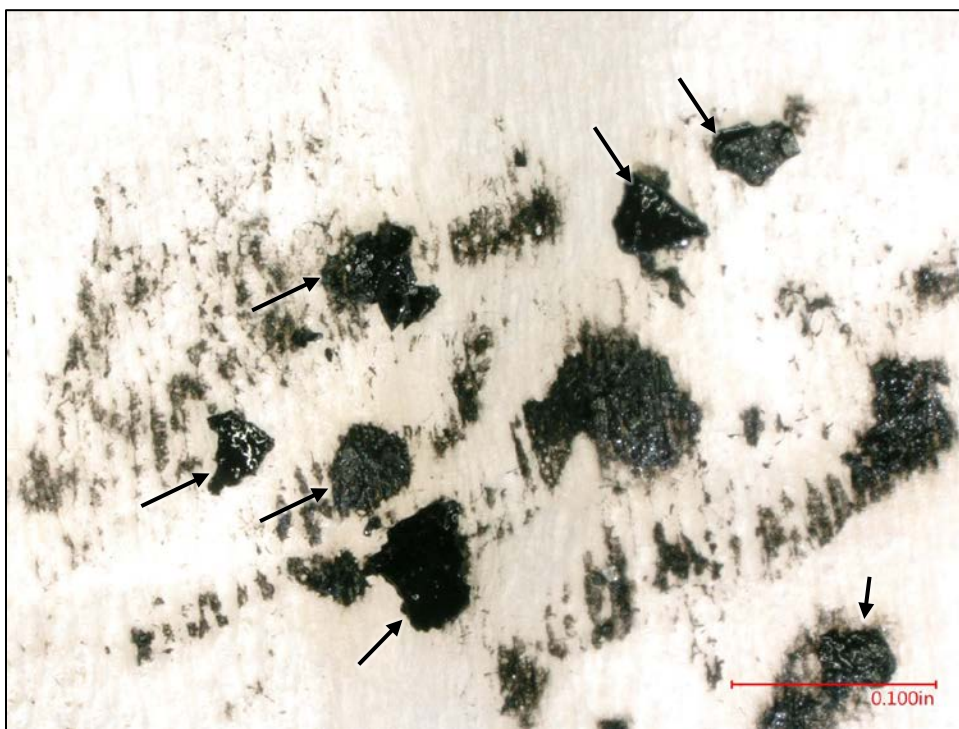
particle analyzed from the left engine. One of the particles from the right engine had relatively small peaks of chromium and nickel.

Figure 6. Sample of particles removed with a scalpel from the left engine oil screen and placed on white paper. Unlabeled arrows indicate particles.
