## N233P Apache – Aircraft Damages Photo Sheet:

**Aircraft:** 1956 Apache

**File #:** AC-19-10311

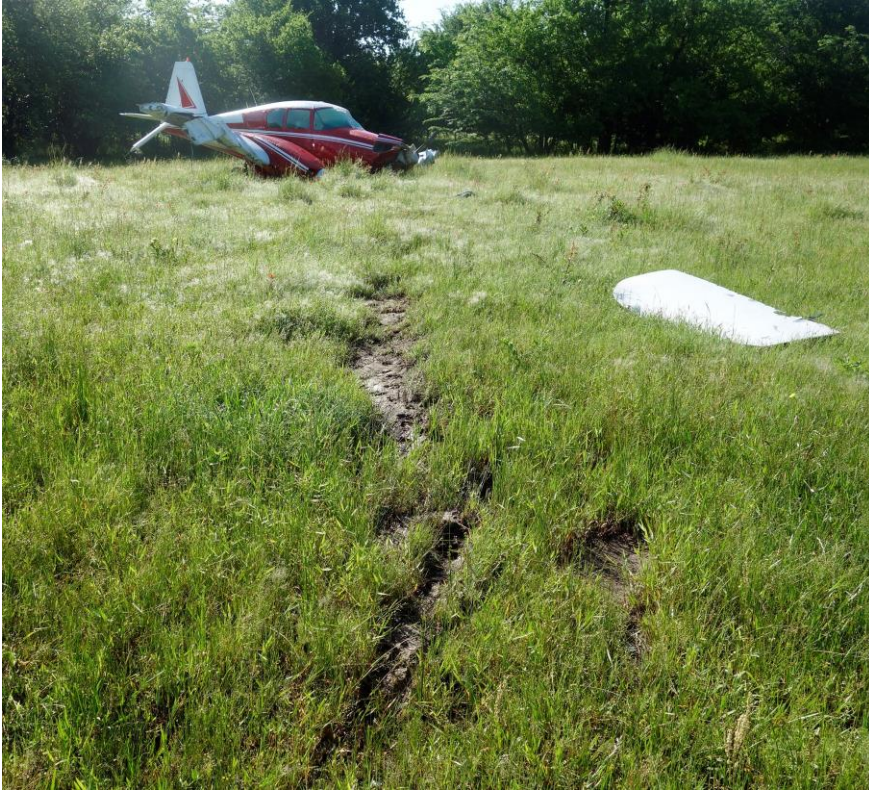
**Picture No:** 1

**Description:** Aircraft crashed in a field near Sulphur Springs, TX. 33.1931N 95.6113W

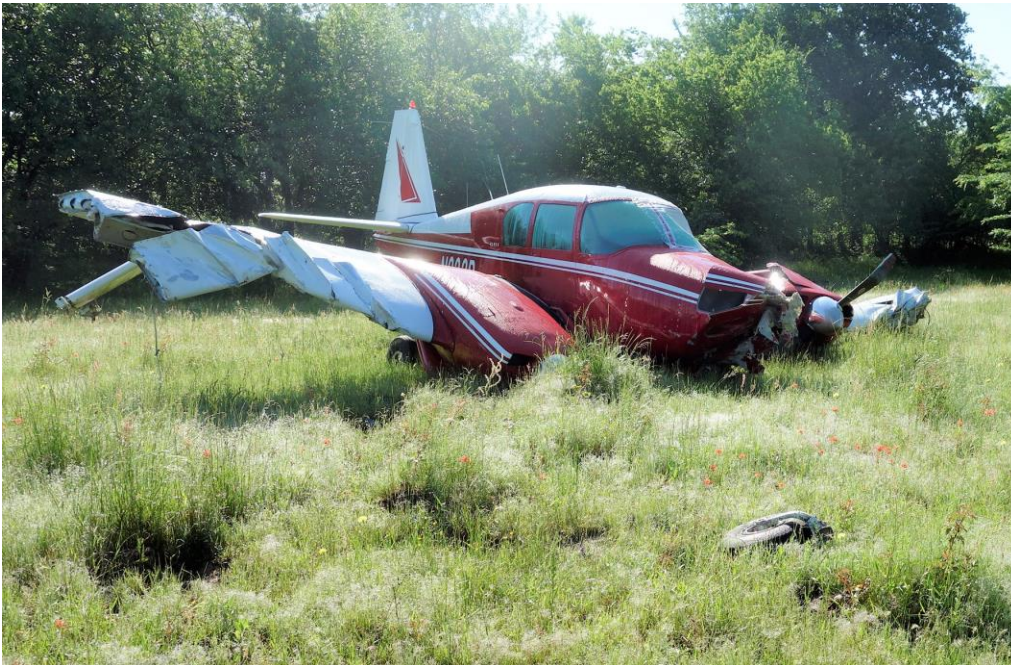
**Picture No:** 2

**Description:** Front right view right wing and right engine is damaged. Aircraft nose wheel has broken free.

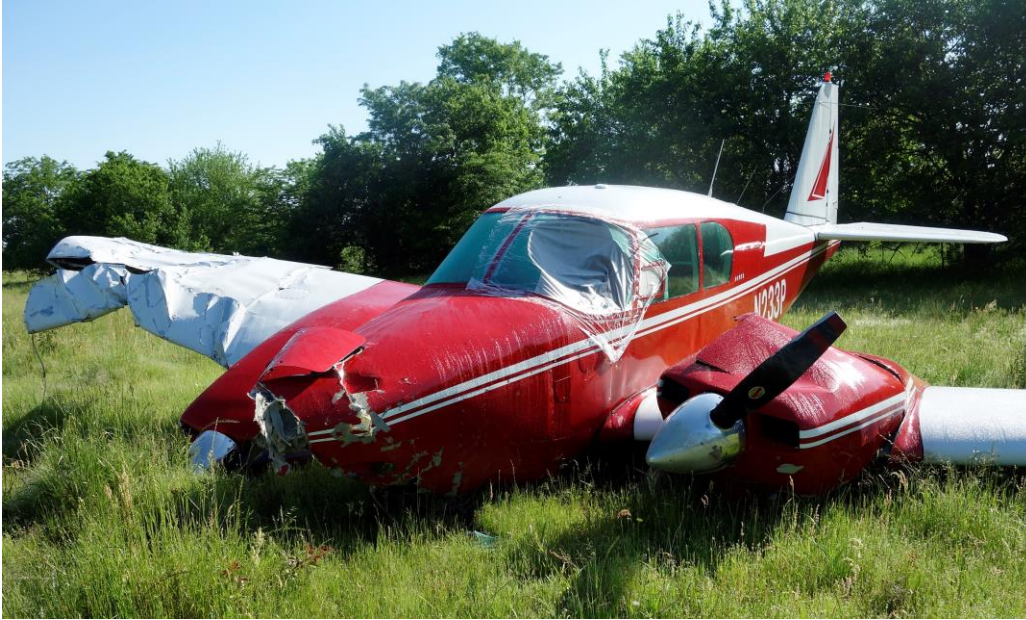
**Picture No:** 3

**Description:** Front left view. Pilot windscreen was kicked out by pilot. Visible damage to propeller and engine.

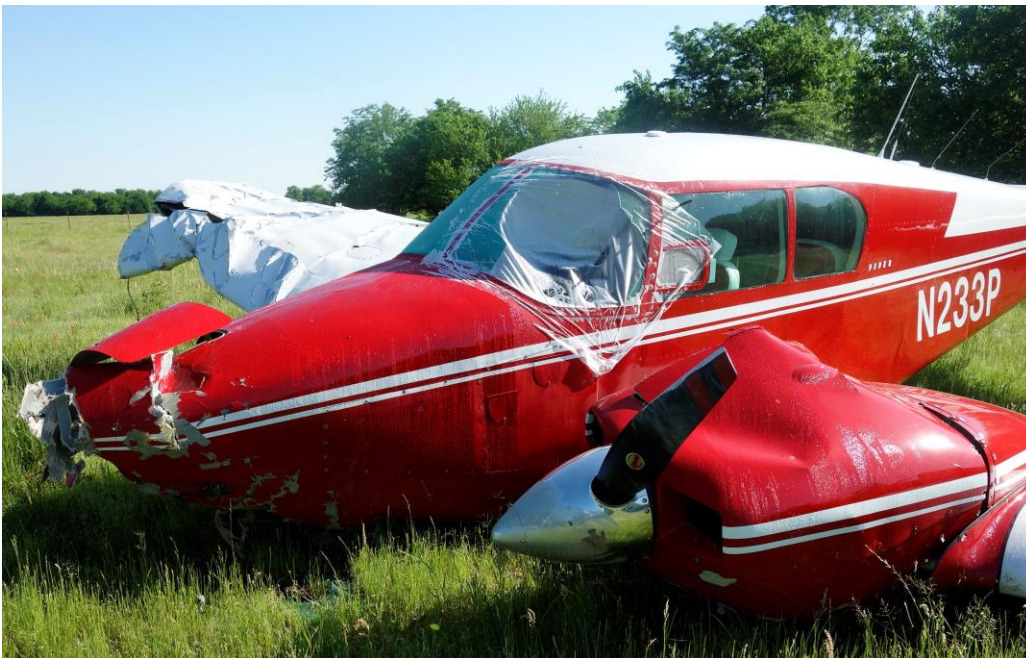
**Picture No:** 4

**Description:** Significant damage to the left engine mount. Propeller blades are bent from contact with ground. Left main mount has collapsed.

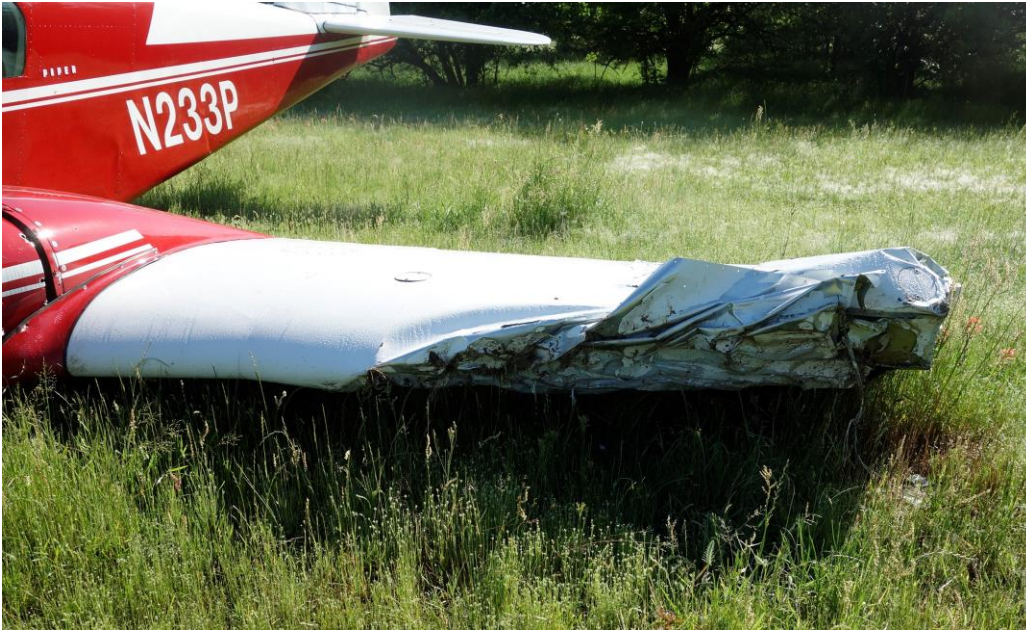
**Picture No:** 5

**Description:** Left wing leading edge is destroyed.

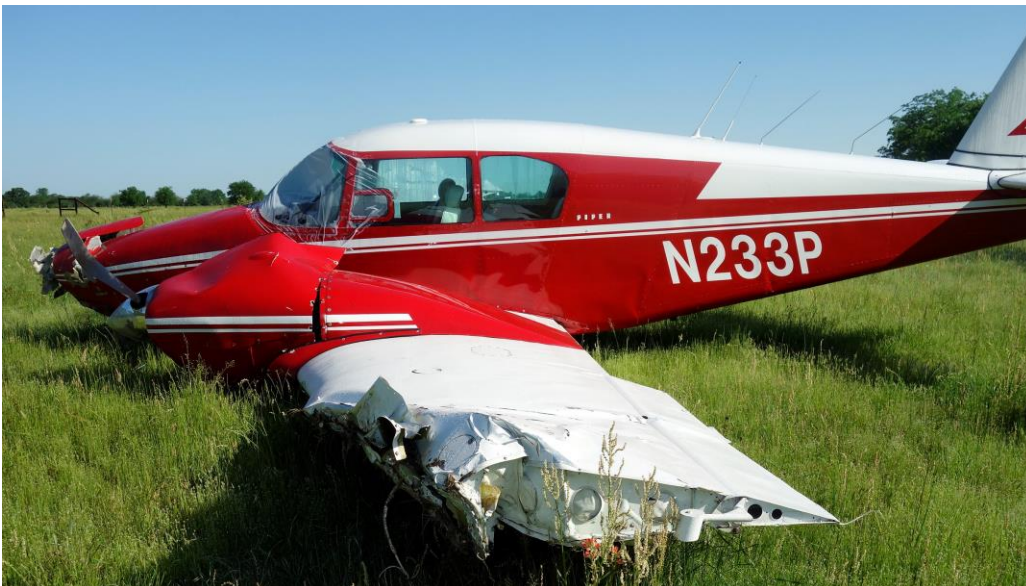
**Picture No:** 6

**Description:** View of left side. Wing tip was torn free.

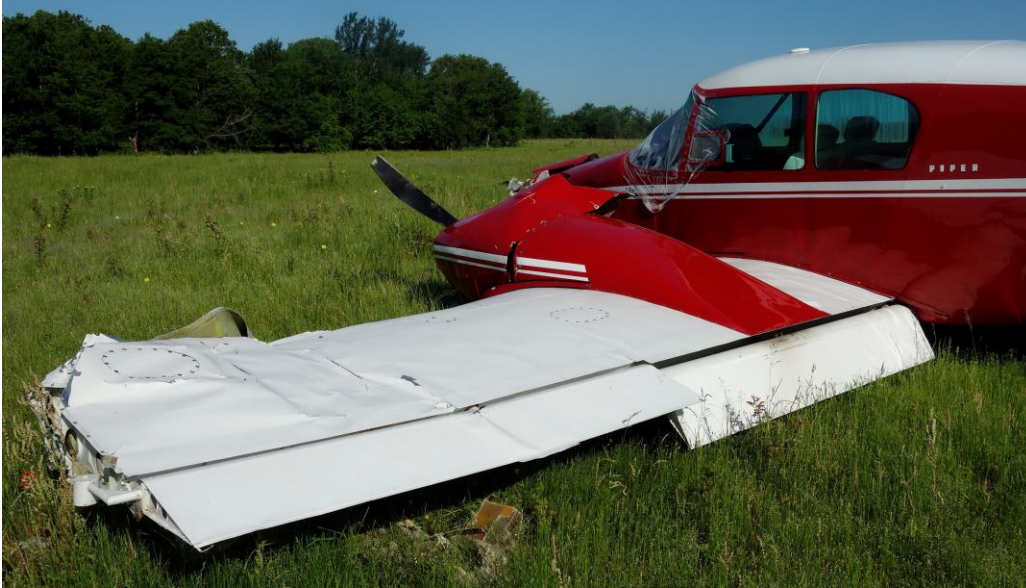
**Picture No:** 7

**Description:** Left flap is bent/damaged.

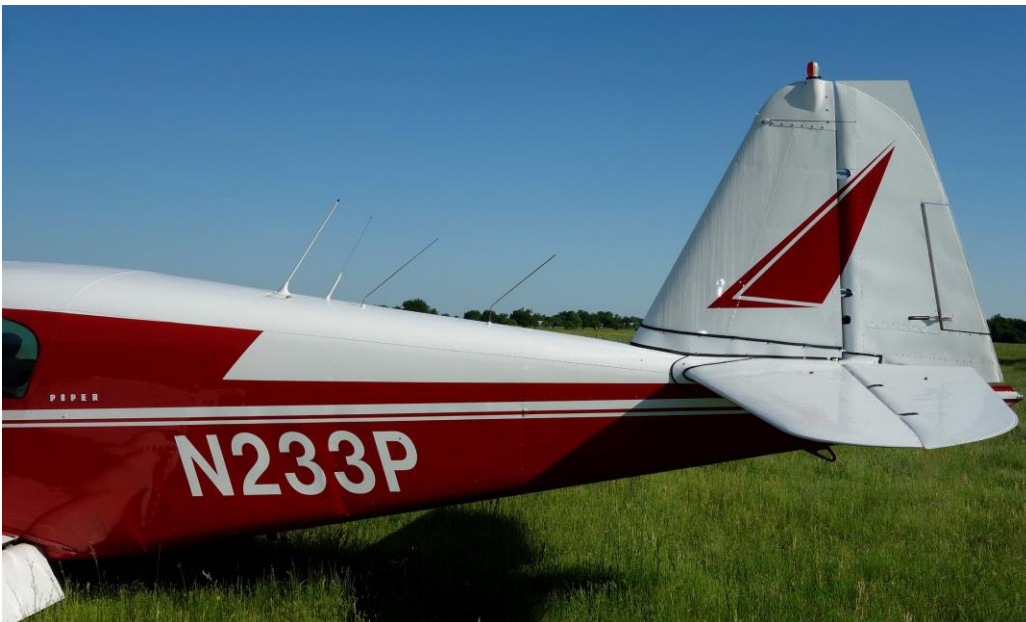
**Picture No:** 8

**Description:** Left aft view, tail does not appear to have damage.

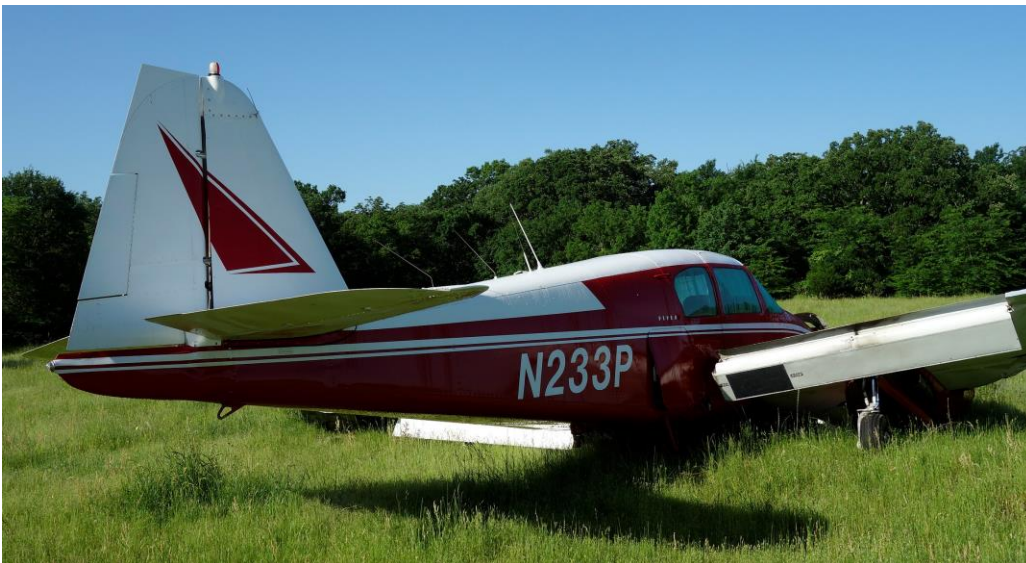
**Picture No:** 10

**Description:** Aircraft right rear quarter. Damage to right wing, right landing gear is torn loose from mount.

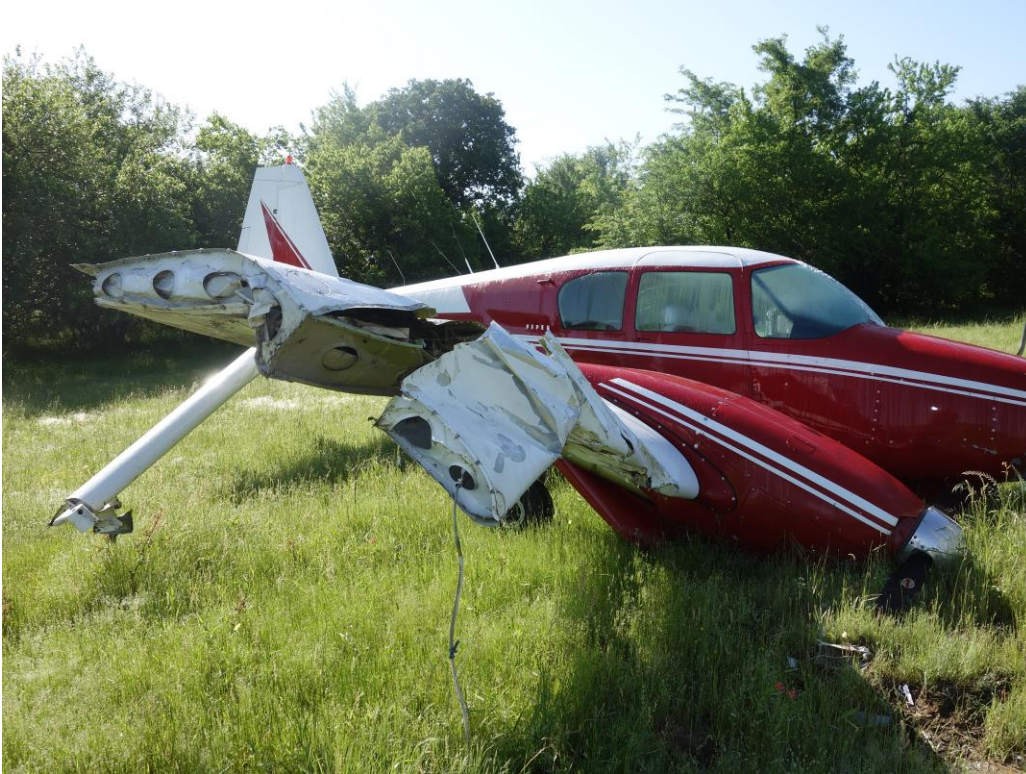
**Picture No:** 11

**Description:** Right wing is destroyed. Aileron is torn loose, leading edge is crushed, engine mount is bent down and aft.

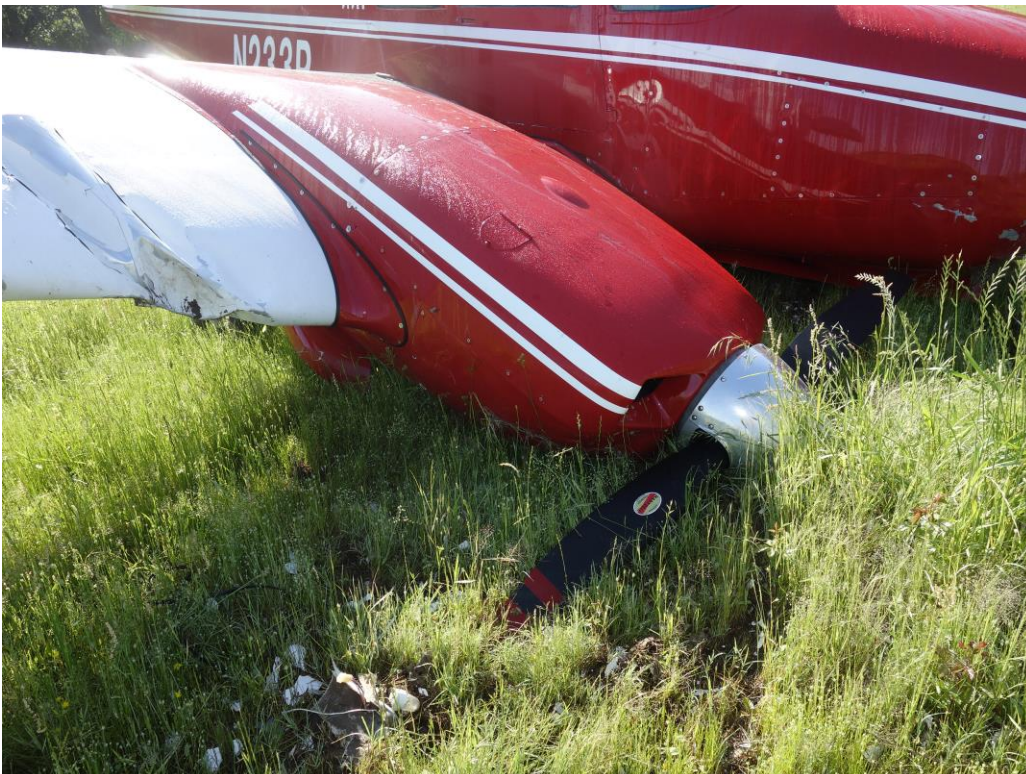
**Picture No:** 12

**Description:** Right propeller could be intact as a result of propeller position being perpendicular to the ground when the engine seized.

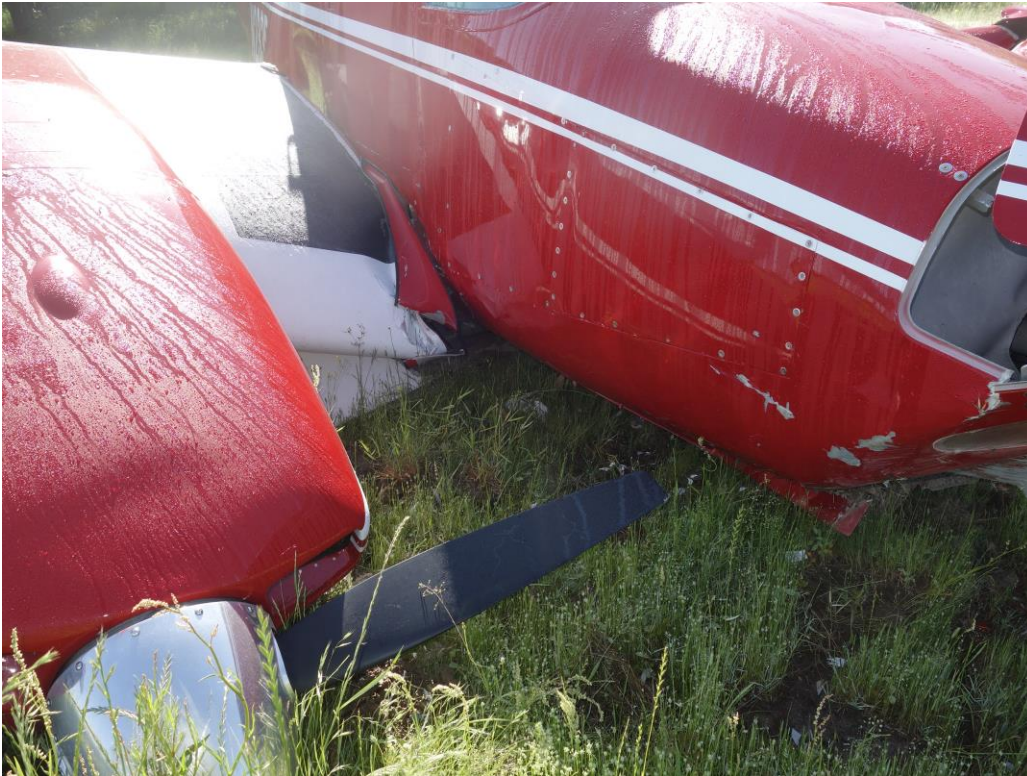
**Picture No:** 13

**Description:** right front view  
nose structure shows impact  
crush damage.

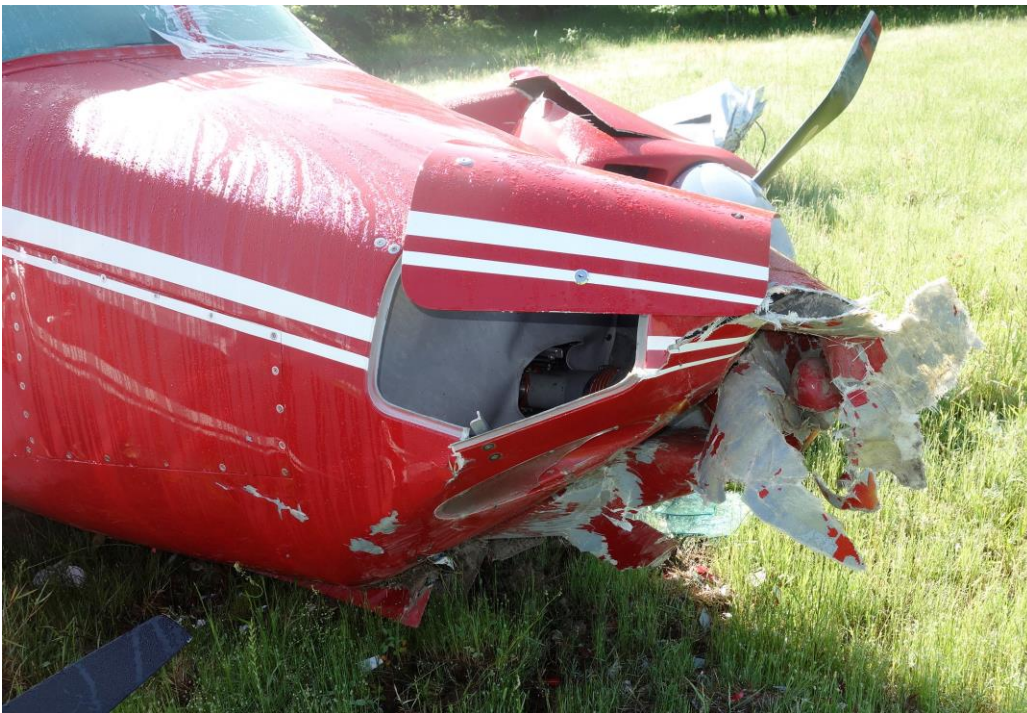
**Picture No:** 14

**Description:** front right view  
of nose skin and structural  
damage.

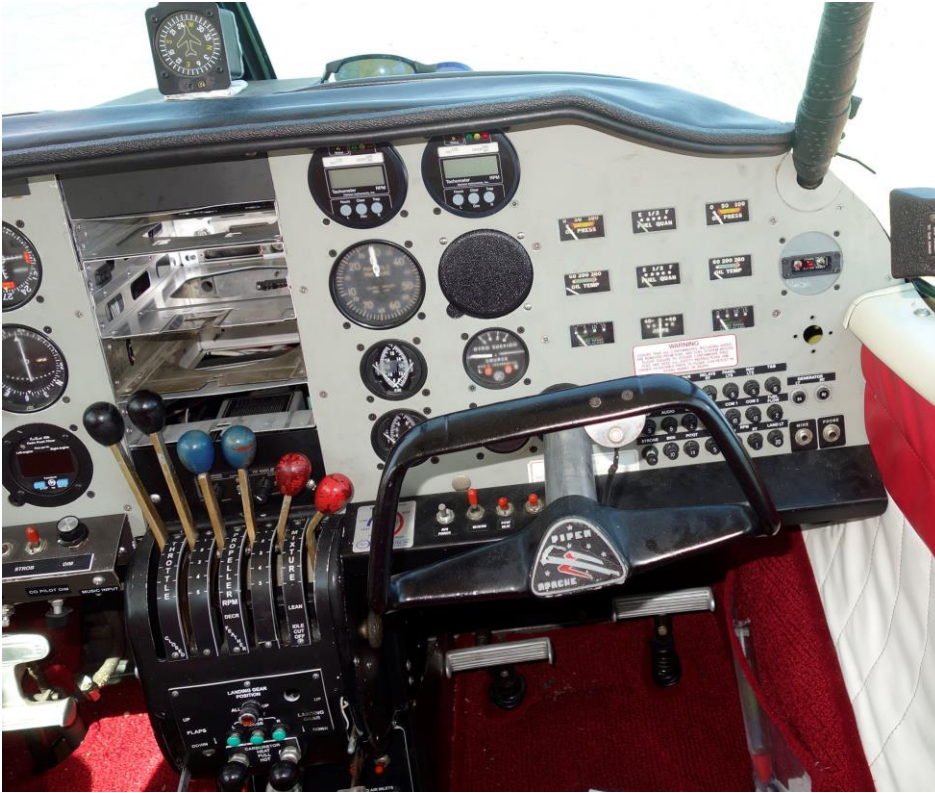
**Picture No:** 17

**Description:** Panel right side.  
Avionics was removed to prevent theft.
