# NATIONAL TRANSPORTATION SAFETY BOARD

## MATERIALS LABORATORY FACTUAL REPORT

Report No. 21-053

Place : Mineral Wells, Texas  
Date : 5/02/2019  
Vehicle : Cirrus SR 20 (SN 1381)  
NTSB No. : CEN19LA133  
Investigator : Andrew Todd Fox

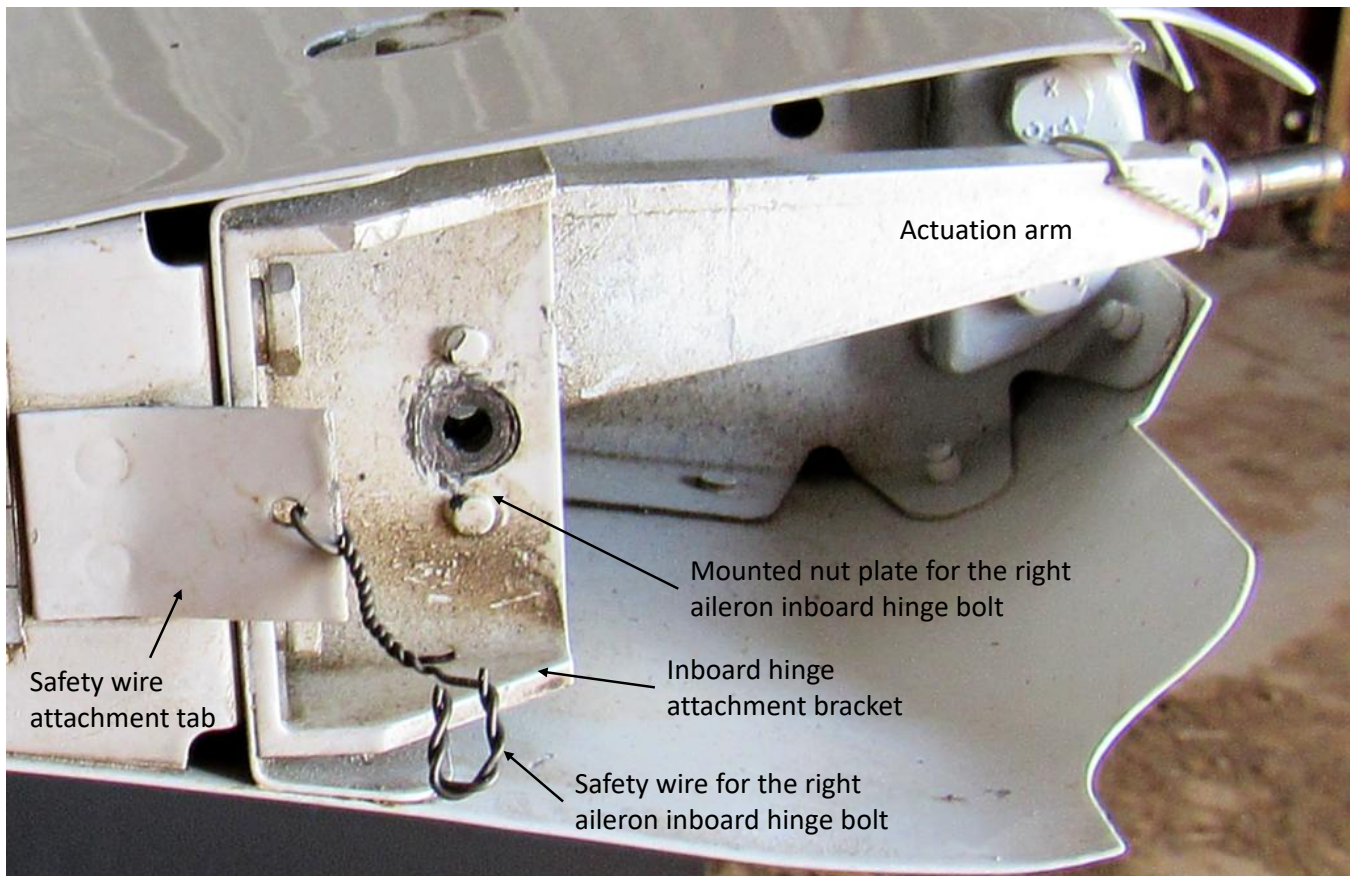
The right aileron inboard hinge attachment bracket with riveted nut plate and actuation arm along with its 0.032-inch diameter safety wire and associated attachment tab from the incident airplane are shown in Figure 1. Closer views of the right inboard aileron hinge bolt and a portion of the hinge assembly are shown in Figures 2 and 3. The image in Figure 4 shows the illustrated parts catalog (IPC) figure for the full assembly, with the components of interest circled in red.

Figure 1 Overview of the as-installed right aileron inboard hinge attachment bracket with riveted nut plate, actuation arm, and safety wire for the inboard hinge attachment bolt with the attachment tab. The safety wire orientation is consistent with that specified in the Cirrus SR20 maintenance manual for right-handed threads.

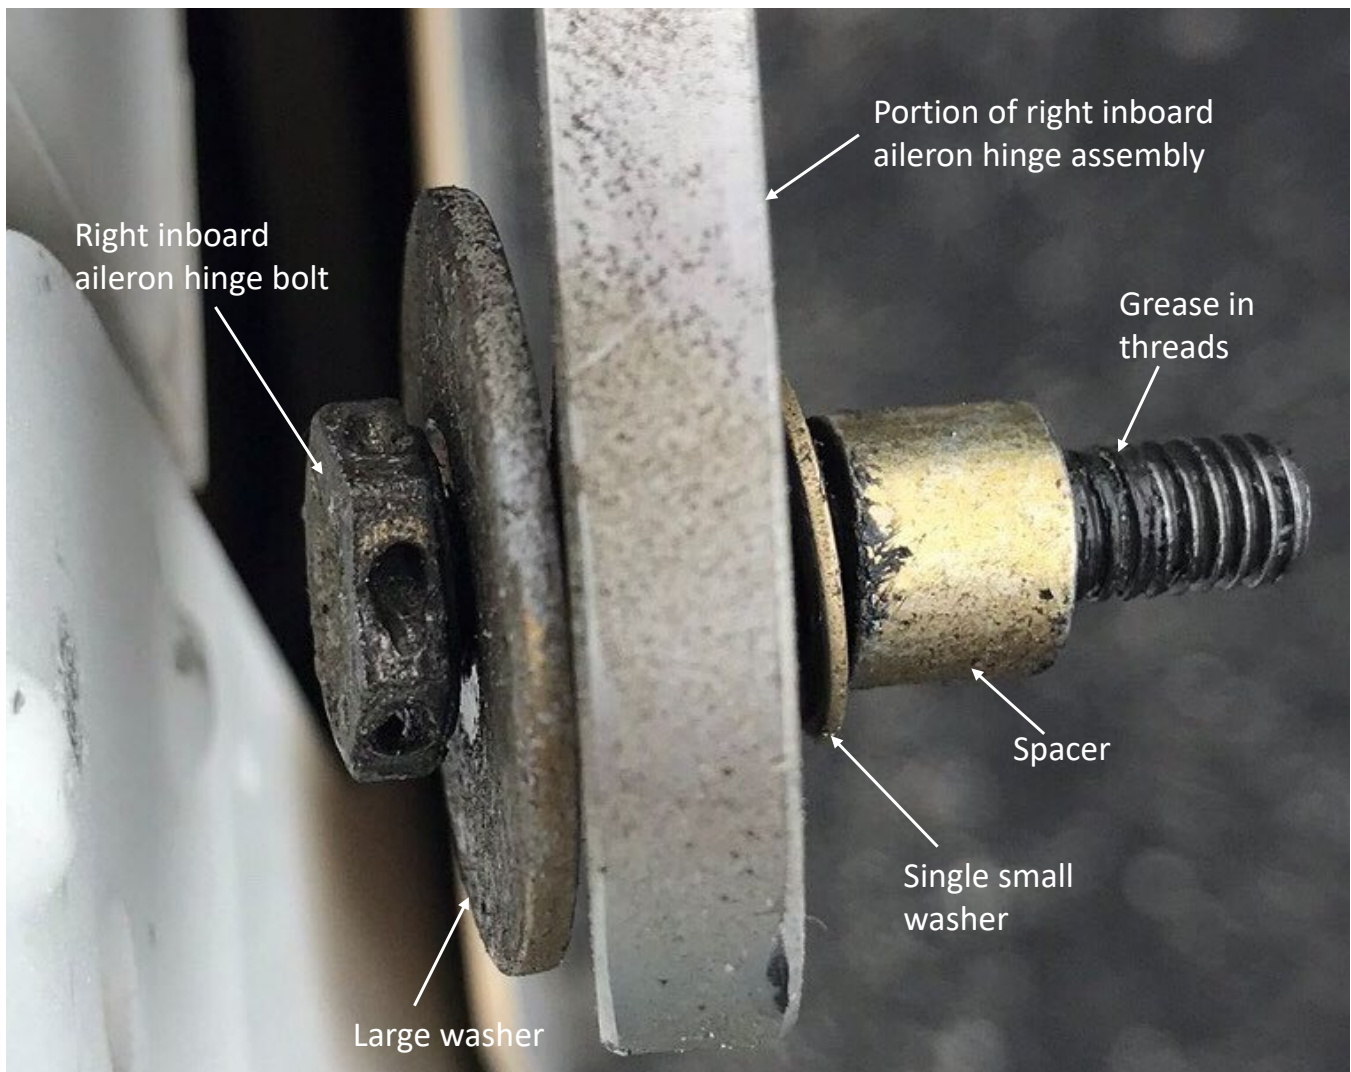
Figure 2 Close view of the right inboard aileron hinge bolt, a portion of the inboard aileron hinge assembly, and associated washers and spacers.

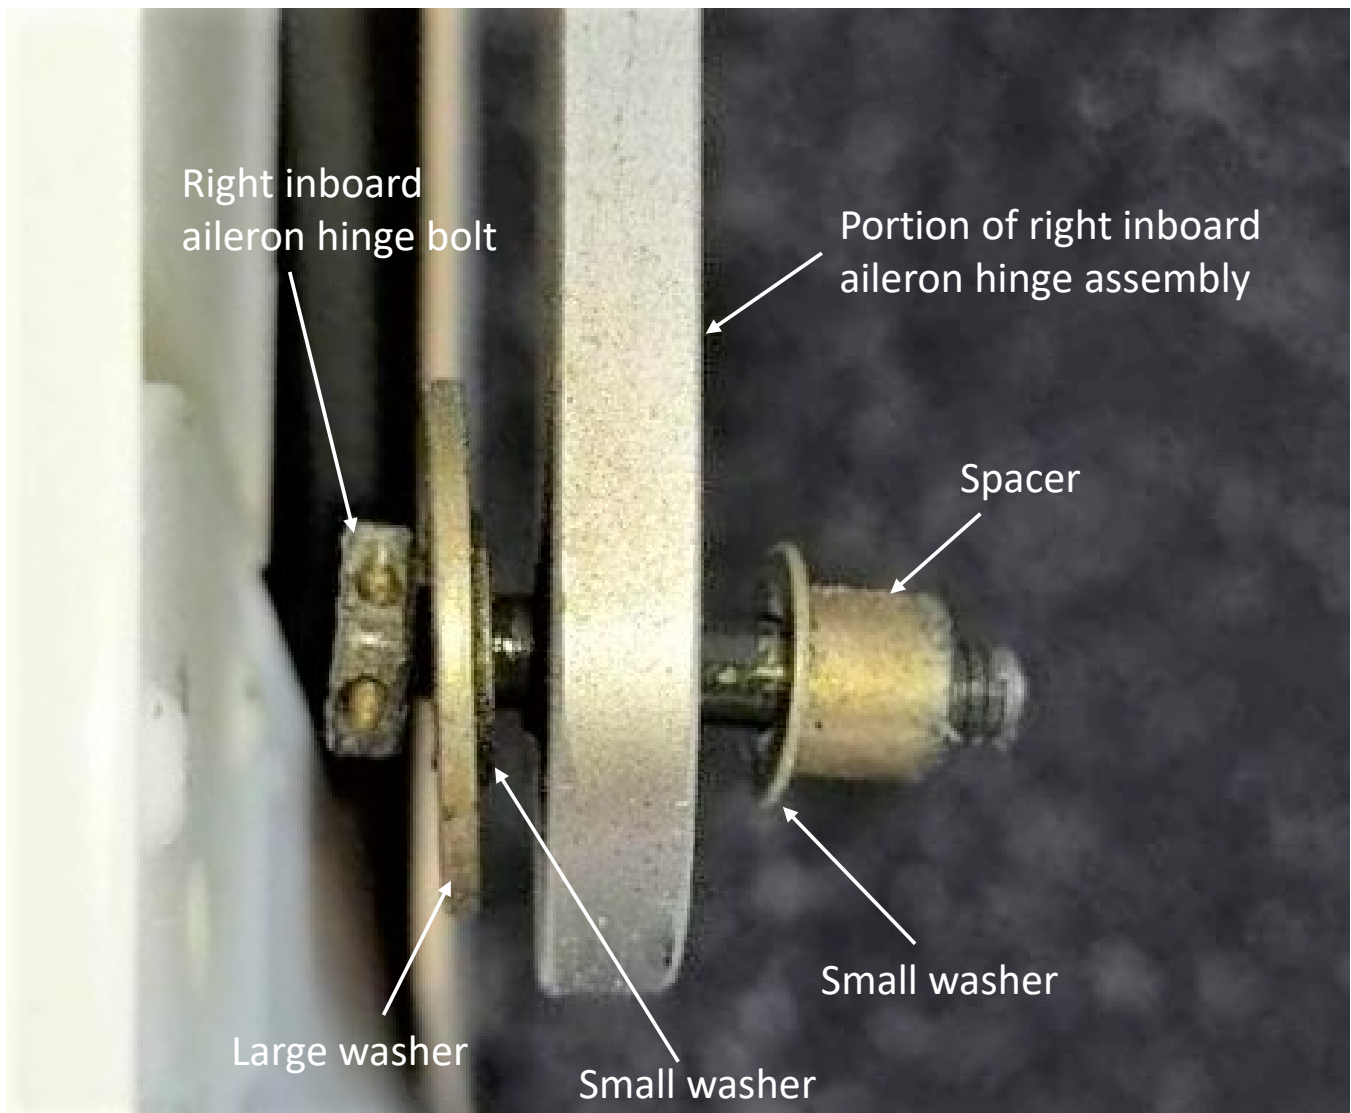
Figure 3 Close view of the right inboard aileron hinge bolt, a portion of the inboard aileron hinge assembly, and associated washers and spacers.

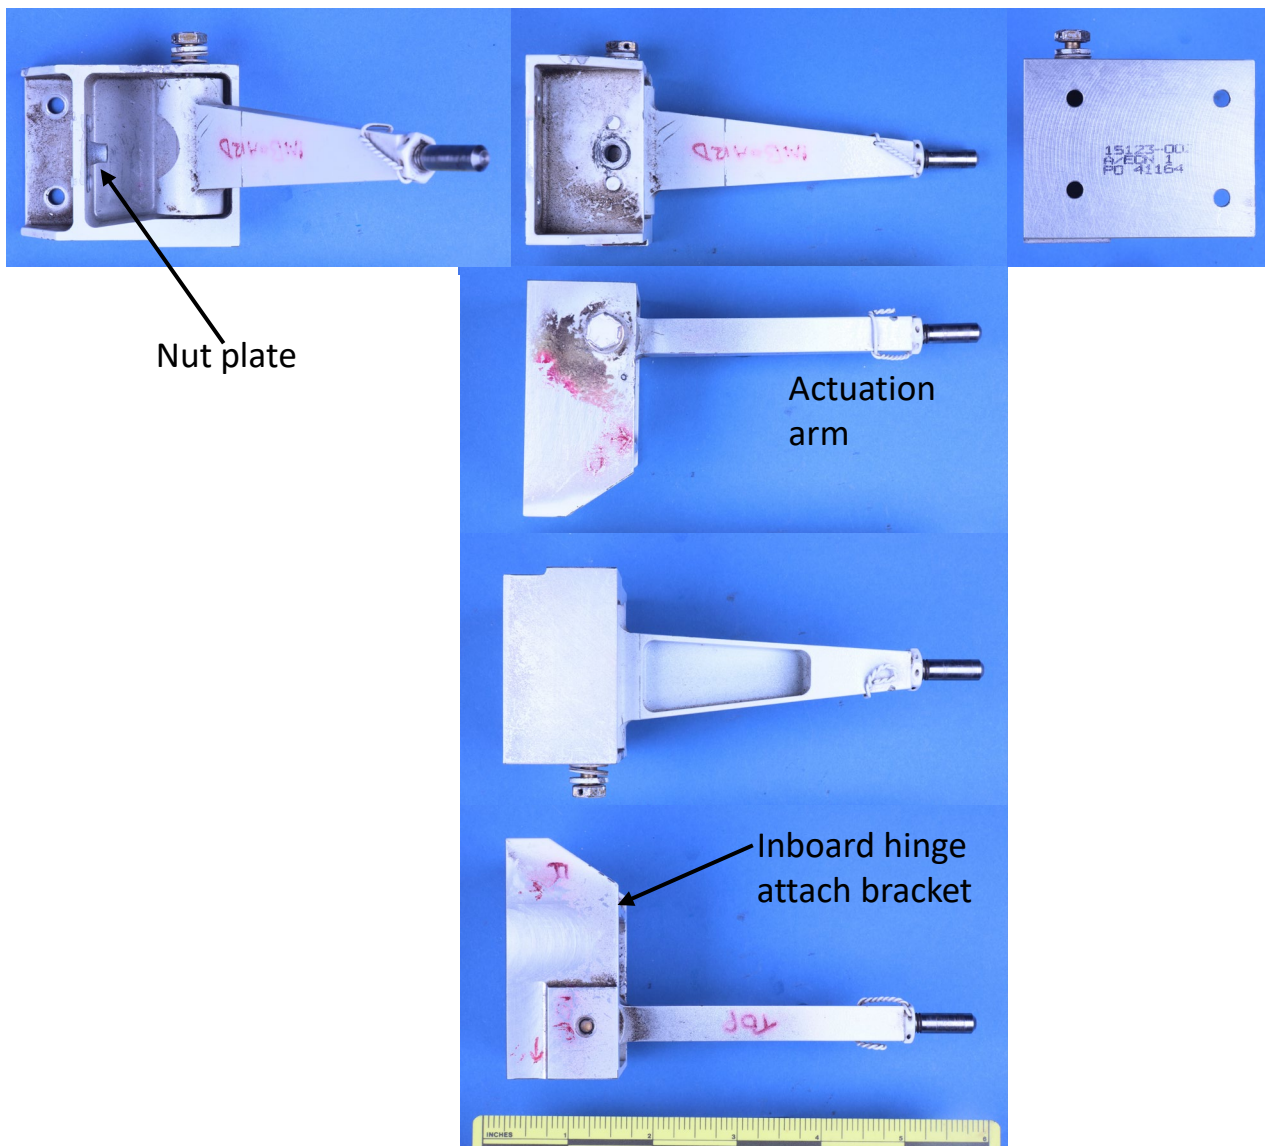
Views of the right aileron inboard hinge attachment bracket with riveted nut plate and actuation arm from the incident airplane are shown in Figure 5. The hinge attachment

Figure 5 Images of the as-received right aileron inboard hinge attachment bracket and actuation arm.

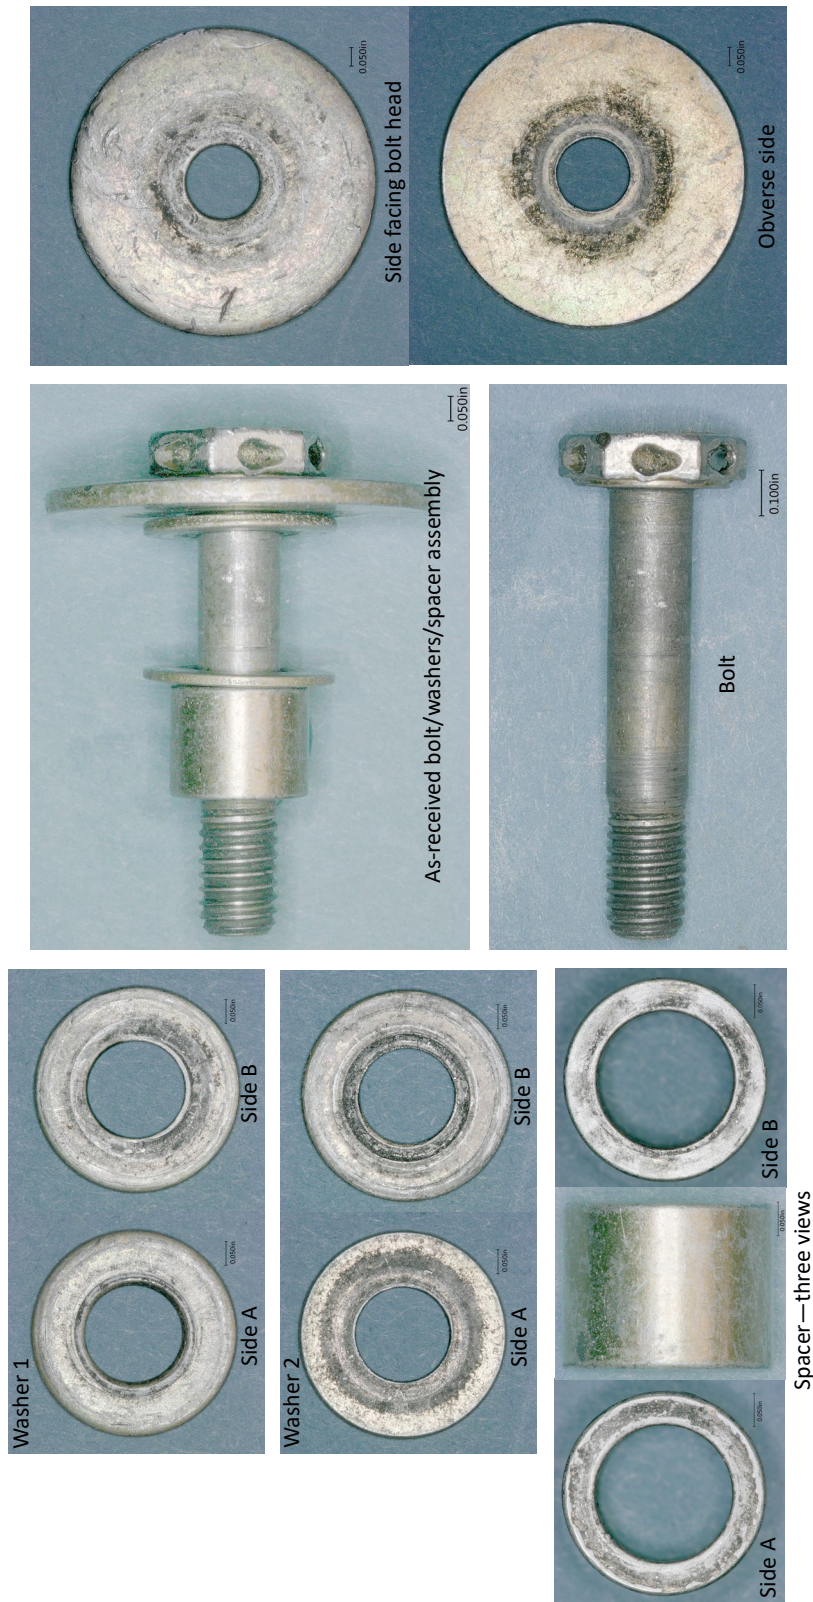
bolt (NAS6203-11H) with 1 large washer (specified as MS63040-3), 2 small washers (specified as NAS1149F0332P), and a spacer is shown in Figure 6. This bolt threads into the nut plate that is riveted to the inboard hinge attachment bracket. Using a dial caliper, the dimensions of the large washer conformed to MS63040-3 and the dimensions of the small washers conformed to NAS1149F0332P.

Figure 6 Images documenting the right inboard aileron hinge attachment bolt and associated washers and spacer (see also Figures 2 and 3).

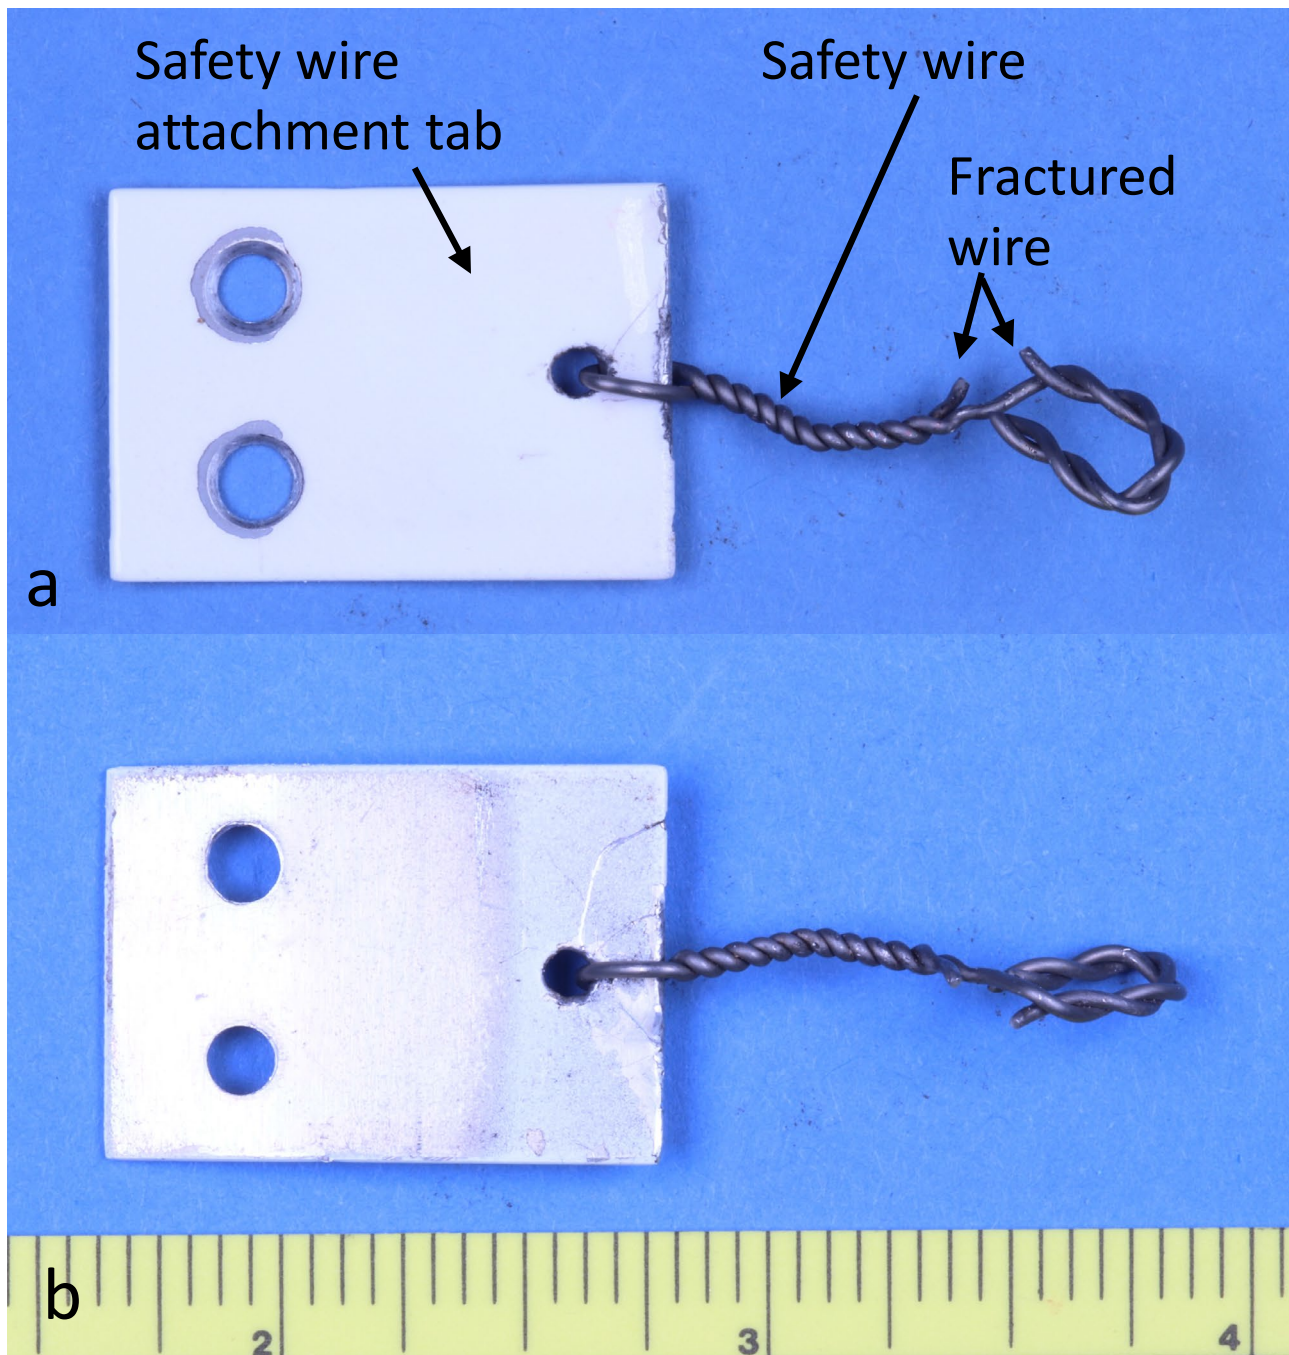
The safety wire attachment tab for the inboard hinge attachment bolt is shown in Figure 7, with the remnant of double-twist safety wire attached. The diameter of the safety wire was approximately 0.0335 inch as measured with a dial caliper. The safety wire was fractured where it would have been threaded through a drilled hole in the bolt head, as identified in the figure (see also Figure 16 for reference). Adjacent to the attachment tab (see Figure 15), the safety wire was twisted approximately 22 twists per inch<sup>1</sup>. The Cirrus SR20 maintenance manual recommends 6 to 12 twists per inch.

Figure 7 Front and back views of the safety wire for the right inboard aileron hinge attachment bolt and its associated attachment tab (removed from the airplane by drilling the rivets).

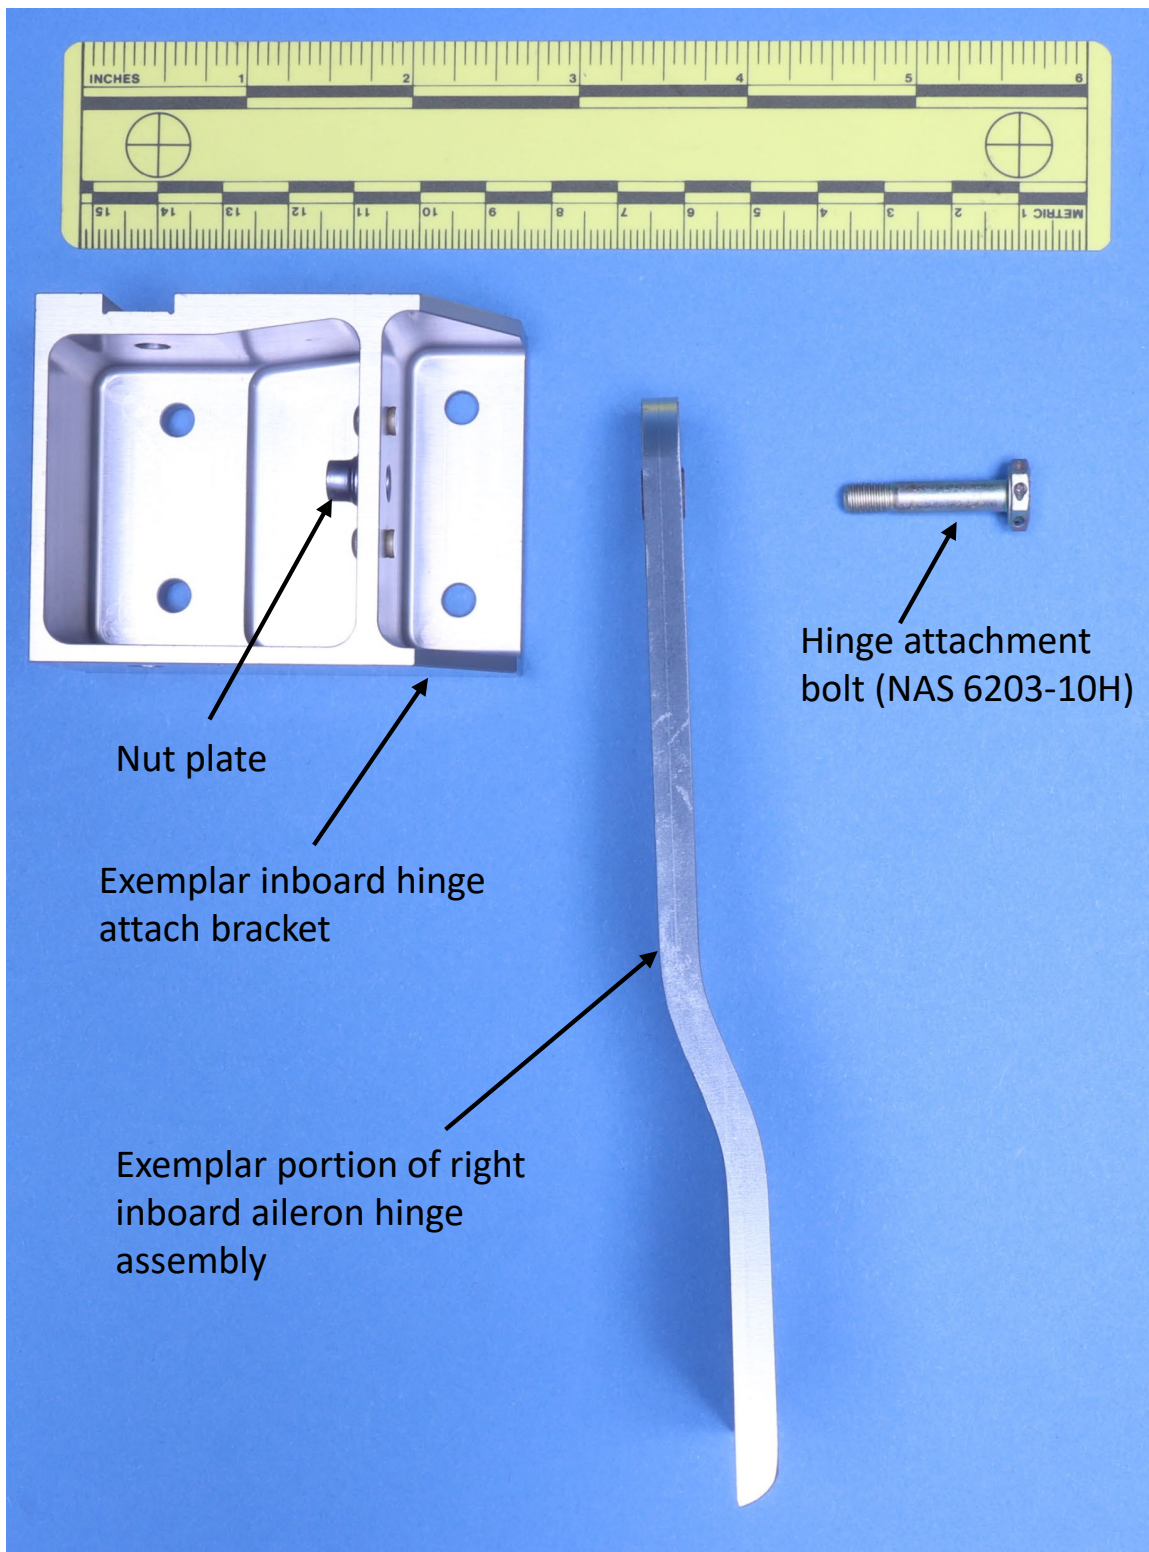
An exemplar aileron inboard attachment bracket with riveted nut plate, a portion of inboard aileron hinge assembly, and an aileron inboard hinge bolt (NAS6203-10H) were also submitted as presented in Figure 8. The purpose of these components was to measure the prevailing torque of the hinge attachment bolt in the nut plate and to confirm that the nut plate can withstand a final tightening torque of 25 lbf-in.

Figure 8 Image of an exemplar inboard hinge bracket, hinge attachment bolt, and a portion of the aileron hinge assembly.

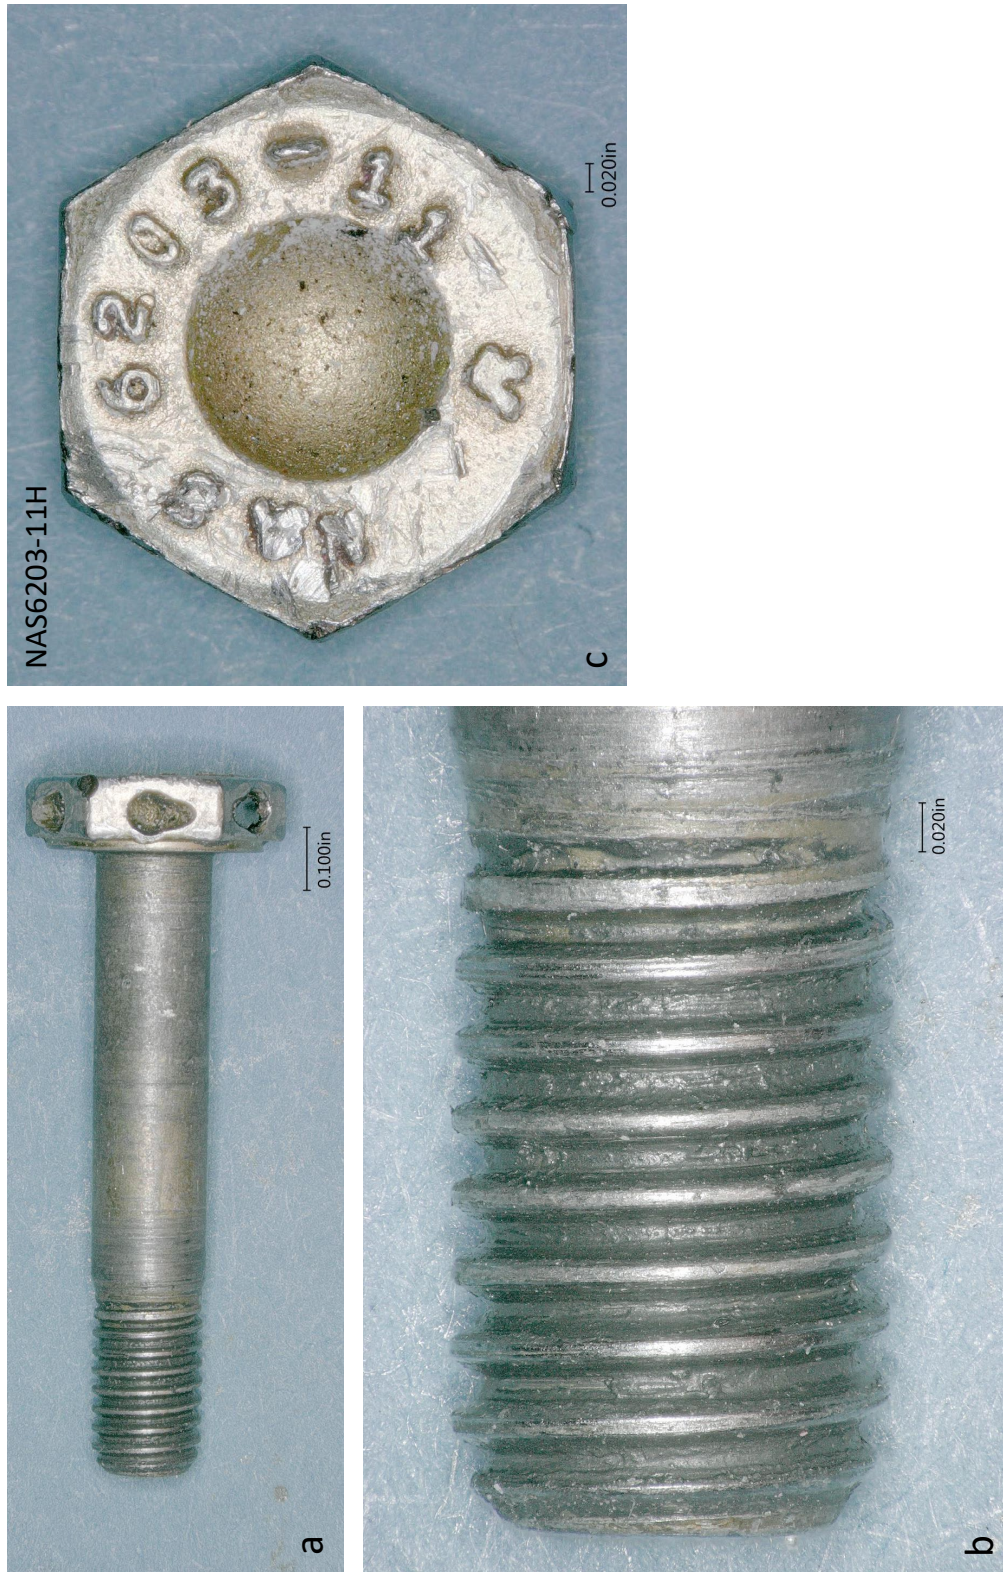
Close views of the right aileron inboard hinge attachment bolt from the incident airplane are shown in Figure 9. The grip area exhibits circumferential wear scars and marks. The threads are intact, fully formed, and in good condition; the thread roots are partially filled with black grease. Material loss due to wear is evident around the periphery of the drilled holes. A top view of the hexagonal head is marked with NAS6203-11 (it would be 11H with the drilled head). The IPC indicates that the hinge bolt shall be NAS6203-9H or NAS6203-10H. For reference, Table 1 lists grip length and overall length for select NAS6203 bolts.

Figure 9 Close views of the threads and head markings on the right aileron hinge attachment bolt.

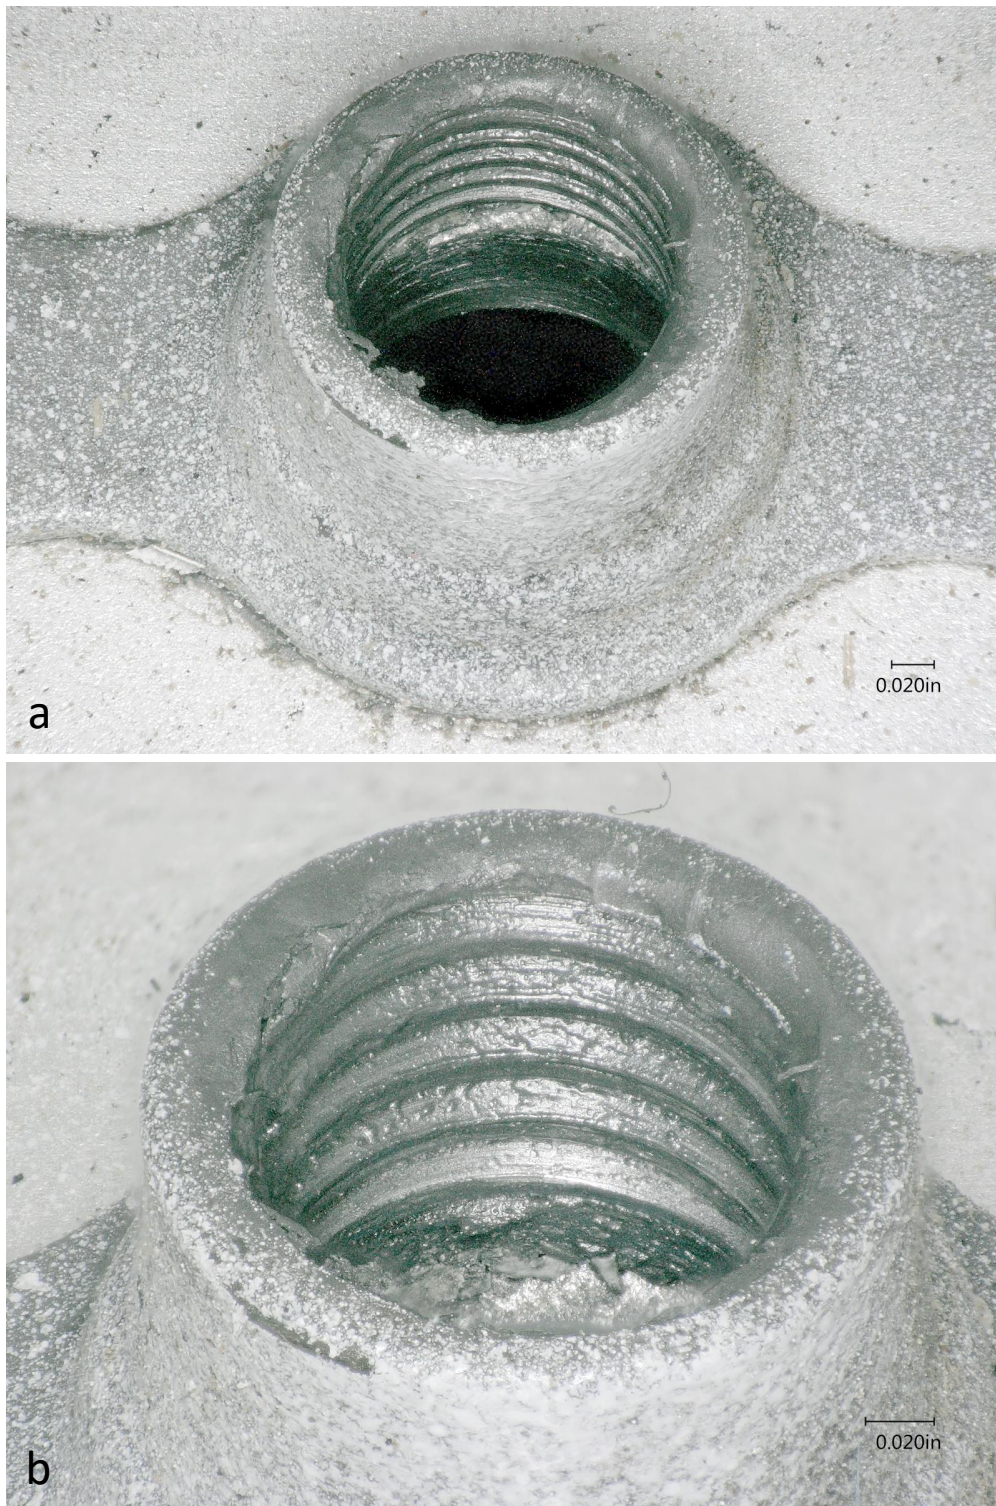
Views of the internal threads of the nut plate on the aileron hinge attachment bracket from the incident airplane are shown in Figures 10-12. The threads are intact, fully formed, and in good condition; the roots are partially filled with black grease. The periphery of the threaded portion of the nut plate is relatively round. Typically, the

Figure 10 Close views of the exterior surfaces of the nut plate on the incident airplane right aileron inboard hinge attachment bracket.

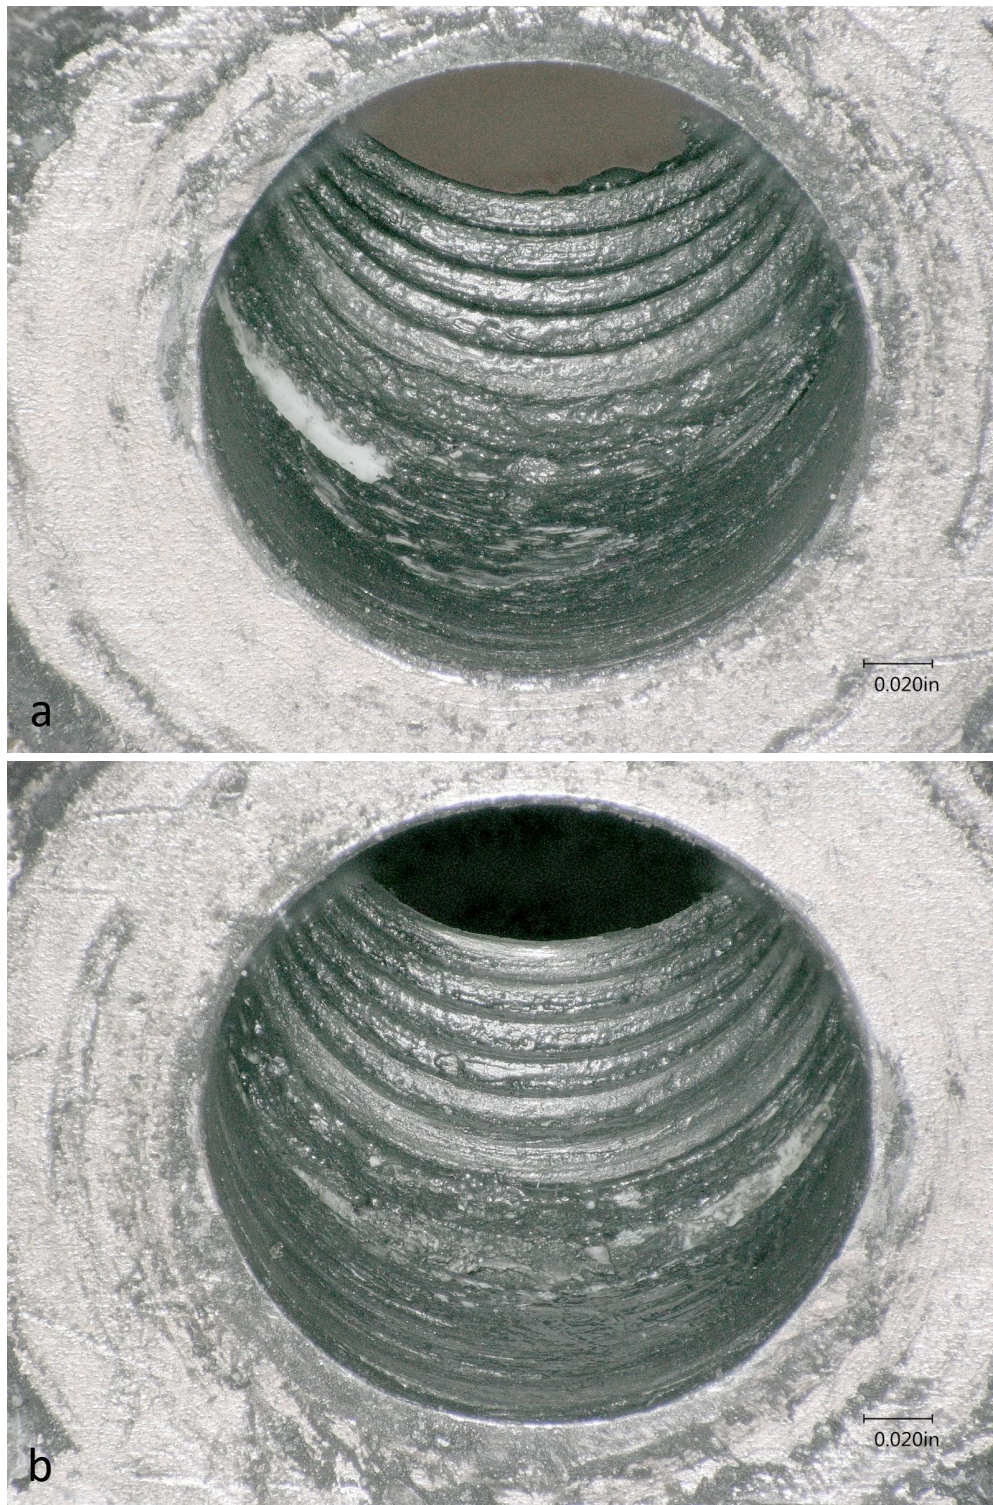
Figure 11 Close views of the threads in the nut plate on the incident airplane right aileron inboard hinge attachment bracket. Views a and b are 180° apart.

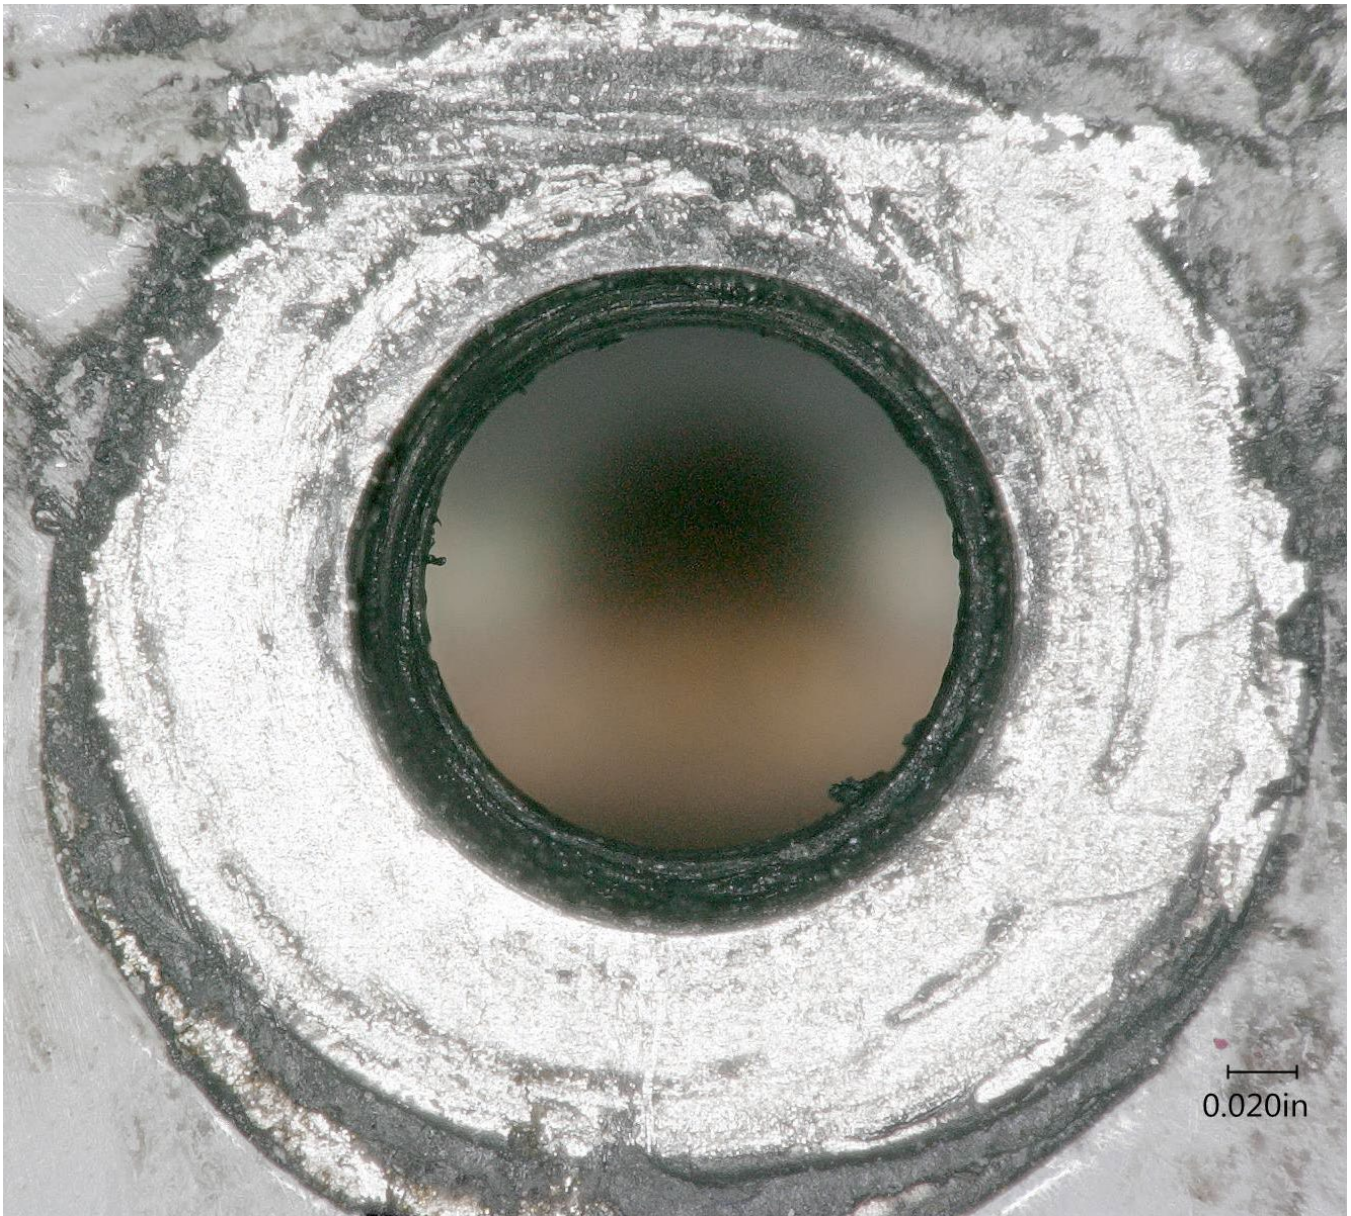
periphery of the threaded portion of the nut plate is intentionally deformed to an oblong or oval shape to provide mechanical resistance (or thread-locking) to the mating bolt threads. For comparison, the internal threads of the nut plate on the exemplar aileron hinge attachment bracket are shown in Figures 13 and 14. The threads are intact, fully formed, and in good condition. The periphery of the threaded portion of the nut plate was oval or oblong as viewed in Figure 14a. Table 2 reveals the prevailing torque of the incident and exemplar hinge bolt and attachment bracket pairs; measured using an analog torque wrench.

Figure 12 Top down view of the threads in the nut plate on the incident airplane right aileron inboard hinge attachment bracket.

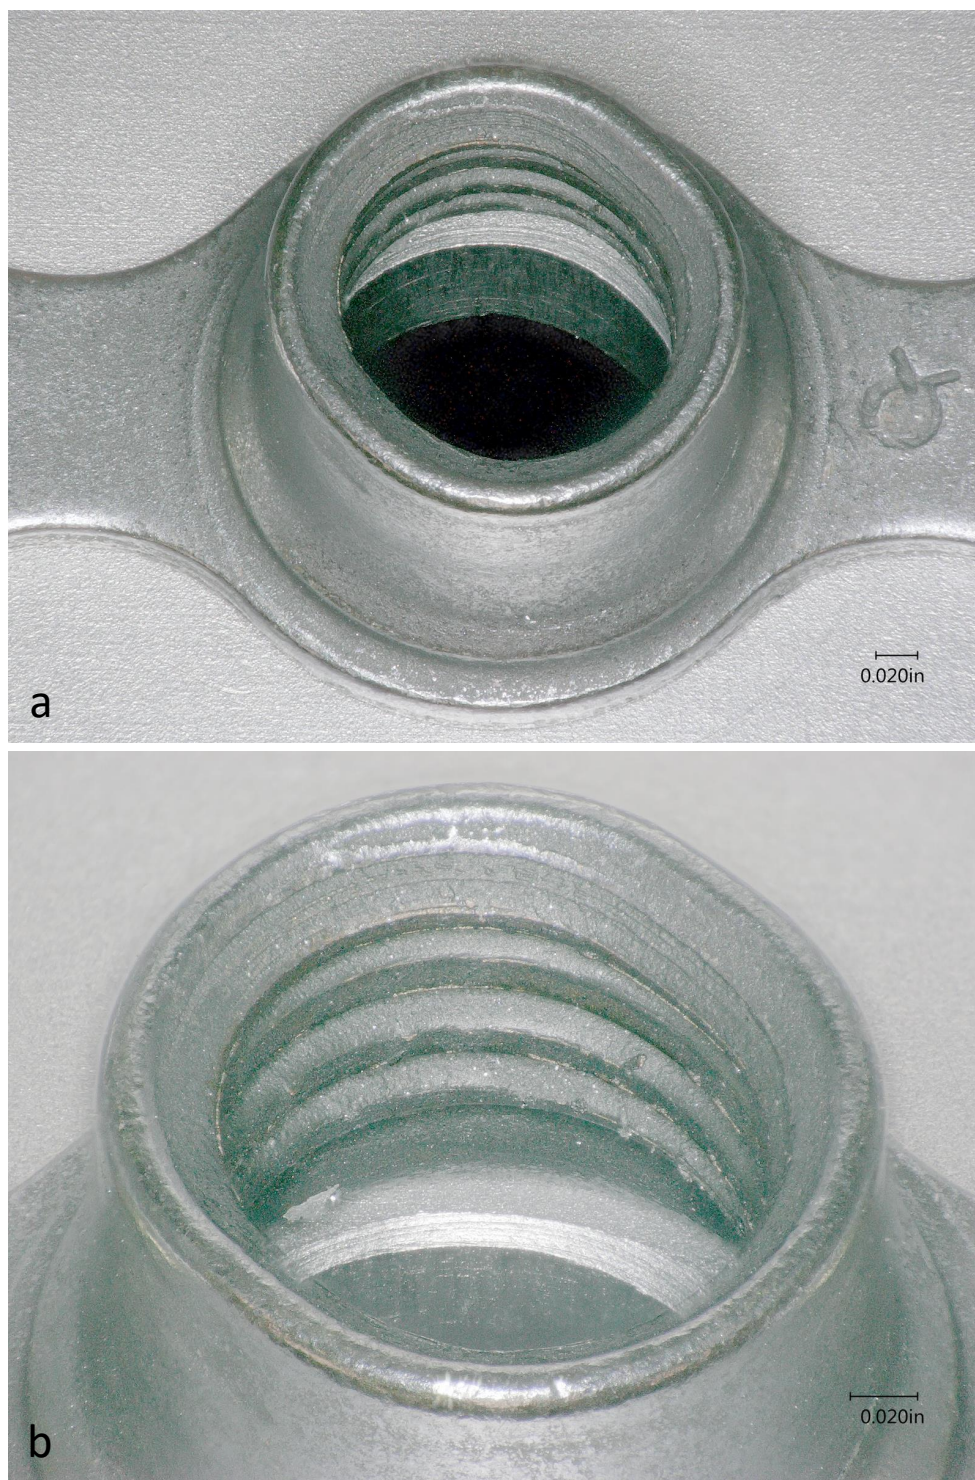
Figure 13 Close views of the exterior surfaces of the nut plate on the exemplar aileron inboard hinge attachment bracket.

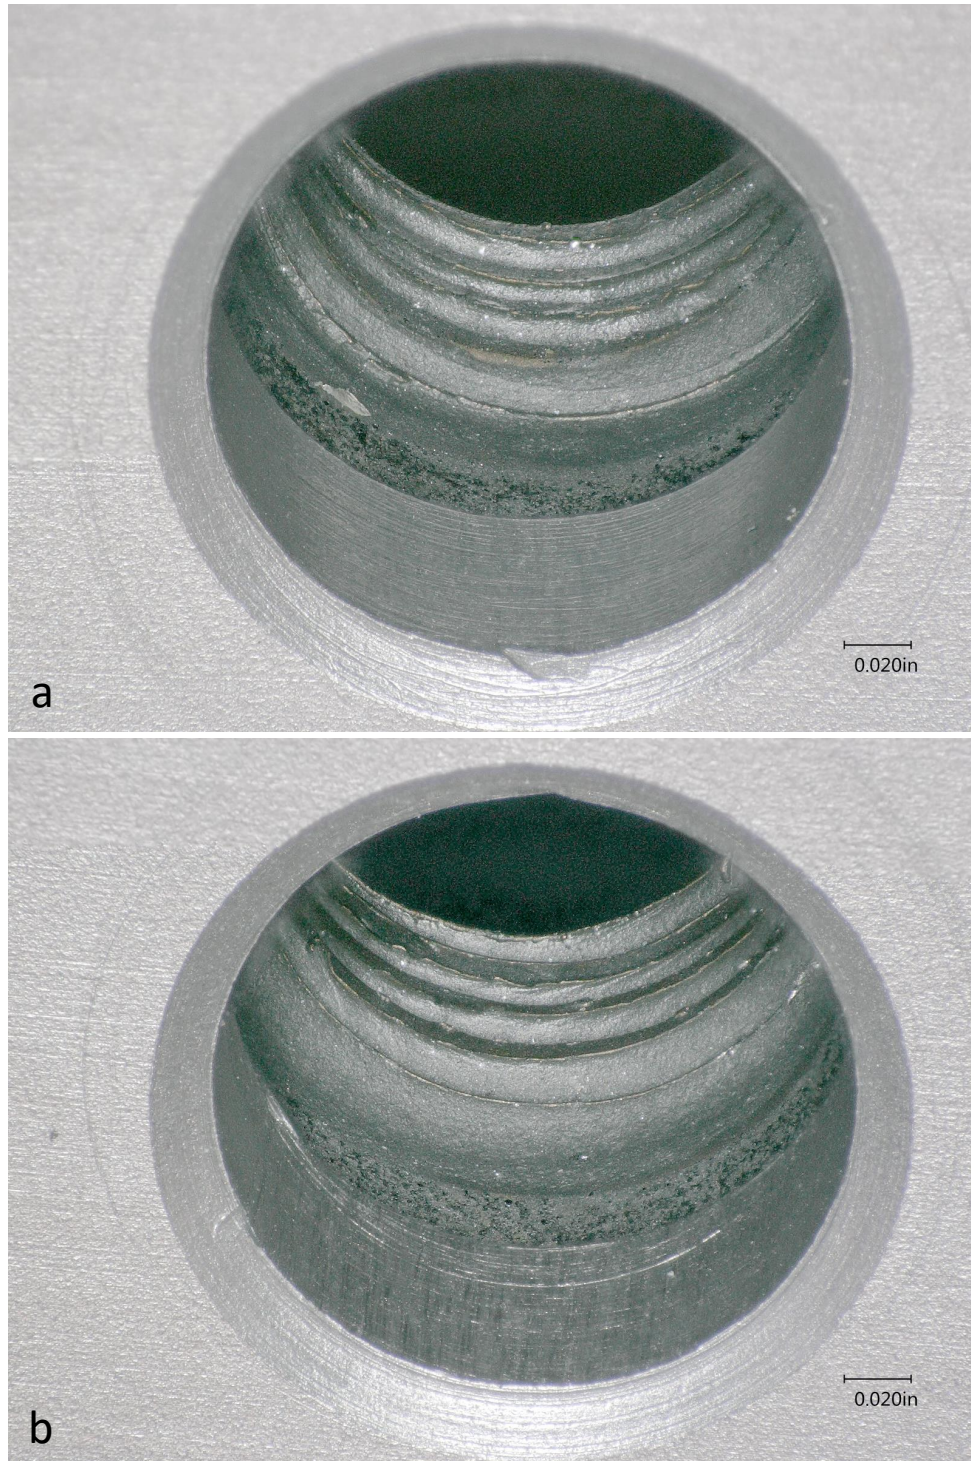
Figure 14 Close views of the threads in the nut plate on an exemplar aileron inboard hinge attachment bracket. Views a and b are 180° apart.

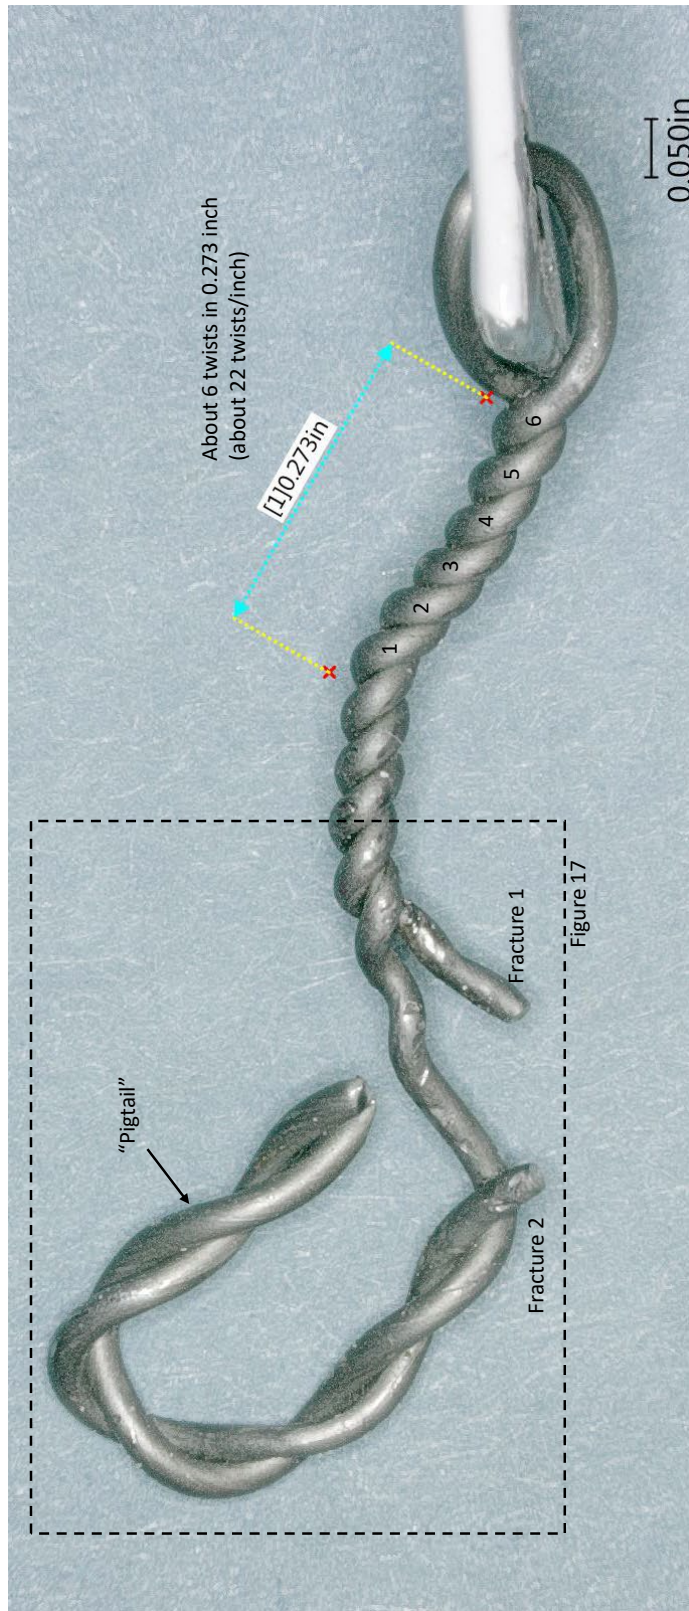
A closer view of the hinge attachment bolt safety wire from the incident airplane is shown in Figures 15-23. In Figure 16, inset images conceptually show how the fractured ends of the safety wire had previously fit within a drilled hole in the hinge bolt hexagonal head. For orientation purposes, Figure 17 shows the location of higher magnification images of the safety wire fractures as well as the terminal cut on the pigtail. Figures 18-22 show images of the safety wire fractures and pigtail cut at progressively higher magnifications. Top-down scanning electron microscope images of the safety wire fractures are shown in Figure 23. Fractographic analysis indicates that the safety wire fractured due to torsional overstress.

Figure 15 Close view of the right aileron inboard hinge attachment bolt safety wire. The location of a fracture in the wire is identified. The twists per inch was also measured as indicated in the figure.
