# NATIONAL TRANSPORTATION SAFETY BOARD

## MATERIALS LABORATORY FACTUAL REPORT

Report No. 21-053

Place : Mineral Wells, Texas  
Date : 5/02/2019  
Vehicle : Cirrus SR 20 (SN 1381)  
NTSB No. : CEN19LA133  
Investigator : Andrew Todd Fox

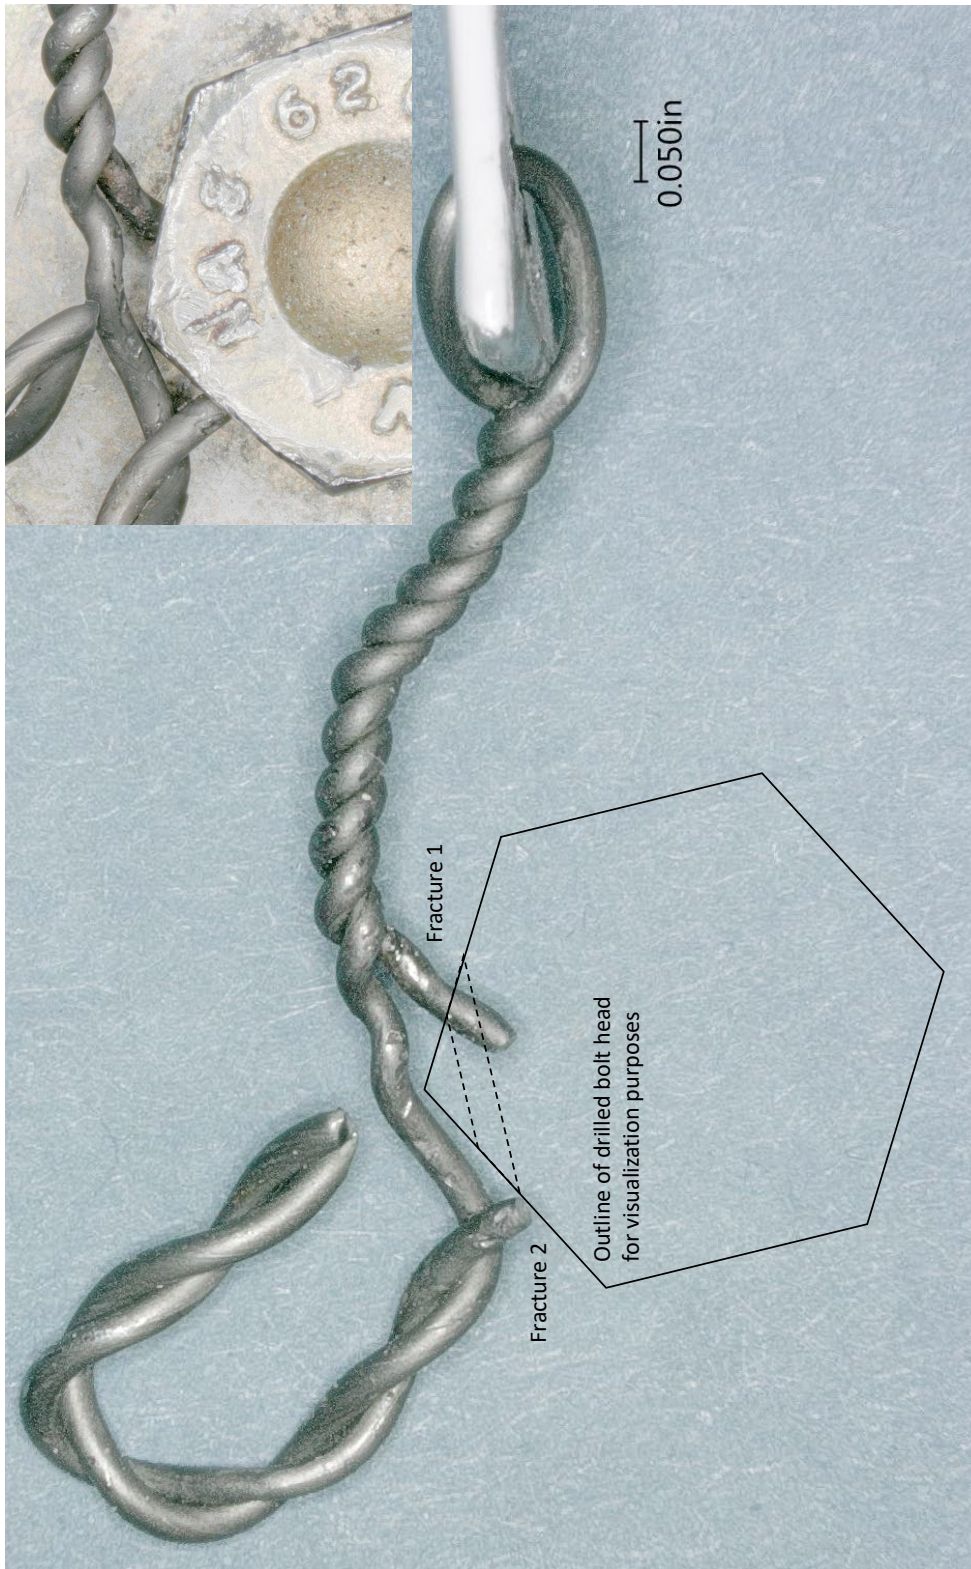
A closer view of the hinge attachment bolt safety wire from the incident airplane is shown in Figures 15-23. In Figure 16, inset images conceptually show how the fractured ends of the safety wire had previously fit within a drilled hole in the hinge bolt hexagonal head. For orientation purposes, Figure 17 shows the location of higher magnification images of the safety wire fractures as well as the terminal cut on the pigtail. Figures 18-22 show images of the safety wire fractures and pigtail cut at progressively higher magnifications. Top-down scanning electron microscope images of the safety wire fractures are shown in Figure 23. Fractographic analysis indicates that the safety wire fractured due to torsional overstress.

Figure 16 Close view of the right aileron inboard hinge attachment bolt safety wire. The location of a fracture in the wire is identified. The outline of a drilled bolt head is placed close to the fractured wire ends for visualization purposes. The inset image shows the approximate mechanical arrangement of the drilled bolt head in close proximity to the fractured safety wire ends.

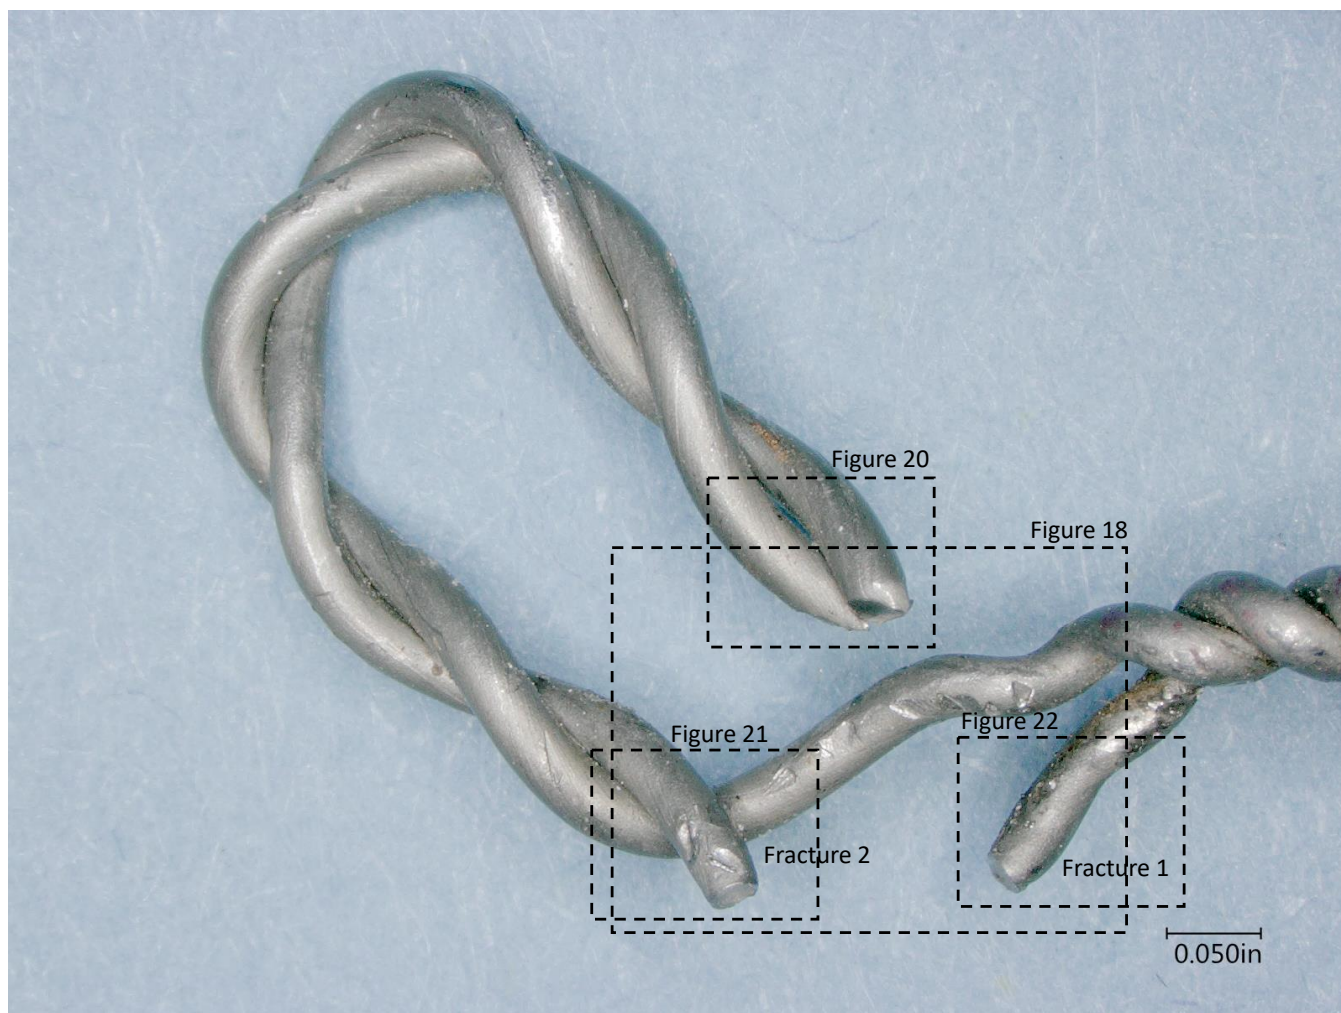
Figure 17 Close image of the fractured safety wire ends as well as the pigtail end.

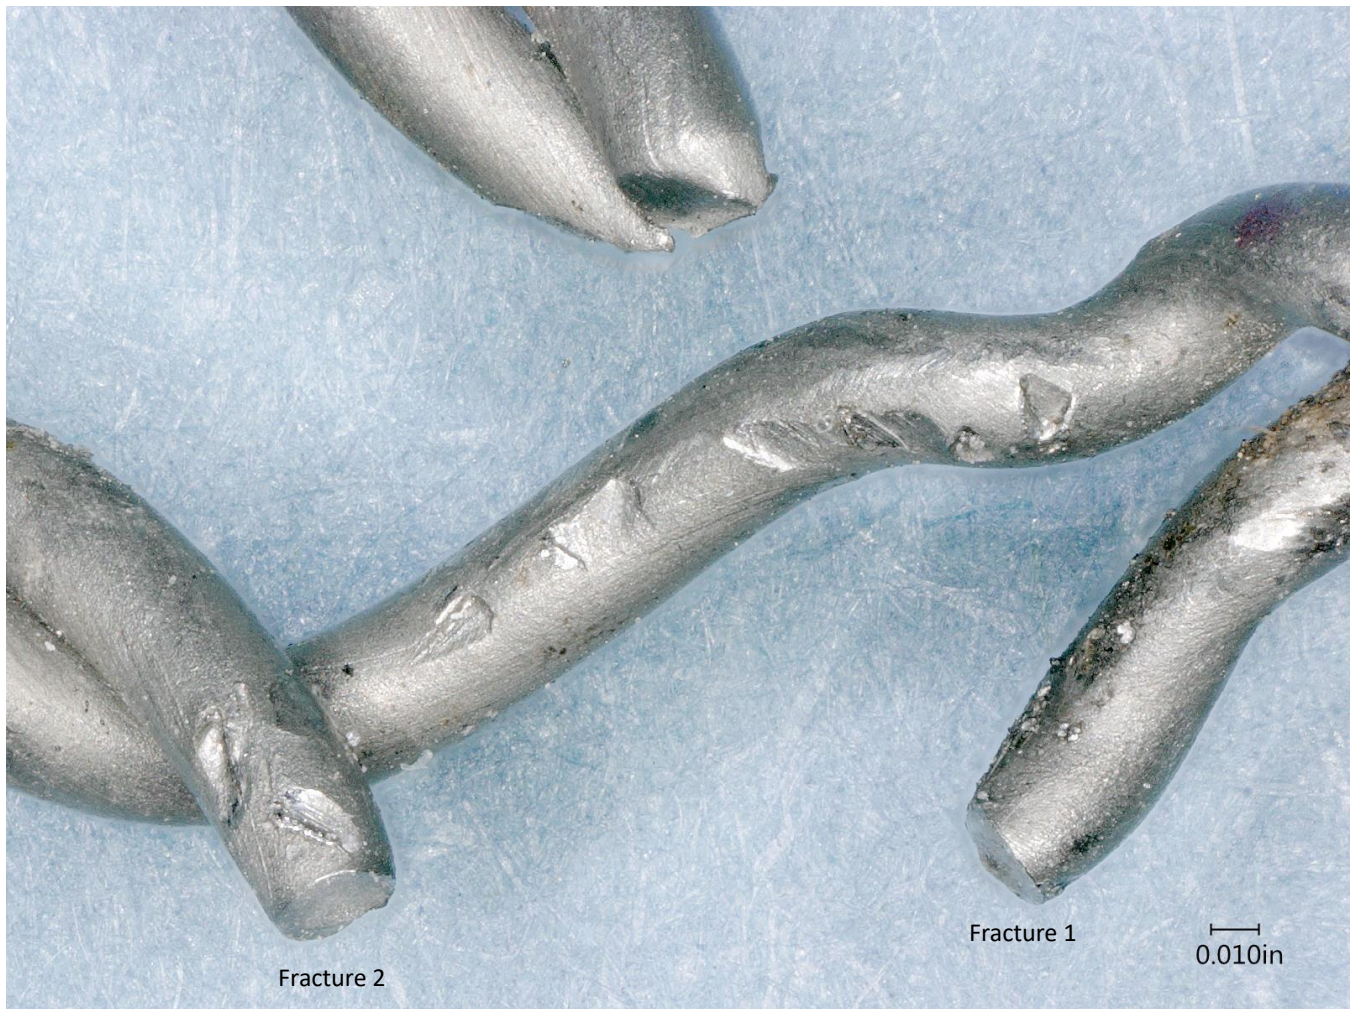
Figure 18 A closer view of the image in Figure 17. Note the mechanical damage to the surface of the intact wire.

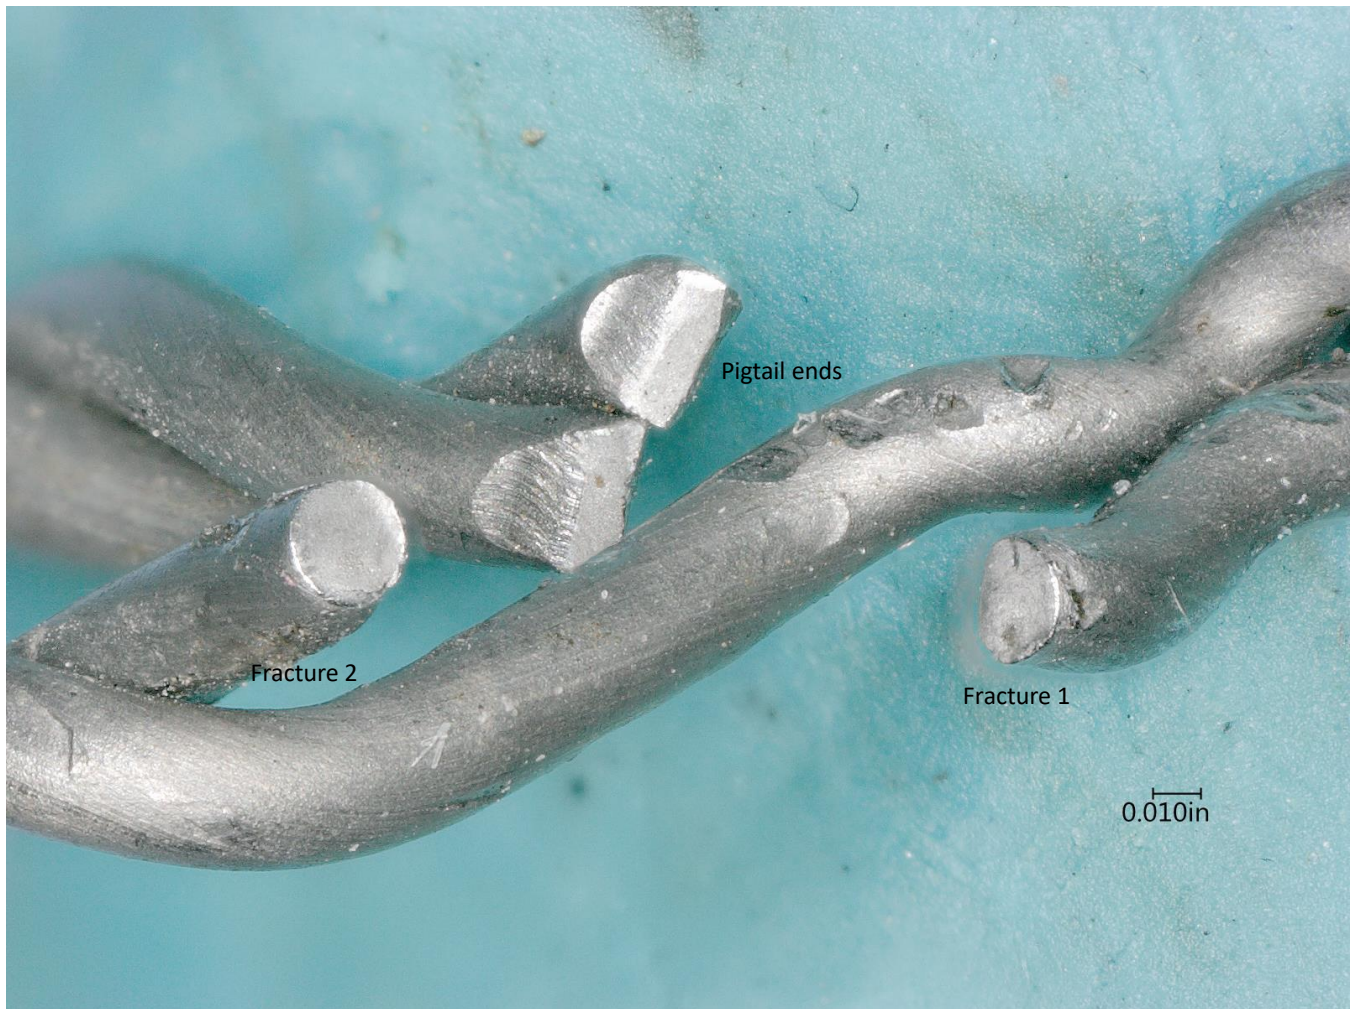
Figure 19 Oblique view of the safety wire to reveal the fracture surfaces and the terminal cuts on the pigtail.

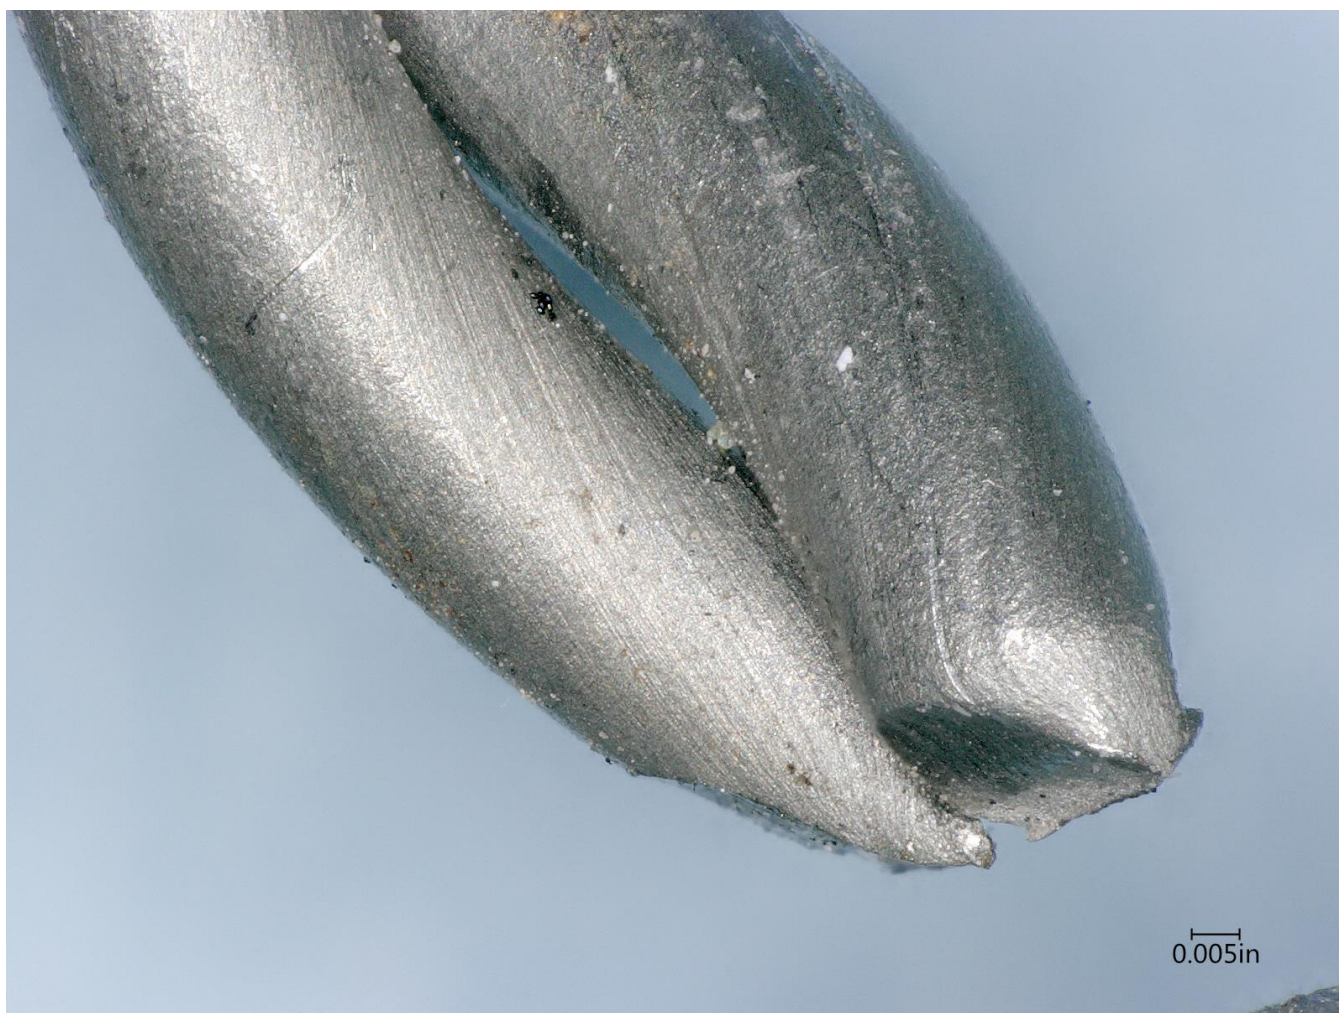
Figure 20 Higher magnification image of the plier-cut terminal-end of the safety wire pigtail.

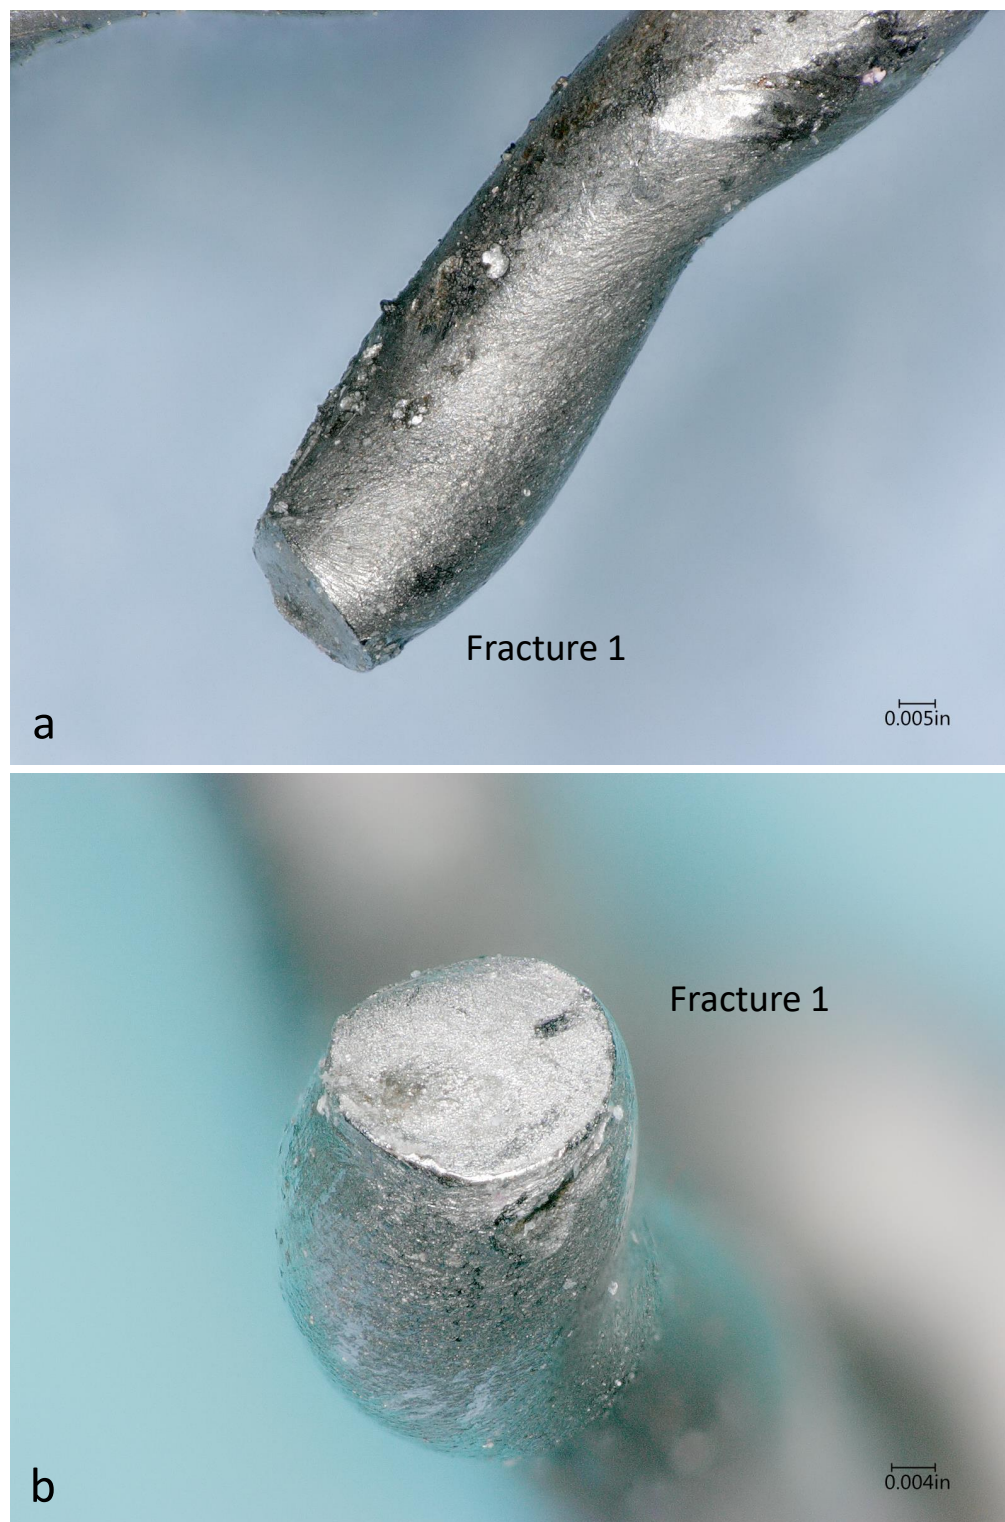
Figure 21 Side and top-down views of Fracture 1 (see Figure 17) safety wire fracture surface.

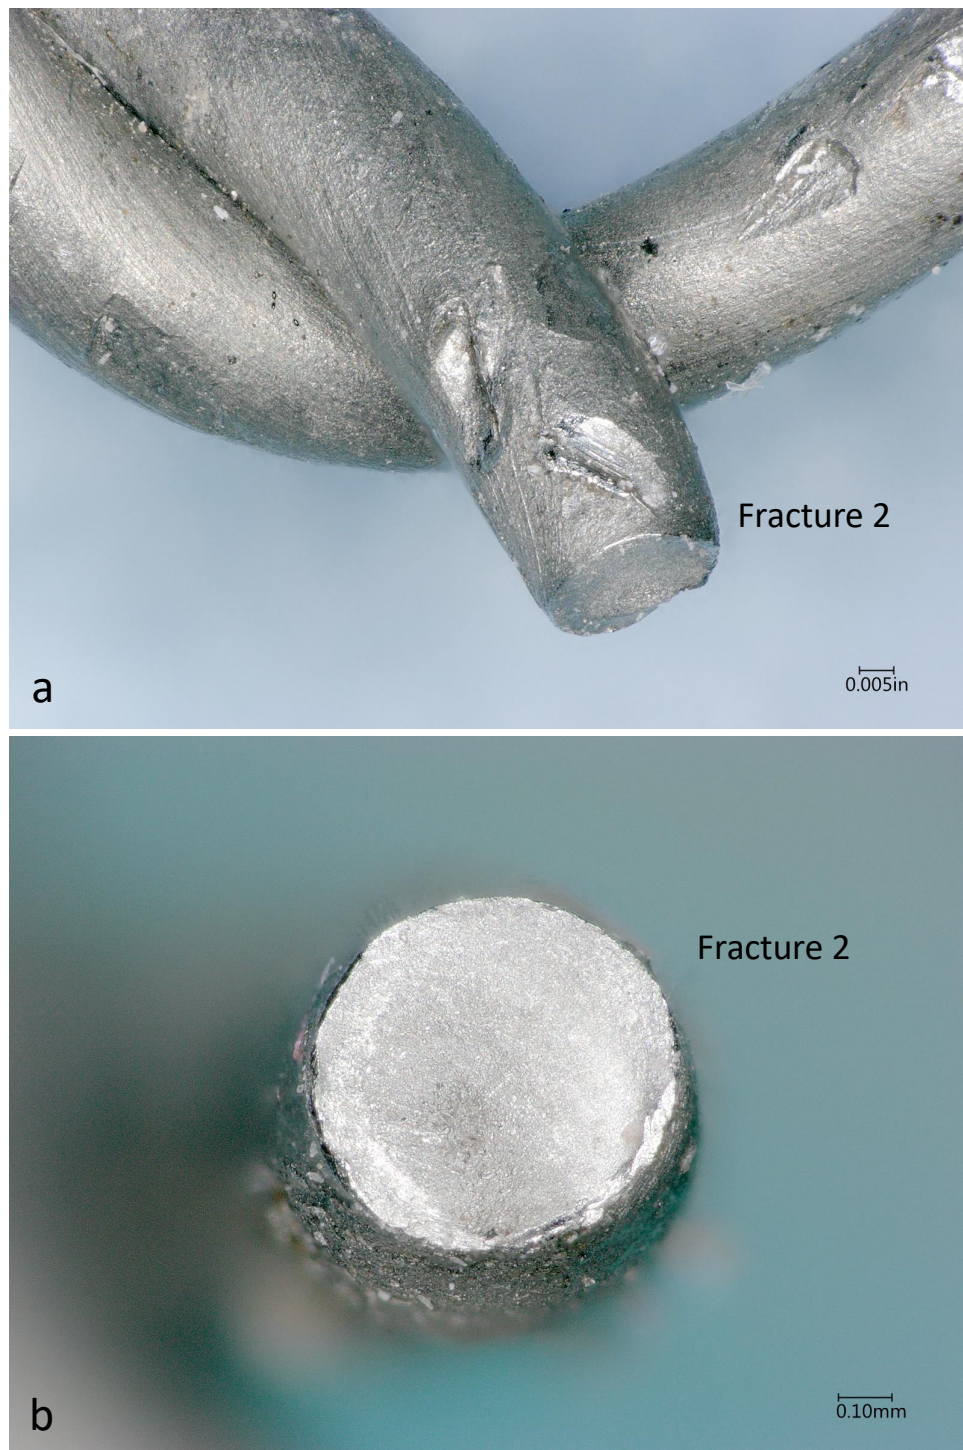
Figure 22 Side and top-down views of Fracture 2 (see Figure 17) safety wire fracture surface.

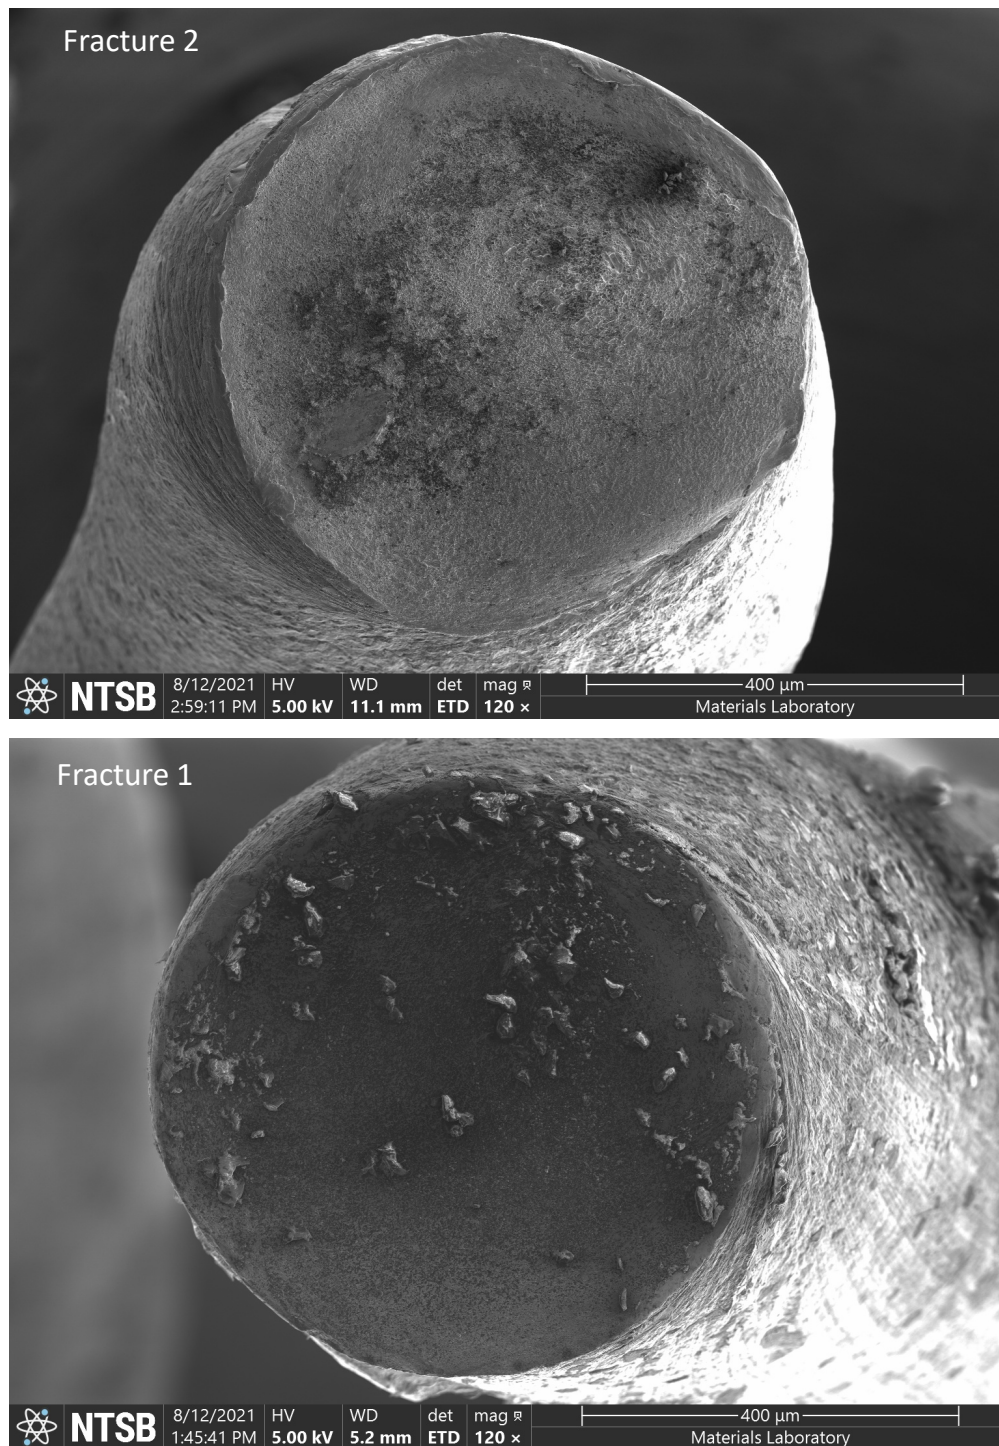
Figure 23 Scanning electron microscope images of the fractured safety wire ends identified in Figures 15-22.
