On May 2, 2019 at approximately 1700 local time, the right side aileron of a Cirrus SR-20 registration number N8160C departed the aircraft while in flight. The aircraft was ½ mile from the airport, on a final approach for one of a series of practice landings, when the aileron departed. VFR conditions prevailed. The aircraft landed without further incidence, the loss of the aileron constitutes substantial damage. The aircraft had 1 and 1 passenger onboard, there were no injuries. The flight originated from the Fort Worth Meacham (KFTW) at approximately 1620 local time. The flight ended at Mineral Wells Airport (KMWL) at approximately 1700 local time.

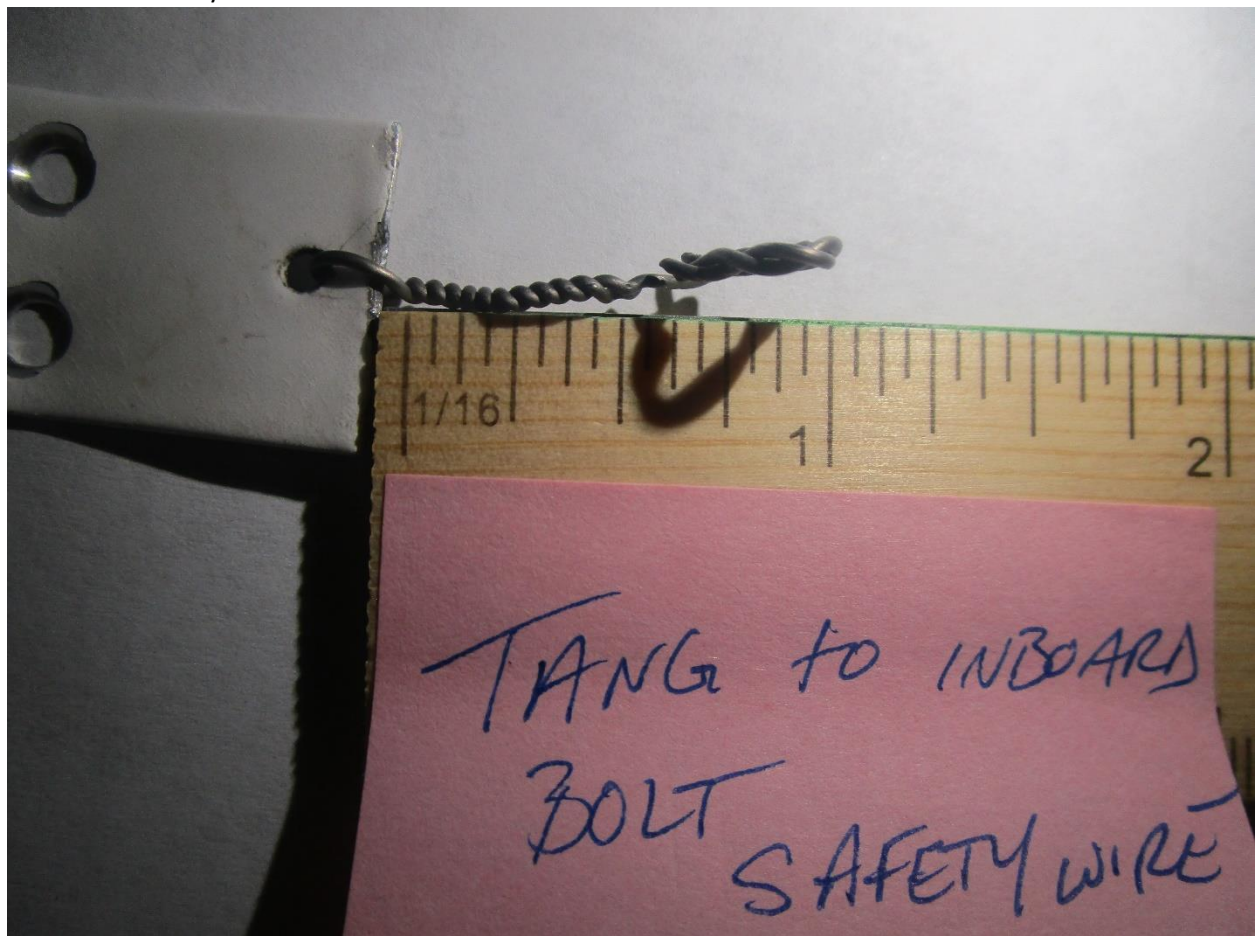
twisted strand of 0.032in safety wire was found attached to the aileron tab. The safety wire was broken at the contact point where it would enter the bolthead. The safety wire had the same aged appearance as the others. The break points were of the same dulled appearance. The surface of the safety wire was uniform except the portion between the body twists and pigtail that showed marks indicative of those left by pliers.

Cirrus SR20 AMM Chapter 20-50 paragraph 2.A.(3): Safety wire 0.032 inch (0.8 mm) in diameter shall have 6 to 12 twists per one inch (25.4 mm).

The broken safety wire was twisted 9 times in 0.5 inches.

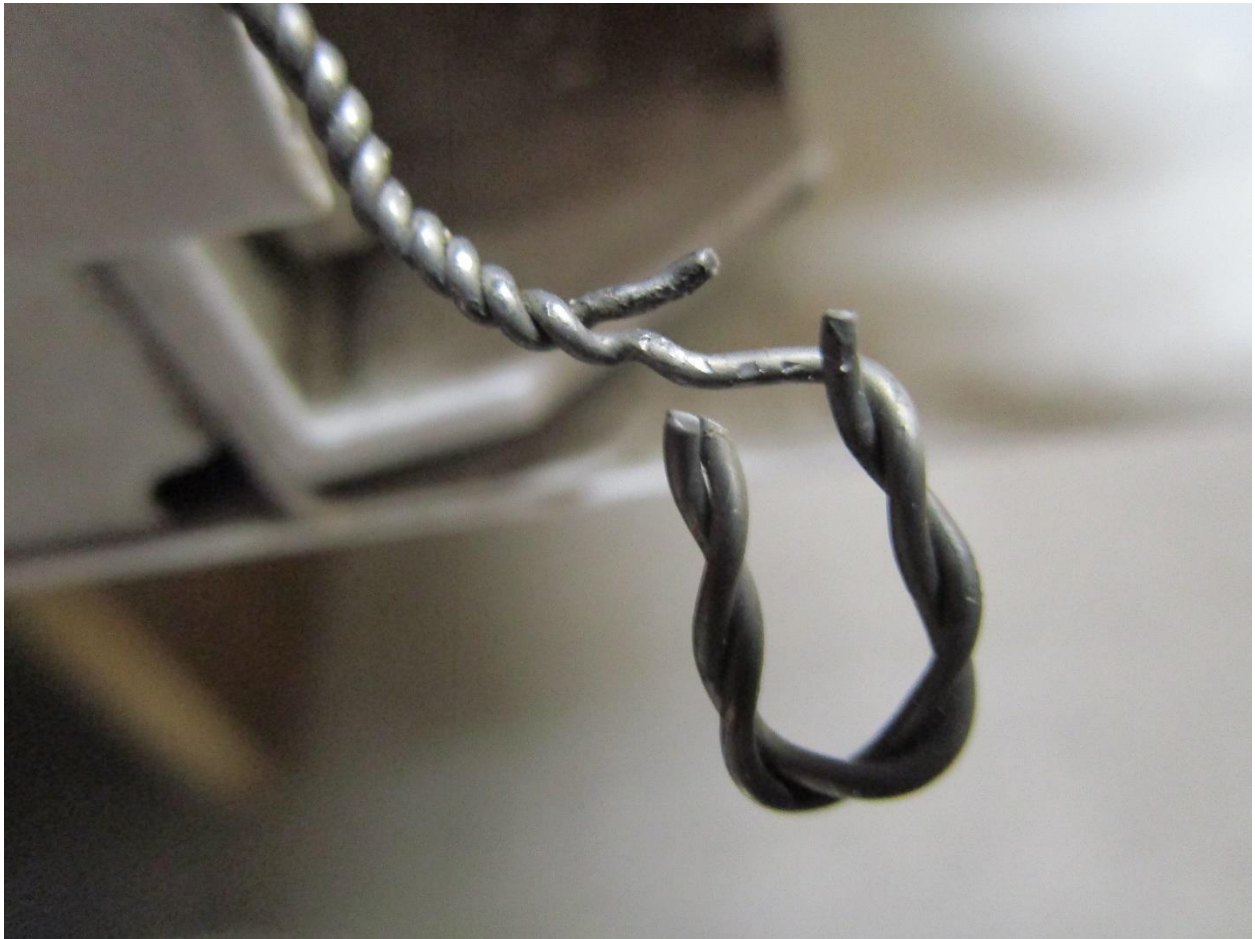
Plier marks visible between the end of twists and breakpoint

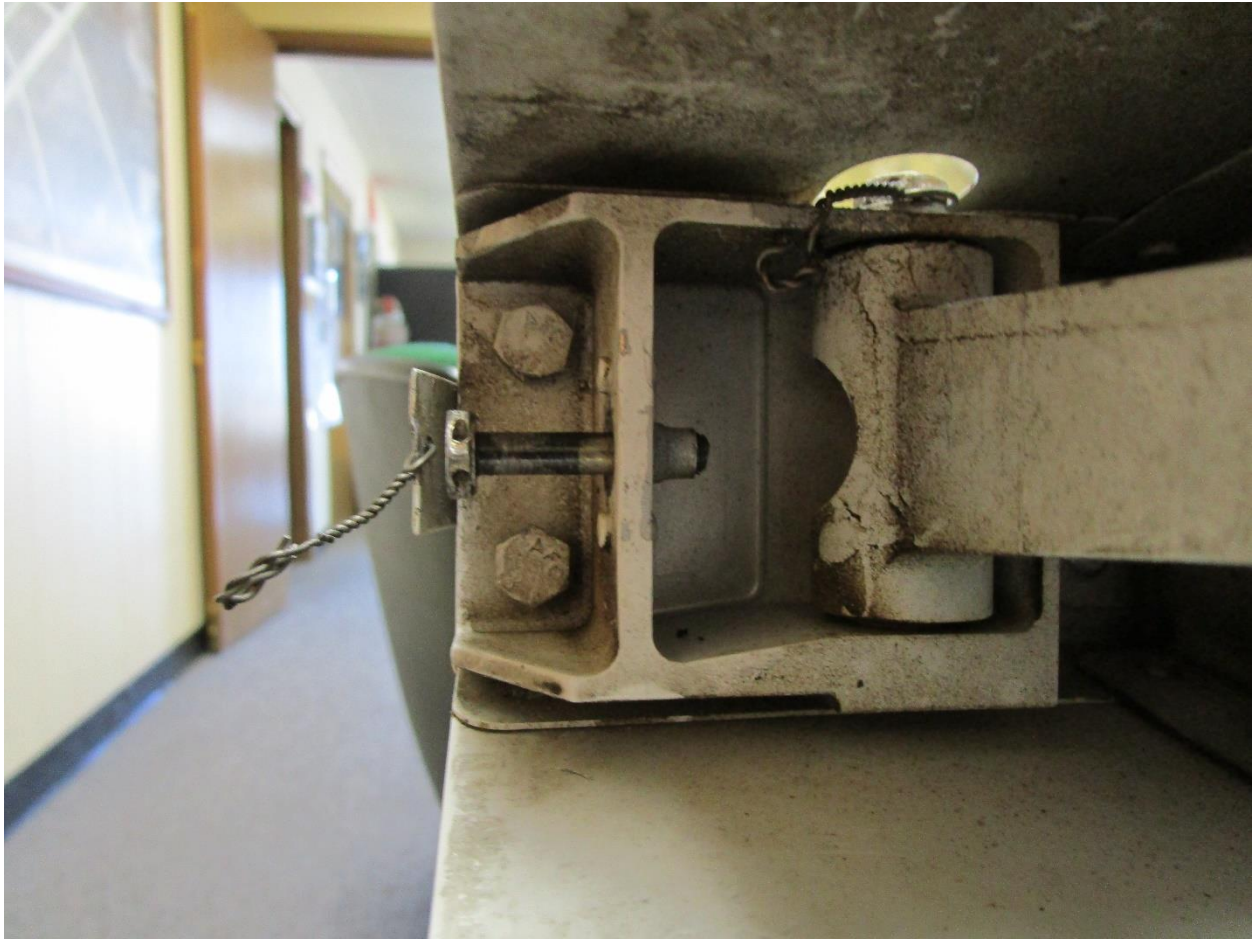
Vertical bolt safety wire present and intact prior to disassembly. (Horizontal bolt inserted for reference only)

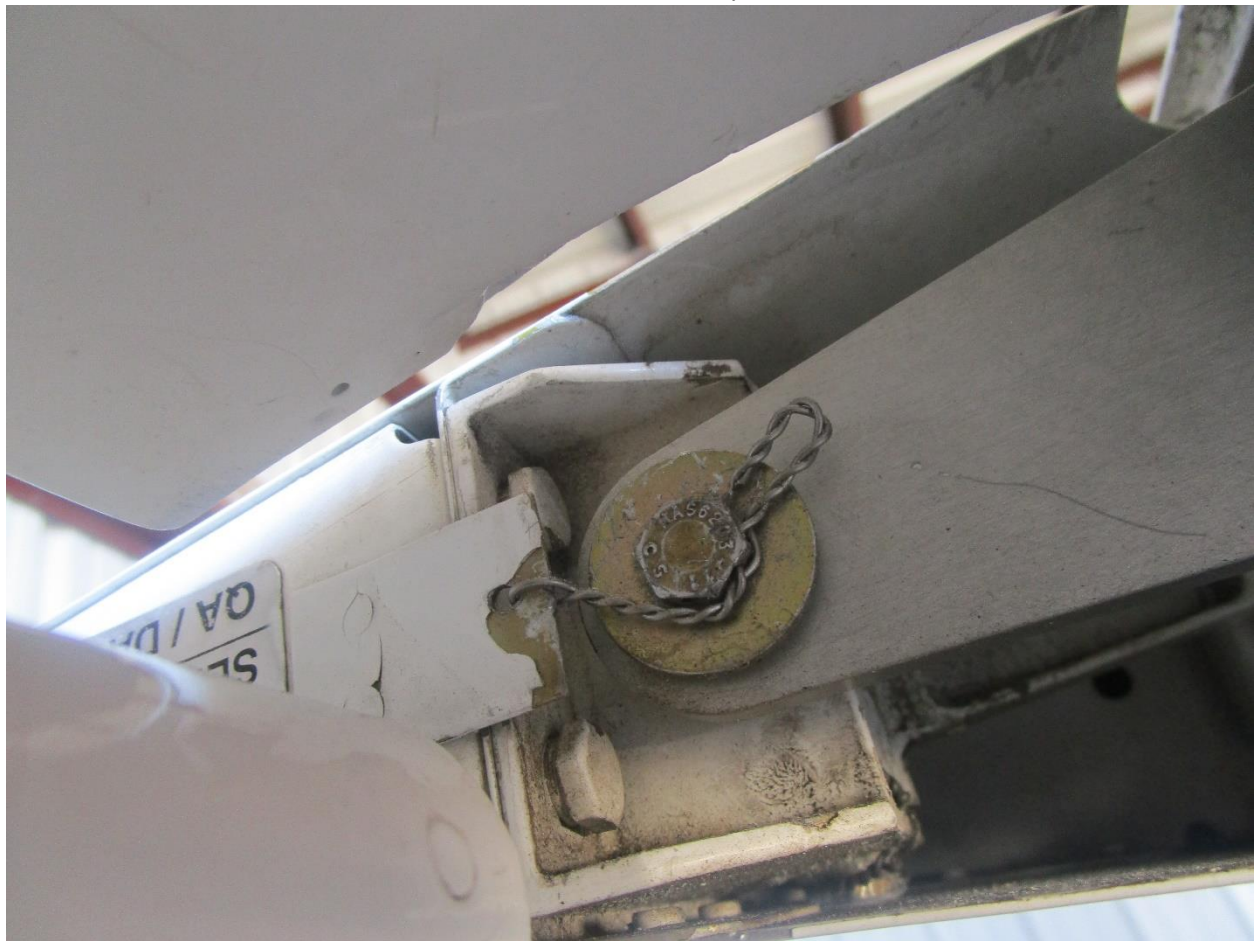
Left aileron still installed. Inboard bolt attachment with safety wire shown for reference.
