# Memorandum of Conversation

Conversation Regarding: CEN19LA147, N4861P

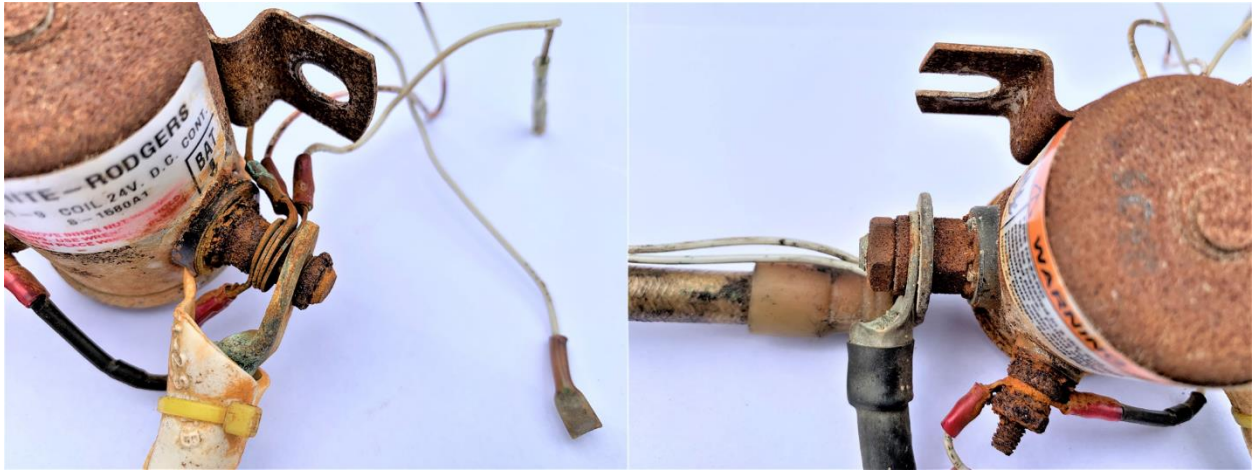
Examination of the airplane's electrical system revealed the battery's positive power cable was loose where it attached to the battery contactor (p/n S-1580A1) terminal. The nut used to secure the battery's positive power cable was significantly smaller

than the nut used on the terminal that secured two cables; one cable to the battery switch and the other cable to the starter motor contactor. Additionally, the loose positive battery cable component stack-up did not include any washers. The nut had backed off about 2 threads, which resulted in a loose cable connection (Figure 1).

Figure 1. Battery contactor terminal for the positive battery cable was loose (left photo). The battery contactor terminal for the battery switch and starter motor contactor cables was tight (right photo).
