# The National Transportation Safety Board

Office of Aviation Safety  
Central Region  
Memorandum for the Record  
Engine Examination Findings  
CEN19LA156  
Oaks, North Dakota  
May 5, 2019

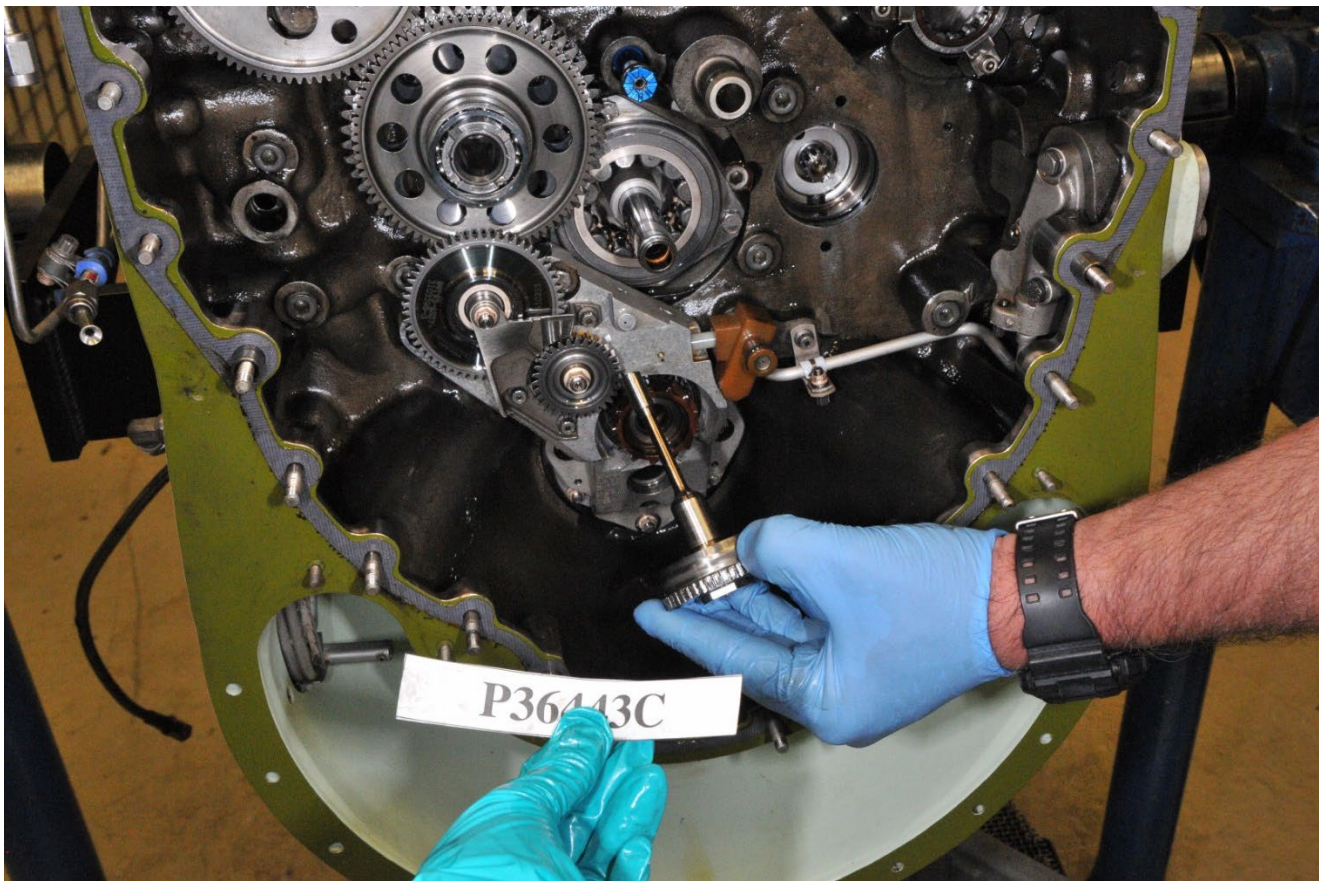
- The torque sensor was found intact and was free to rotate.
- Rotational scoring was present in the bore of spur gear teeth of helical cam gear.
- There were witness marks on the forward end of the helical cam gear of the torque sensor.
- The spur teeth on the helical cam gear were found severely damaged. About ½ of the gear teeth were smeared and the remaining gear teeth broken off.
- There was a slight witness mark on the aft end of the helical gear teeth.

Photo 1 Helical Cam Gear as found during Teardown Examination

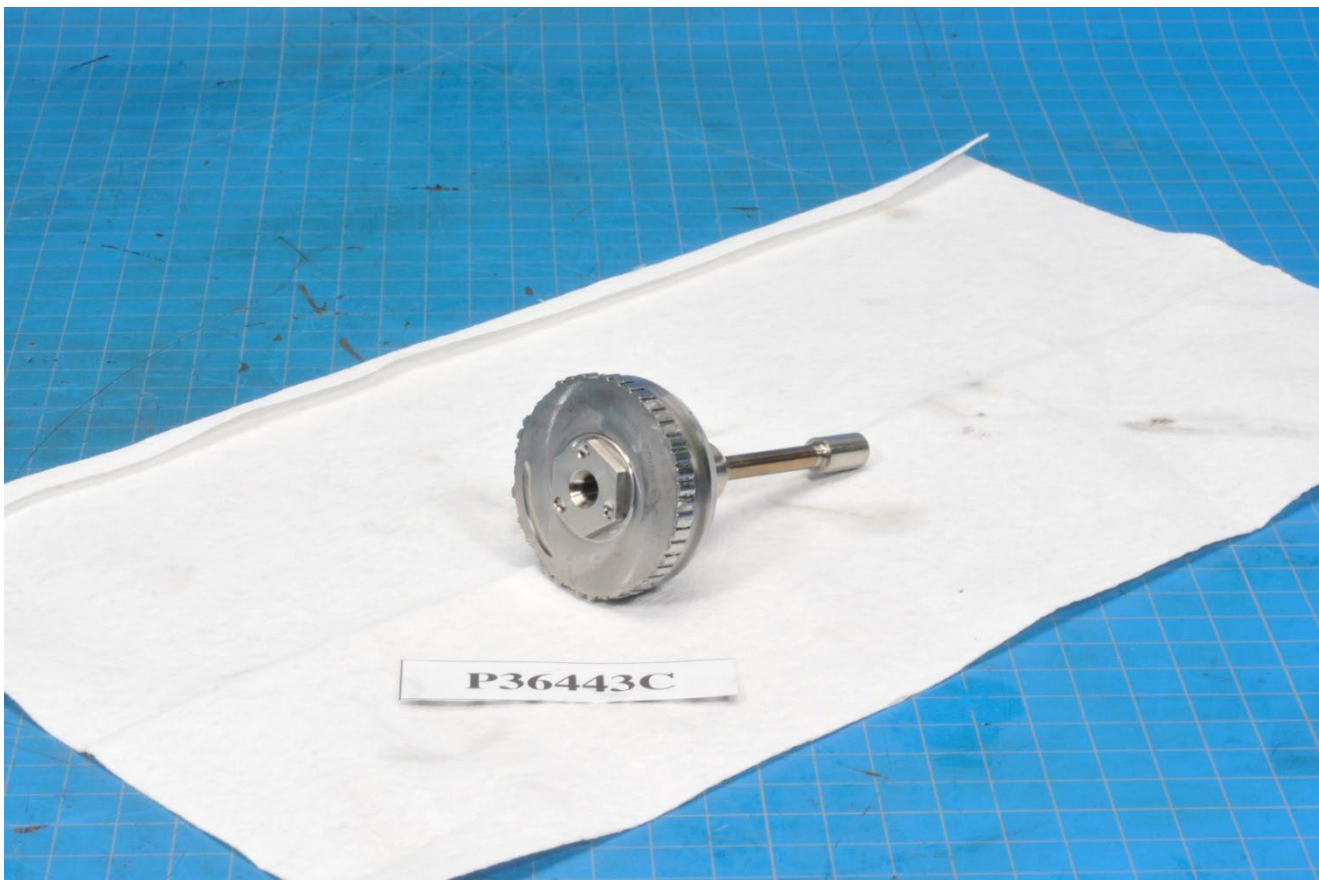
Photo 2 Helical Cam Gear Removed

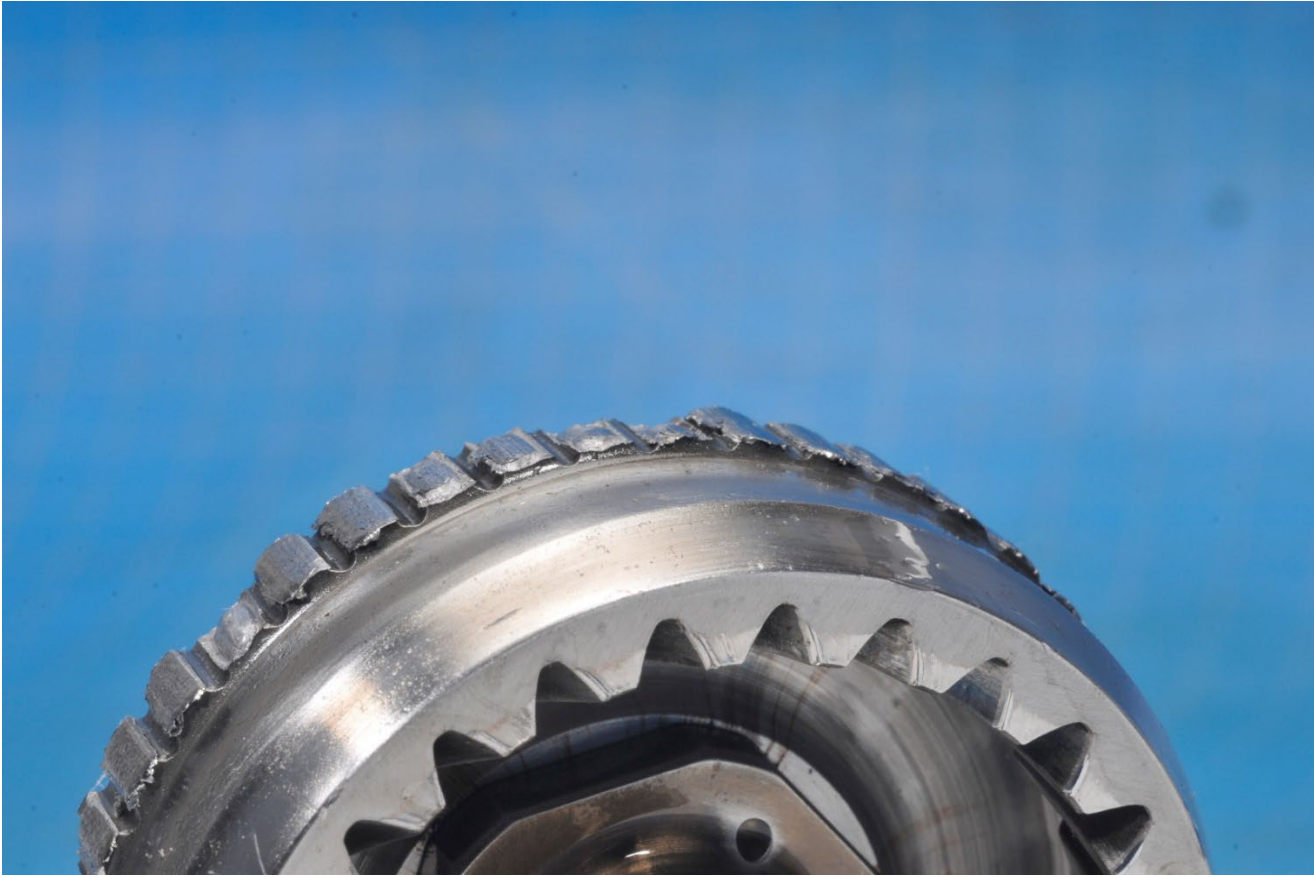
Photo 3 Closeup of Helical Cam Gear Teeth

- The test, teardown, and examination of the engine disclosed that the type and degree of damage to the helical gear teeth was indicative of an uncoupling of the high-speed pinion from the helical cam gear of the engine torque sensor.
- Examination of the gear teeth of the helical cam gear shows indication of fatigue on several of the broken gear teeth. No defects in the helical gear were identified during the material analysis. The cause of the fatigue could not be identified.
