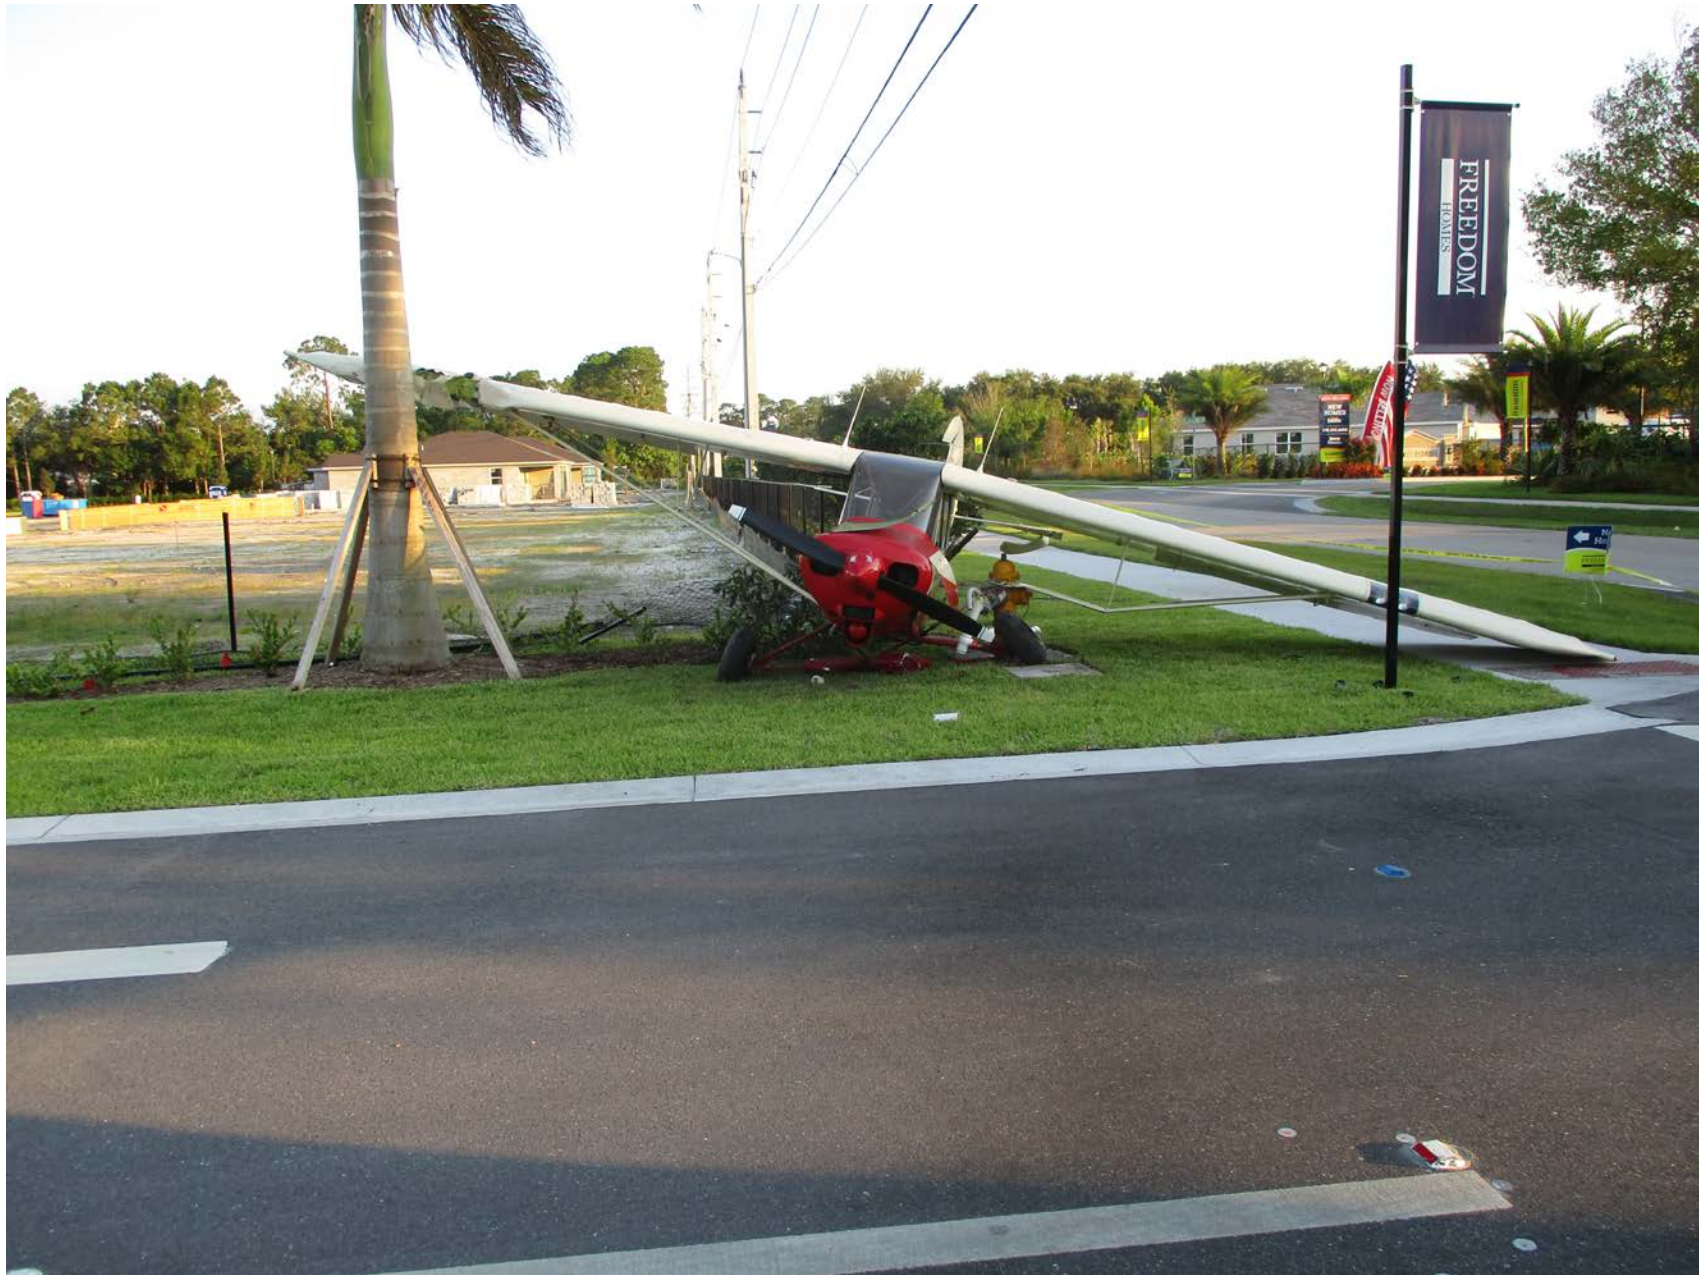
**Photo 1 – FAA supplied view of the front of the airplane.**

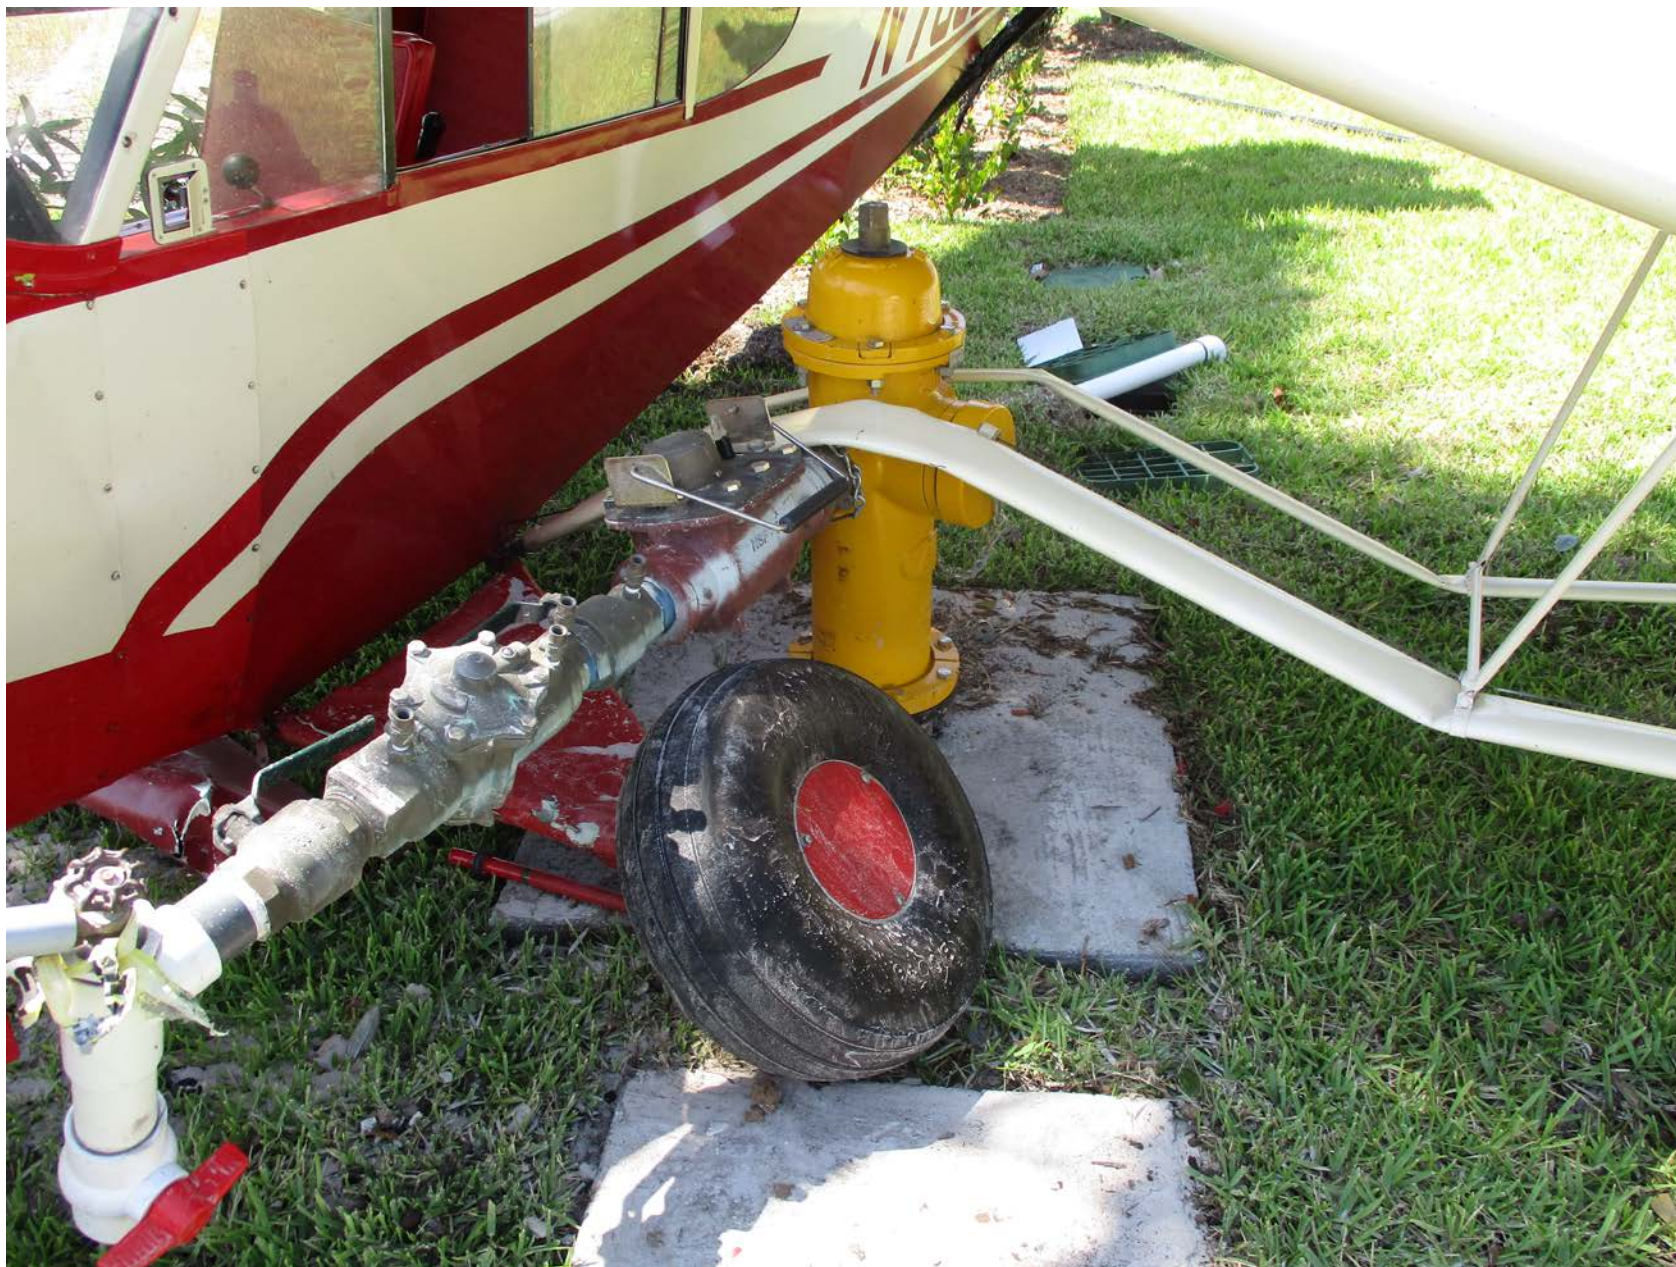
**Photo 2 - FAA supplied view of the left main landing gear.**

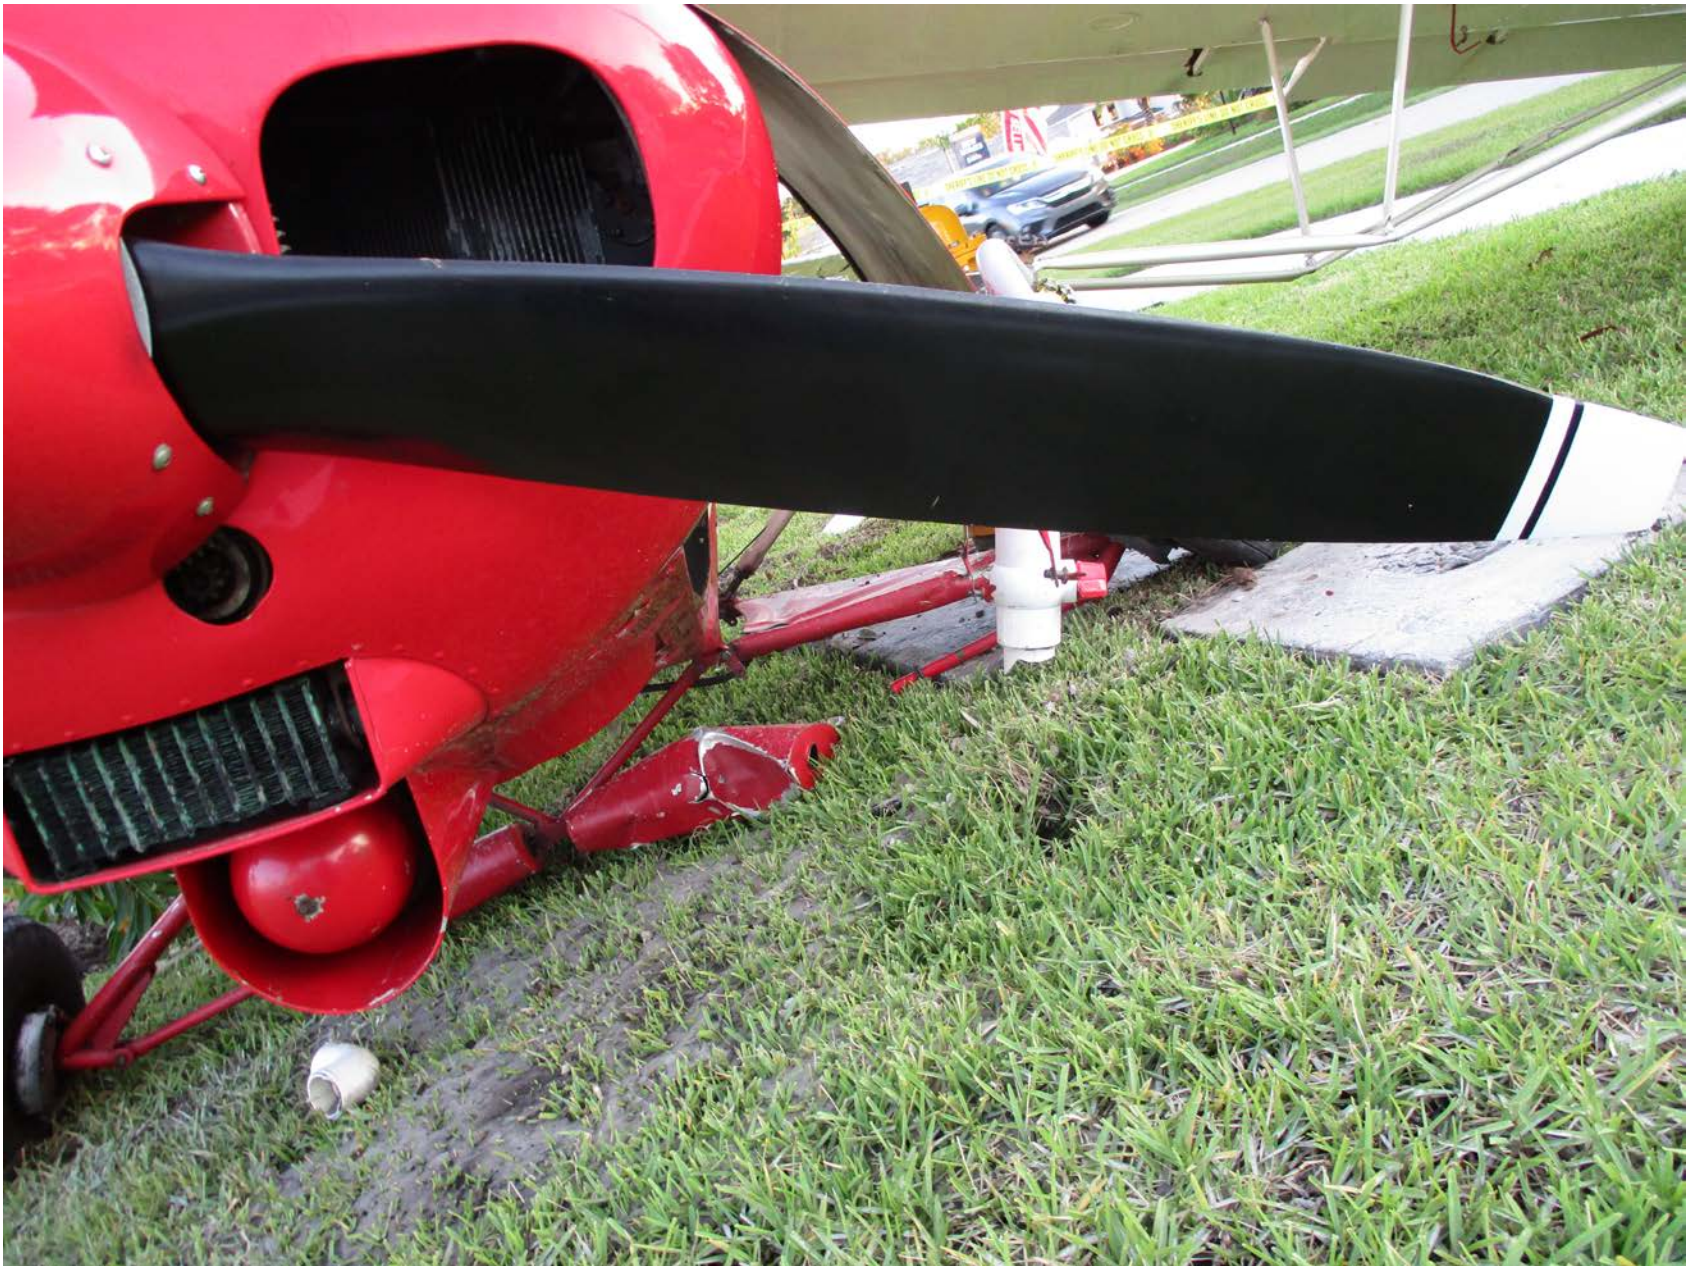
**Photo 3 - FAA supplied view of a propeller blade.**

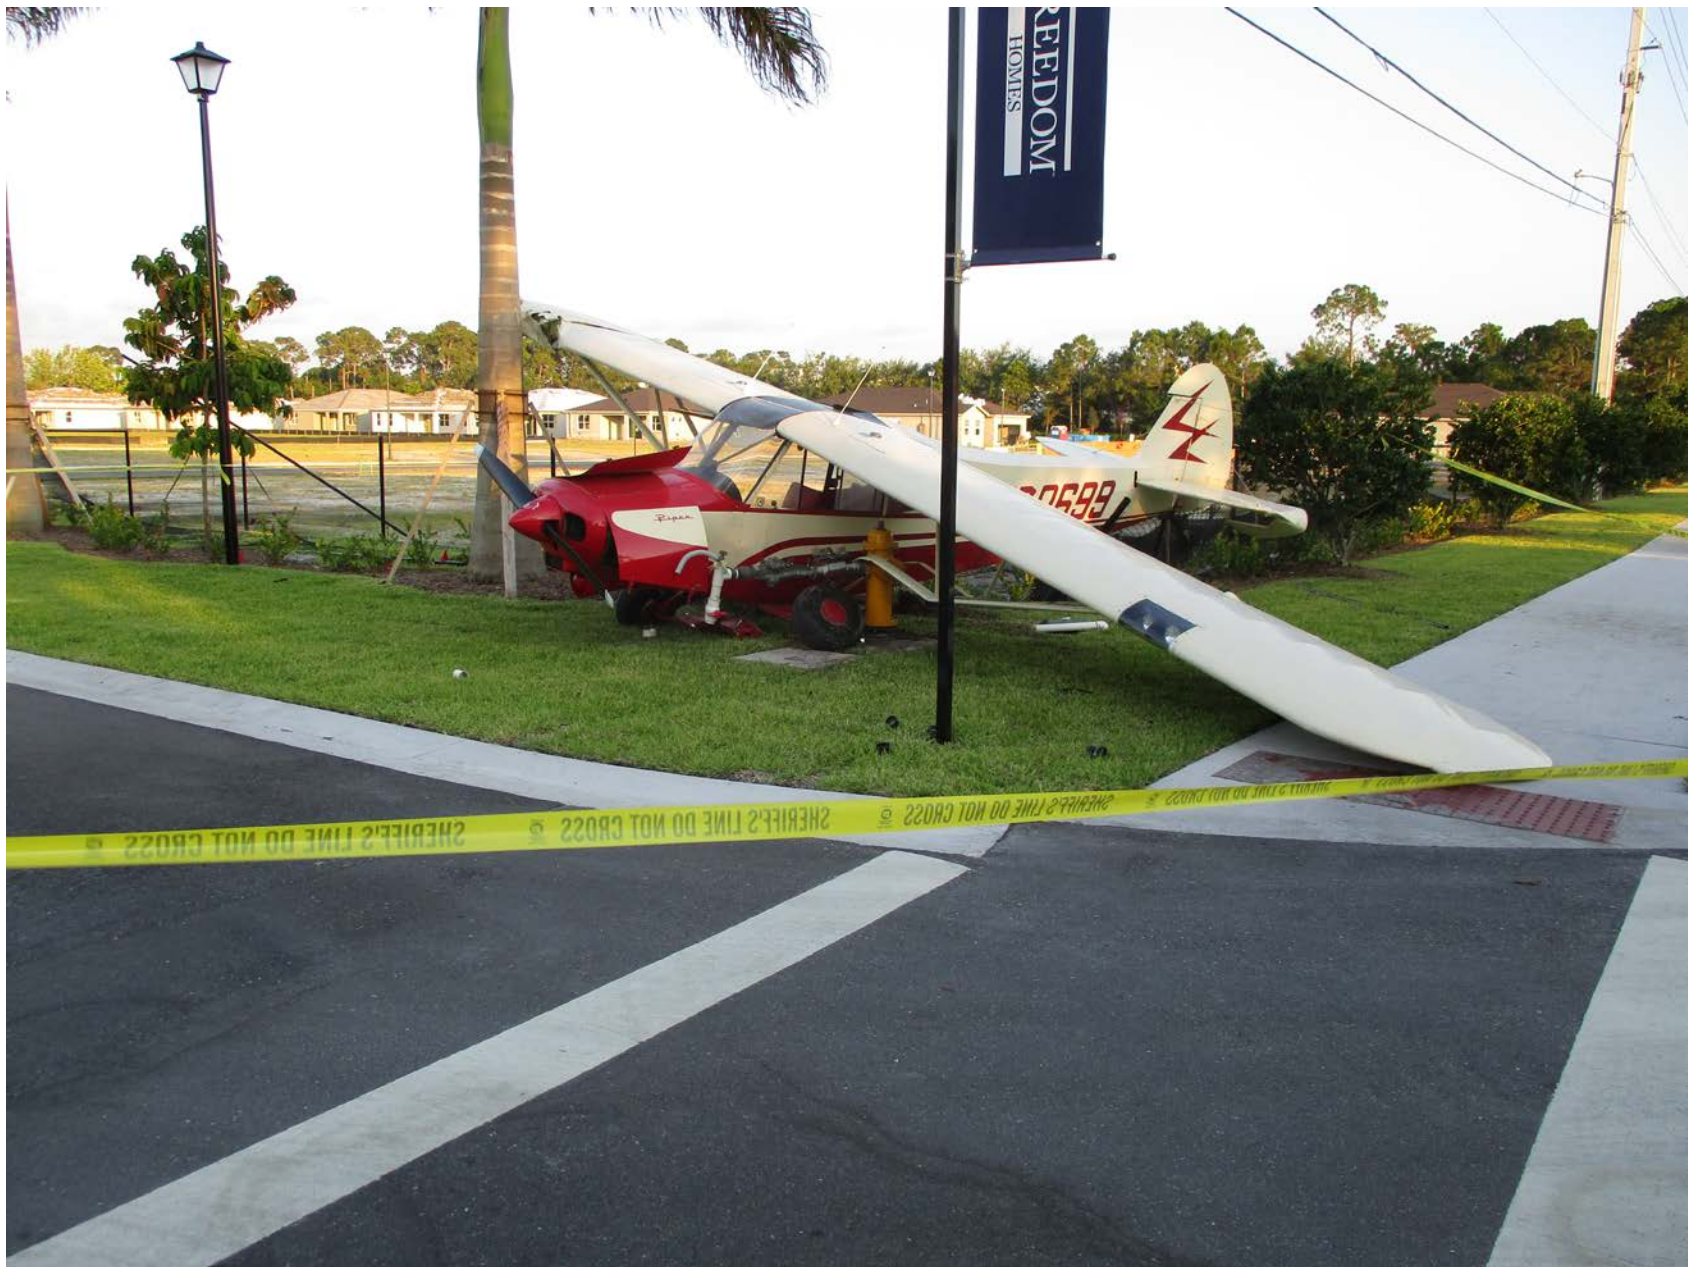
**Photo 4 - FAA supplied front quartering view of the left side of the airplane.**

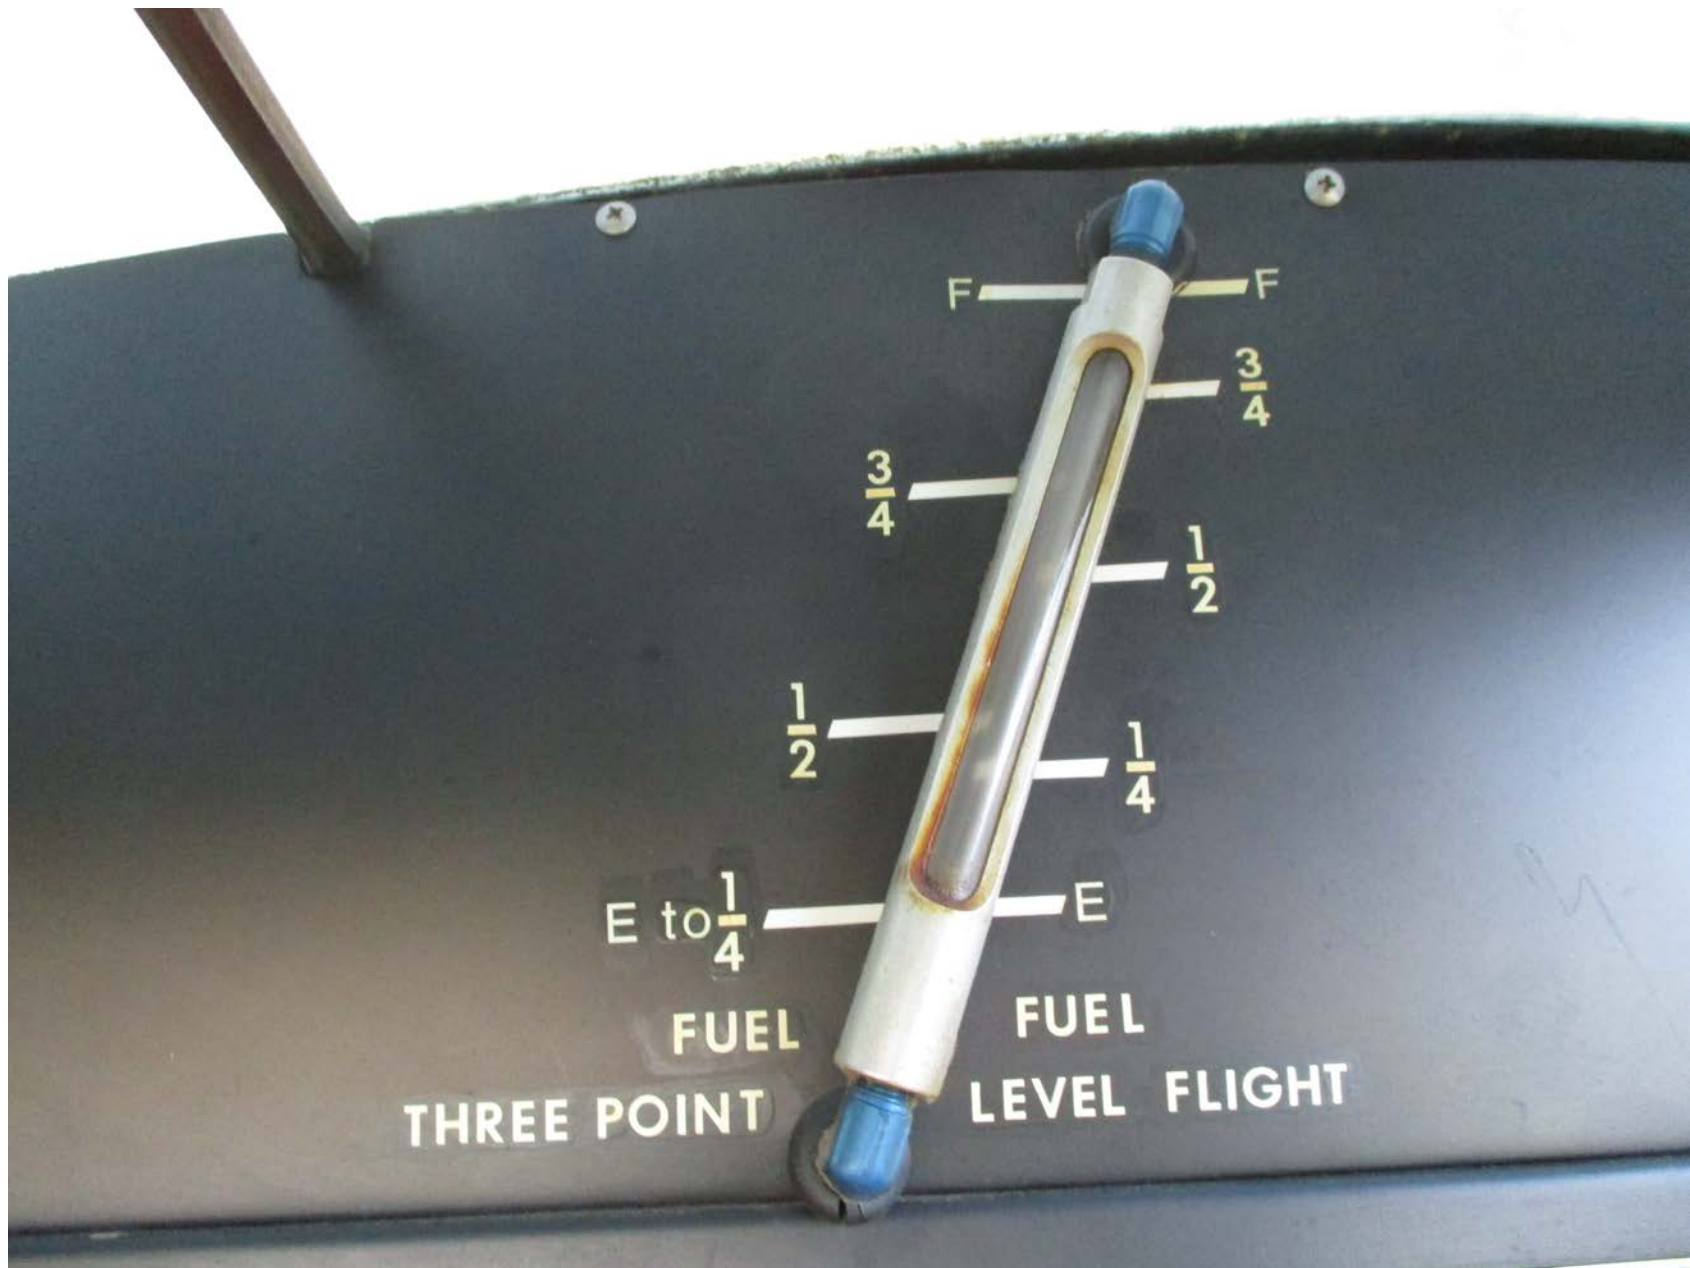
Photo 5 - FAA supplied view of a fuel sight glass.

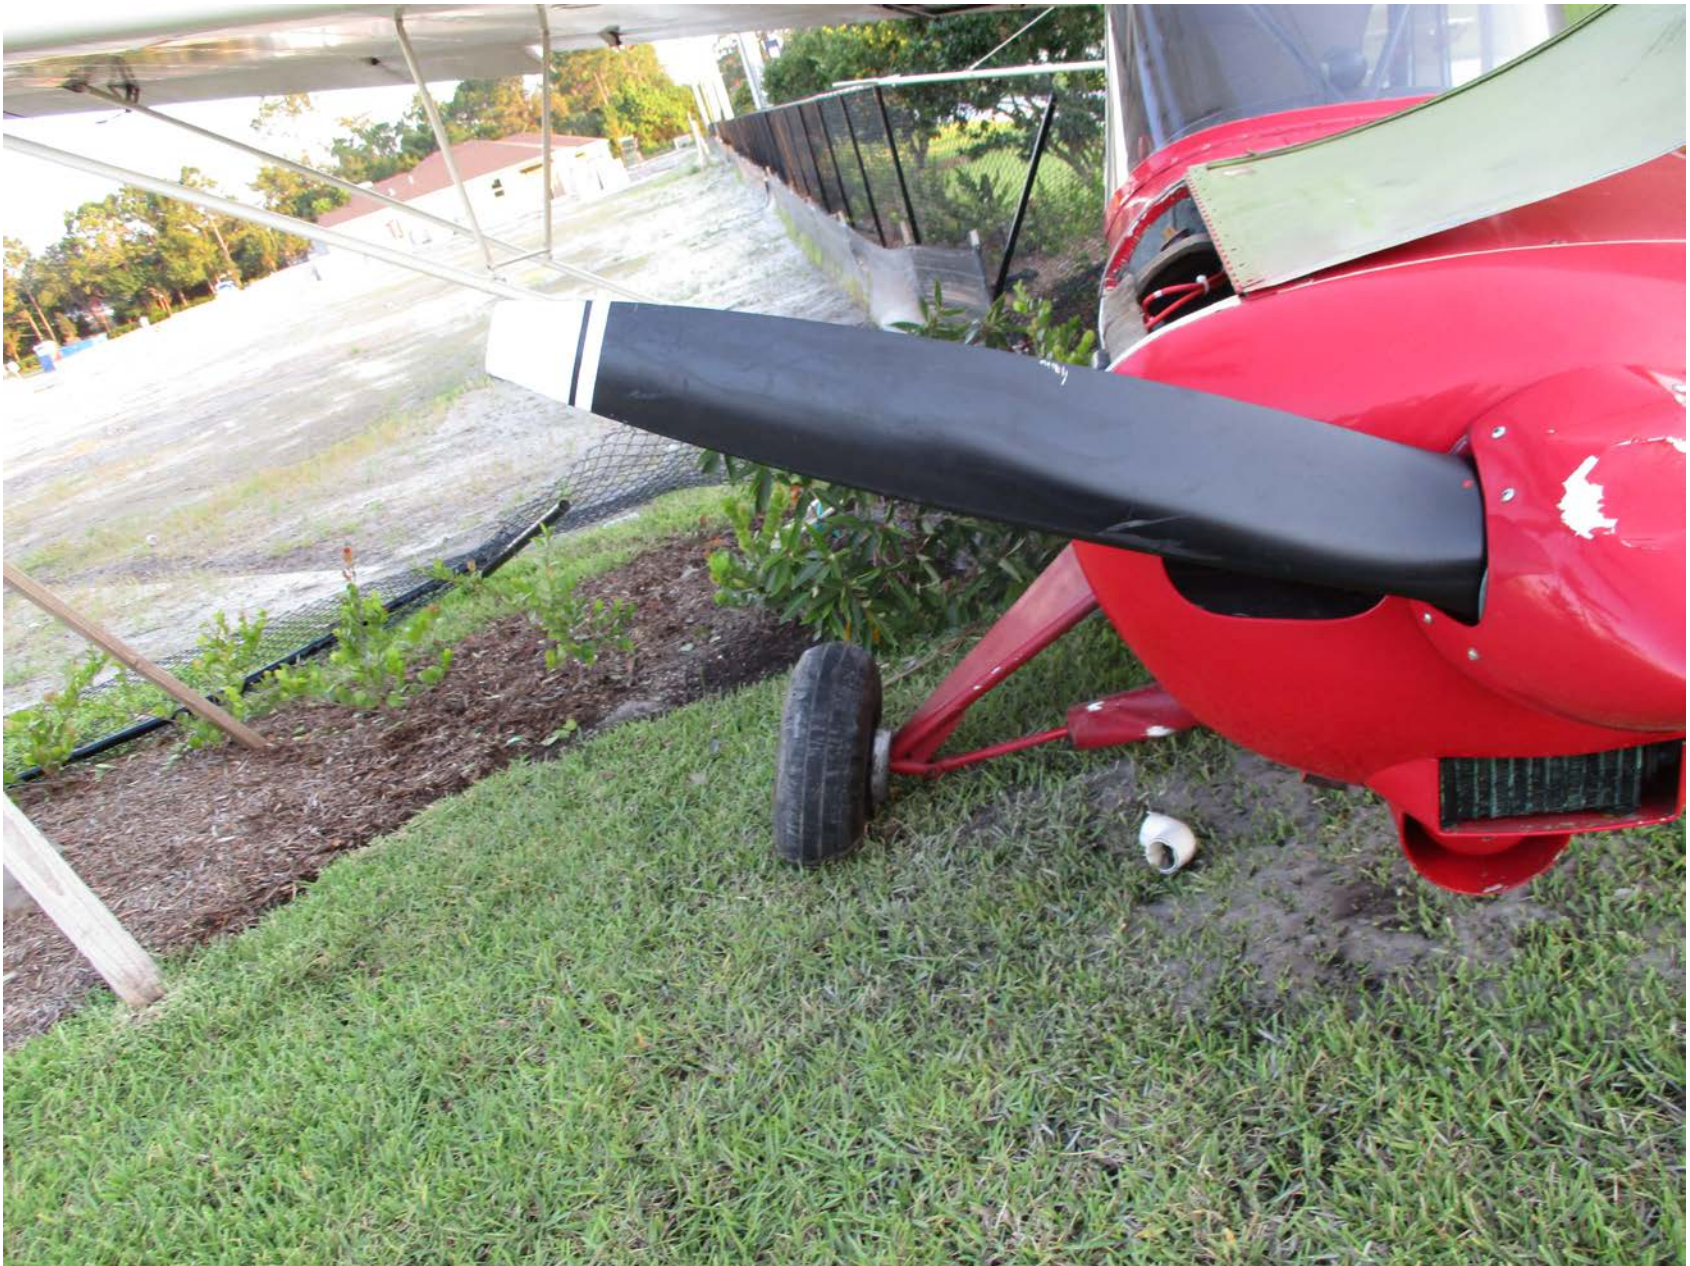
**Photo 6 - FAA supplied view of a propeller blade.**

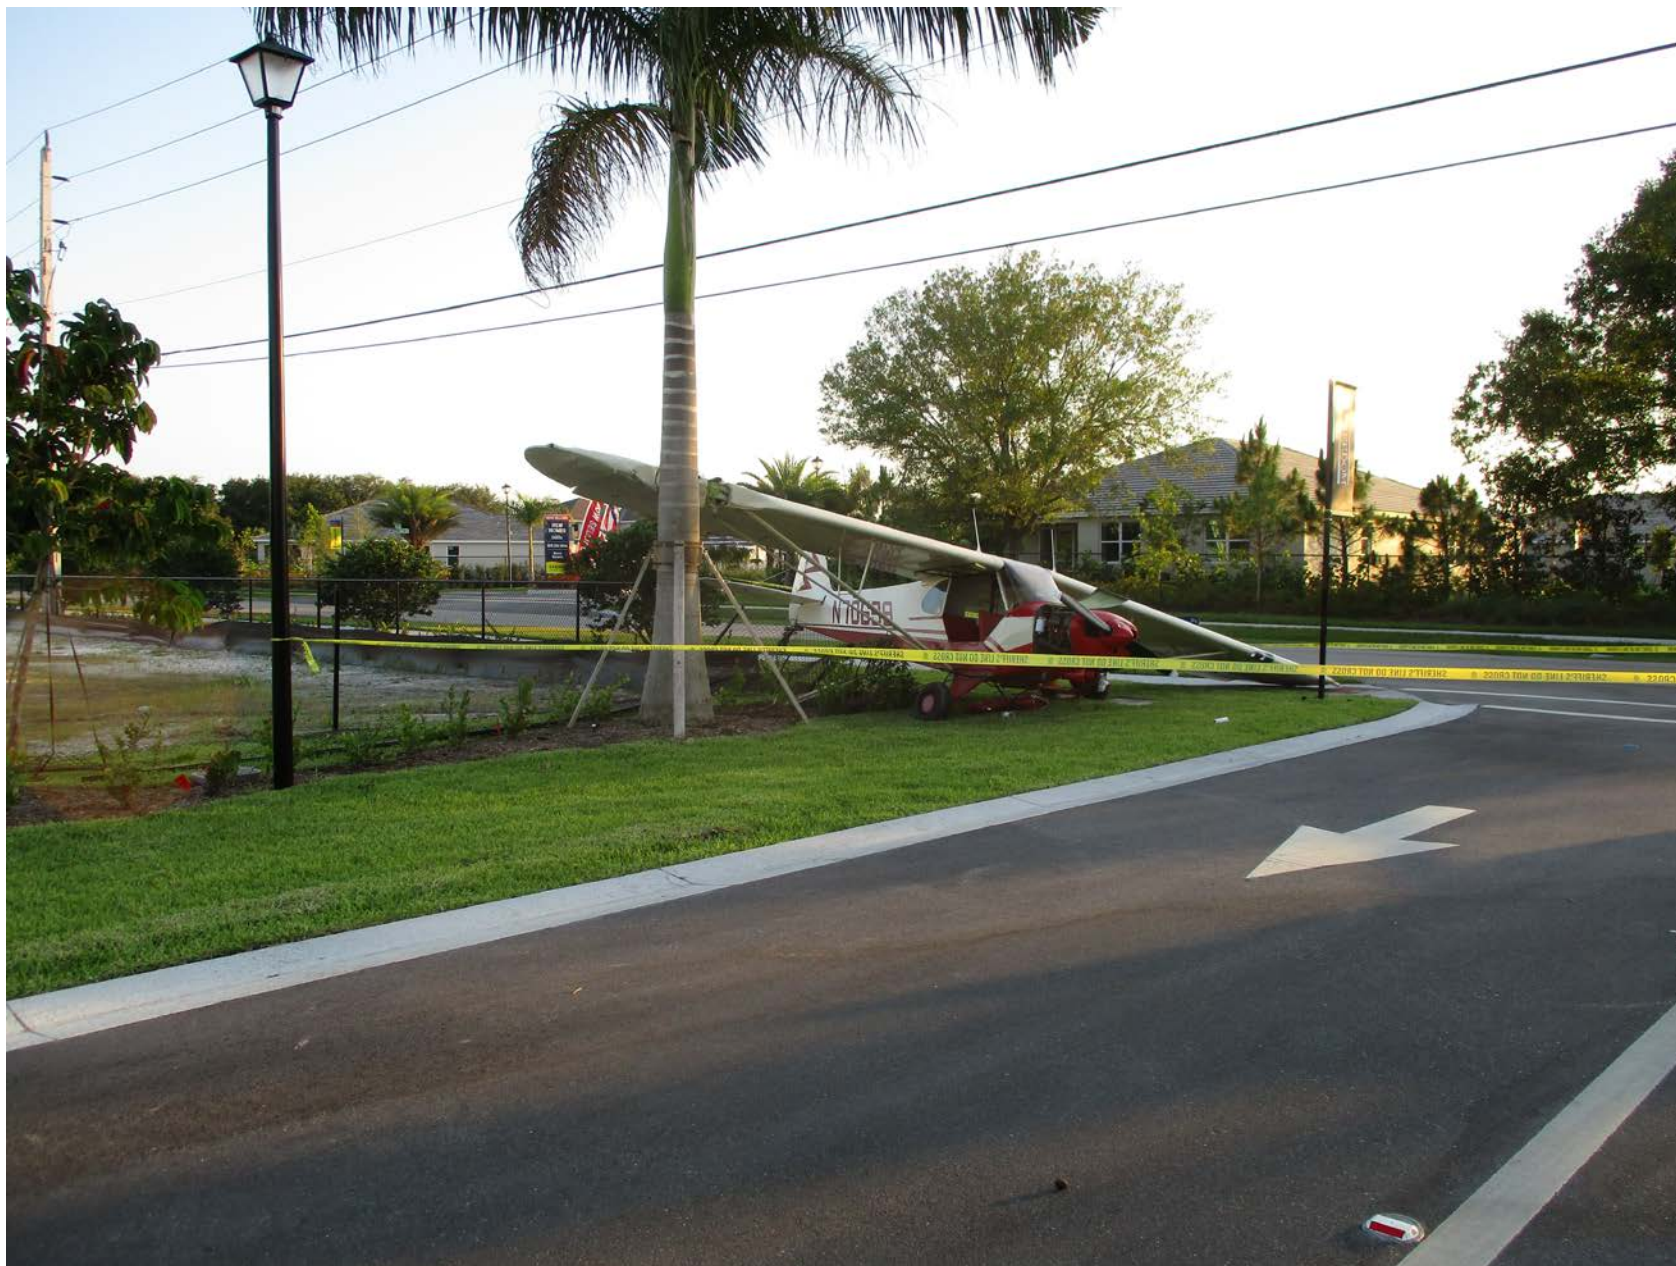
**Photo 7 - FAA supplied front quartering view of the right side of the airplane.**

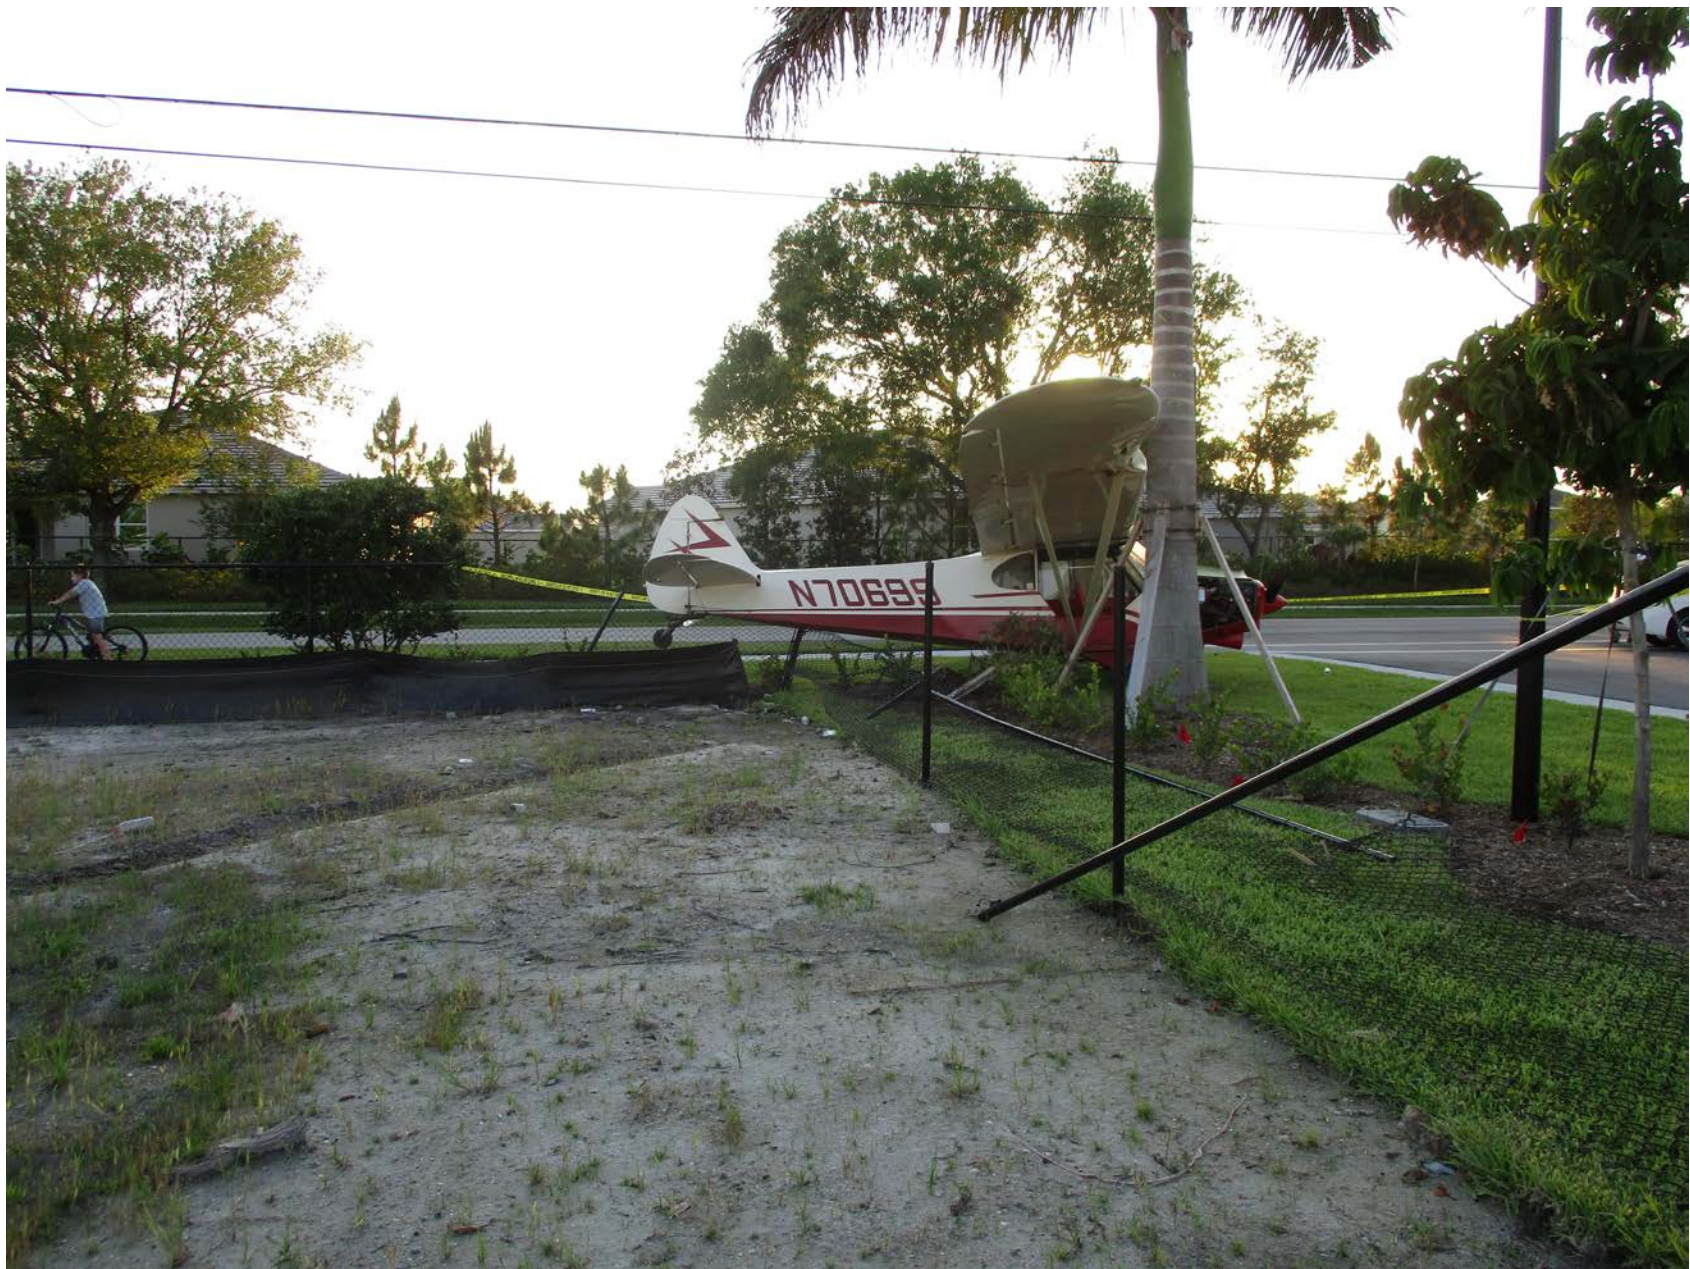
**Photo 8 - FAA supplied view of the right side of the airplane.**

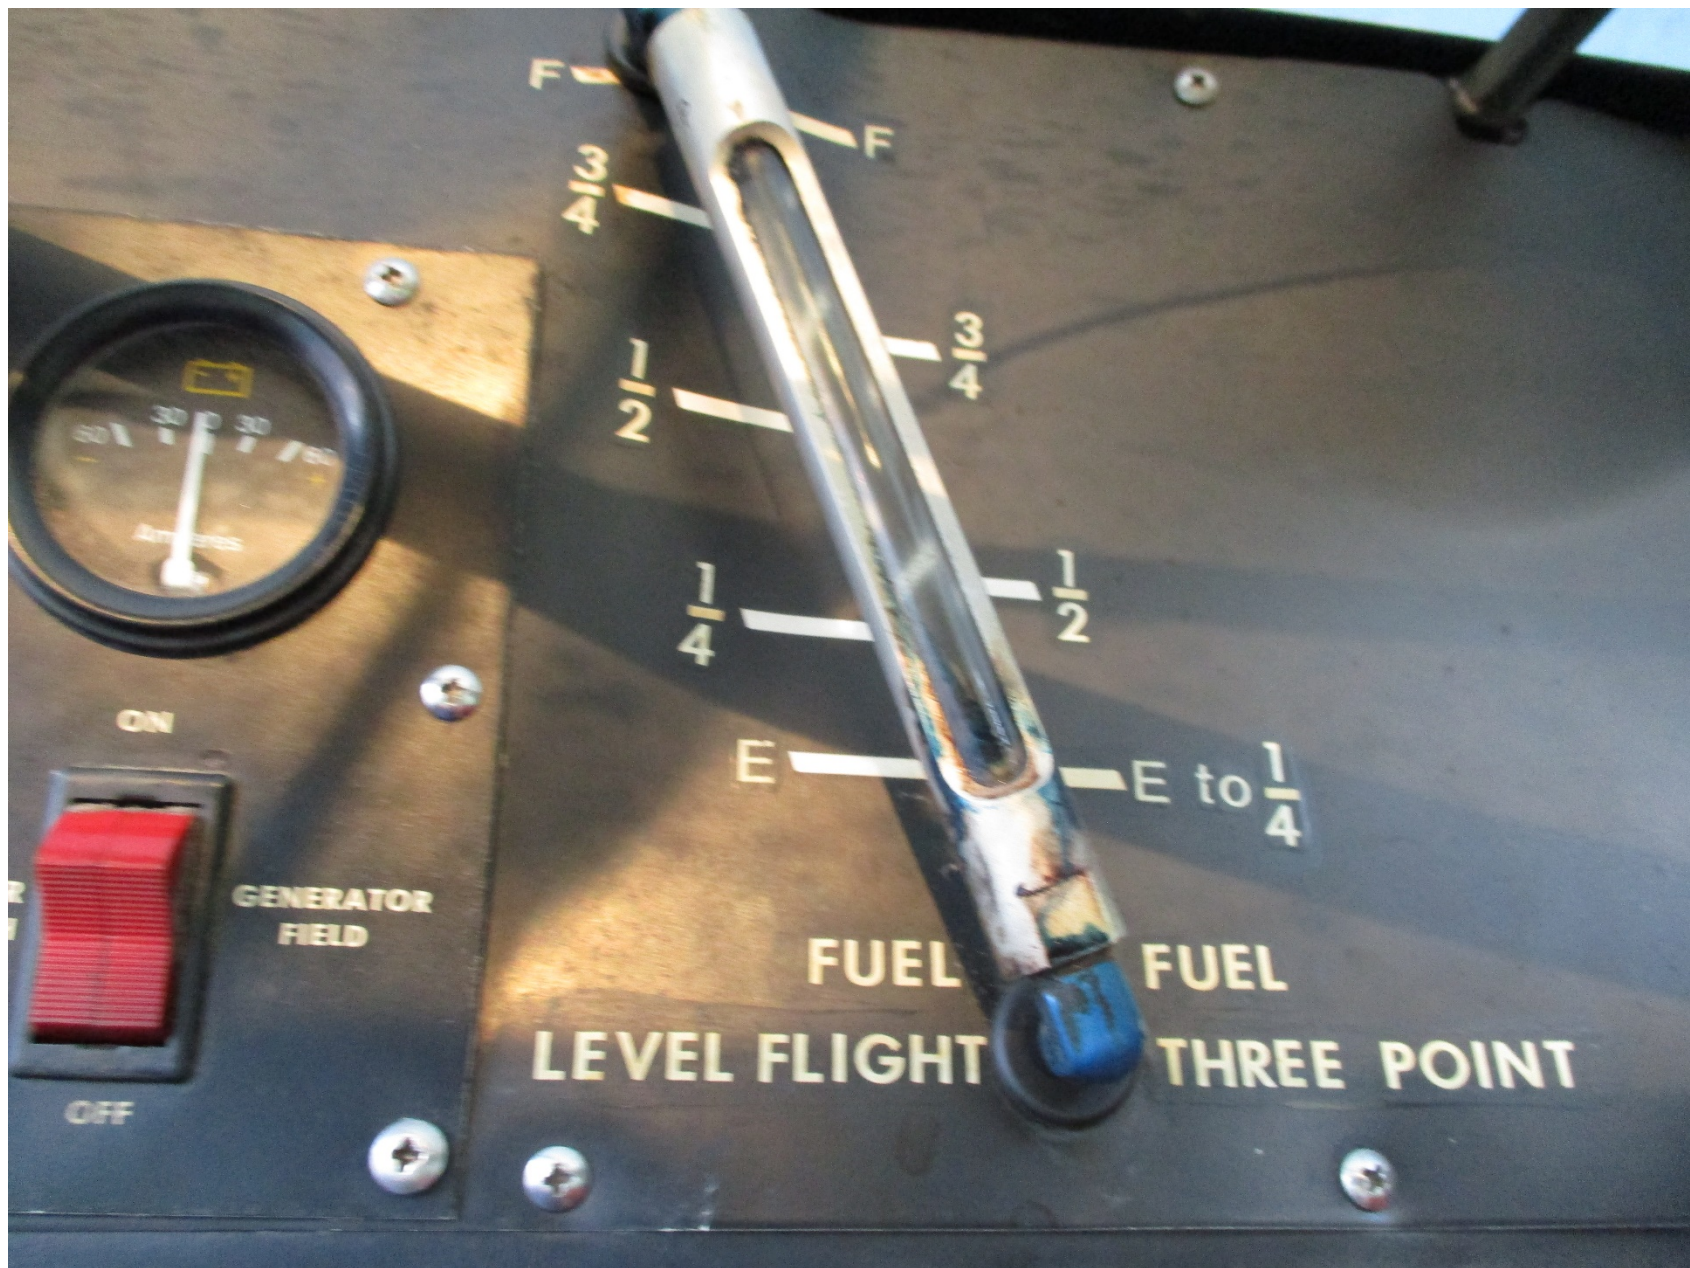
Photo 9 - FAA supplied view of a fuel sight glass.

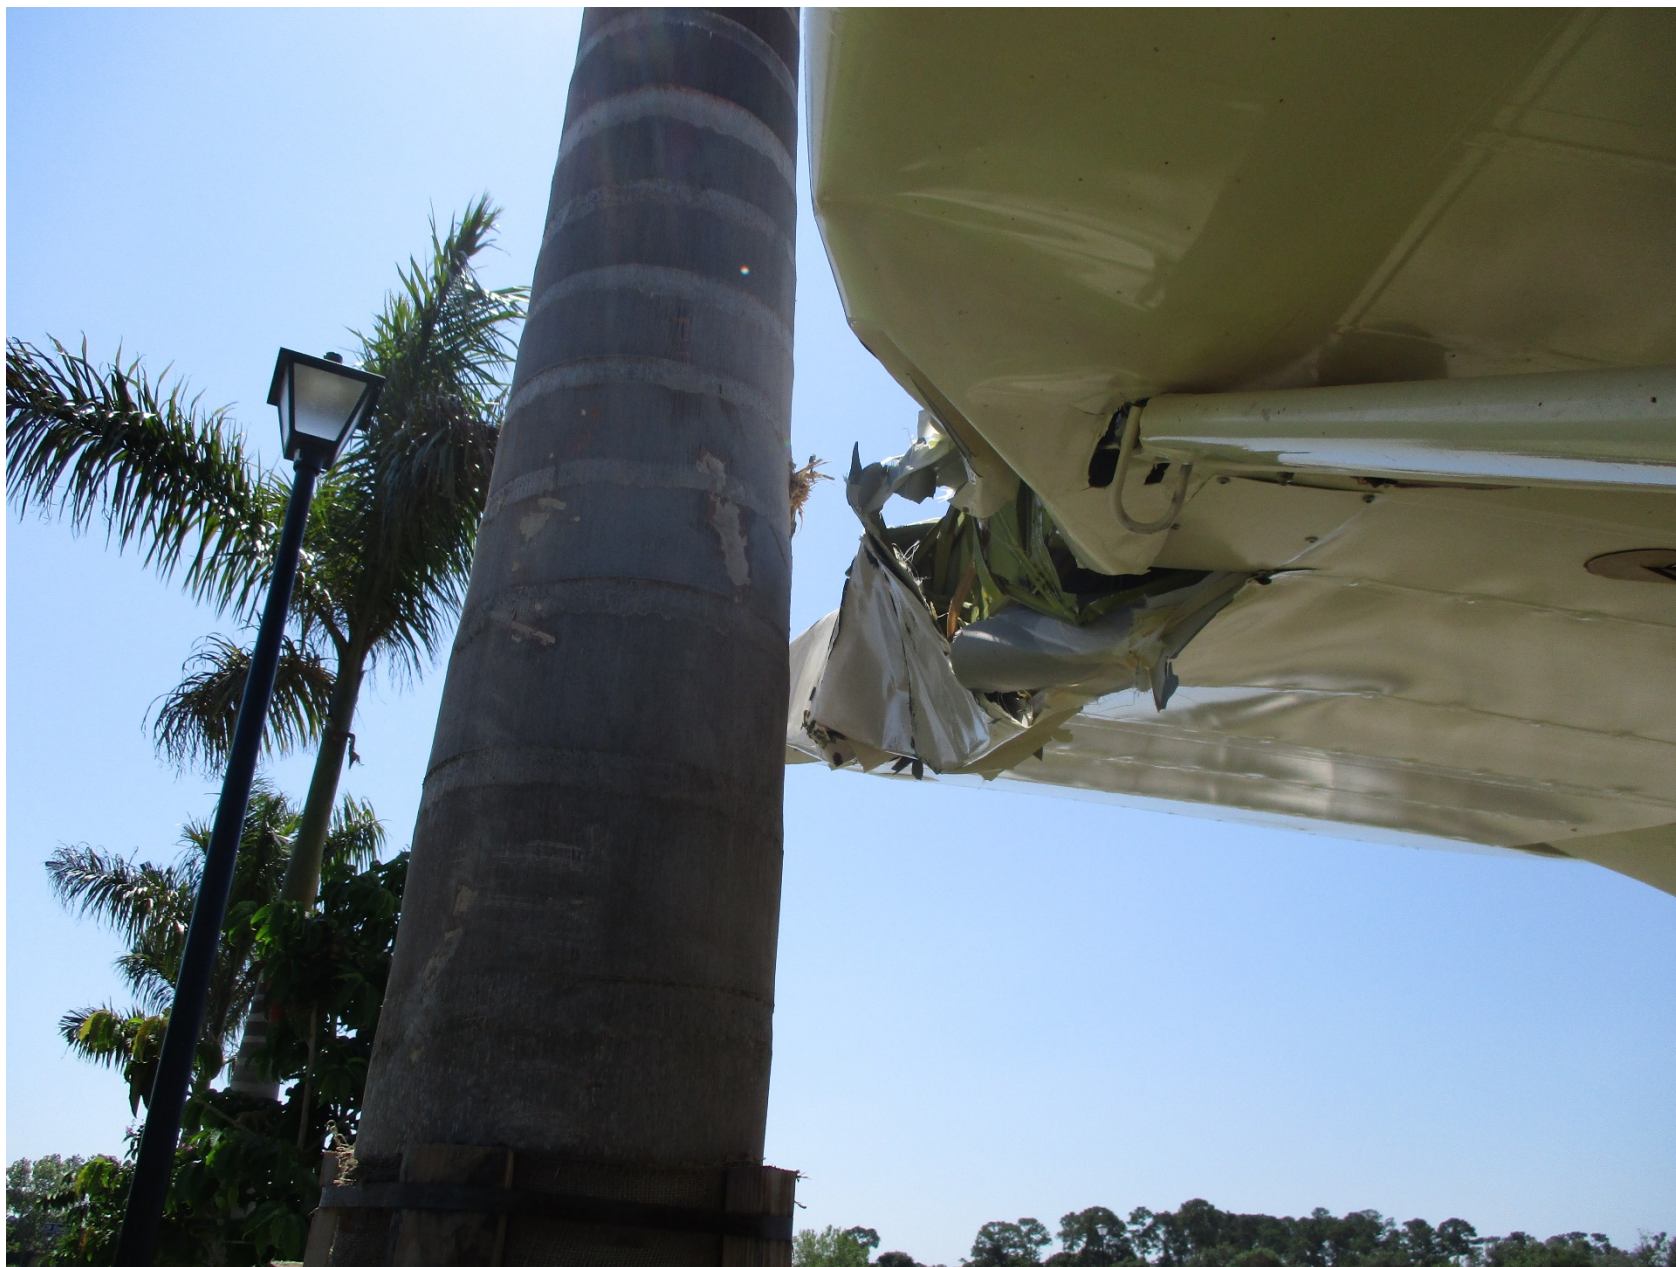
**Photo 10 - FAA supplied view of a tree and damage to the right wing leading edge.**
