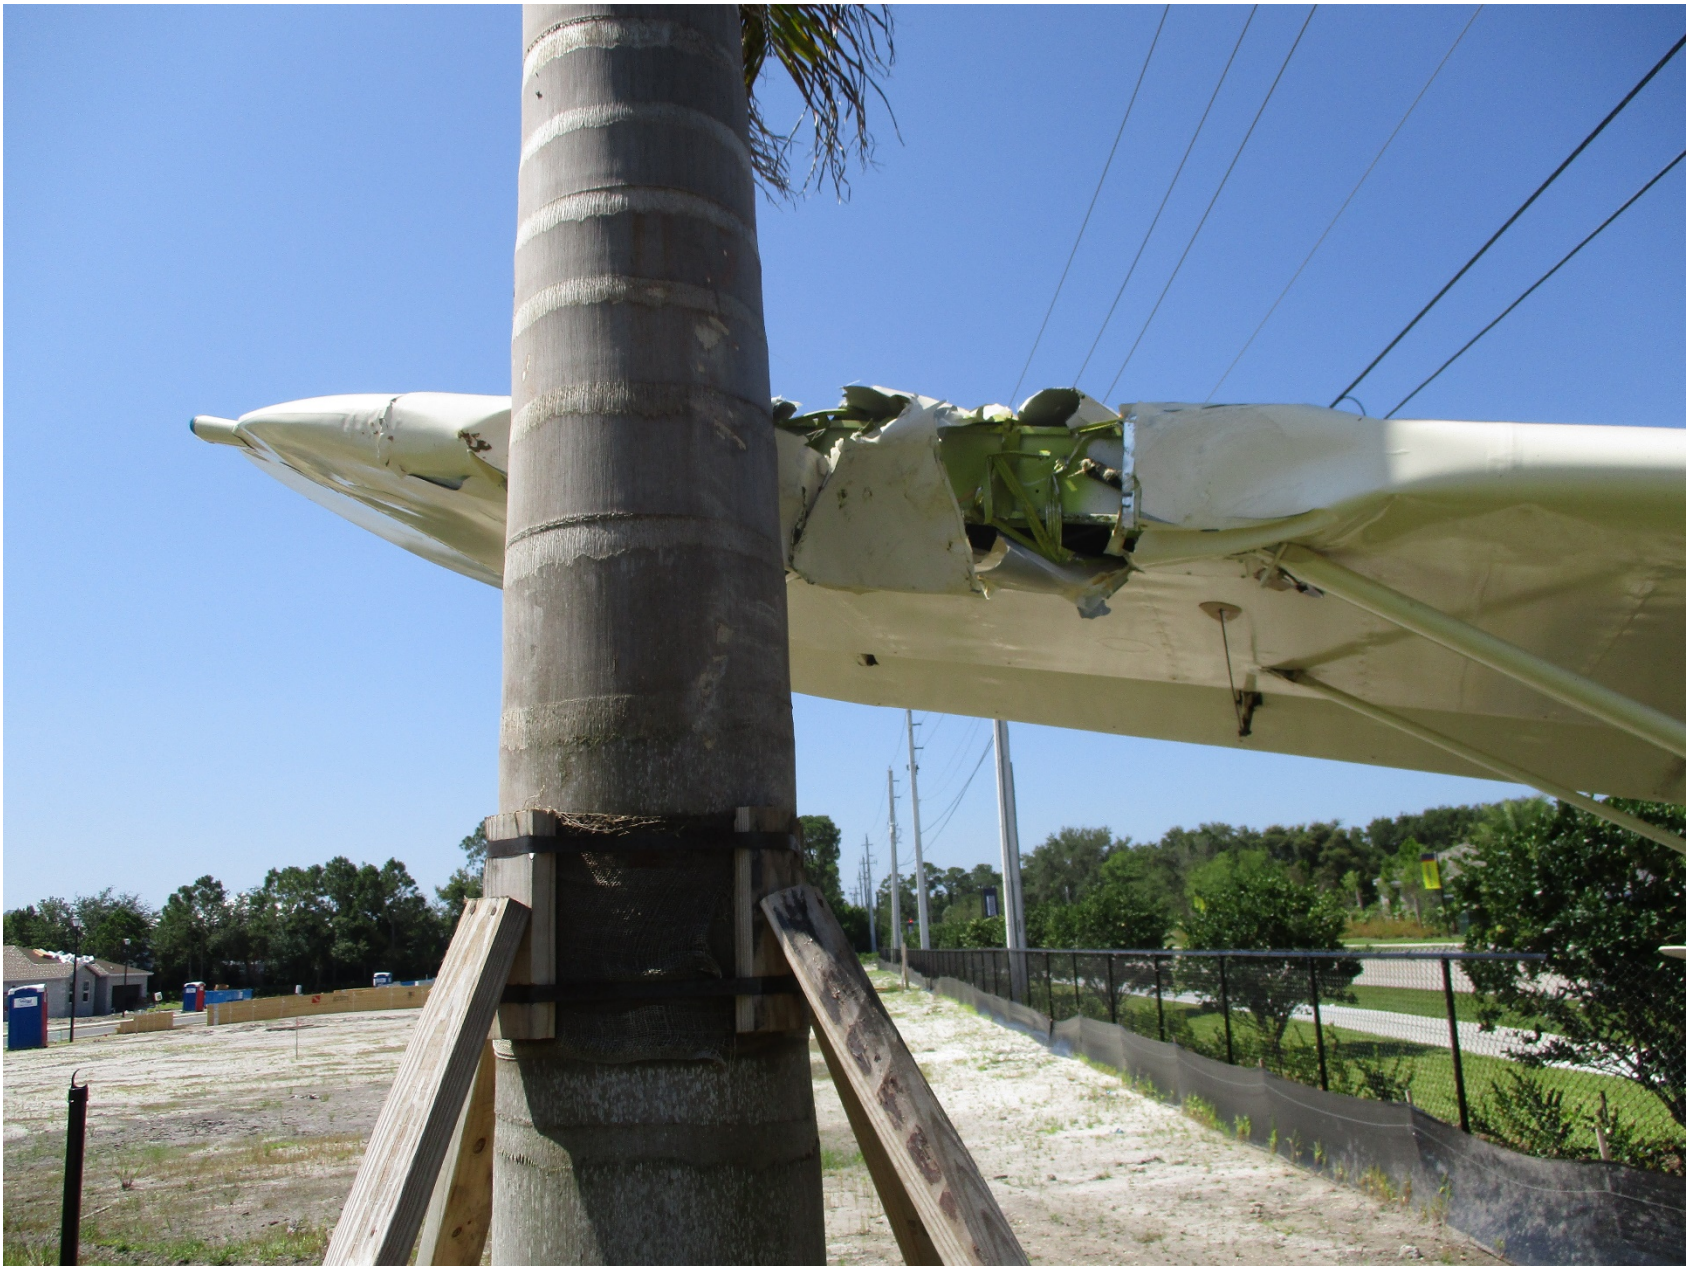
**Photo 11 - FAA supplied view of a tree and damage to the right wing leading edge.**

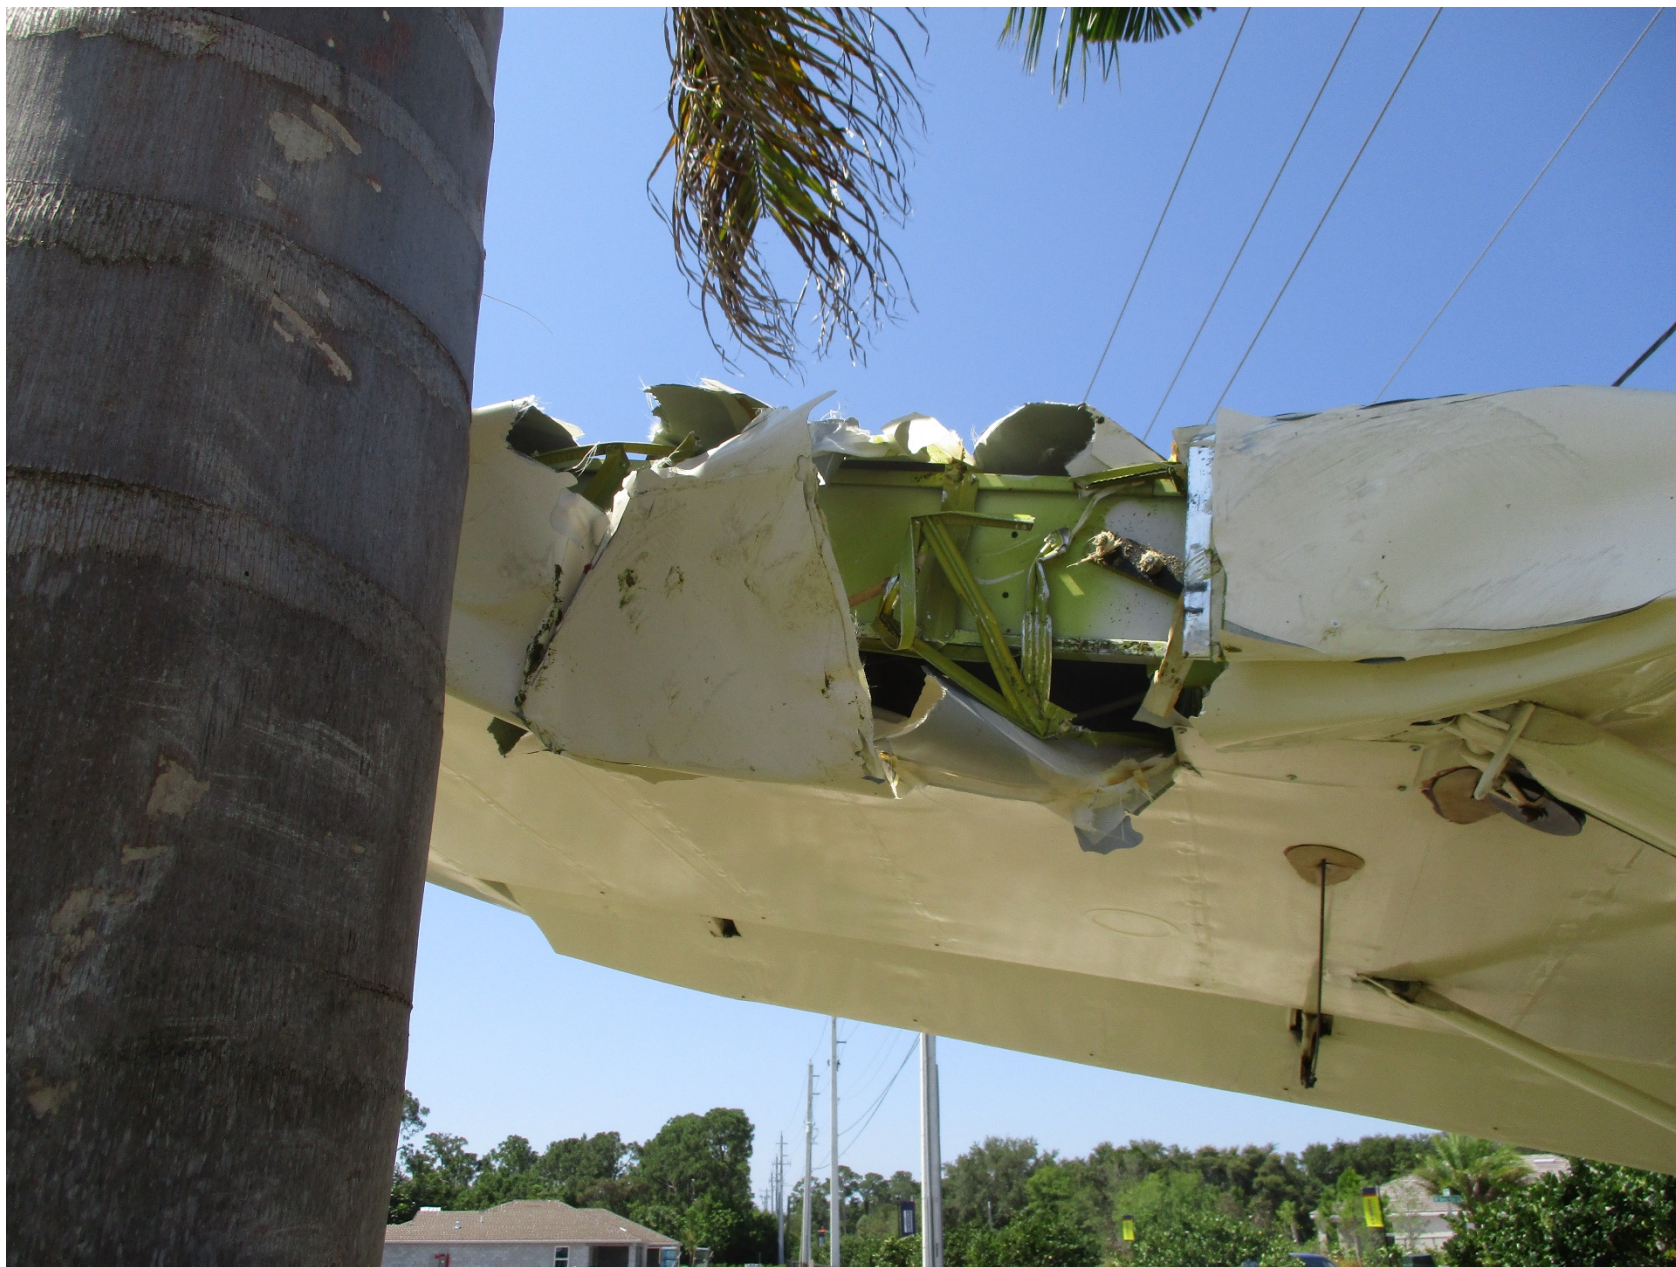
**Photo 12 - FAA supplied close-up view of a tree and damage to the right wing leading edge.**

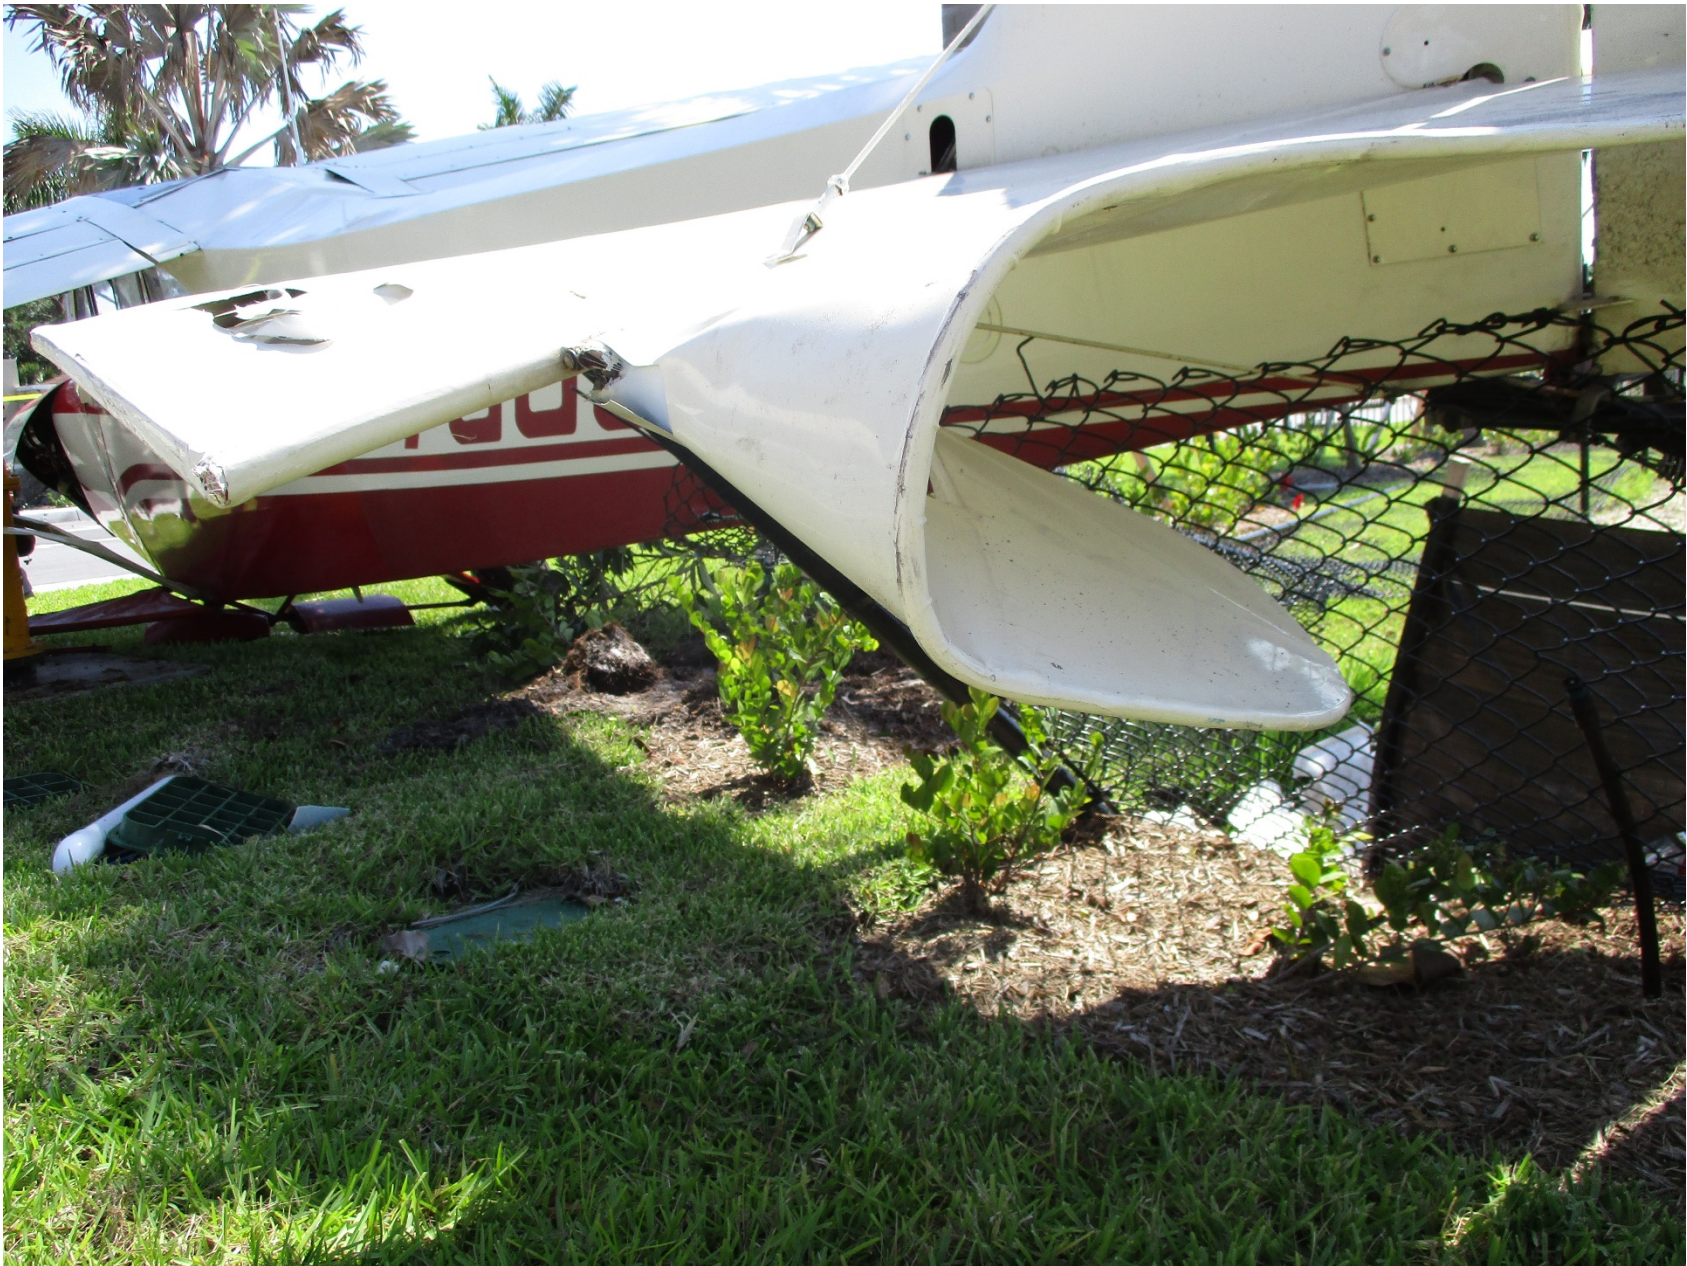
**Photo 13 - FAA supplied view of the left elevator trailing edge.**
