# NATIONAL TRANSPORTATION SAFETY BOARD

## MATERIALS LABORATORY FACTUAL REPORT

Report No. 19-053

Place : Jacksonville, Florida  
Date : June 10, 2019  
Vehicle : Rockwell 690  
NTSB No. : CEN19LA168  
Investigator : Courtney Liedler

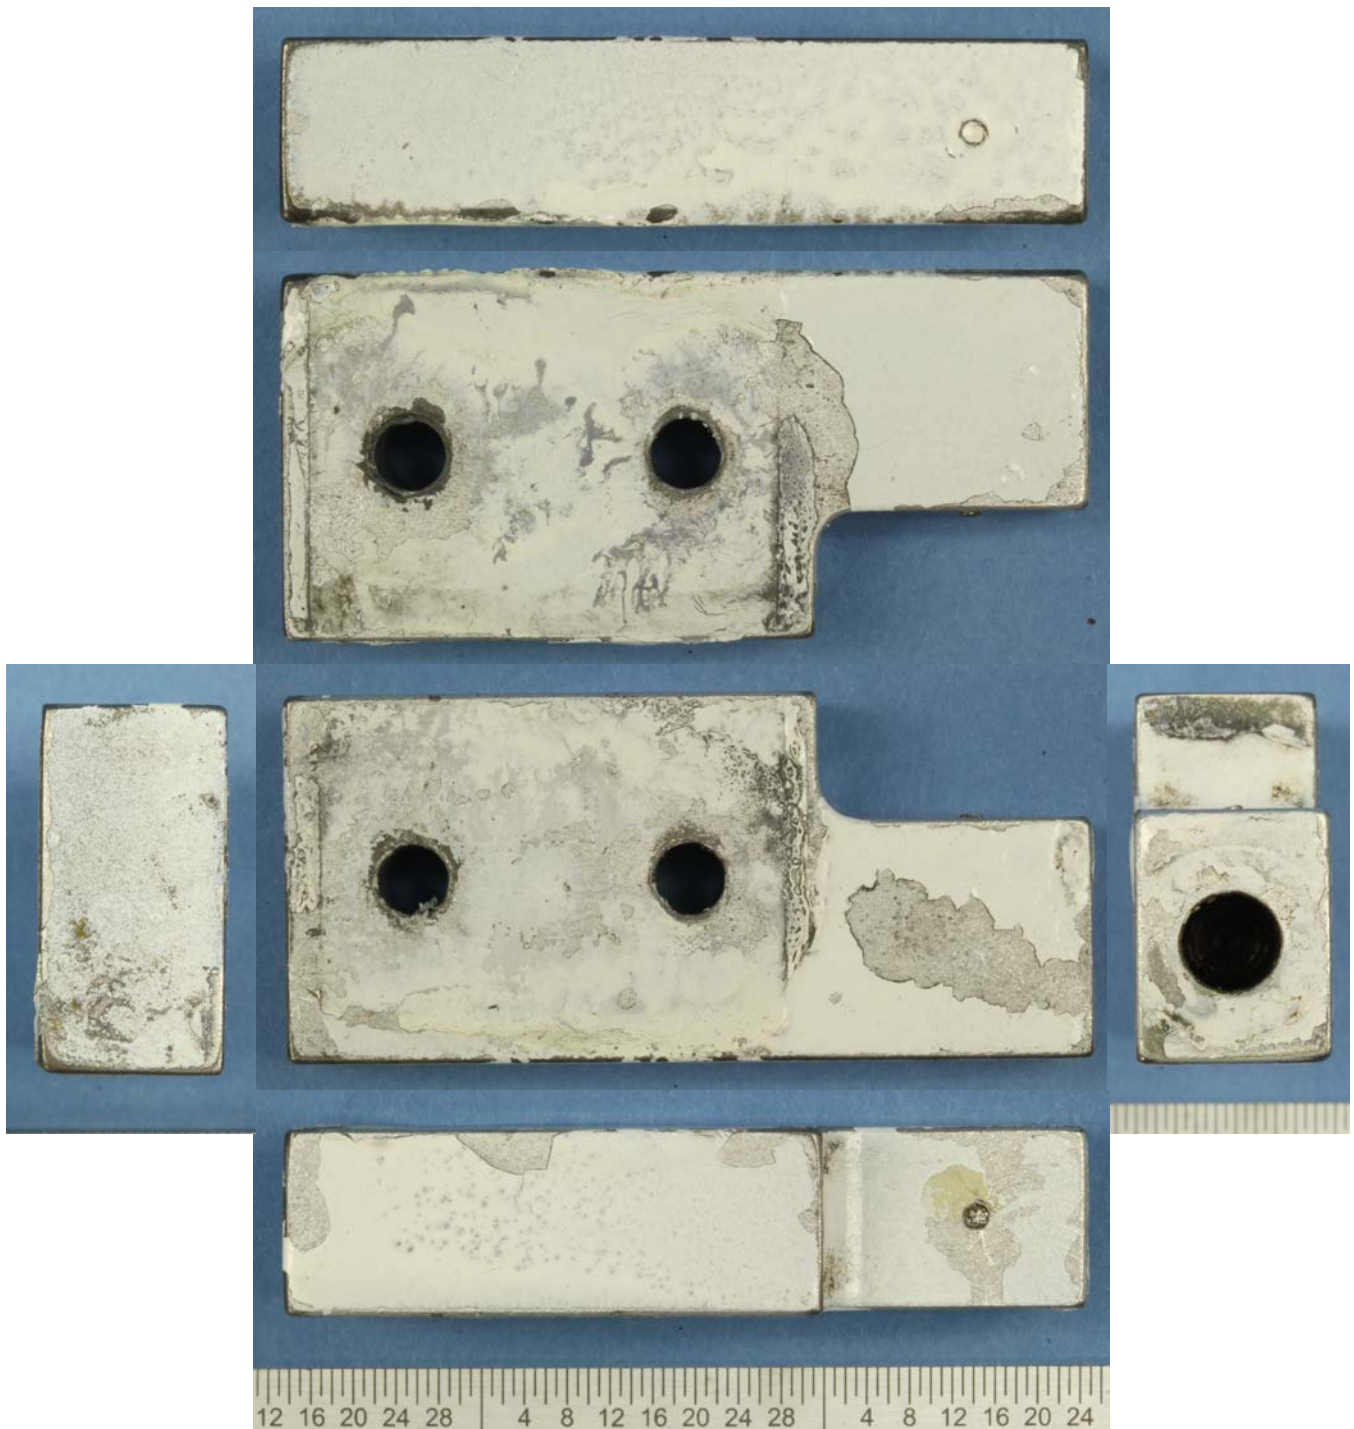
Figure 1 Image of the as-received nose gear spacer with fractured split spring pin pieces.

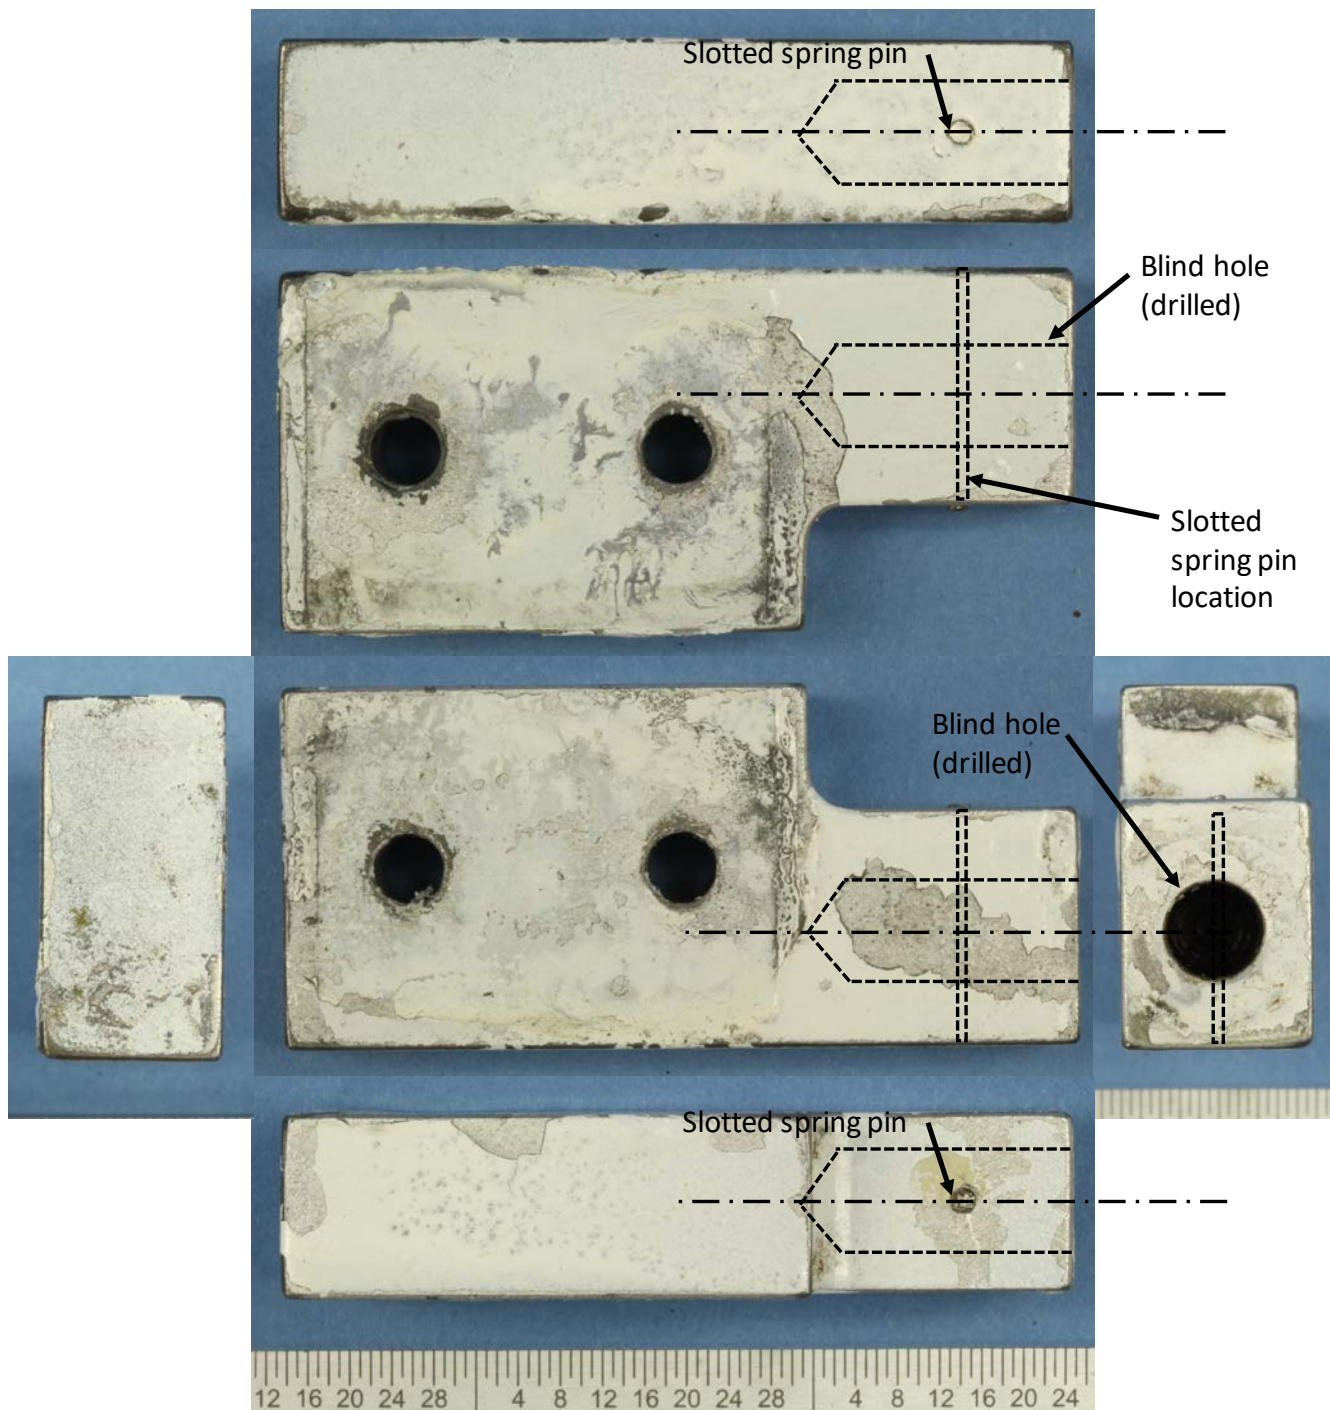
Figure 2 Same image is Figure 1 with key features identified.

Red dashed lines show the wafering saw cuts to open the blind hole and reveal the fractured ends of the slotted spring pin

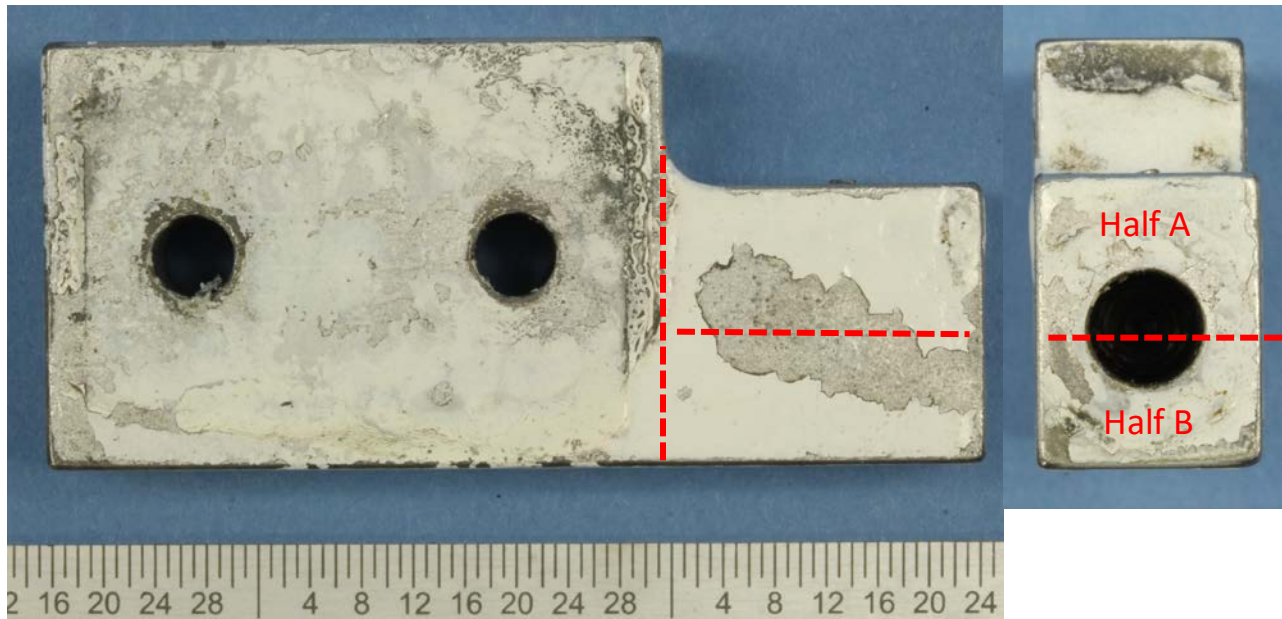
Figure 3 To reveal the fracture surfaces of the slotted spring pin, the spacer was sectioned according to the dashed lines.

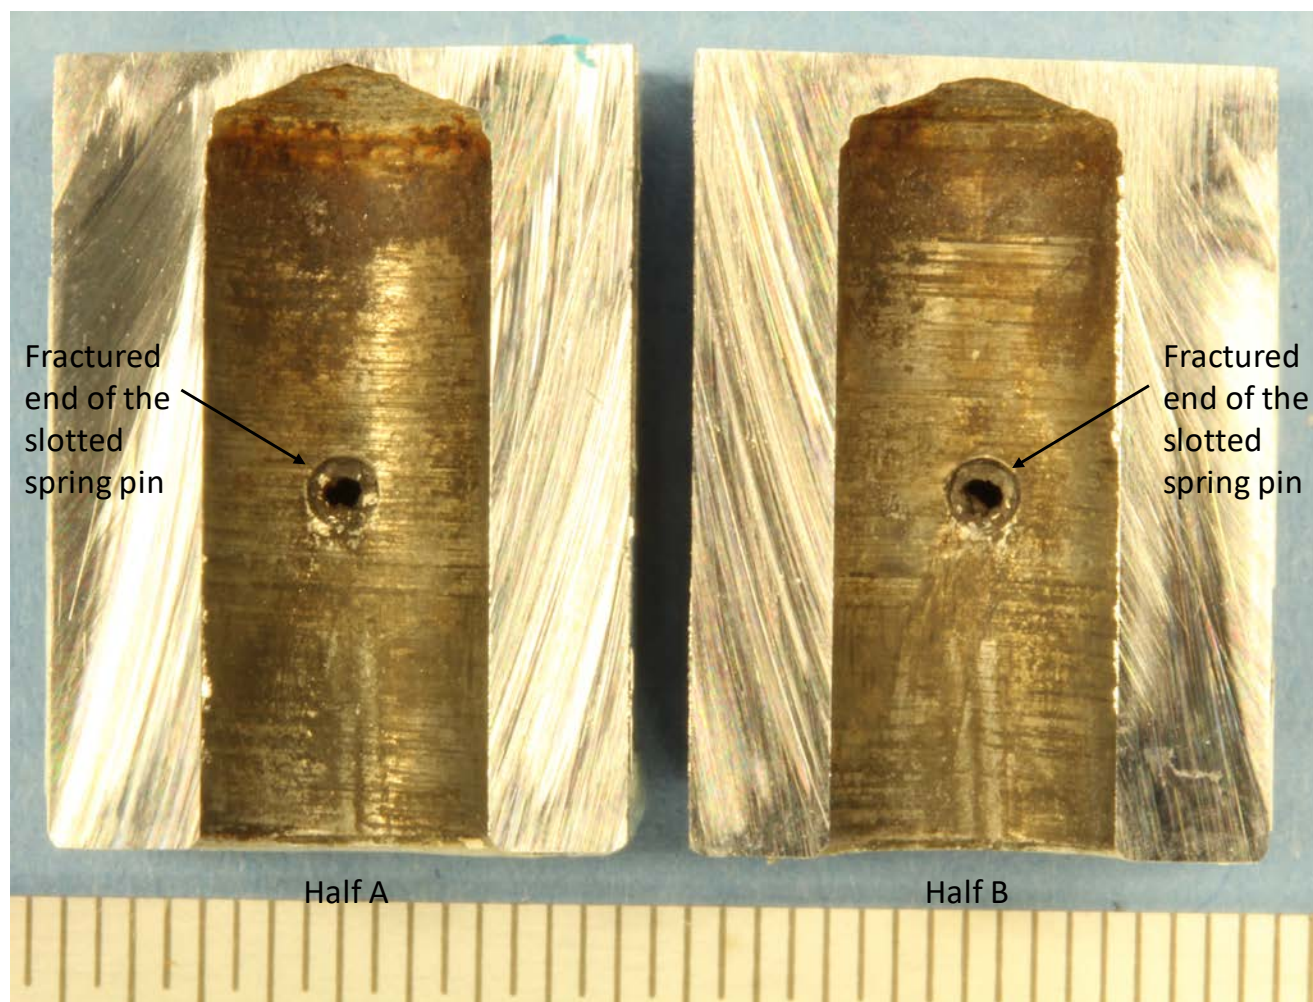
Figure 4 As-sectioned image of both halves of the sectioned blind hole, showing the fracture faces of the slotted spring pin.

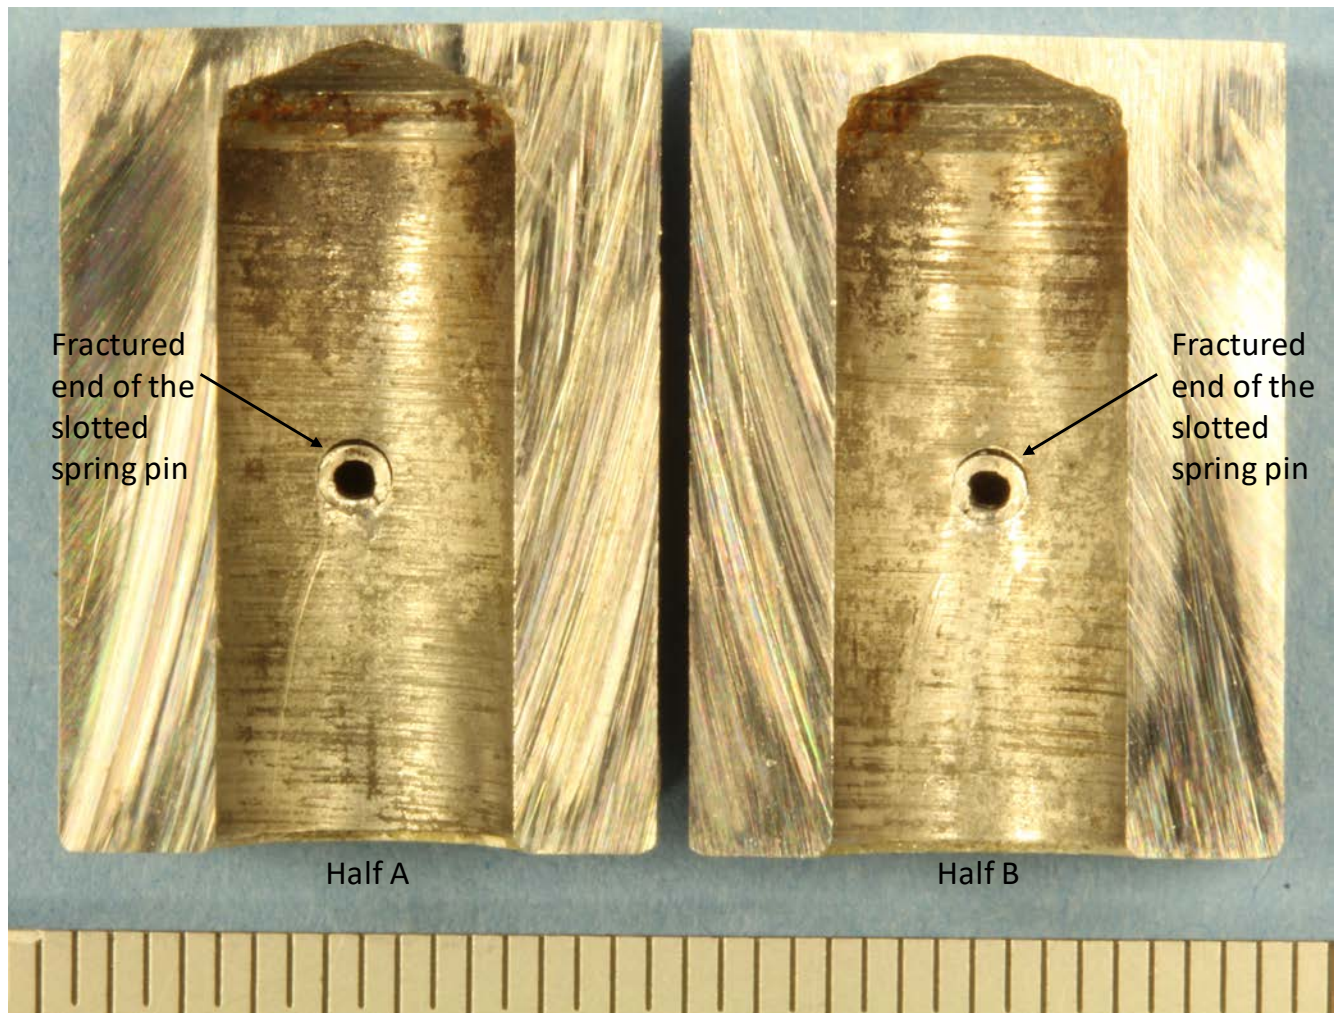
Figure 5 After ultrasonic cleaning in detergent image of both halves of the sectioned blind hole, showing the fracture faces of the slotted spring pin.

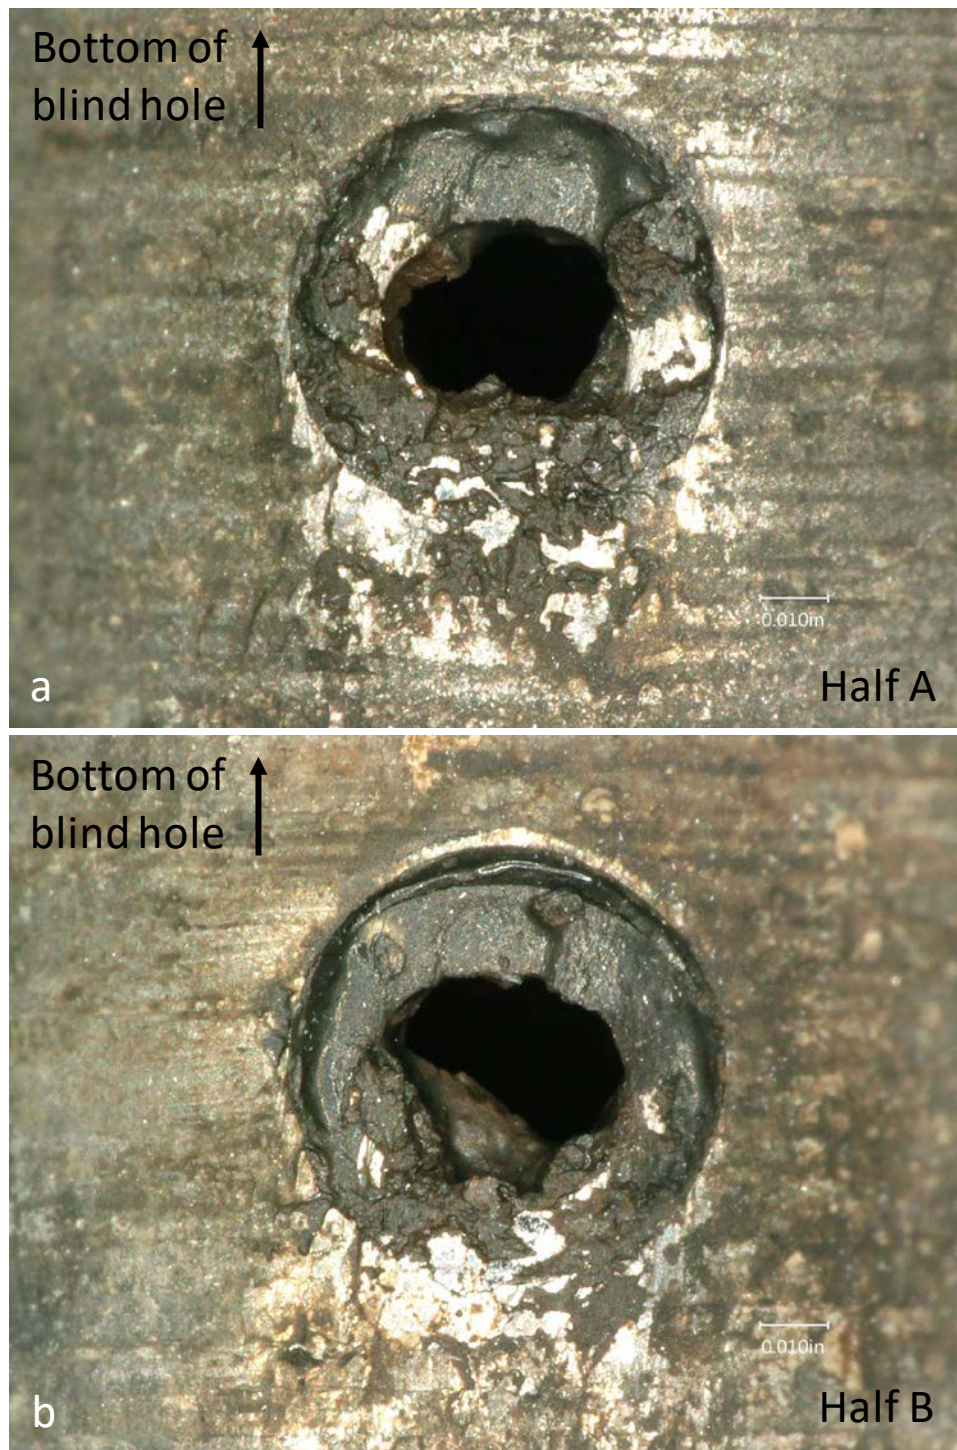
Figures 6-10 show digital microscope close views of the fracture faces of the slotted spring pin before and after cleaning. The annotated image in Figure 10 shows the direction of fracture. The fracture surfaces exhibit features consistent with the application of bending and shear stresses, resulting in overstress fracture.

Figure 6 Digital microscope close views of the fracture faces of the slotted spring pin, before cleaning.

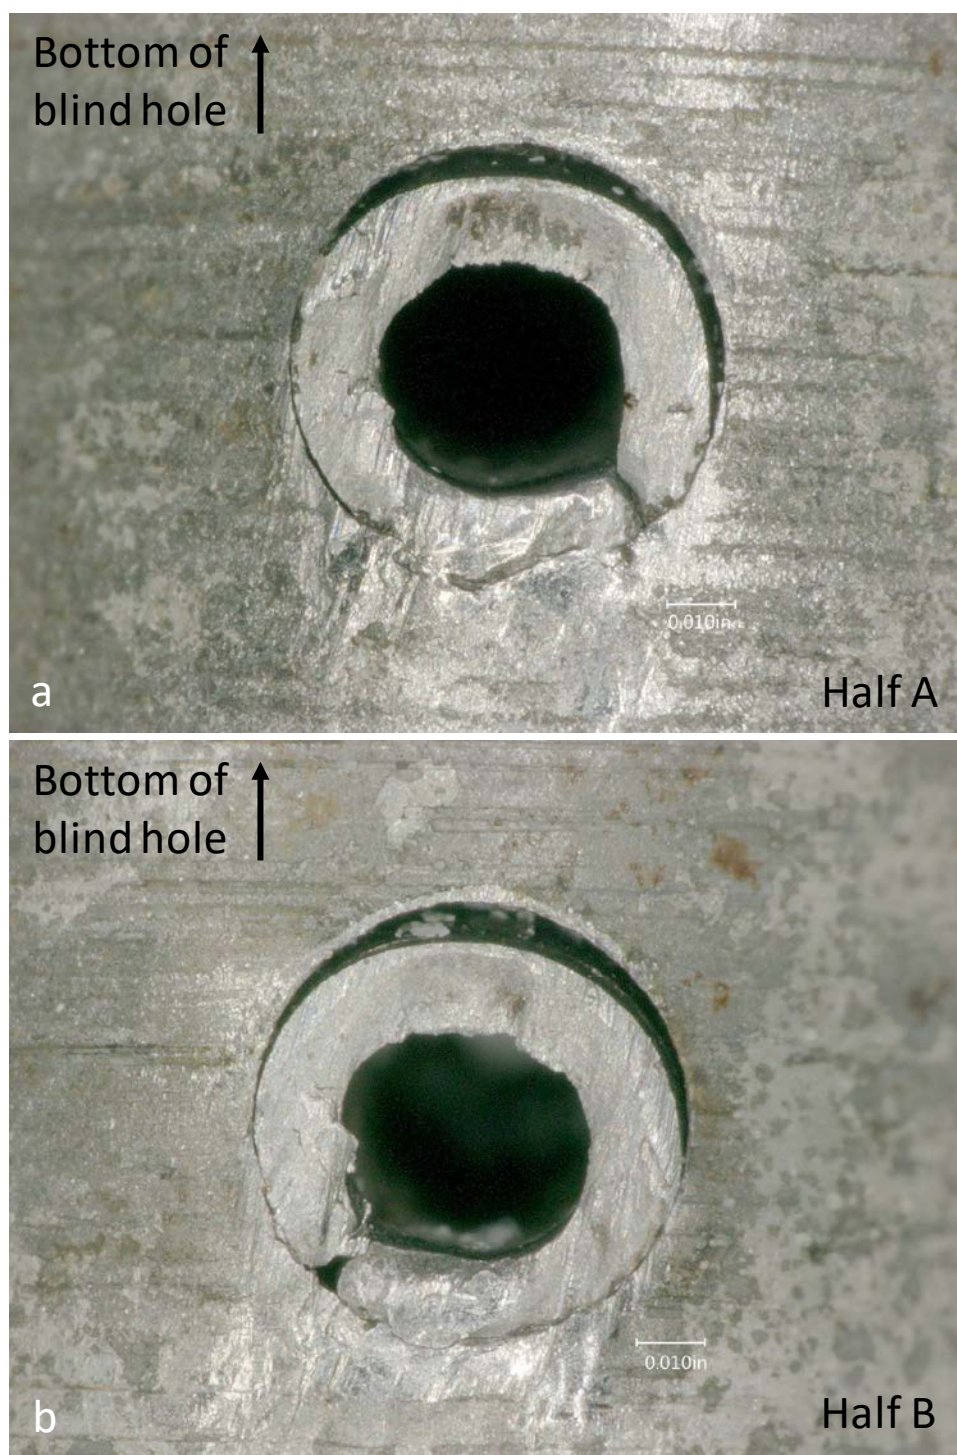
Figure 7 Digital microscope close views of the fracture faces of the slotted spring pin, after cleaning.

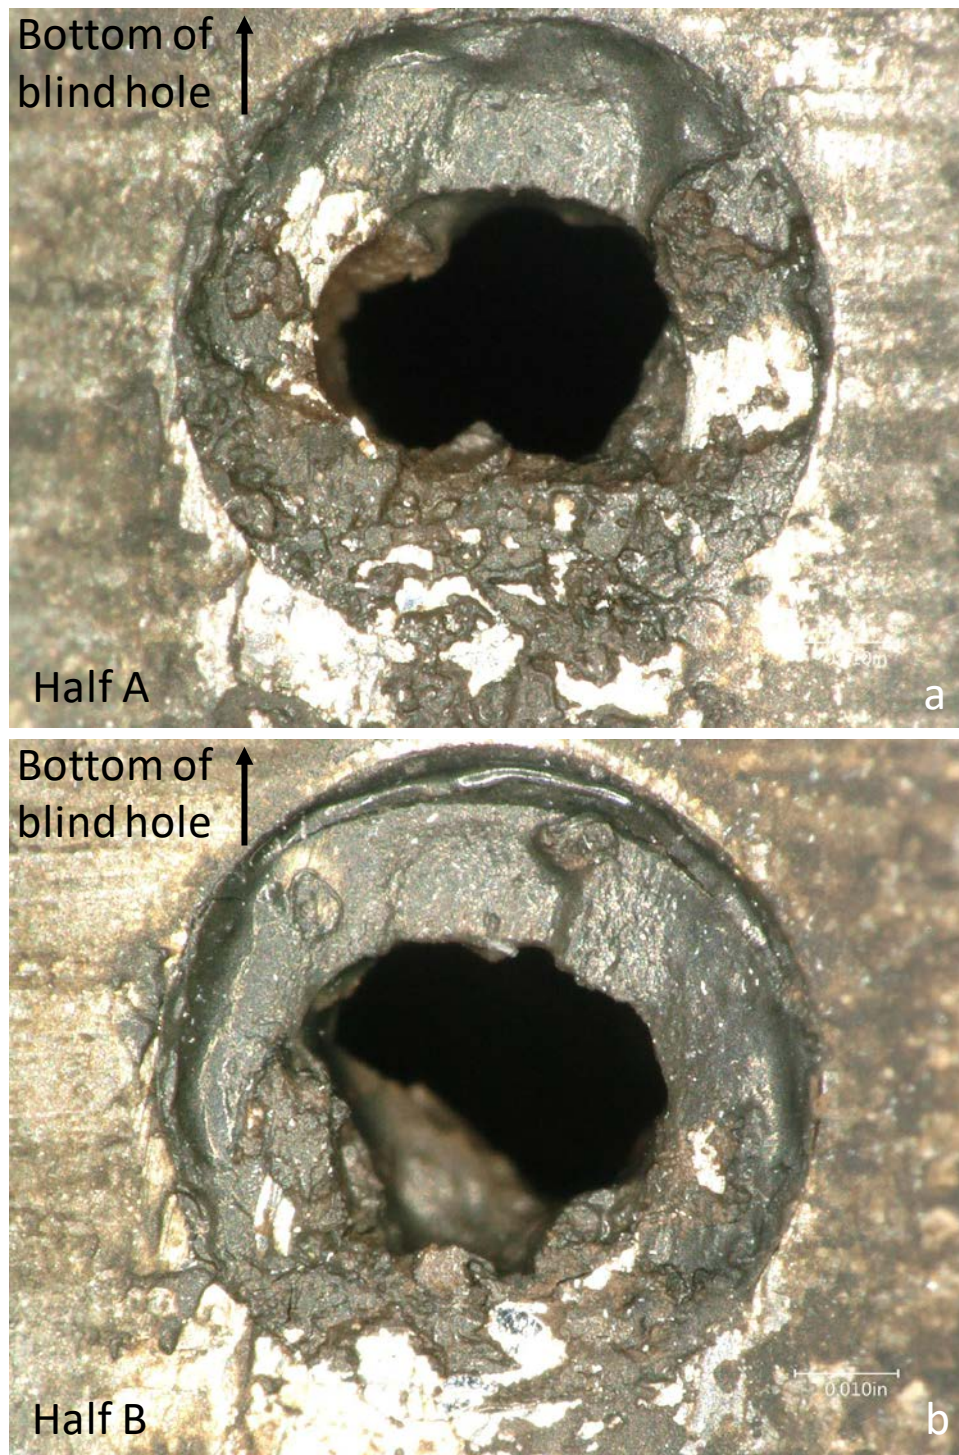
Figure 8 Higher magnification views of the images in Figure 6 showing the fracture faces of the slotted spring pin, before cleaning.

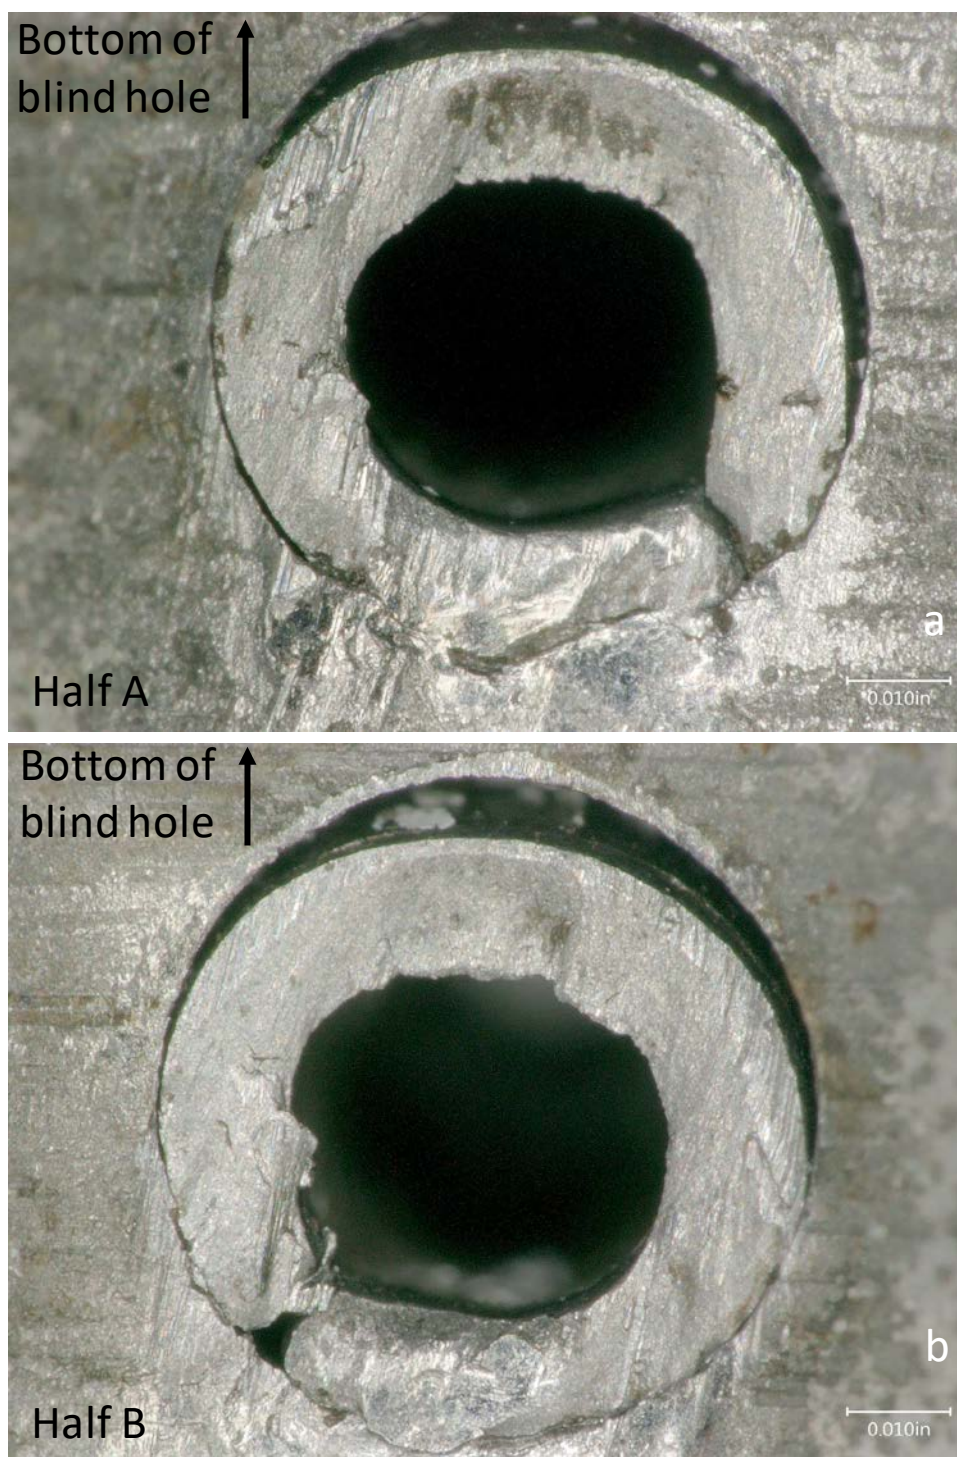
Figure 9 Higher magnification views of the images in Figure 7 showing the fracture faces of the slotted spring pin, after cleaning.

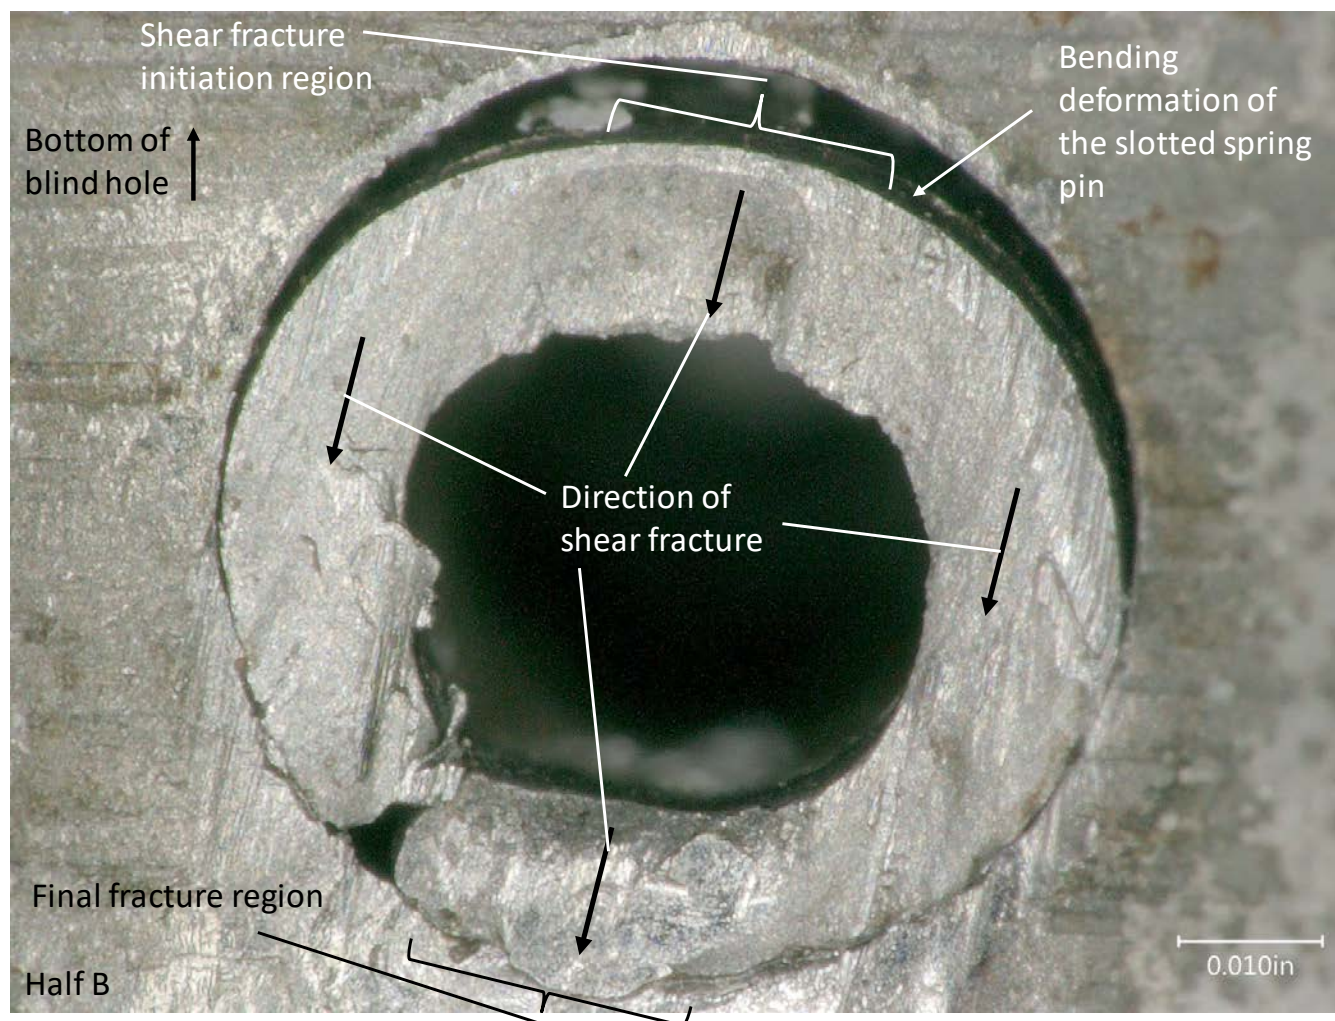
Figure 10 Image of Figure 9 view b with annotations indicating the fracture initiation region and the direction of fracture.

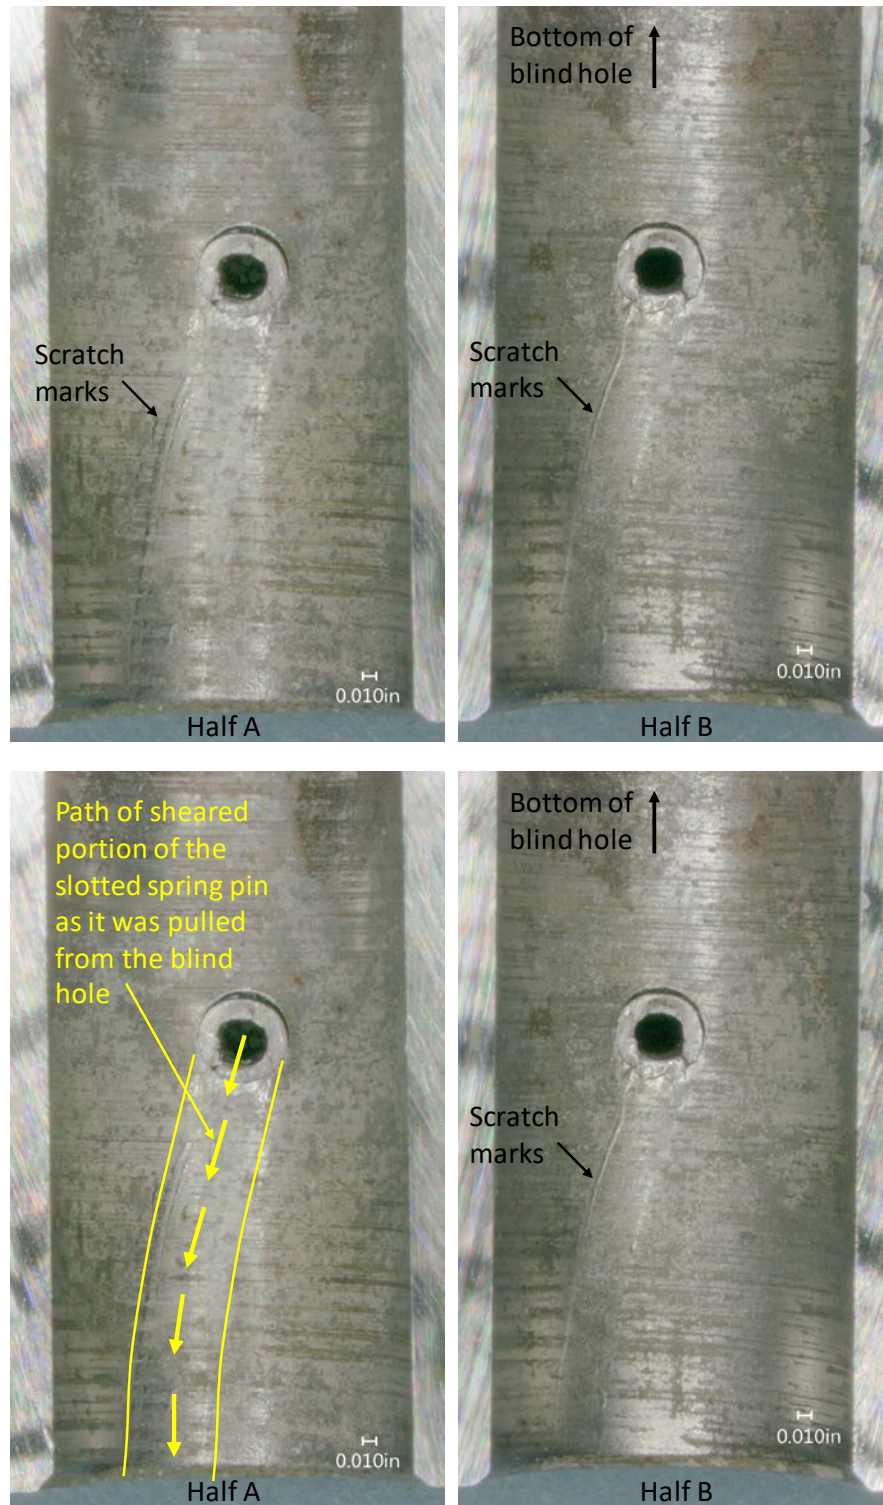
As shown in Figure 11, digital microscope images reveal that the shaft in the blind hole was pulled towards the opening of the blind hole leaving scratch marks as shown in the lower images in Figure 11.

Figure 11 Digital microscope images of the sectioned bore of the blind hole identifying scratch marks on the bore surface that indicate the direction of travel of the shaft after the slotted spring pin fractured.
