# NATIONAL TRANSPORTATION SAFETY BOARD

## MATERIALS LABORATORY FACTUAL REPORT

Report No. 19-041

Place : Hector, Minnesota  
Date : 6/13/2019  
Vehicle : Kolb Twinstar  
NTSB No. : CEN19LA176  
Investigator : Joshua Lindberg

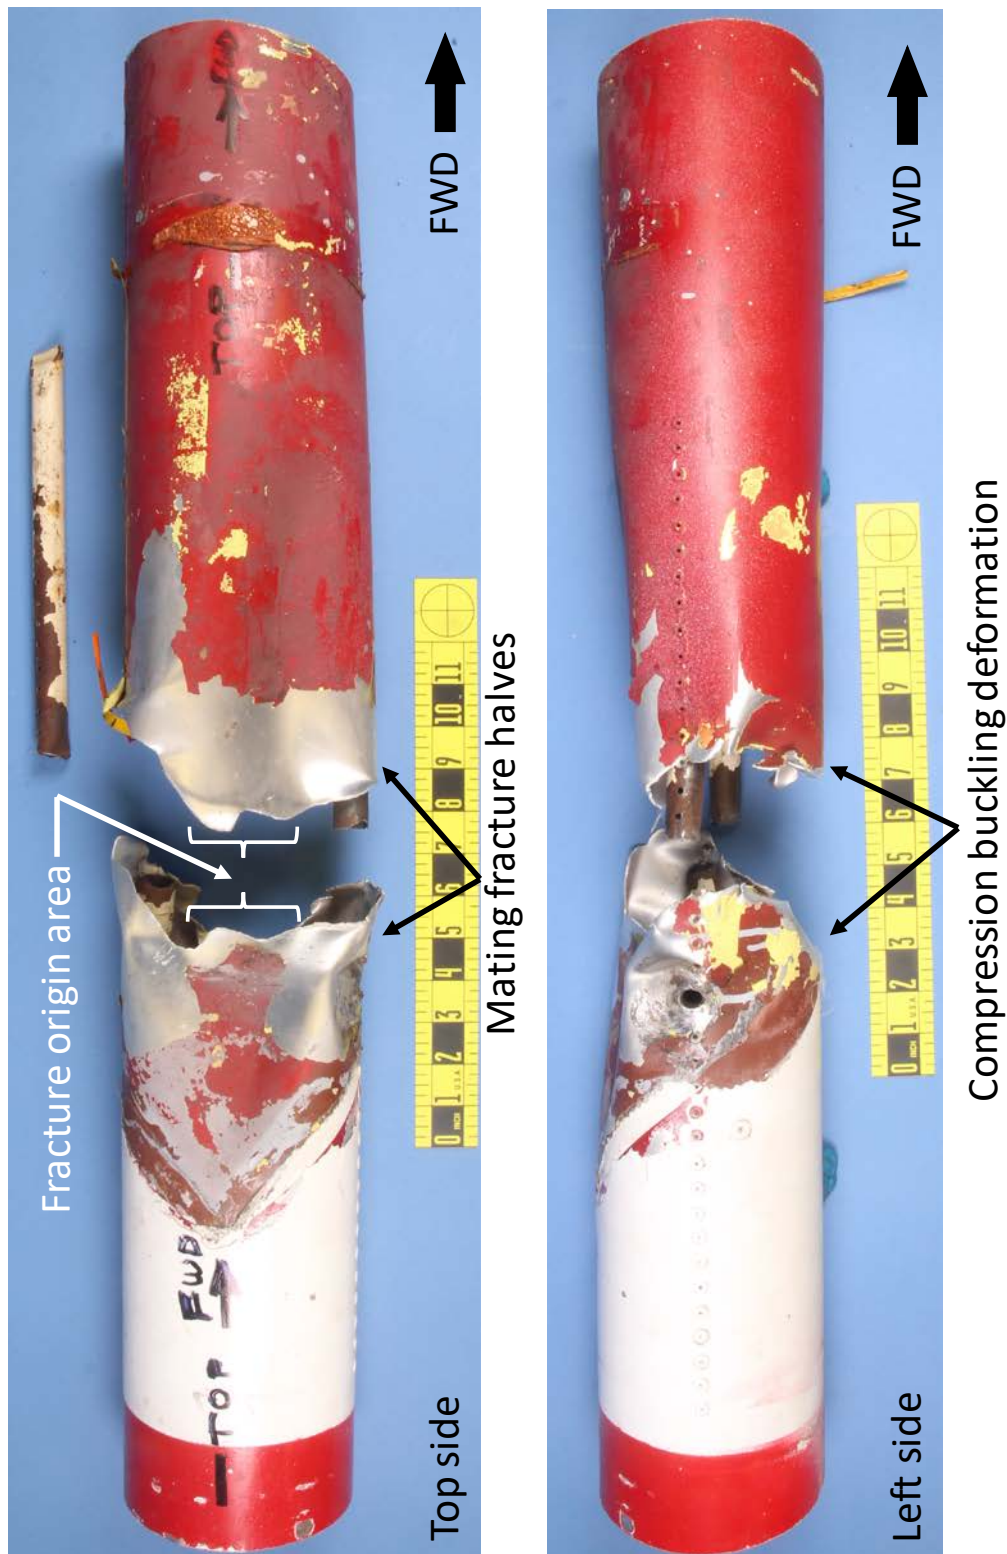
The purpose of this laboratory investigation is to identify the mode of fracture of the tail boom tube and associated H-section. The as-received tail pieces are shown in figure 1, with key features and part orientation identified. The mating halves of the fracture are identified in the upper image in Figure 1.

Figure 1 Image of the as-received evidence.

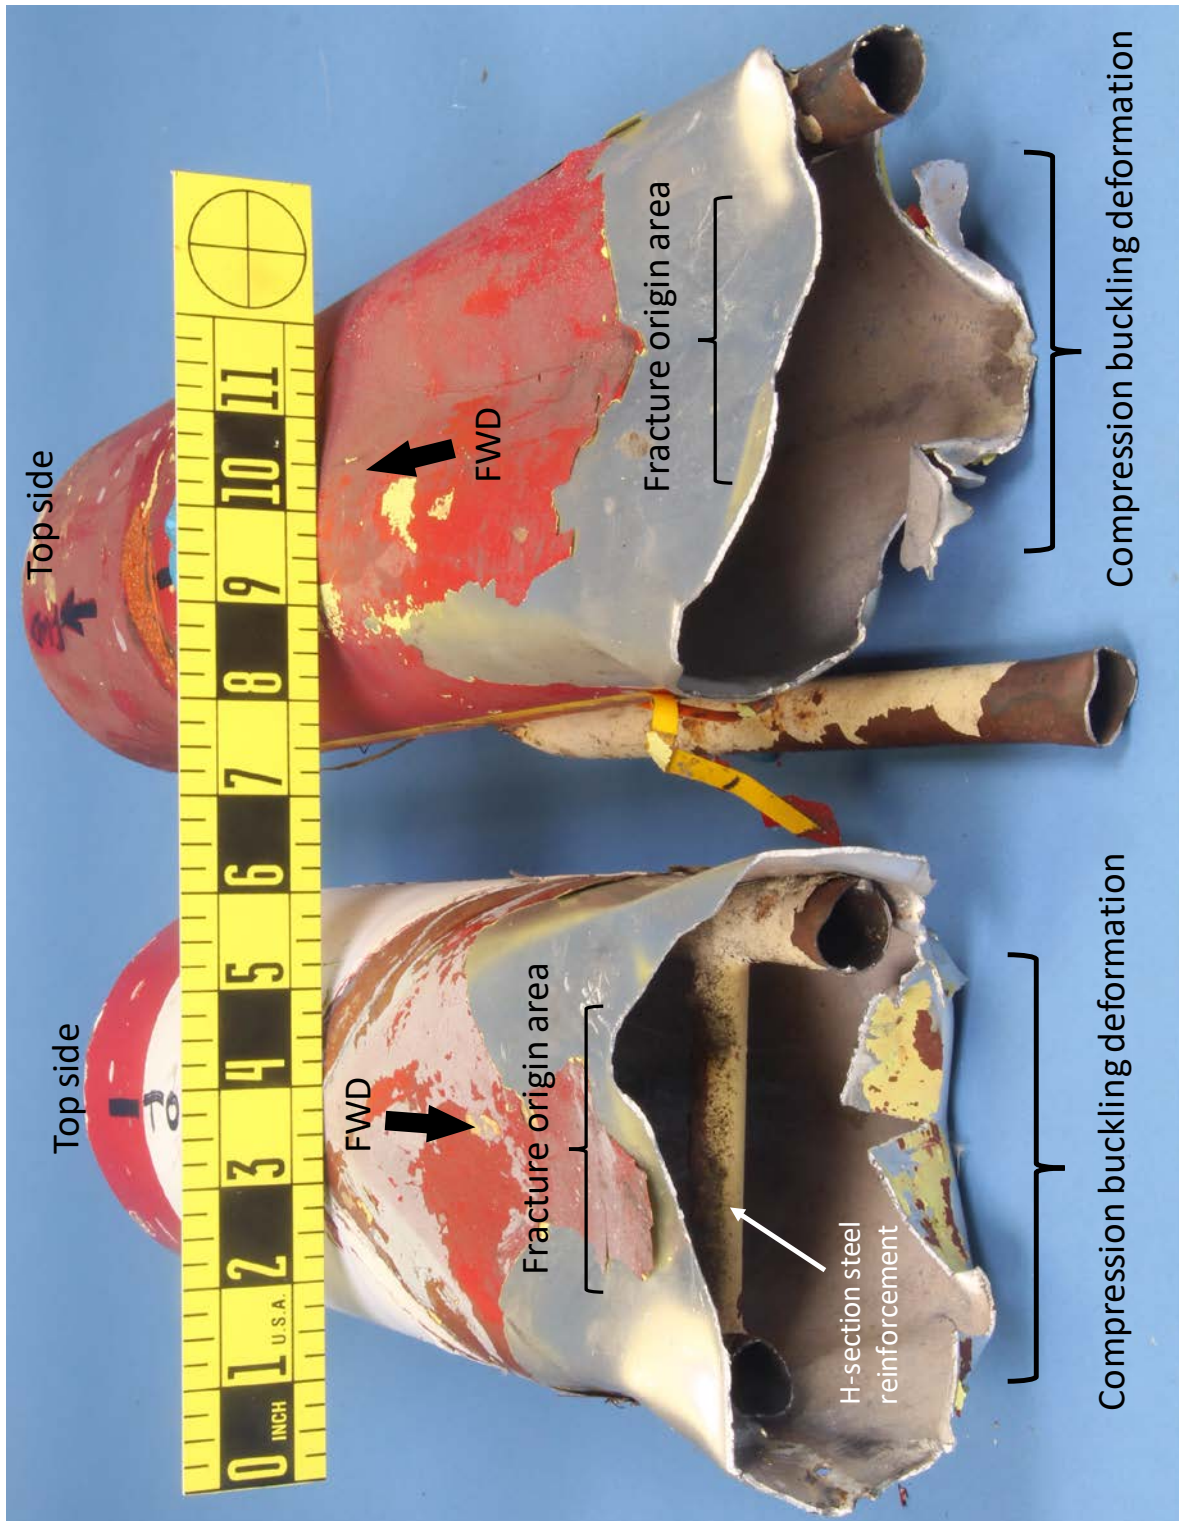
Similarly, using a 5X to 50X stereo zoom microscope, both halves of the fracture surfaces on the H-section steel tubes were examined (see Figures 2 and 3). All fractographic features were consistent with cantilever-bending overstress-fracture due to the application of a monotonically increasing load until fracture.

Figure 2 Oblique view of the tail boom tube and H-section fracture surfaces.

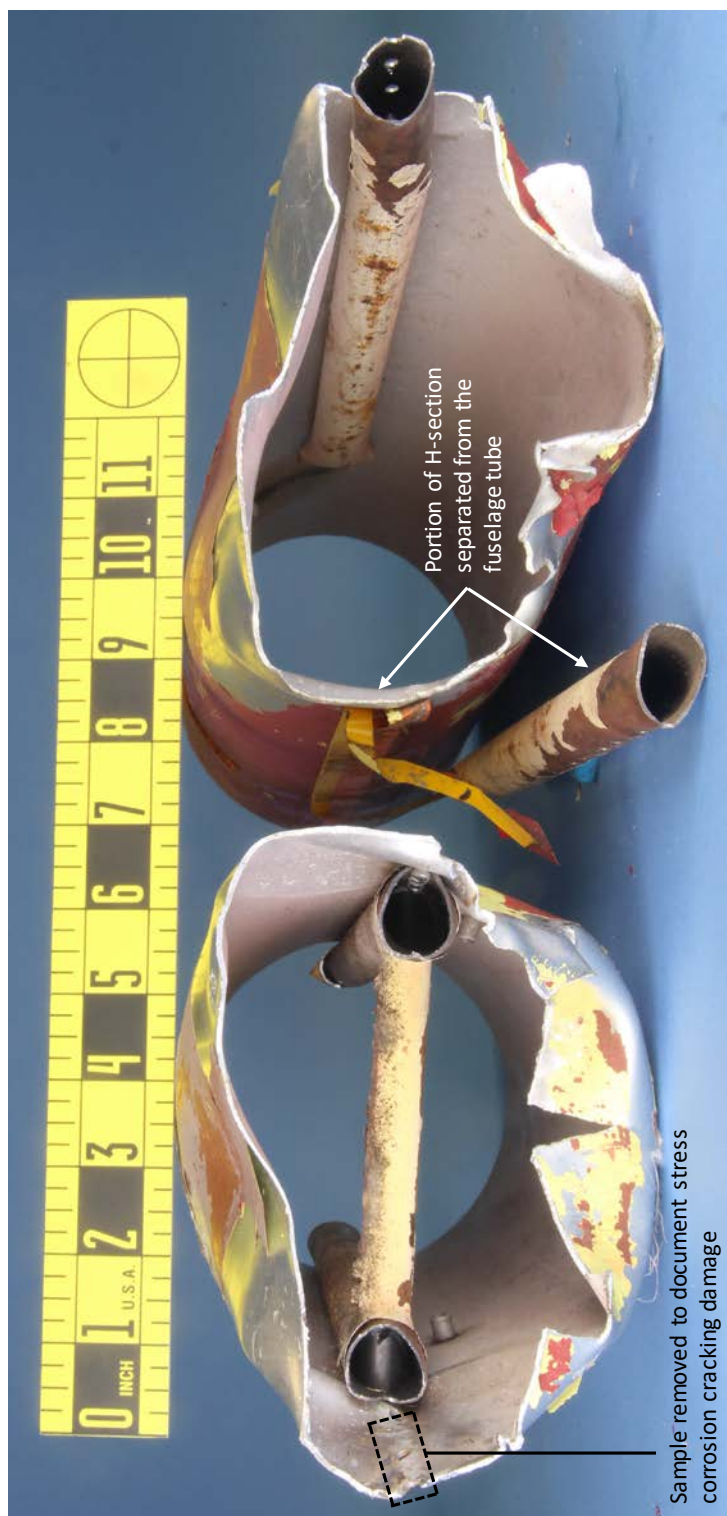
The inside surface of the aluminum tail boom tube, where it contacted the steel H-section via pop rivets, exhibited intergranular network cracks consistent with stress corrosion cracking (see Figure 3 and 4). A survey of the interior region around the rivet holes revealed the presence of chlorine and sodium via standardless semiquantitative energy dispersive spectroscopy. Although noted for completeness, the location of the network cracks did not contribute to the overstress fracture of the tube section.

Figure 3 Axial view of the tail boom tube and H-section fracture surfaces.

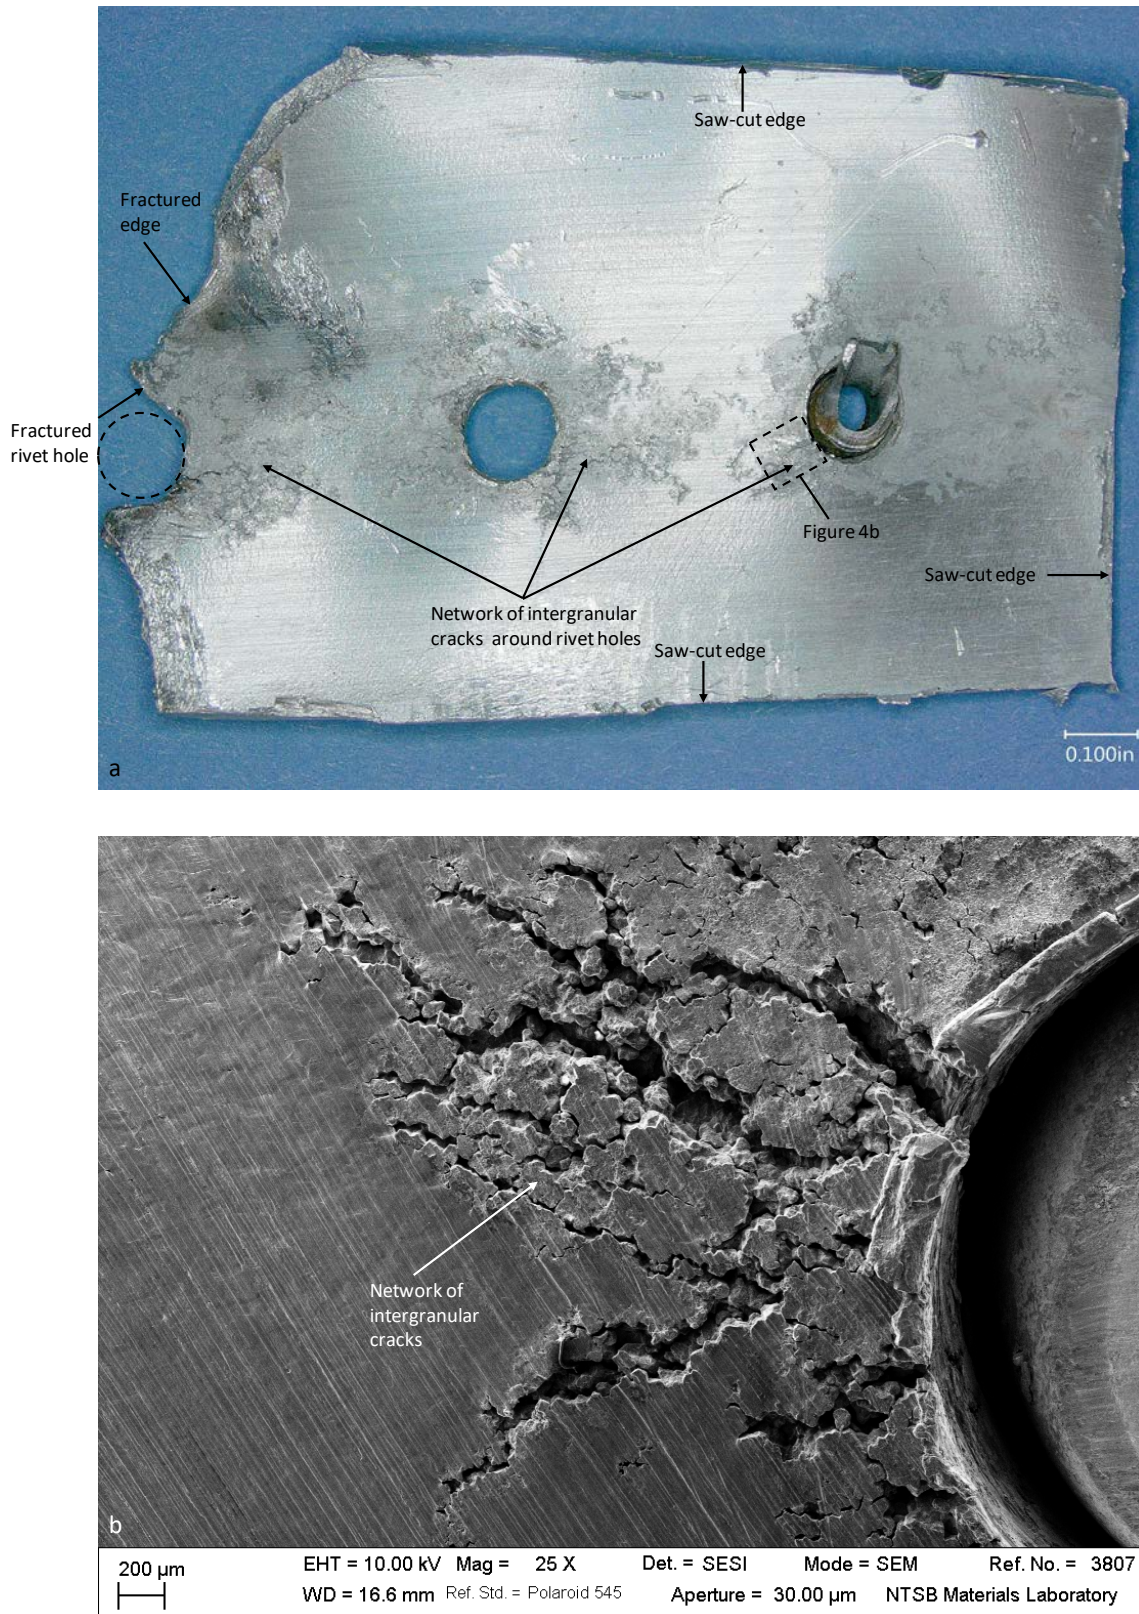
Figure 4 Images of the network of intergranular cracks around the rivet holes in the aluminum tail boom tube. View (a) is a digital microscope image after cleaning. View (b) is a scanning electron microscope image of the cleaned sample showing a closer view of the cracks.
