**CEN19LA168**

**Piper PA-24**

**N5866P**

## **NTSB LANDING GEAR EXAMINATION REPORT**

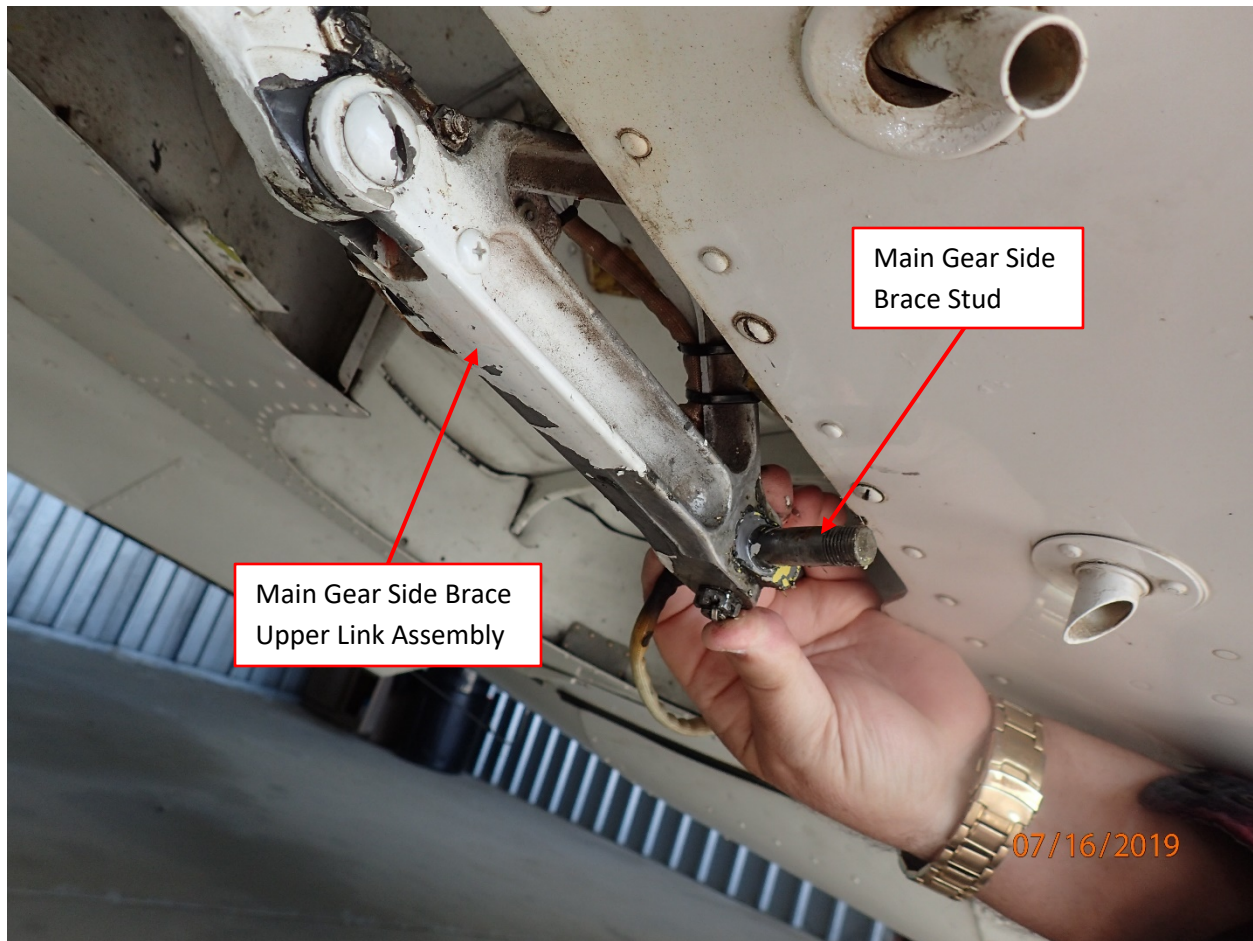
It was determined the gear was not able to be swung due to impact damage. The side brace stud of the main gear side brace upper link assembly was disconnected from the main gear side brace support fitting assembly. The roll pin inserted through the threading on the stud that connects to the support fitting was sheared and the threads of the stud were stripped. The push pull (conduit) cable assembly arm that connects to the main gear side brace upper link assembly and actuated the landing gear was bent upward. These damages appear consistent with a side load on the landing gear.

**Figure 1: Disconnected Main Gear Side Brace Upper Link Assembly and Main Gear Side Brace Stud**

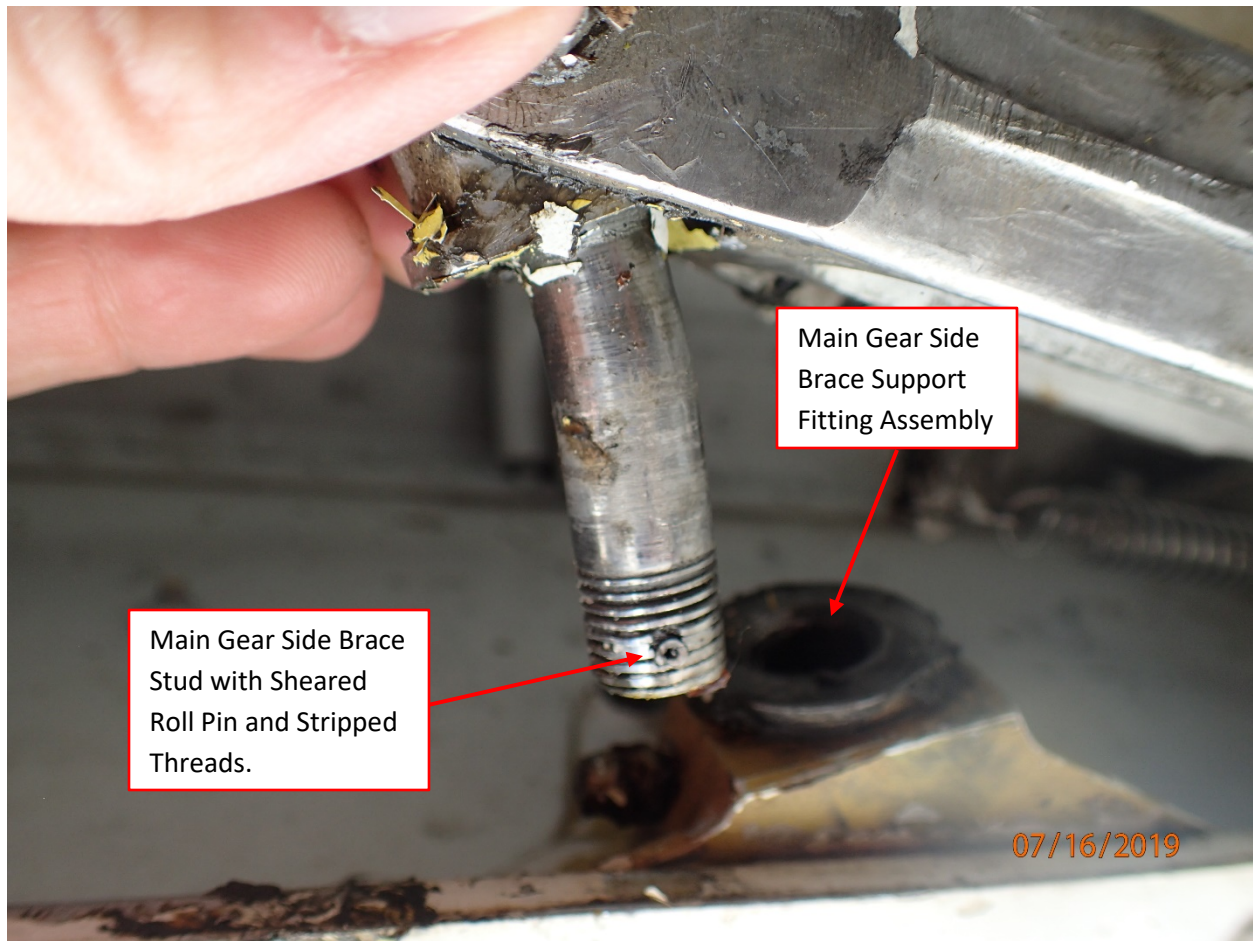
**Figure 2: Main Gear Side Brace Stud and Main Gear Side Brace Support Fitting Assembly**

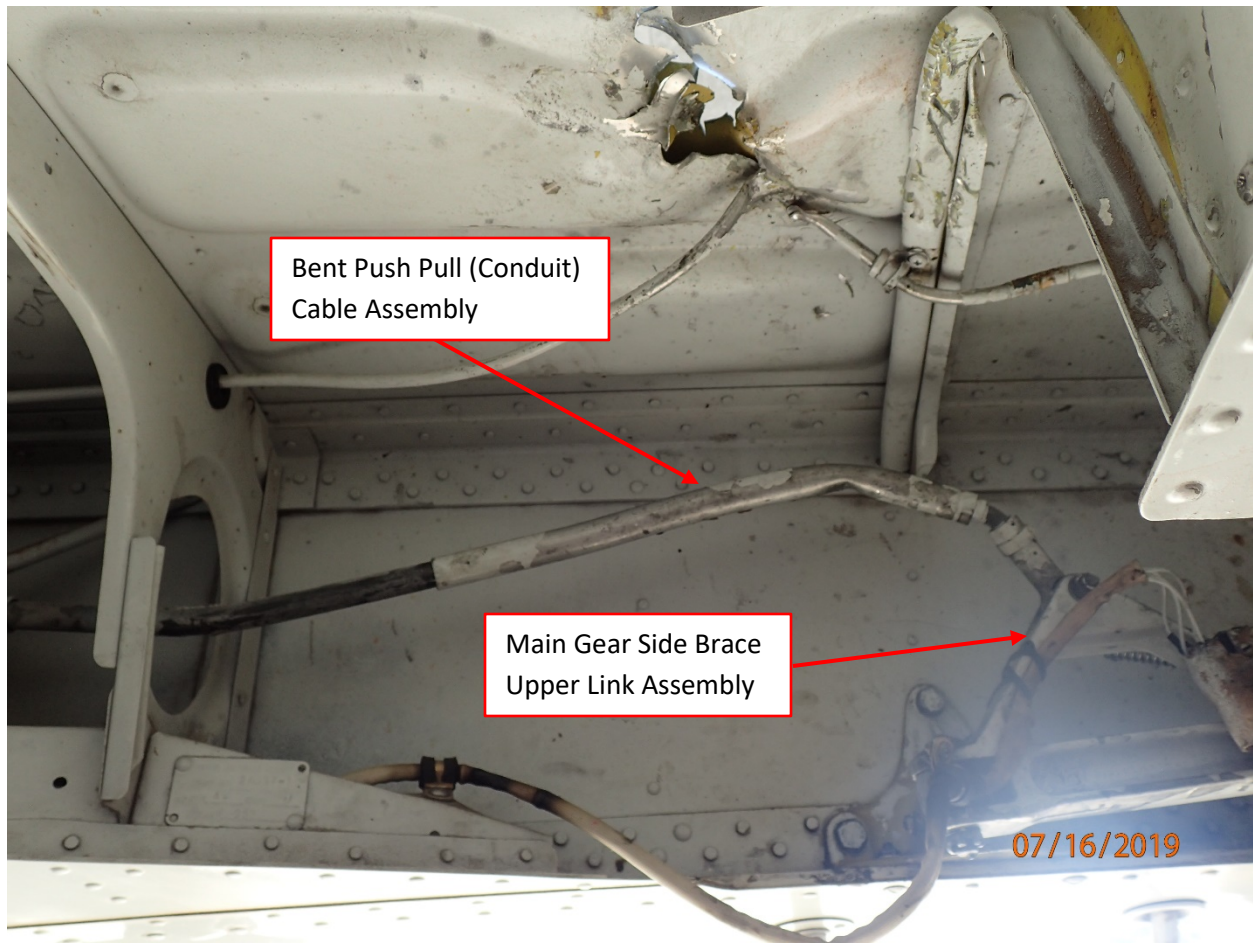
**Figure 3: Bent Push Pull (Conduit) Cable Assembly and Main Gear Side Brace Upper Link Assembly**
