# National Transportation Safety Board

### Device Download and Data Summary

| NTSB Accident No: | CEN19LA199 |
| Aircraft Make/Model: | Zenair CH750 STOL |

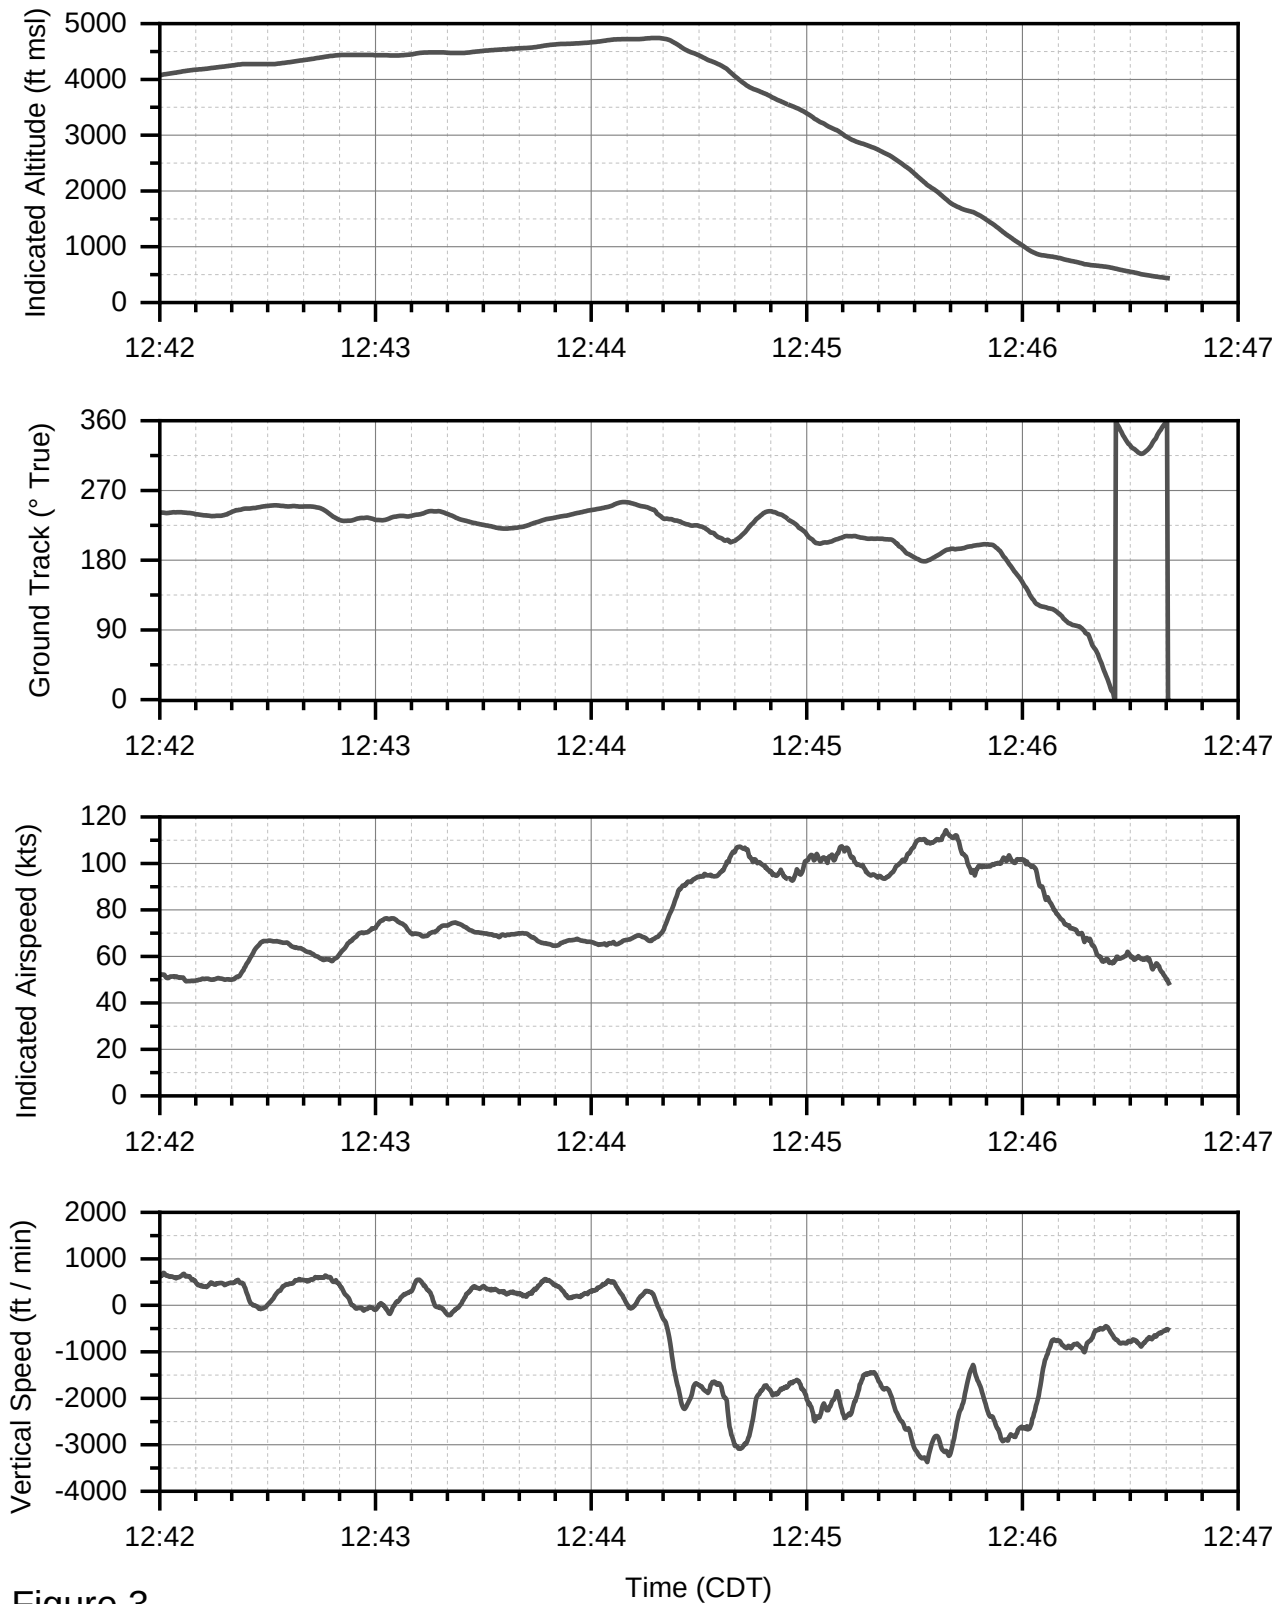
Figure 3.

About 1245:34, the airplane's indicated airspeed and descent rate were about 114 knots and 3,200 feet per minute (fpm), respectively, as shown in figure 3. At 1245:42, The EGT for cylinder Nos. 2 and 4 also began to decrease rapidly when the fuel pressure dropped as low as 7.5 psi, as shown in figure 5.

At 1246:41, about 10 seconds after the engine stopped the second time, the final recorded data showed the airplane in a right turn about 60 feet above the ground, and in a 542 fpm descent at 48 knots indicated airspeed, as shown in figure 3. The final recorded position was about 263 ft south of the accident site. The elevation at the accident site was 372 ft msl.

# CEN19LA199 -- Dynon Avionics SV-D1000T Flight Parameters (End of Flight)

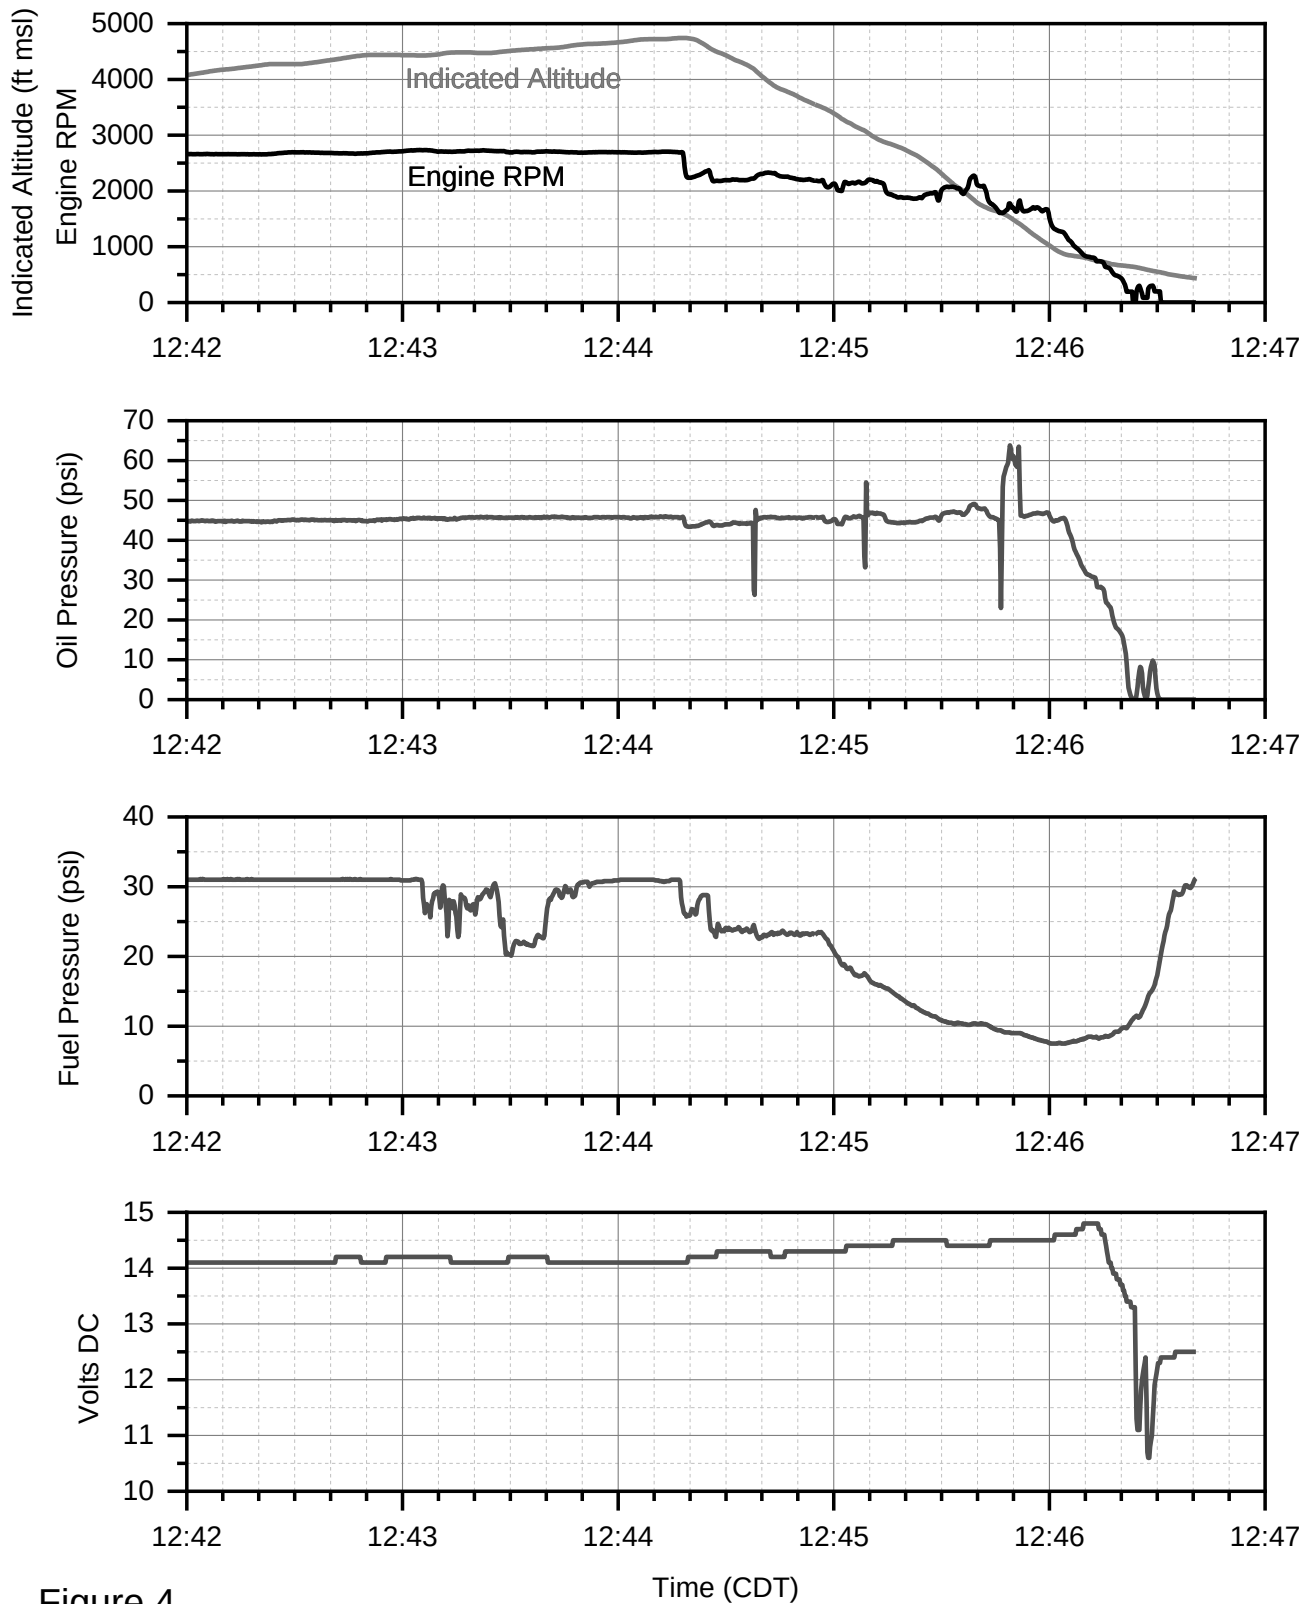
Figure 4.

At 1230:07, the pilot restarted the engine while on the ramp at M34. At 1230:59, the pilot increased throttle to takeoff power and departed on runway 28 at M34. After takeoff, the pilot maintained an engine speed of about 2,750 rpm. The fuel pressure remained about 31 pounds per square inch (psi) until 1243:05, when over the next 49 seconds, the fuel pressure decreased to

20 psi before it returned to 31 psi, and the exhaust gas temperature (EGT) for all four engine cylinders increased about 30°C before returning to their previous temperatures, as shown in figure 4 and figure 5.

At 1244:19, the airplane had climbed to 4,741 ft msl, the highest recorded altitude for the flight, and the engine speed decreased from 2,700 rpm to 2,200 rpm with corresponding decreases in fuel pressure and EGT. However, at 1244:57, while the airplane was in a sustained descent, the EGT for cylinder Nos. 1 and 3 began to decrease rapidly, and fuel pressure decreased below 23 psi with the engine speed about 2,100 rpm, as shown in figure 4 and figure 5.

# CEN19LA199 -- Dynon Avionics SV-D1000T

## Engine Parameters (End of Flight)

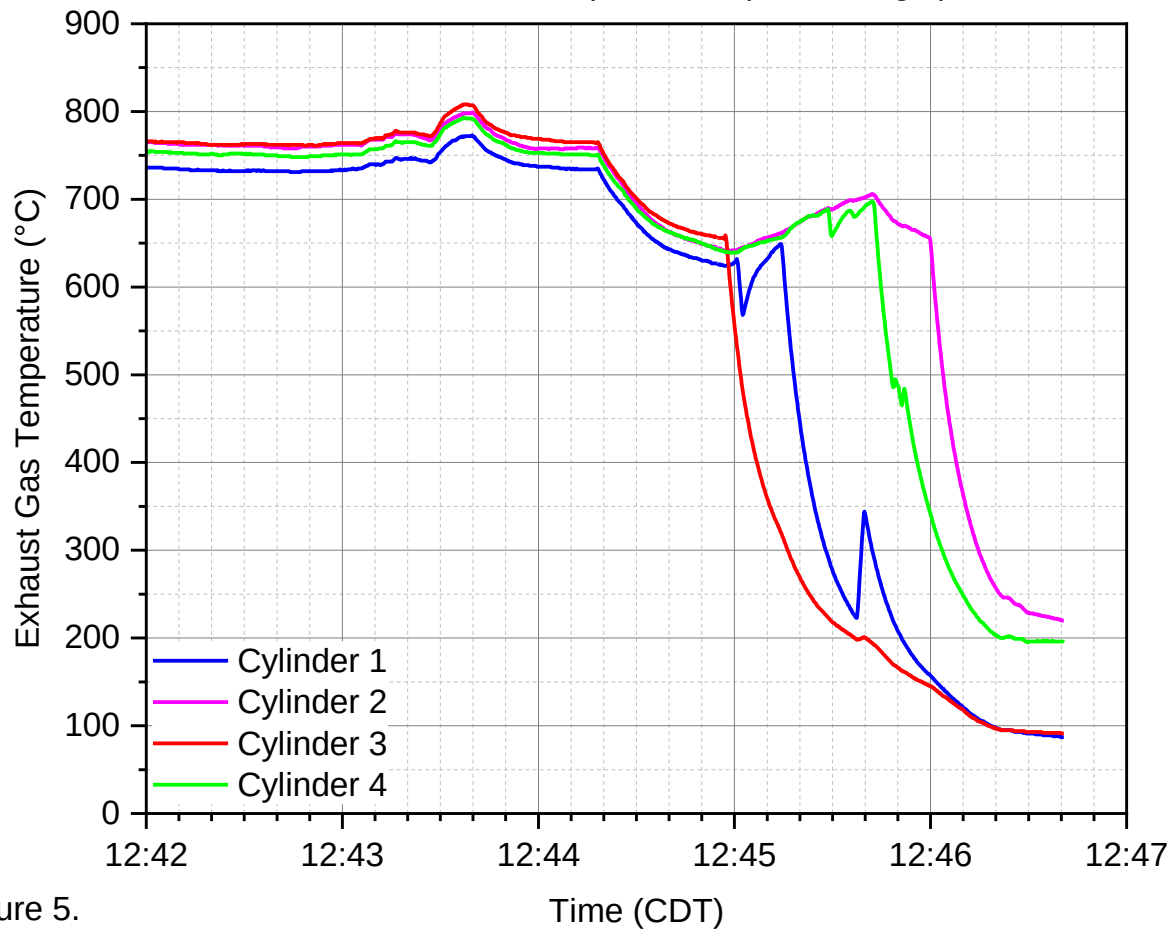
Figure 5.

Between 12:44:57 and 1245:42, the EGT decreased 335°C (626°C to 291°C) and 461°C (659°C to 198°C) for the No. 1 and No. 3 cylinders, respectively. However, in contrast, during the same 45 second period, the EGT for cylinder Nos. 2 and 4 increased about 60°C (640°C to 700°C).

CEN19LA199 -- Dynon Avionics SV-D1000T  
Exhaust Gas Temperatures (End of Flight)
