# The National Transportation Safety Board

Office of Aviation Safety  
Central Region  
Memorandum for the Record  
Stabilizer Examination  
Findings  
CEN19LA224  
Osceola Wisconsin  
July 14, 2019

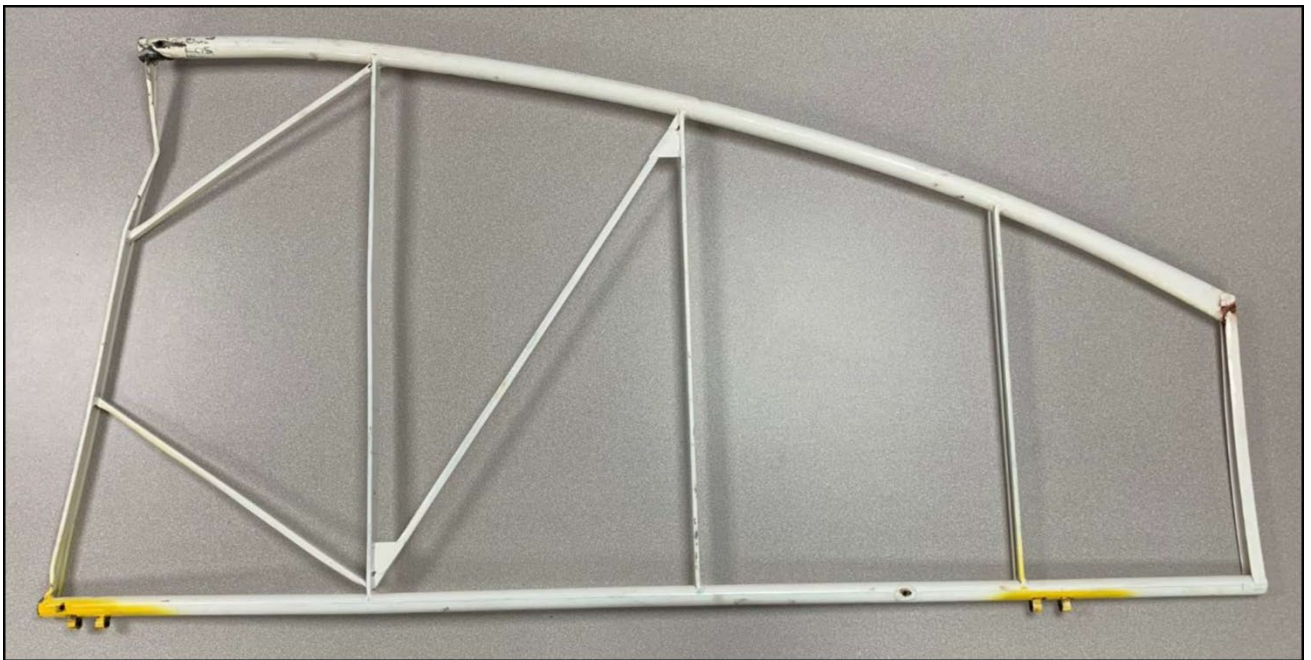
- When the Ceconite fabric covering was removed from the right and left stabilizers, it was found that the right stabilizer (failed part) was not a Piper FAA-PMA approved part. It was powder coated and a larger diameter sleeve was not welded on the leading-edge tubing at the root for strength. Further examination of the right stabilizer revealed pitting and multiple broken welds with visible corrosion in the areas of the breaks. There also were no visible part or serial numbers unlike the left stabilizer which was a FAA-PMA approved Piper part.

Photo 1 Right Stabilizer Frame Top View (Source: Piper)

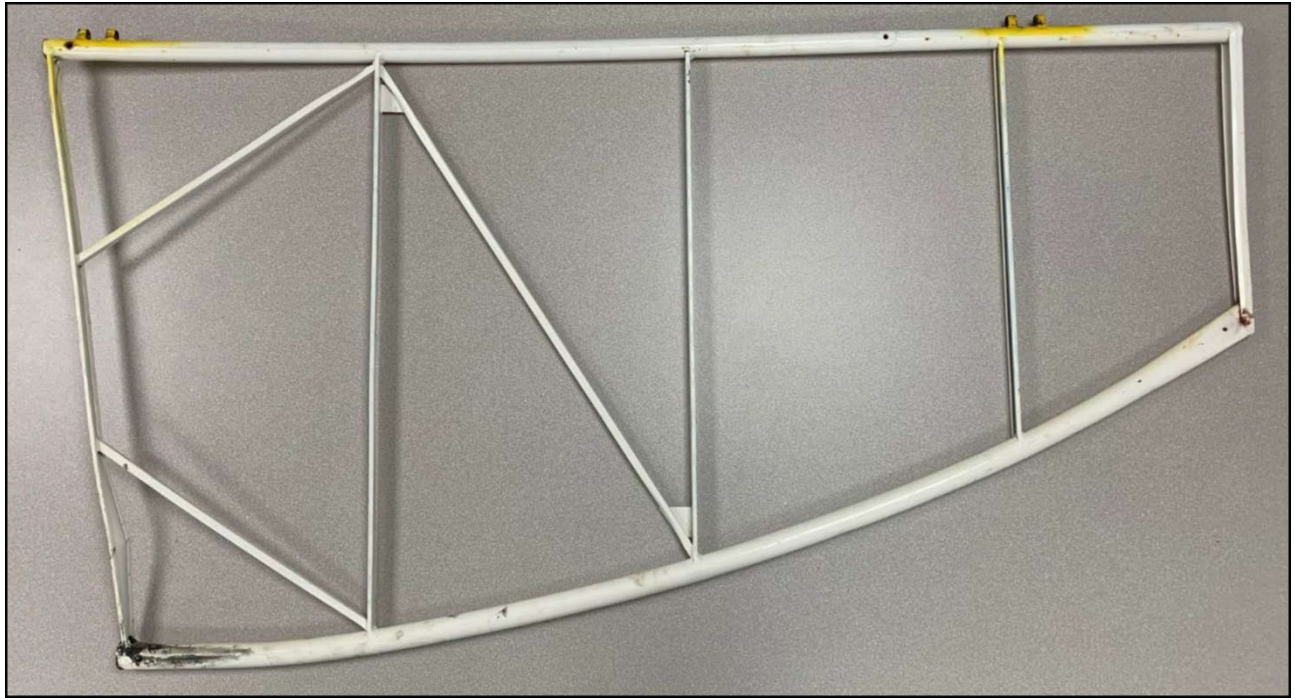
Photo 2 Right Stabilizer Frame Bottom View (Source: Piper)

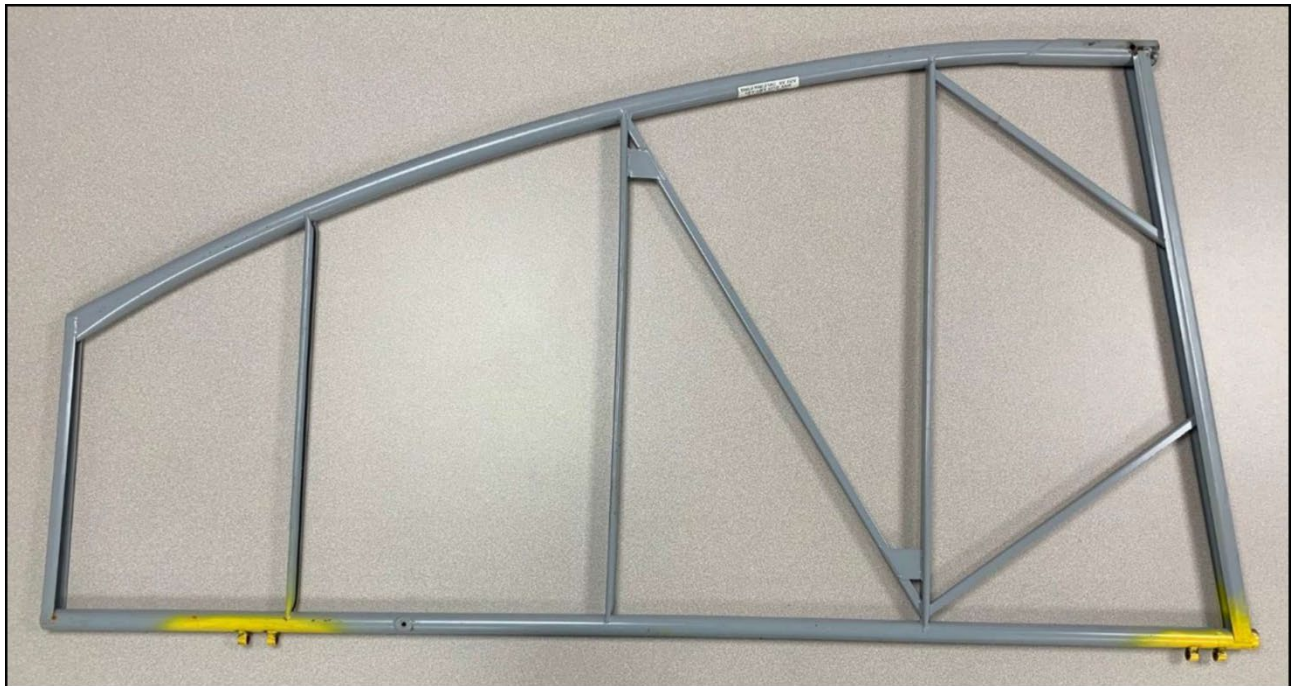
Photo 3 Left Stabilizer Frame Top View (Source: Piper)

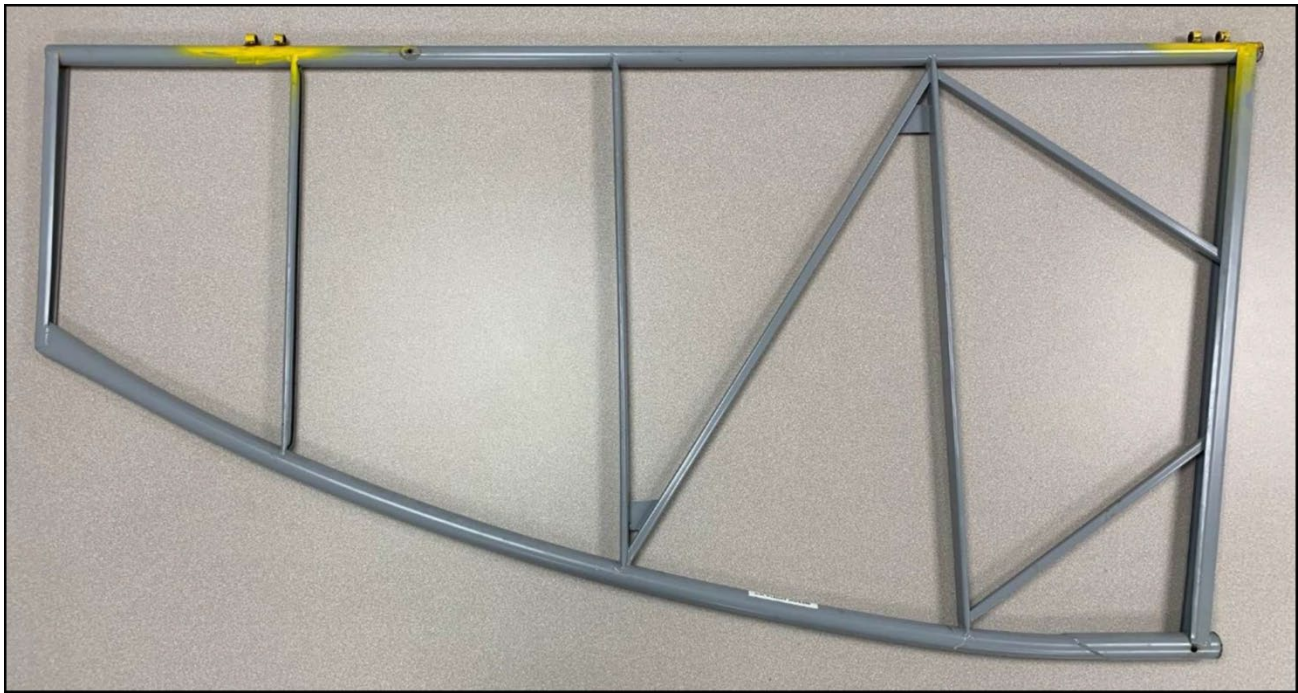
Photo 4 Left Stabilizer Frame Bottom View (Source: Piper)
