**NATIONAL TRANSPORTATION SAFETY BOARD  
OFFICE OF AVIATION SAFETY  
WASHINGTON, D.C. 20594**

**POWERPLANTS GROUP CHAIRMAN'S FACTUAL REPORT**

**NTSB ID No.: CEN19LA231**

Location: Breckenridge, Michigan  
Date: July 21, 2019  
Time: 0705 Eastern Daylight Time  
Aircraft: Ayres S2R-G10, Registration: N766BF

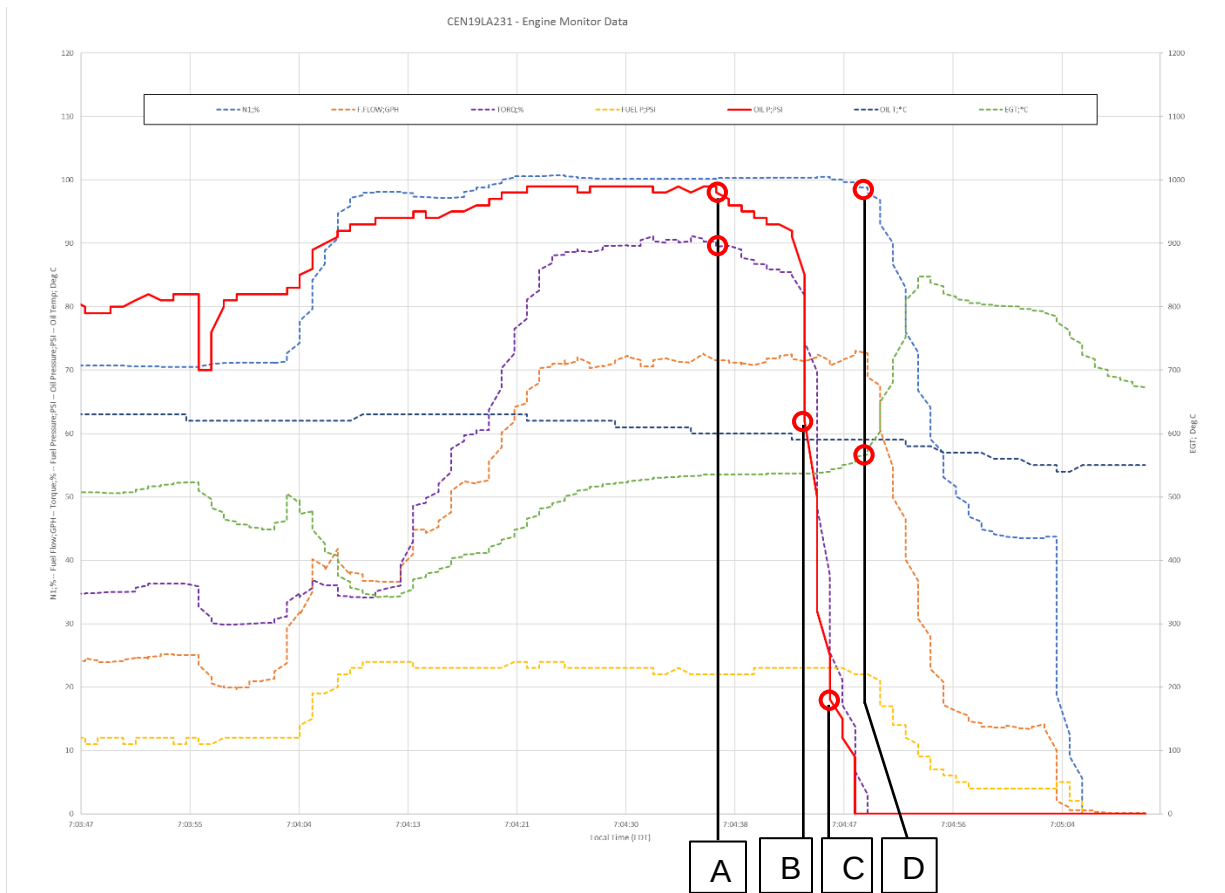
Figure 4 – Event Flight Plotted from Digital Engine Monitor Data.

Engine operation prior to reference line A (at approximately 7:04:37 local time) appears normal, after which engine oil pressure and torque begin to decrease. The decrease in oil pressure is consistent with a low oil supply to the oil pump when the main engine oil pump begins to ingest some air and the regulator can no longer maintain regulated oil pressure. The TPE331 engine features a hydraulic torque sensor, which requires engine oil pressure as a reference. With a decrease in oil pressure, the resultant indicated torque would also decrease despite the actual engine torque remaining unchanged.

Between the reference lines A to B (approximately 6 seconds), the oil pressure and indicated torque continue to decrease. During this time, the engine maintains 100% speed, constant fuel flow, and EGT. This condition is consistent with a constant power demand i.e. the power lever angle (PLA) set by the pilot, and the propeller governor controlling propeller blade angle to maintain 100% engine speed. The propeller governor controls propeller blade angle by metering high-pressure oil to and from the propeller to counteract the propeller spring and counterweight forces (See [D.4 Propeller Operational Notes](#) for more details). Oil from the main engine oil pump is supplied to the propeller governor, which contains its own internal oil pump to increase the oil pressure required

At reference line B (approximately 7:04:43 local time), there is dramatic reduction in oil pressure and indicated torque. This sudden drop is consistent with the loss of oil quantity and the engine oil pump ingesting more air and no longer being able to provide pressurized oil. For the next three seconds, engine speed, fuel flow, and EGT remain constant due to the constant PLA and the propeller governor continuing to provide high-pressure oil to the propeller.

At reference line C (approximately 7:04:45 local time), the engine oil pressure drops to approximately 20 pounds per square inch (psi). At this pressure and flow, the propeller governor internal oil pump begins to cavitate and is no longer able to provide the oil flow and pressure needed by the propeller to maintain the blade angle required to maintain the engine speed at 100 %. The resultant inability to counteract the spring and counterweight force in the propeller will allow the propeller blade angle to increase toward the feather position, increasing load from the propeller. For the next three seconds, the increasing propeller blade angle and corresponding load increases, results in a proportional drop in engine speed. The data also shows a very slight increase in fuel flow as the under-speed governor in the fuel control gains authority and reacts to the drop in engine speed. During this time, the EGT starts to increase as the engine speed decreases along with a corresponding drop in engine airflow.

As the engine speed continues to drop, the fuel control switches authority from the under-speed governor to the accel schedule (Reference Line D). The accel schedule controls fuel flow as a function of compressor discharge pressure which is determined by engine speed. However, due to the lack of oil pressure available to the propeller, the propeller blades continue to move toward a feathered blade angle and the accel schedule is unable to accelerate the engine back to 100% speed, resulting in the engine roll-down. Following the accel schedule, the fuel flow continues to decrease as the engine speed decreases due to the increased load from the propeller as it moves closer to the feathered blade angle. EGT increases rapidly as the engine airflow decreases with engine speed.

Engine speed and fuel flow eventually begin to stabilize at approximately 45% speed. The pilot reported that he exited the aircraft while the engine was still running but reached back inside the cockpit and activated the emergency shutdown. The fuel flow terminated at approximately 7:05:06 local time.

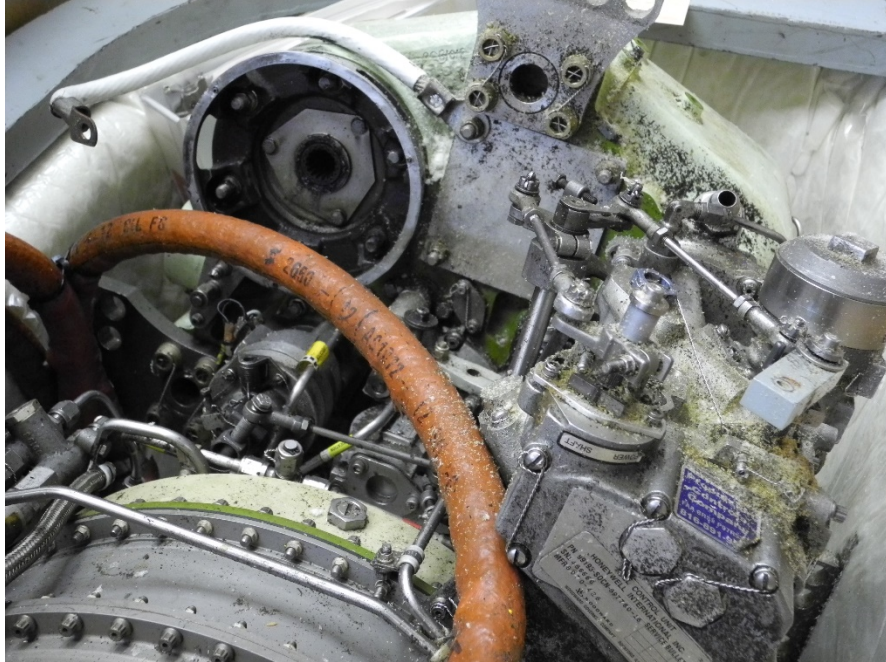
The nose cone, gearbox housing and the compressor housing were intact and undamaged ([Photo 5](#)). The nose cone chip detector ([Photo 6](#)) and the oil filter ([Photo 7](#)) were removed, and both were clean and oil wetted. The oil tank was intact; however, it was dented and scratched in several locations, consistent with impact damage ([Photo 8 & Photo 9](#)). The oil tank appeared to be empty; however, as the engine was tilted aft-wards while it moved to the engine stand via overhead crane, approximately 0.5 liter of clean oil was captured as it drained from the oil tank and lines. The tank normally contains 6 liters.

Photo 5 - Nose Cone, Gearbox Housing and Compressor Housing - Undamaged

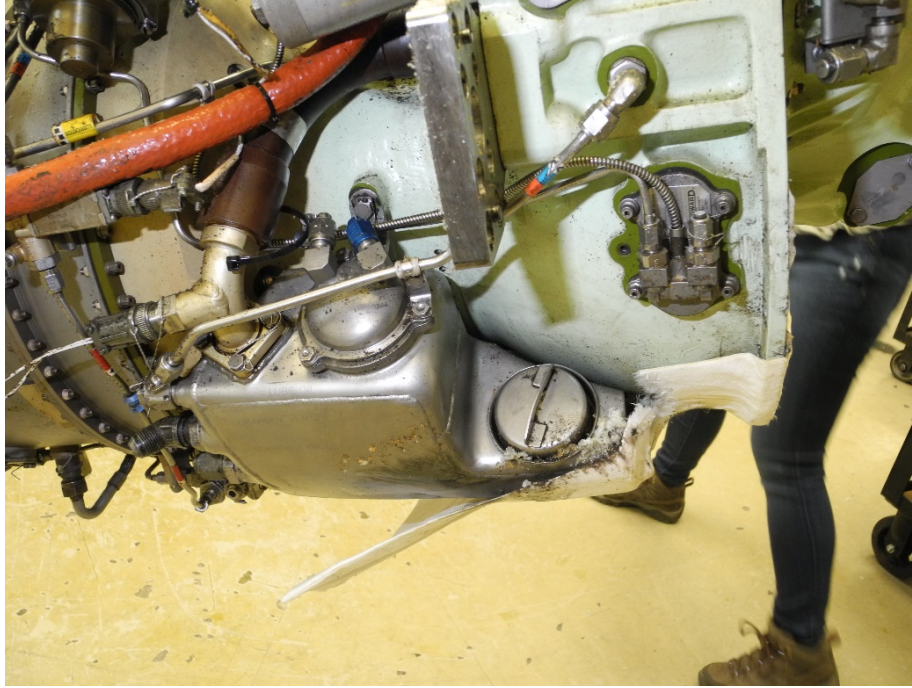
The oil tank was dented and scratched in several locations, consistent with impact damage; however, it was intact and not breached (Photo 9). The oil tank was removed from the engine and the air/oil separator and the fuel heater were withdrawn from the oil tank. The air/oil separator was intact and undamaged (Photo 21); however, an airframe supplied B-nut and short section of tubing was attached to the fitting. Routing of the vent line in the Ayres installation is unknown. The internal surface of the short section of tubing was coated with a thick layer of black debris. The external face of the Teflon ribbon cylinder was coated with black debris; however, the cylinder and aft face of the Teflon ribbon cylinder were clean. Additionally, the Teflon ribbon cylinder was observed to slide in the metallic sleeve when tapped on a hard surface. The air oil separator cavity in the oil tank contained loose black debris. In this Ayres airframe installation, the fuel heater function is not used; however, the fuel heater is still mounted in the oil tank and the fuel fittings are blanked off. The fuel heater (Photo 22) was undamaged, and all O-rings were in location and undamaged.

Photo 9 – Oil Tank – Removed from Engine – Dented & Unbreached

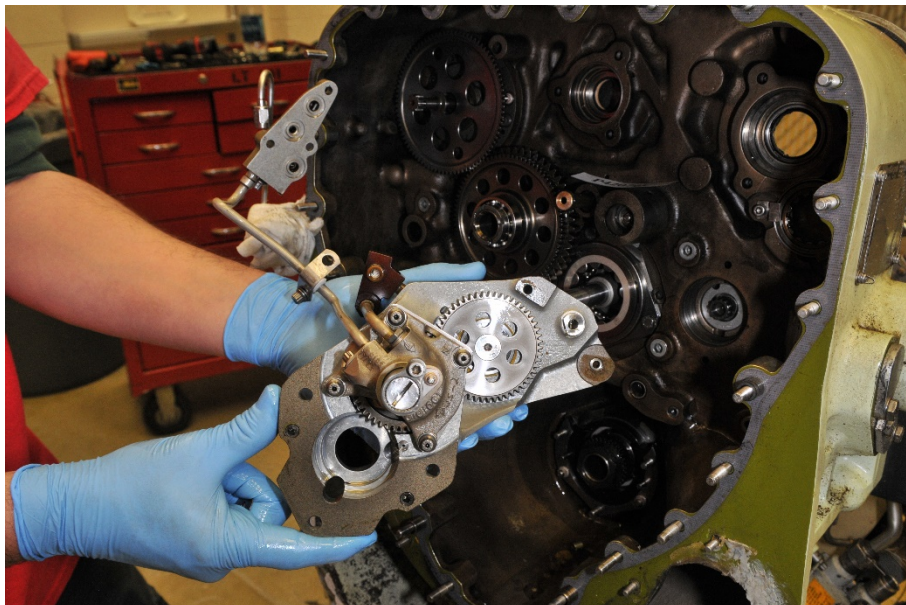
**Photo 18** – Torque Sensor Helical Gearshaft & Spur Gear and Cam Assembly – Seized

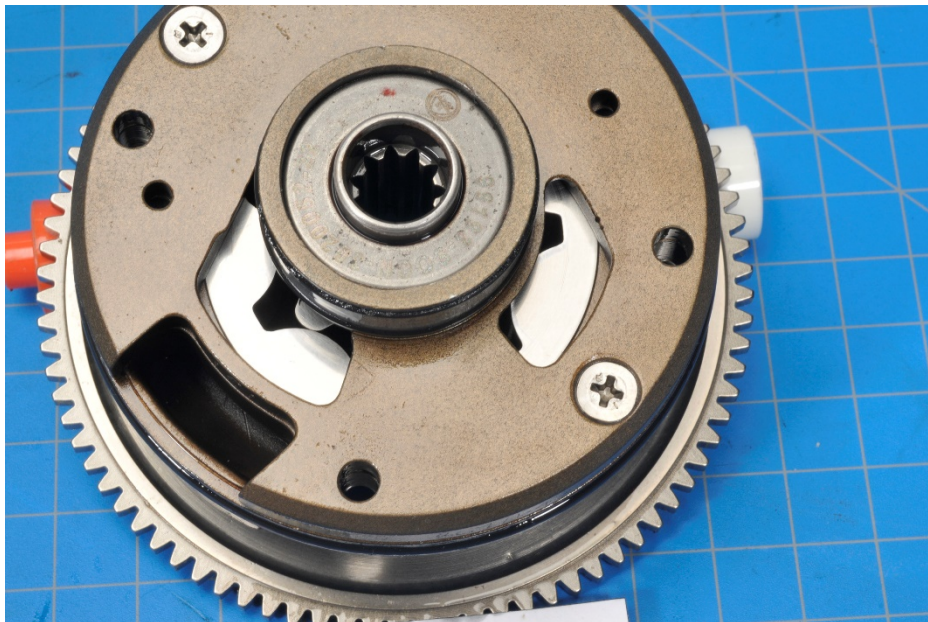
The turbine bearing scavenge pump was removed, examined, and found to be oil wetted and undamaged ([Photo 26](#)).

Photo 26 - Turbine Bearing Scavenge Pump - Undamaged

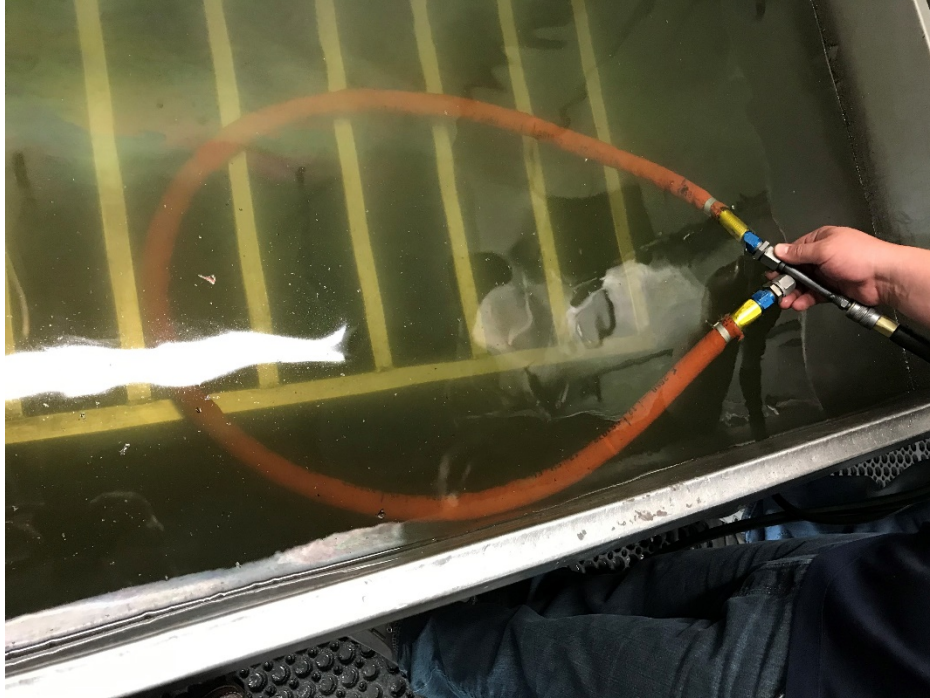
Similarly, the two flex-hoses were blocked at one connector end and 100 psi air pressure was introduced into the other ([Photo 32](#) & [Photo 33](#)). No leaks were seen on either flex-tube.

Photo 33 - Flex-Hose (2) with 100 psi Air Pressure in Tank – No Leaks

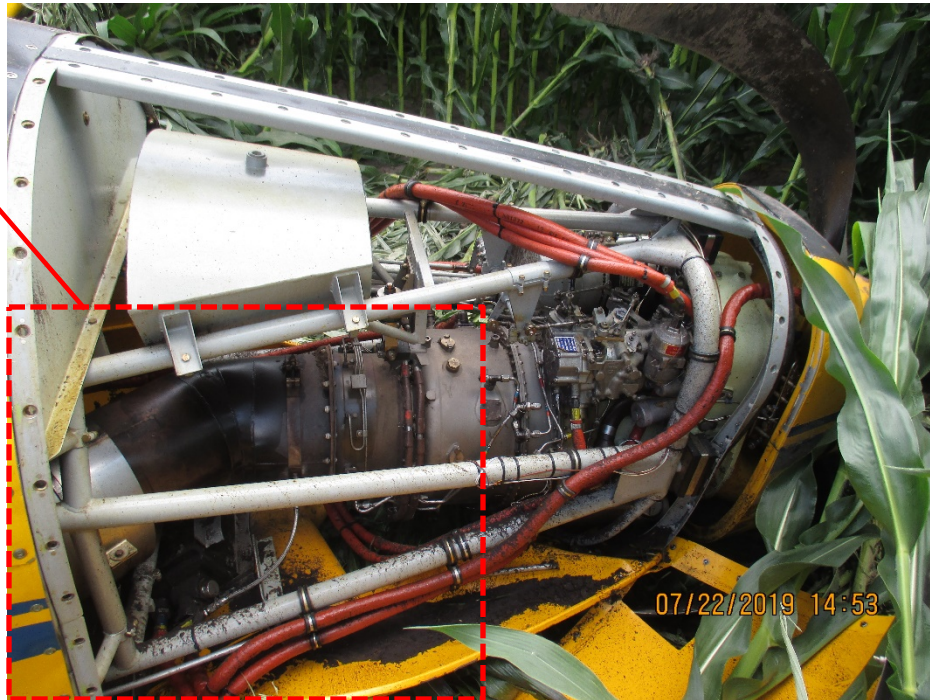
Photo 35 – Close up of Photo 34

An examination of the on-scene images, taken by the FAA, revealed that escaped engine oil was present inside the nacelle. [Photo 34](#) & [Photo 35](#) depict the rear frame of the engine, the exhaust duct, the firewall/battery box, the oil cooler just below the exhaust duct and the oil cooler hoses. The photos reveal (1) engine oil pooled on the ledge of the

battery box frame, which is consistent with escaped oil being distributed around the inside surfaces of the nacelle. (2) engine oil wetting as far as the top of the exhaust duct and the engine rear frame, which is consistent with eductor<sup>2</sup> operation and an engine still in high-speed operation, drawing oil particles that have escaped into the nacelle to be drawn through 360 degrees of the annulus. It is observed that there was more oil wetting on the center of the engine exhaust pipe, at the same plane as the oil cooler, gradually becoming less until it stops at the mid-point of the engine rear frame. This observation is consistent with a leak in the plane of the oil cooler area. An engine oil leak would manifest itself as significant oil wetting of the engine body, which was not observed.

Oil Pooling  
on Ledge of  
Battery Box  
Frame

Engine Rear  
Frame – Oil  
Wetted until  
Mid-point

Engine  
Exhaust Duct  
– Oil Wetted

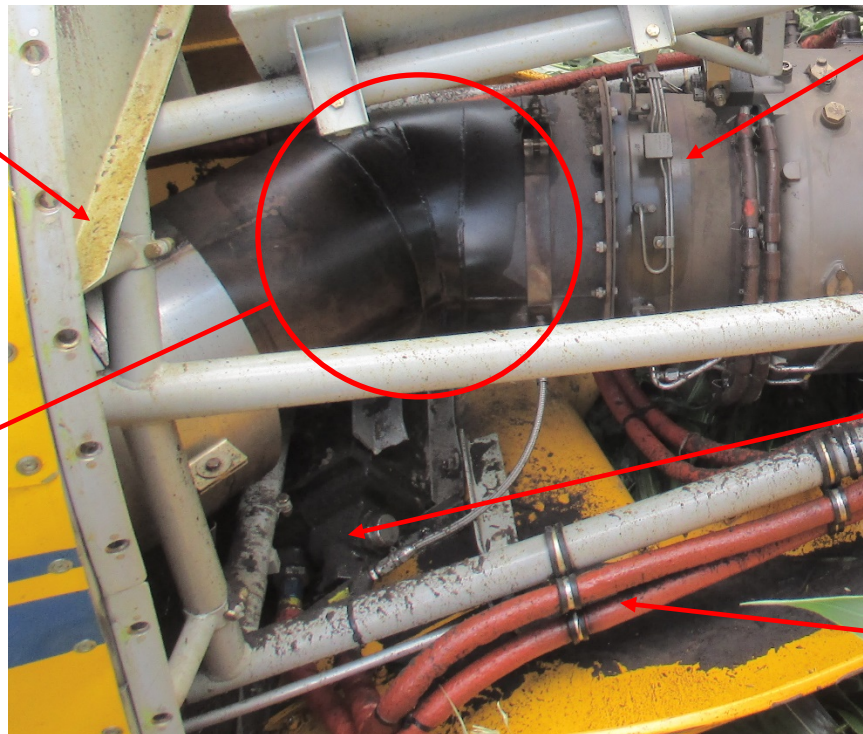
[Photo 36](#) was taken during the wreckage review and its examination reveals that the eductor mixing duct is oil wetted on the inside, consistent with the engine in operation, drawing escaped oil particles through the annulus into the mixer duct.

Photo 36 – Eductor Interior Surface – Oil Wetted near Exhaust Duct
