## **NATIONAL TRANSPORTATION SAFETY BOARD**

# **ENGINE EXAMINATION**

**CEN19LA233**

Location: Air Salvage of Dallas (ASOD)  
Date: November 8, 2019  
Aircraft: Cessna 172: N8251L  
NTSB IIC: Jason Aguilera

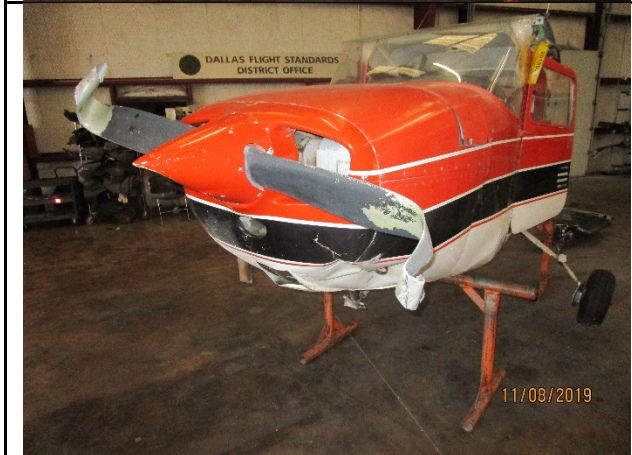
Front view. Both ends of the two-bladed fixed pitched propeller, show significant twisting, scrapes, etc.

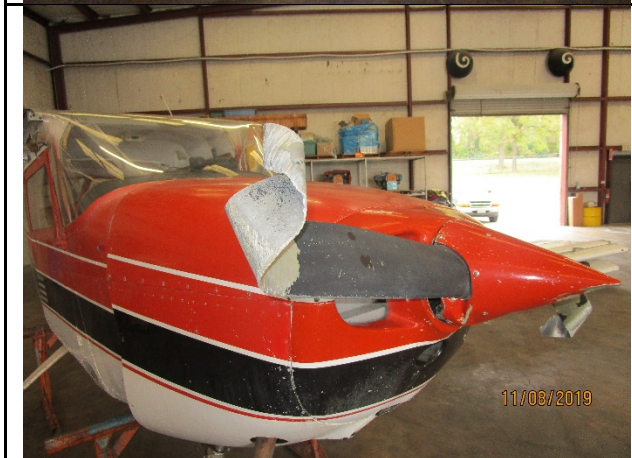
Another view of the propeller.

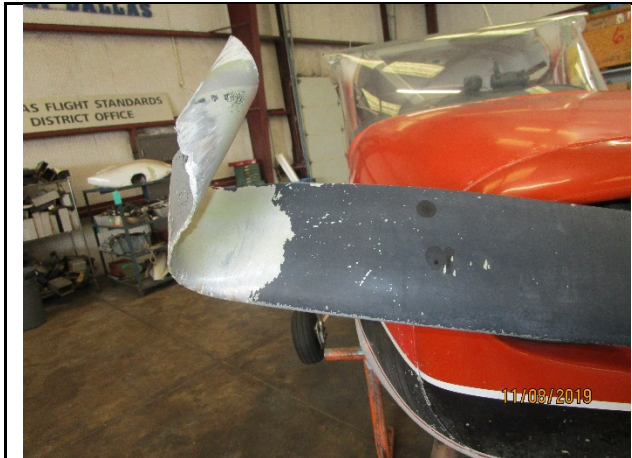
A close of view of the propeller tip.

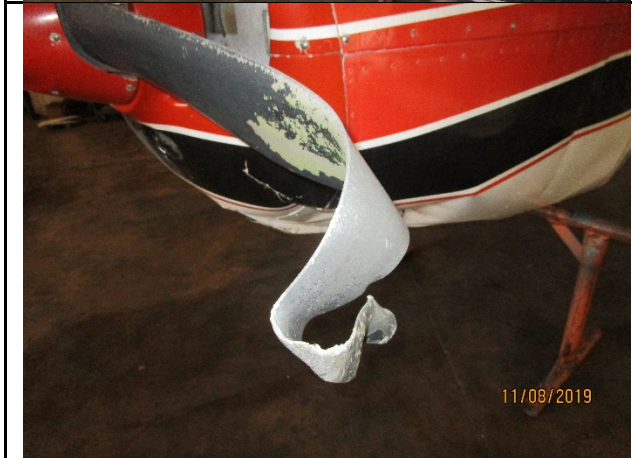
View of the other propeller tip.

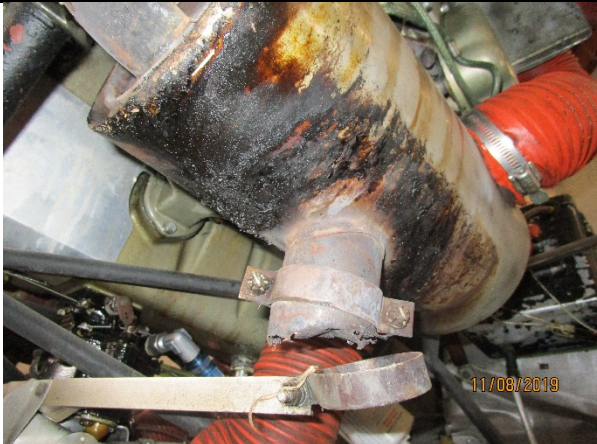
| | <p>Evidence of slight oil leakage was noted</p> |

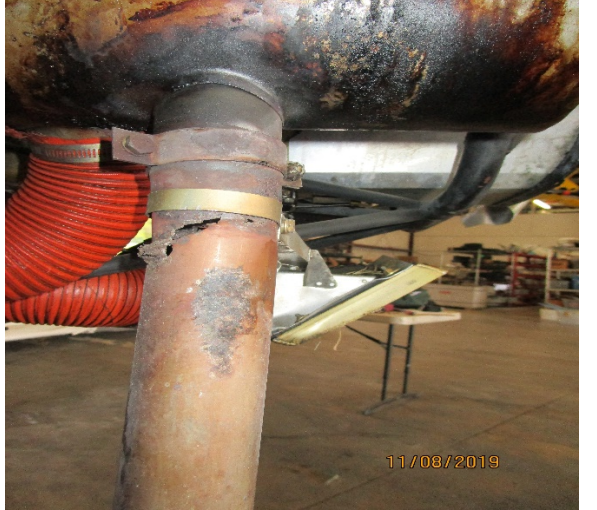
| | <p>Rust noted on exhaust pipe</p> |

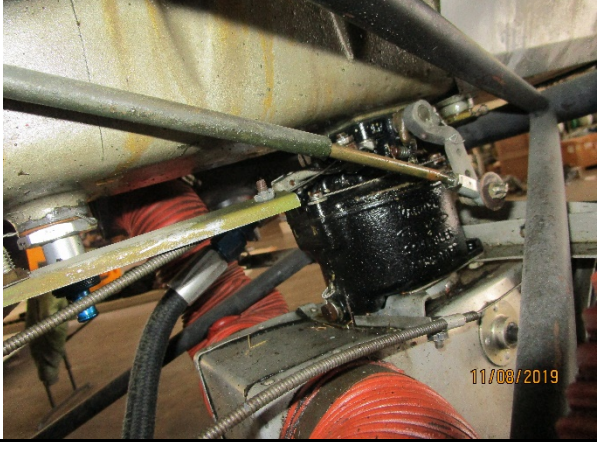
| | <p>Controls were attached to the carburetor; inspection of the carburetor throat did not find any debris in its intake.</p> |

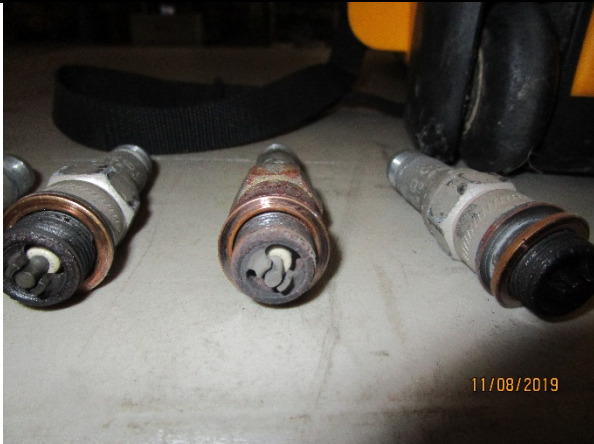
| | <p>The topset of sparkplugs were removed.</p> <p>The sparkplugs appeared normal.</p> <p>Spark was observed at each terminal, on the top set of ignition wires, when the engine was rotated by hand. Additionally, the impulse couplings were also heard.</p> |

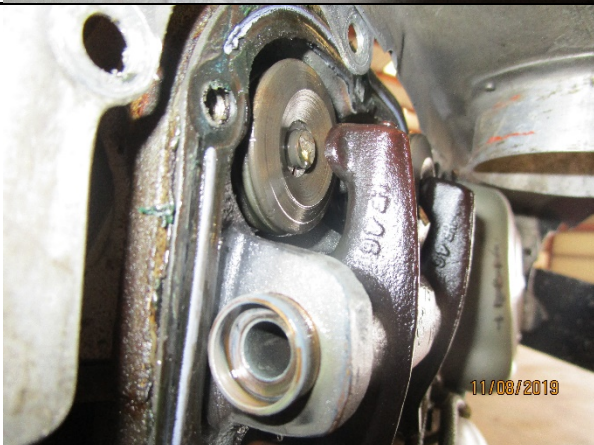
| | <p>During thumb compression test; no suction/compression was noted on cylinder No 1.</p> <p>The exhaust valve was found stuck, in the open position.</p> |

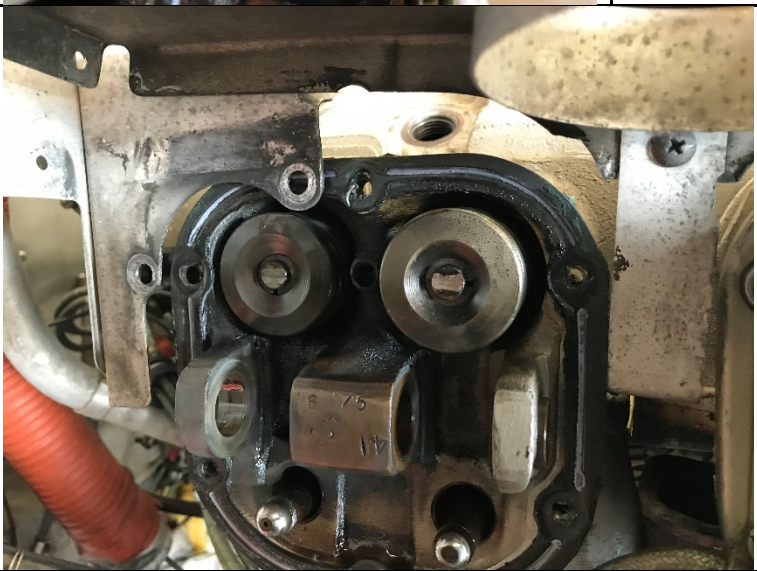
| | <p>Some 'hammering' of the top of the valve stem is noted. Likely from rocker action, while the engine was running.</p> |
