# NATIONAL TRANSPORTATION SAFETY BOARD

## MATERIALS LABORATORY FACTUAL REPORT

Report No. 20-042

Place : Saginaw, Michigan  
Date : August 3, 2019  
Vehicle : Cessna A185E, N5806J  
NTSB No. : CEN19LA249  
Investigator : Craig Hatch, AS-CEN

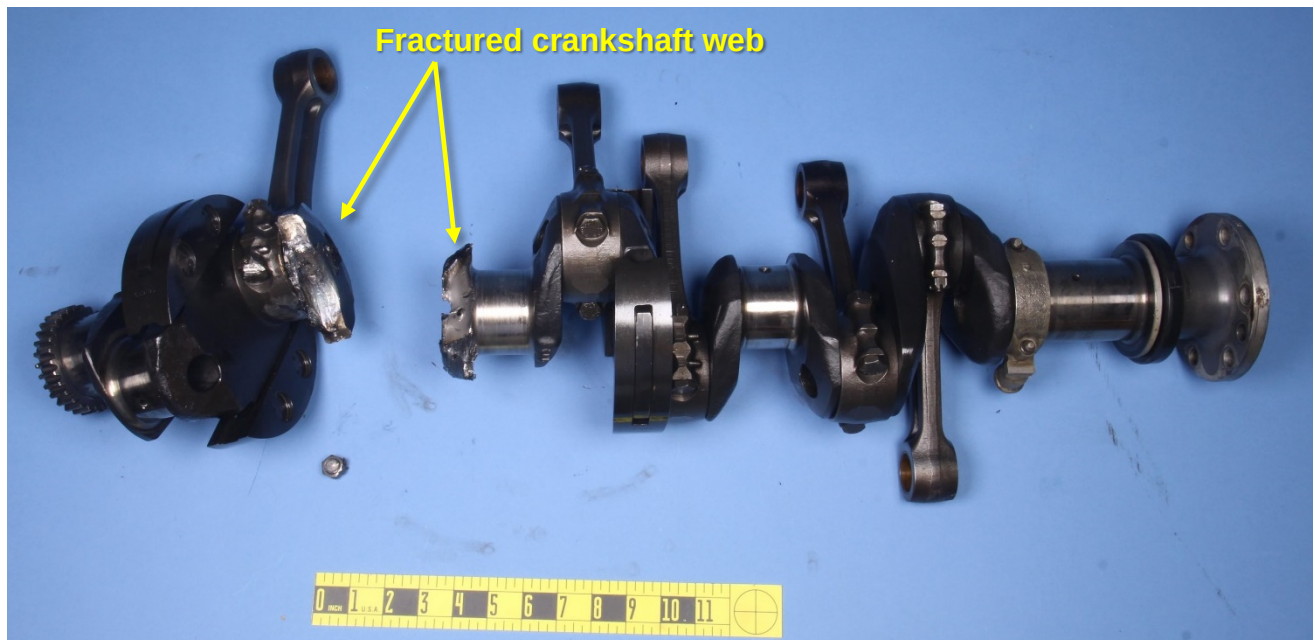
Pieces from the Continental IO-520 series engine crankshaft were secured and sent to the NTSB Materials Laboratory. Figure 1 shows the remnants of the crankshaft assembly, as received. The crankshaft had fractured at the web between the #2 connecting rod journal (C2) and the #2 intermediate main journal (M2).<sup>1</sup> The airplane was recovered to a secure facility for further examination.

Figure 1 – The fractured pieces of the crankshaft assembly, as received.

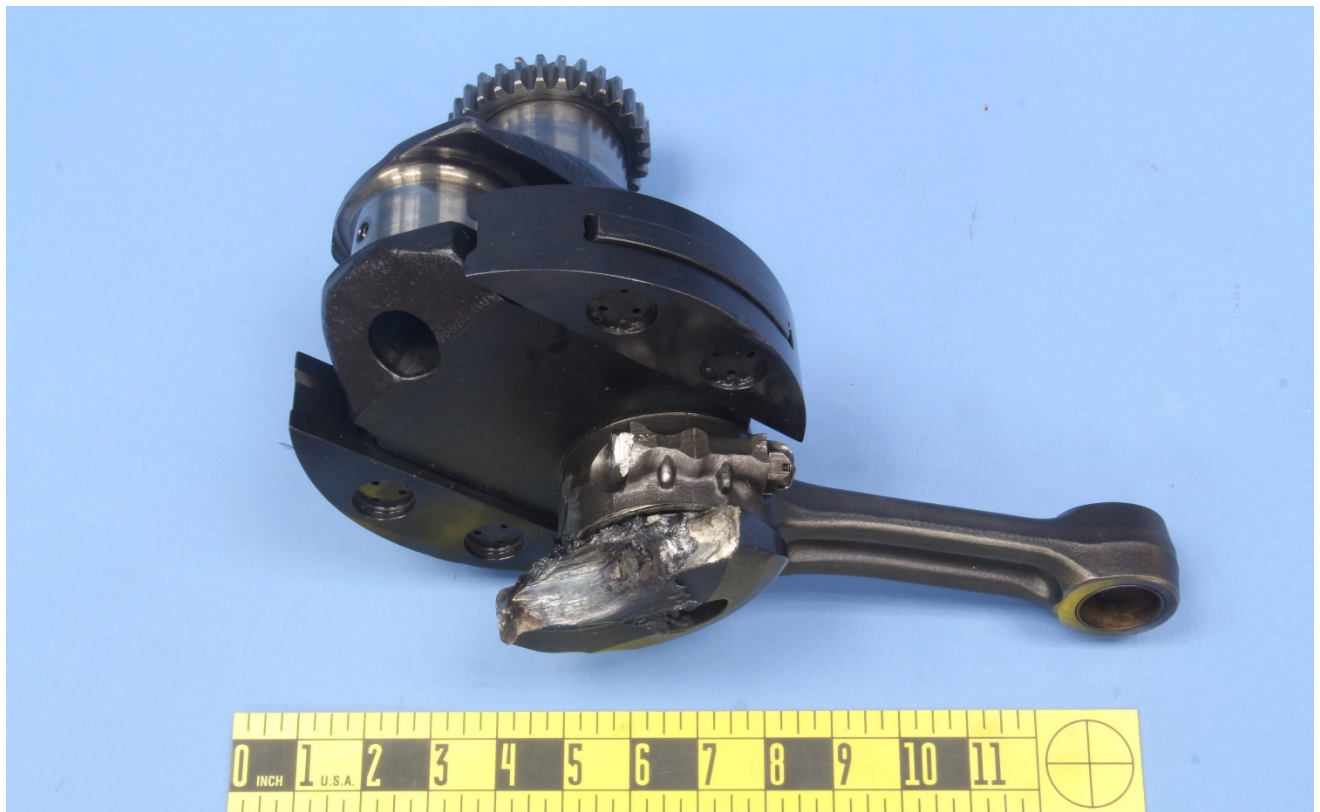
Figure 1 shows the two halves of the crankshaft assembly, as received. Except for the C1 journal, all the connecting rods and caps were still affixed to their respective journals upon receipt. Figure 2 shows the aft fracture surface of the fractured web near the M2 journal. The connecting rod adjacent to this fractured area (C2) was still affixed and able to be rotated about its journal. This web fracture surface exhibited rounded,

flattened features, consistent with smearing, batter, and other types of post-fracture damage.

Figure 2 – View of the aft fractured piece of the crankshaft assembly, viewed forward looking aft. The fracture surface across the web adjacent to the #2 connecting rod journal is visible.

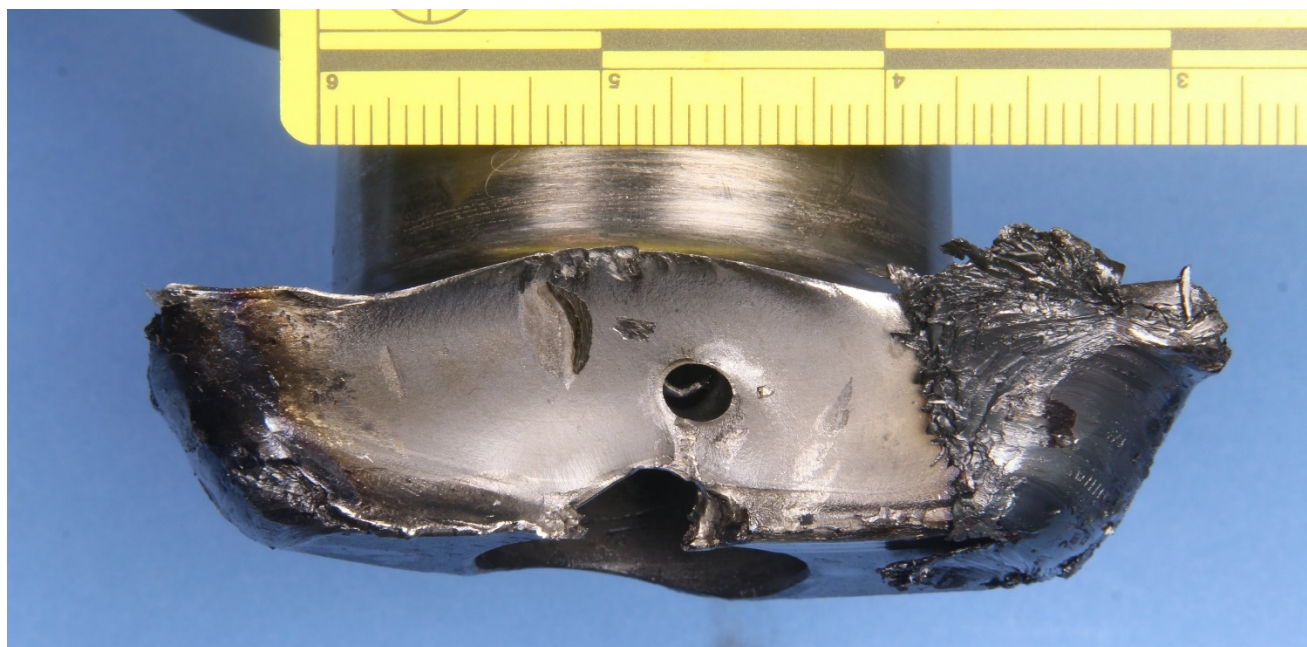
In contrast, the forward mating web fracture surface was relatively undamaged, as illustrated in Figure 3. The center of the fracture surface was generally flat, with some vertical gouges consistent with post-fracture impacts. The sides of the fracture surface exhibited material folded inward over the fracture surface. This was consistent with post-fracture smearing of the sides of the fractured web being deformed back over the fracture surface. The smearing on the left side of Figure 3 also exhibited banded coloring from yellow to violet to blue, consistent with heat tinting of this side of the web.

Figure 3 – View of the forward side fracture surface across the web at the M2 journal.

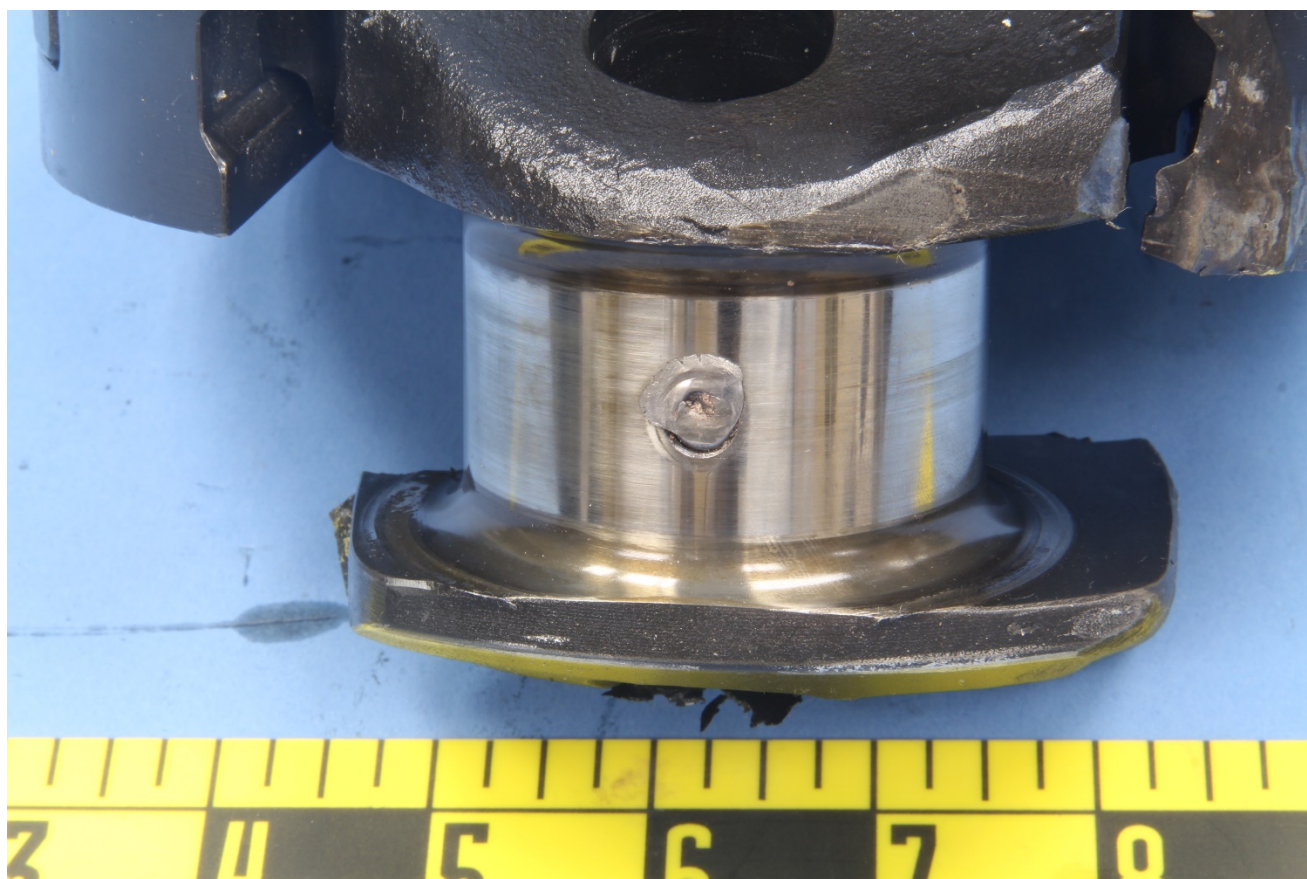
Figure 4 shows the adjacent C2 journal to the aft side of the fractured web. The connecting rod at this position, which contained a severed and missing nut on one side, was disassembled and removed. This journal exhibited indications of circumferential wear marks, consistent with rotational wear around the journal. The oil hole in Figure 4 was plugged with the remnants of the oil lubrication tube. The tube material was smeared and flattened over the journal surface surrounding the hole, consistent with protrusion and deformation of the tube between the journal and mating bearings.

Figure 4 – View of the C2 journal adjacent to the forward side of the fractured web, showing a smeared lubrication tube in the oil lubrication hole, after removal of the connecting rod.

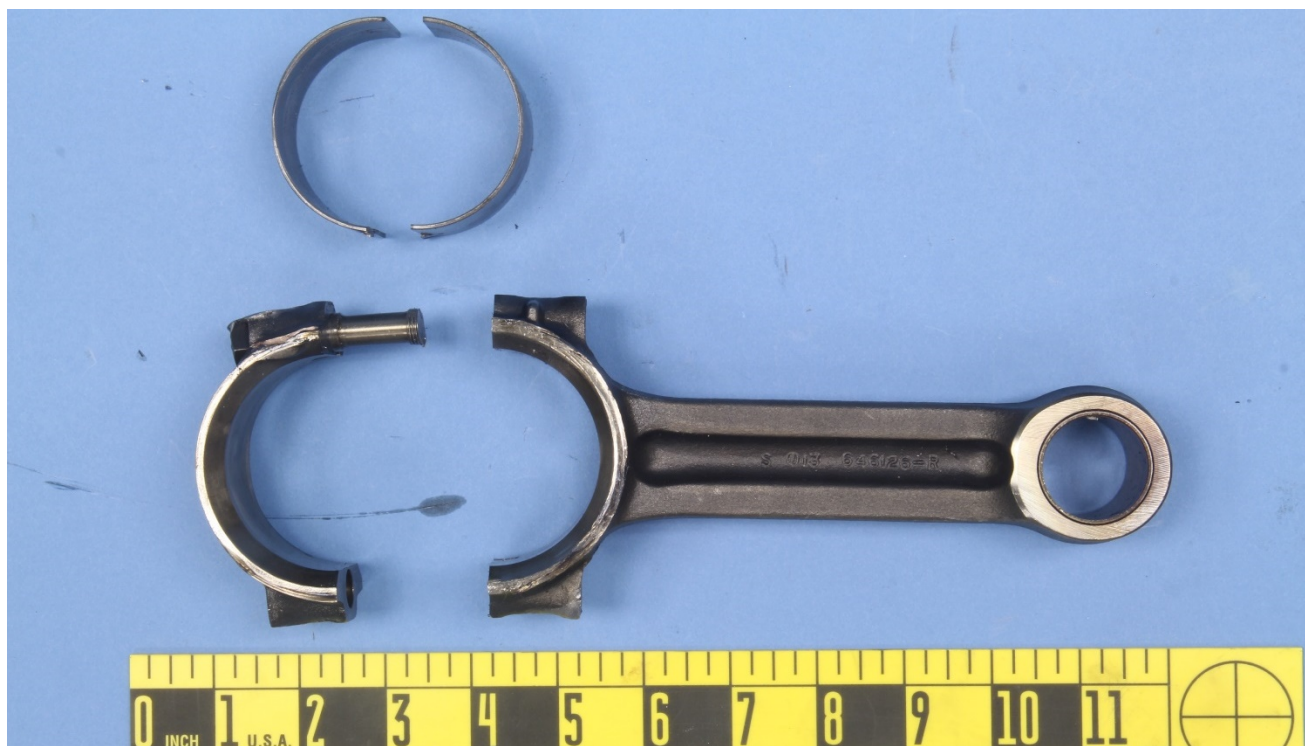
Figure 5 shows the removed C2 connecting rod, rod cap, and bearings, as received. The lower portion of one of the attachment bolts was still present inside one of the bolt holes of the cap; the other bolt was not present. The inside surfaces of the cap and rod did not exhibit any features consistent with wear or damage.

Figure 5 – View of the connecting rod and bearing from the C2 position, after disassembly.

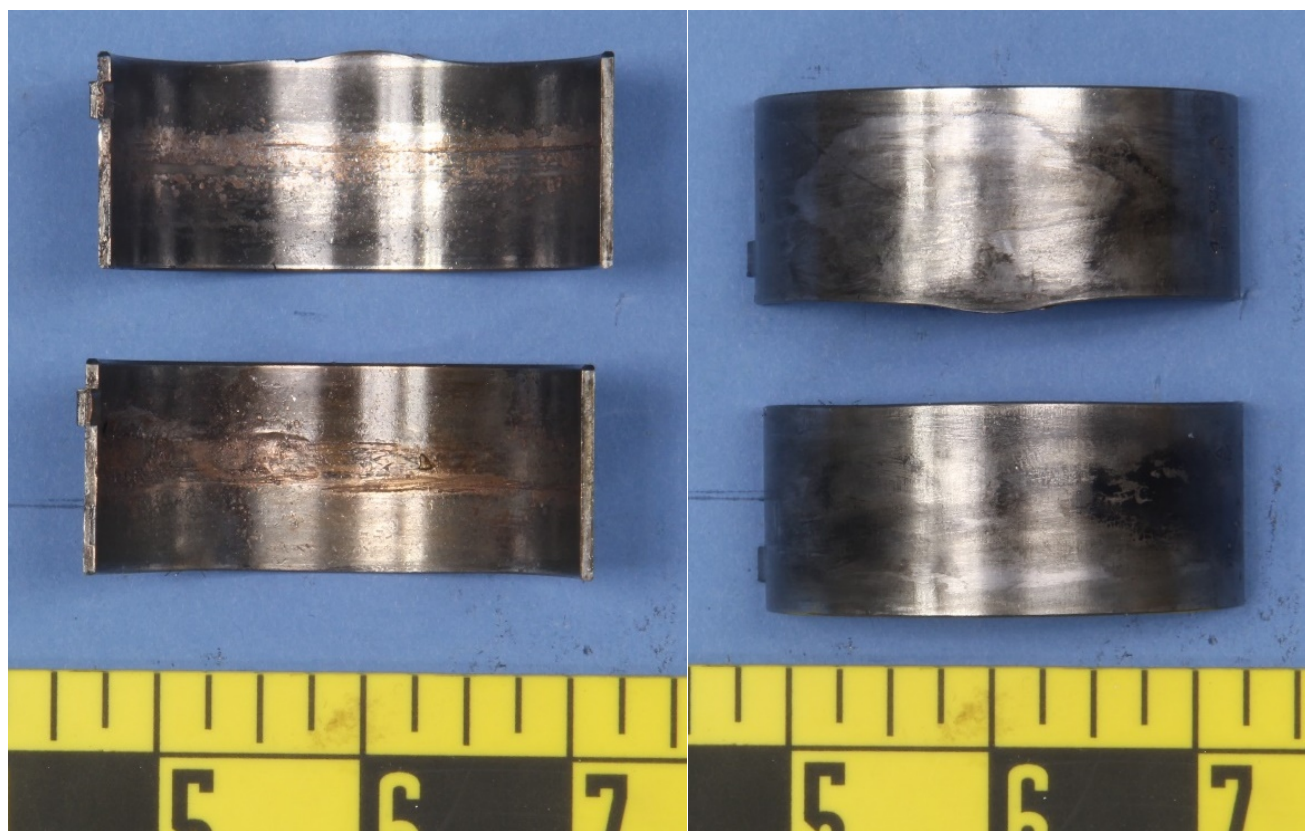
Figures 6a and 6b show the rod bearings from the inside and outside surfaces, respectively. Both bearings exhibited circumferential wear marks on the interior and exterior faces. One of the bearings exhibited a 0.25 inch wide by 1.5 inch long area with gouging and material spalling. The location and width of this gouging was consistent with smearing of the oil lubrication tube in the journal shown in Figure 4. The opposite bearing exhibited outward (longitudinal) deformation outward, perpendicular to the bearing rotation direction. This deformation was visible on both surfaces of the part.

Figure 6 – View of the #2 connecting rod bearings viewed from (a) the internal and (b) exterior bearing surfaces.

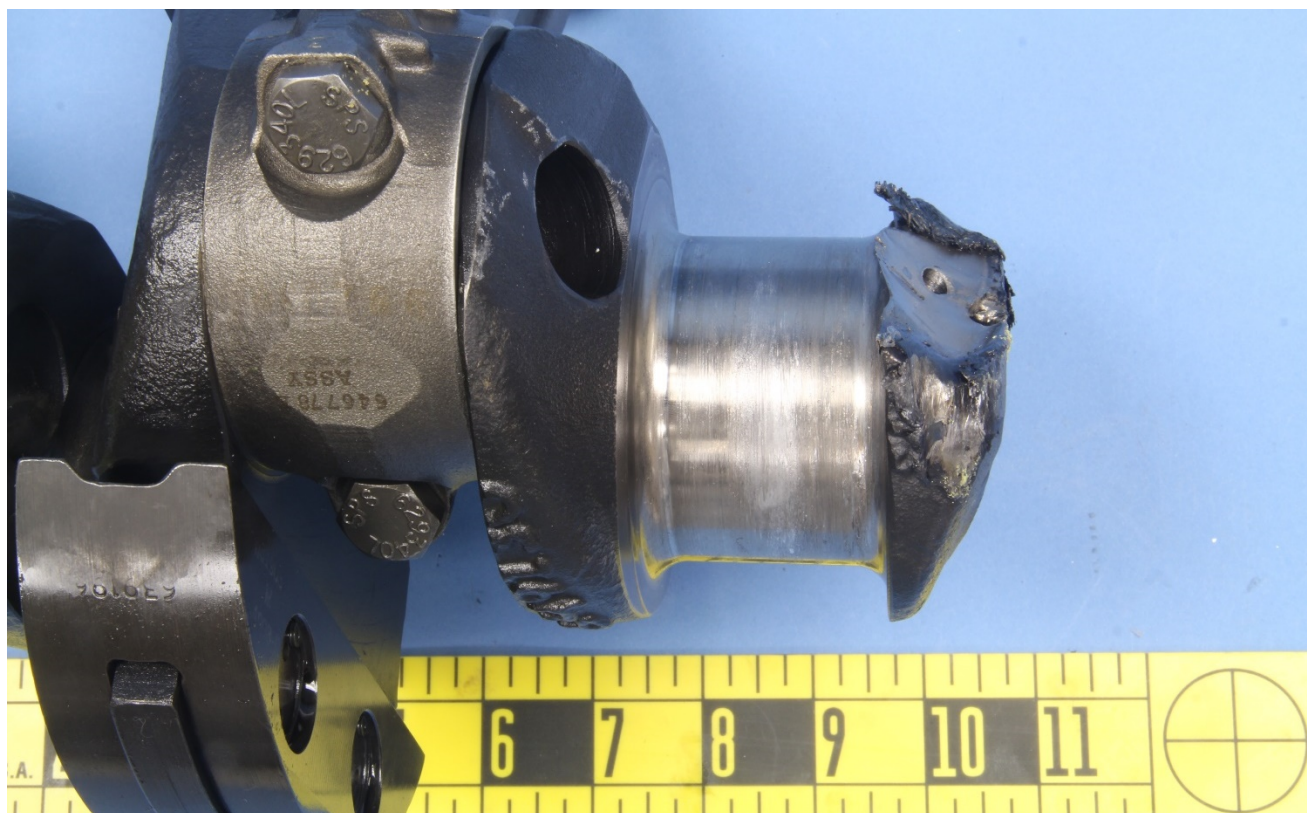
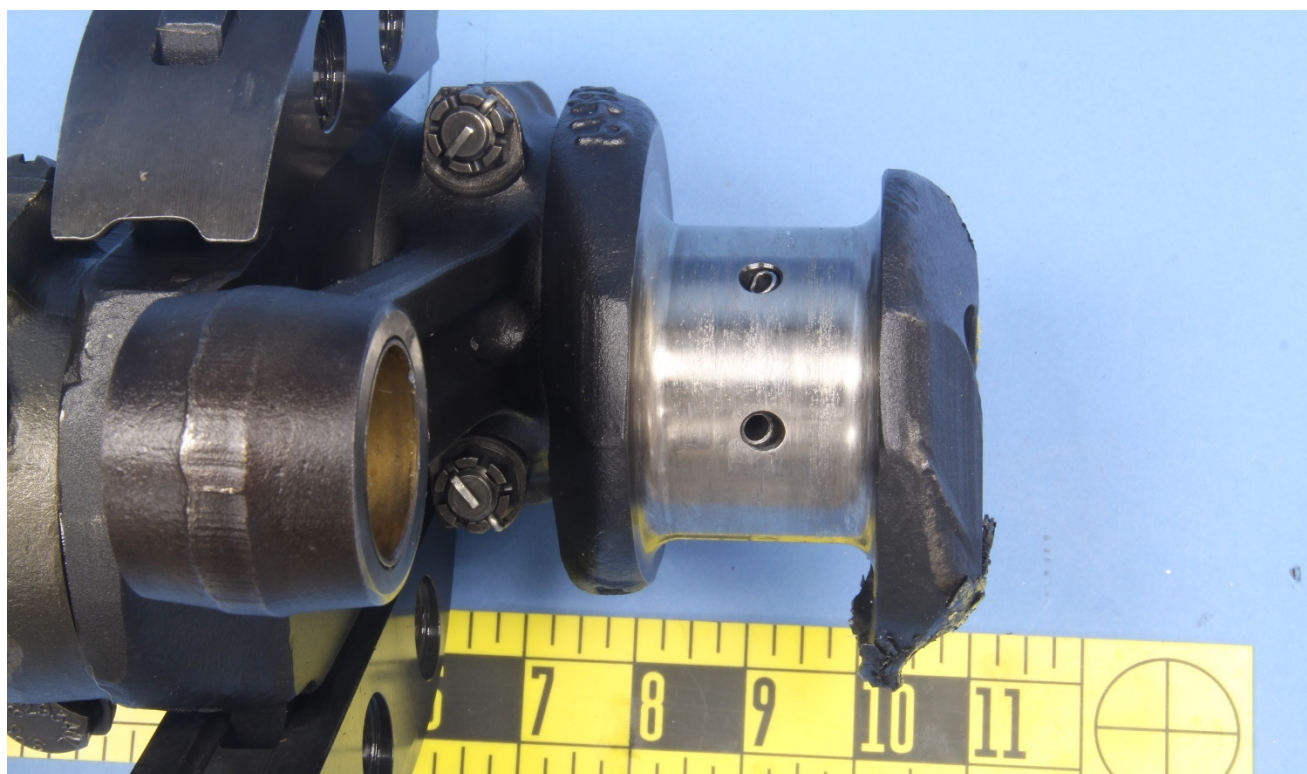
Returning to the crankshaft web fracture surface, the M2 journal is shown from opposite sides in Figure 7 and 8. The initiation side of the fracture surface was located approximately 0.125 inches from the journal surface, along the journal-to-web radius. These surfaces show indications of light wear, but no indications of plastic deformation in the form of gouging, smearing, or material loss. As shown in Figure 3, there were indications of circumferential wear marks, consistent with rotational wear around the journal. The bearings from this location were not sent to the NTSB Materials Laboratory, as they were reportedly found in the oil sump, consistent with having fractured and deformed repeatedly after fracture of the crankshaft.

Figure 7 – View of the M2 journal adjacent to the fracture through the crankshaft web.

Figure 8 – View of the M2 journal from 180° opposite that of Figure 7.

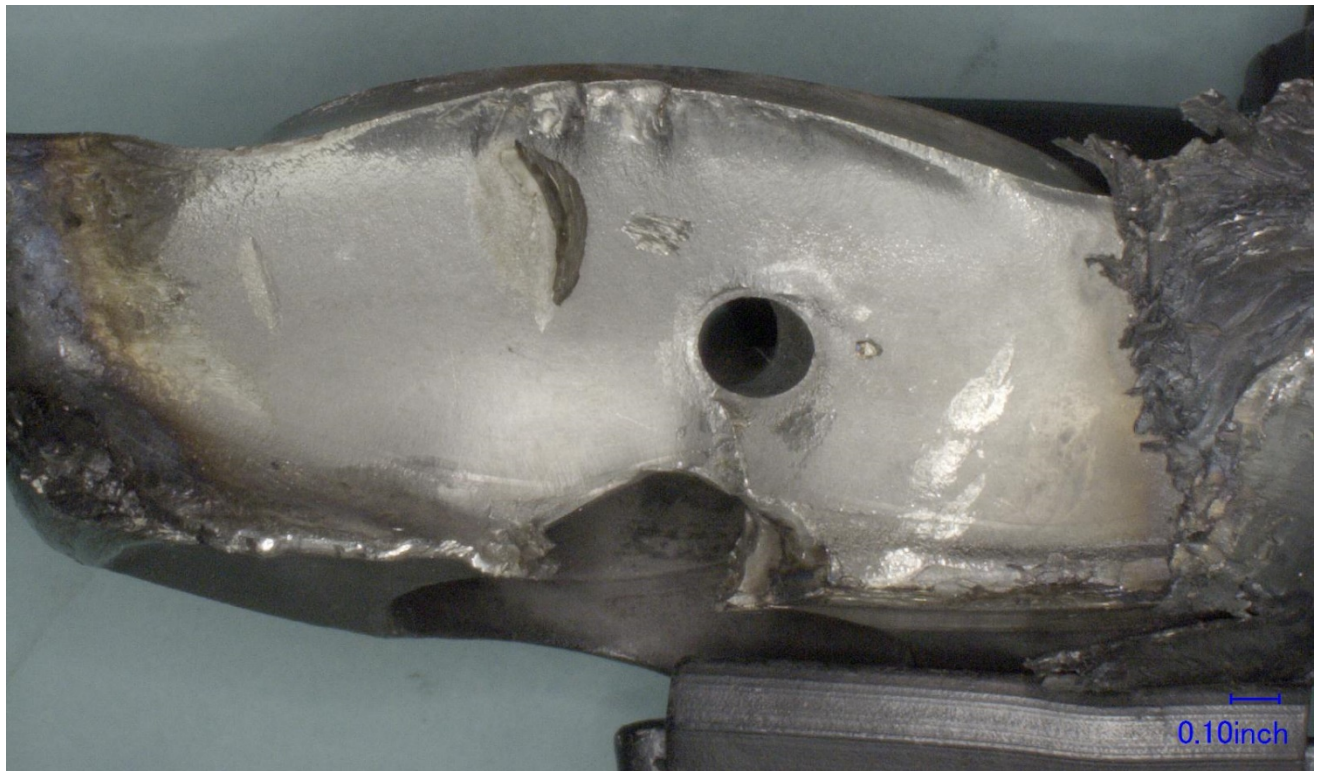
The forward web fracture was sectioned from the rest of the crankshaft remnant. This piece was cleaned with soapy water, acetone, and ethanol. Figure 9 shows a closer view of the undamaged regions of the crankshaft web fracture surface. The fracture surface exhibited crack arrest marks, consistent with crack propagation from the top to the bottom of the figure.

Figure 9 – View of the forward fracture surface of the fracture web, after sectioning.

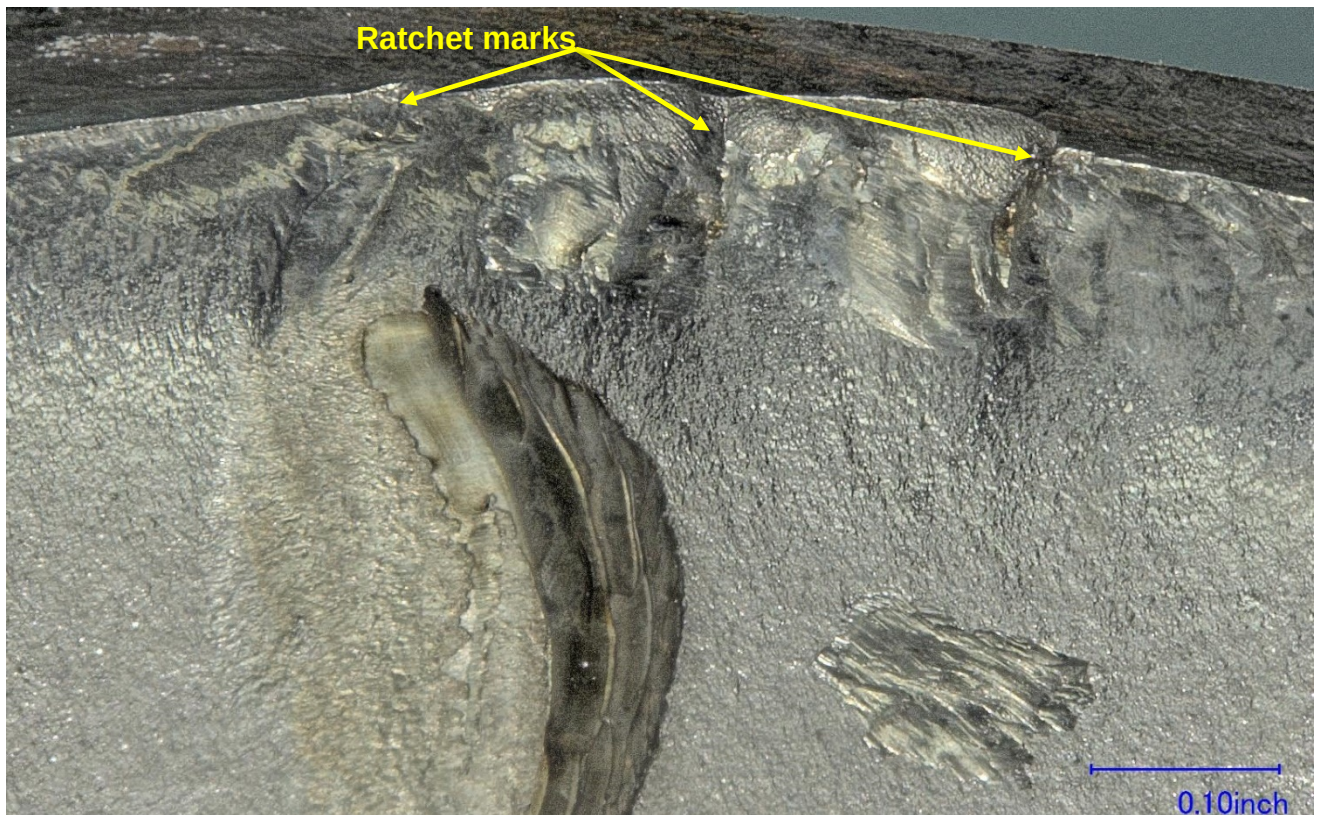
Near the crack initiation region, on the top of Figure 9, several ratchet marks were observed. As shown in Figure 10, these marks were adjacent and perpendicular to the journal-to-web radius. Much of the surface material in this area had been damaged by smearing, manifest as angled horizontal streaks in the figure. Figure 11 shows a closer view of the area between two ratchet marks. Features such as river patterns were present and oriented consistent with propagation outward and downward in the figure from initiation sites on the edge. These ratchet marks were consistent with multiple cracks that coalesced during early propagation of the crack.

Figure 10 – Closer view of the top of Figure 9, showing 3 ratchet marks.

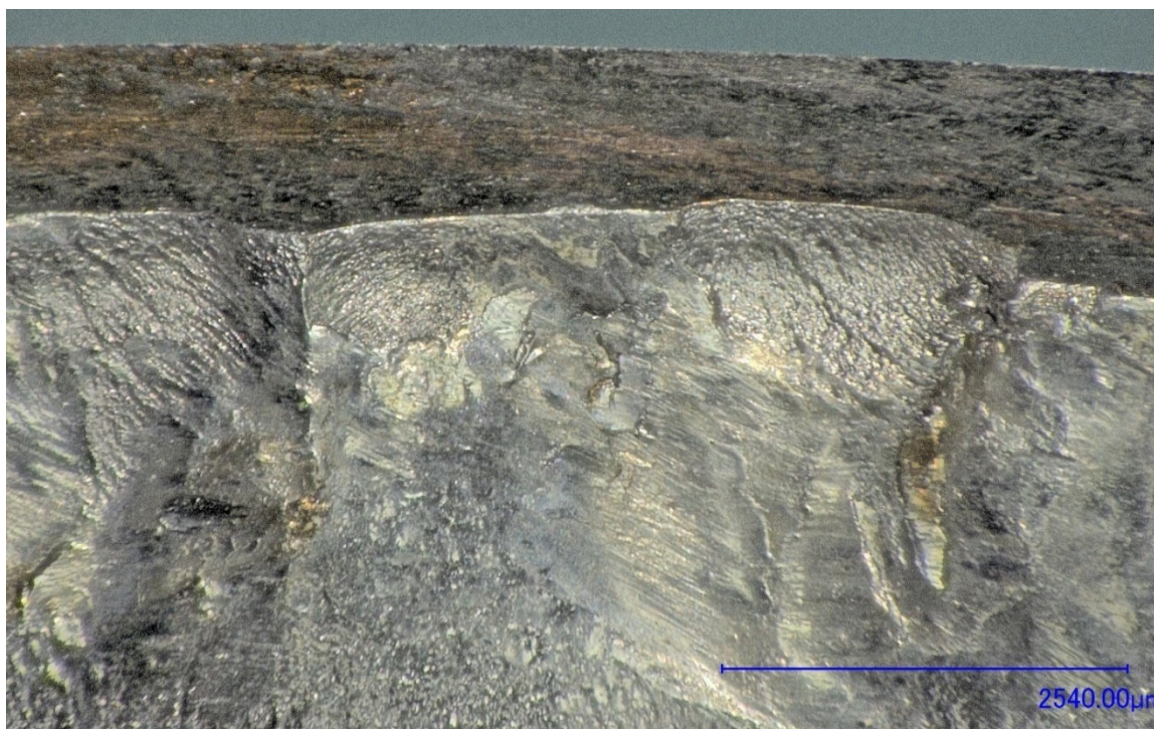
Figure 11 – Closer view of a crack initiation site between two ratchet marks.

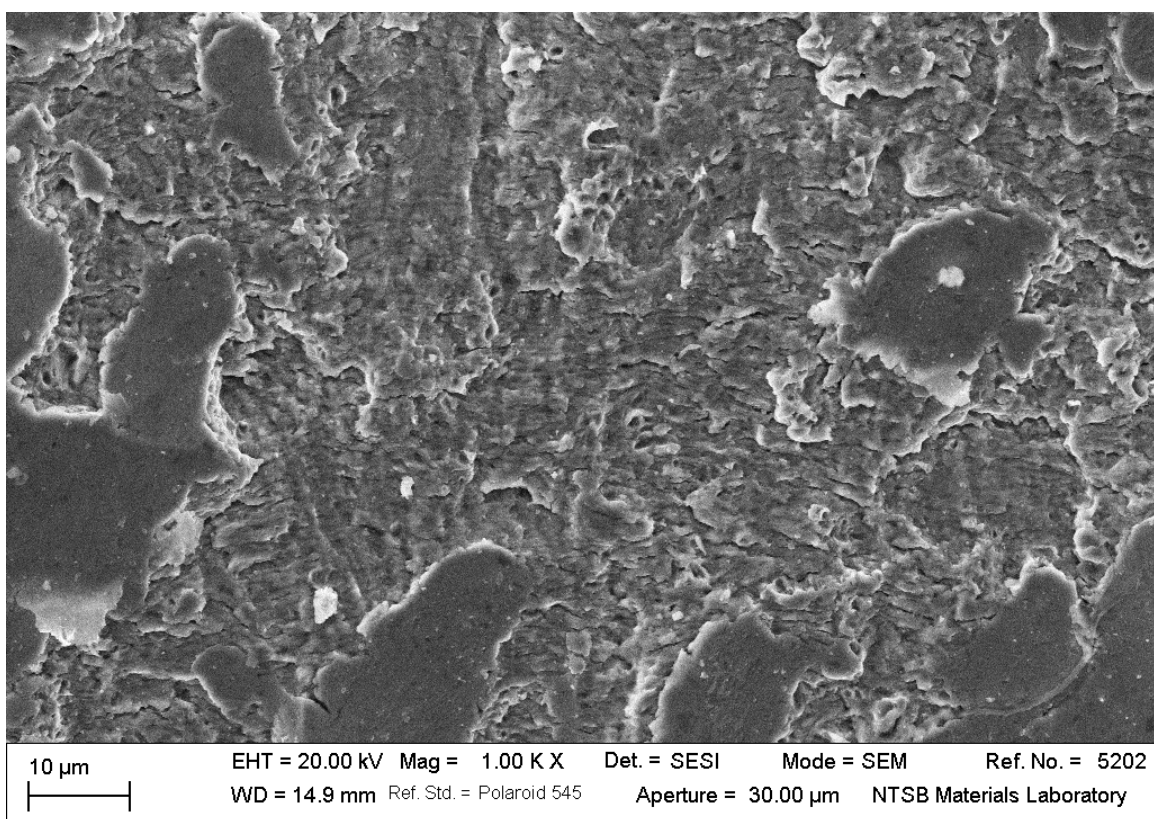
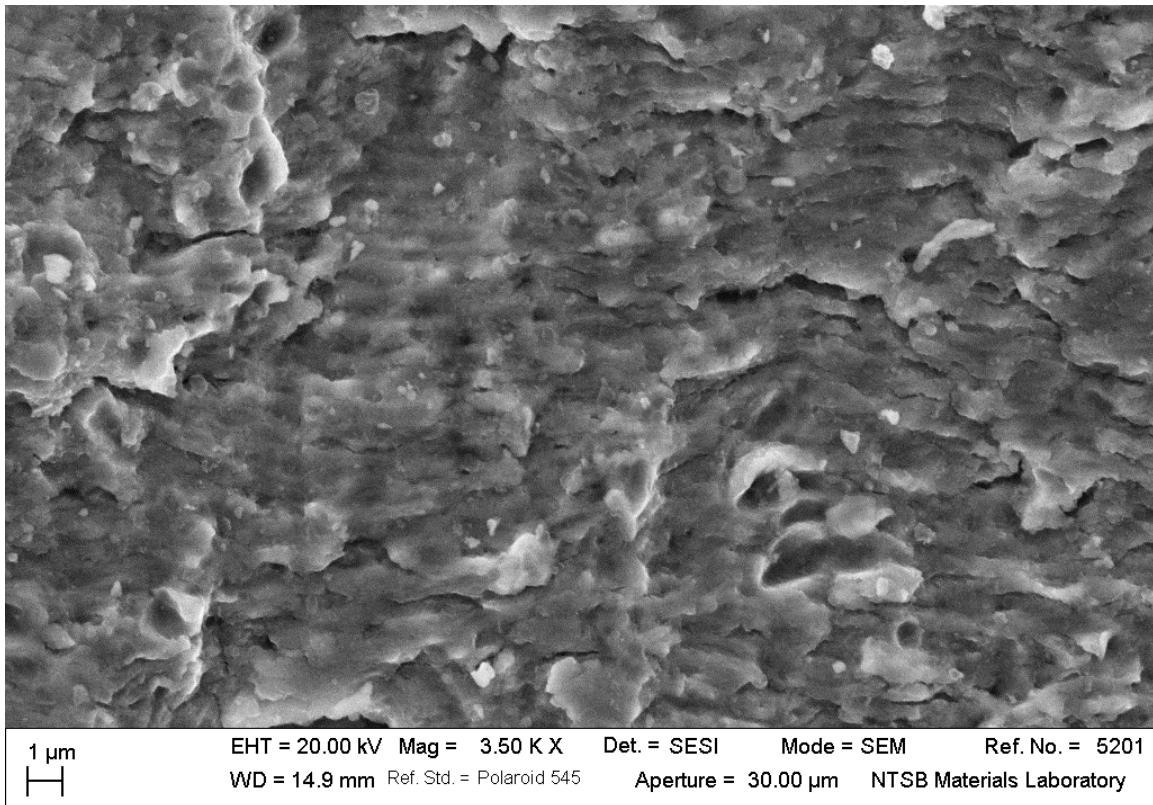
The web fracture surface was examined using a scanning electron microscope (SEM). Figure 12 shows a typical area of the fracture surface in the progressive cracking region. This figure shows fatigue striations, consistent with fatigue crack propagation. Figure 13 shows a closer view of these striations, showing consistent spacing, along with limited secondary cracking.

Figure 12 – Secondary electron (SE) micrograph of fatigue striations on the web fracture surface.

Figure 13 – SE micrograph of a closer view of the striations in Figure 12.

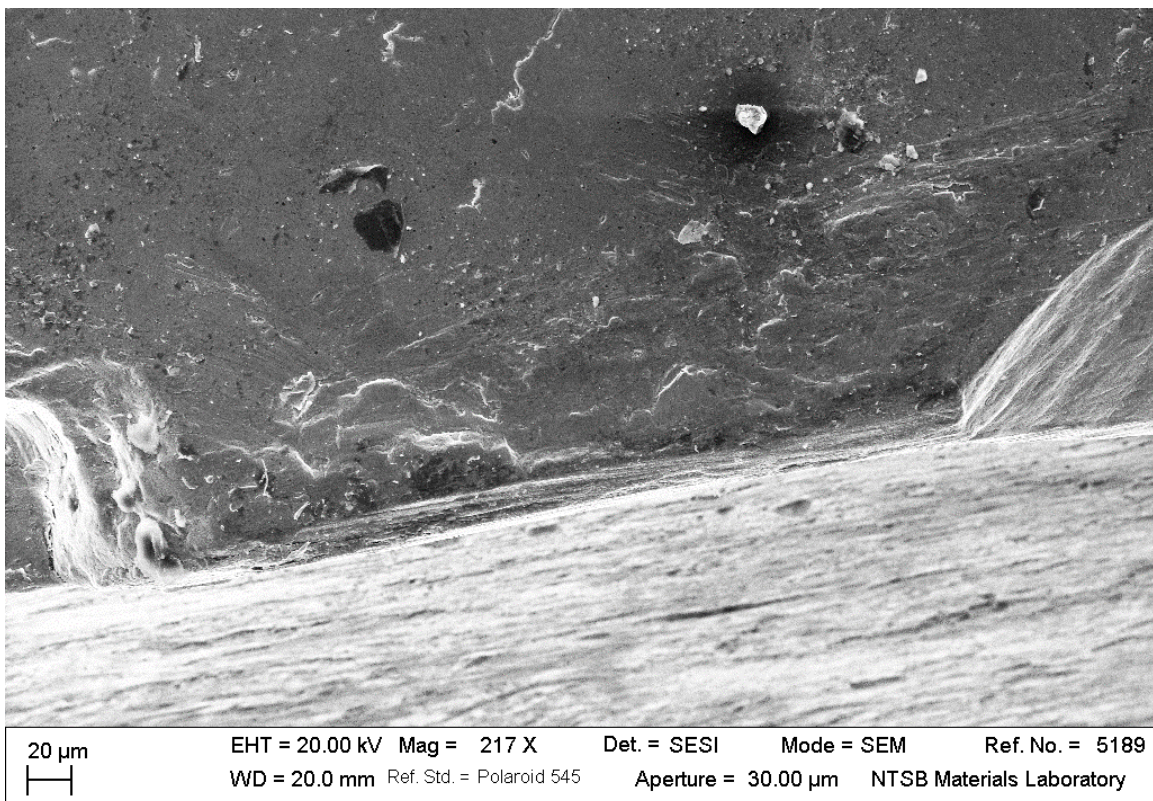
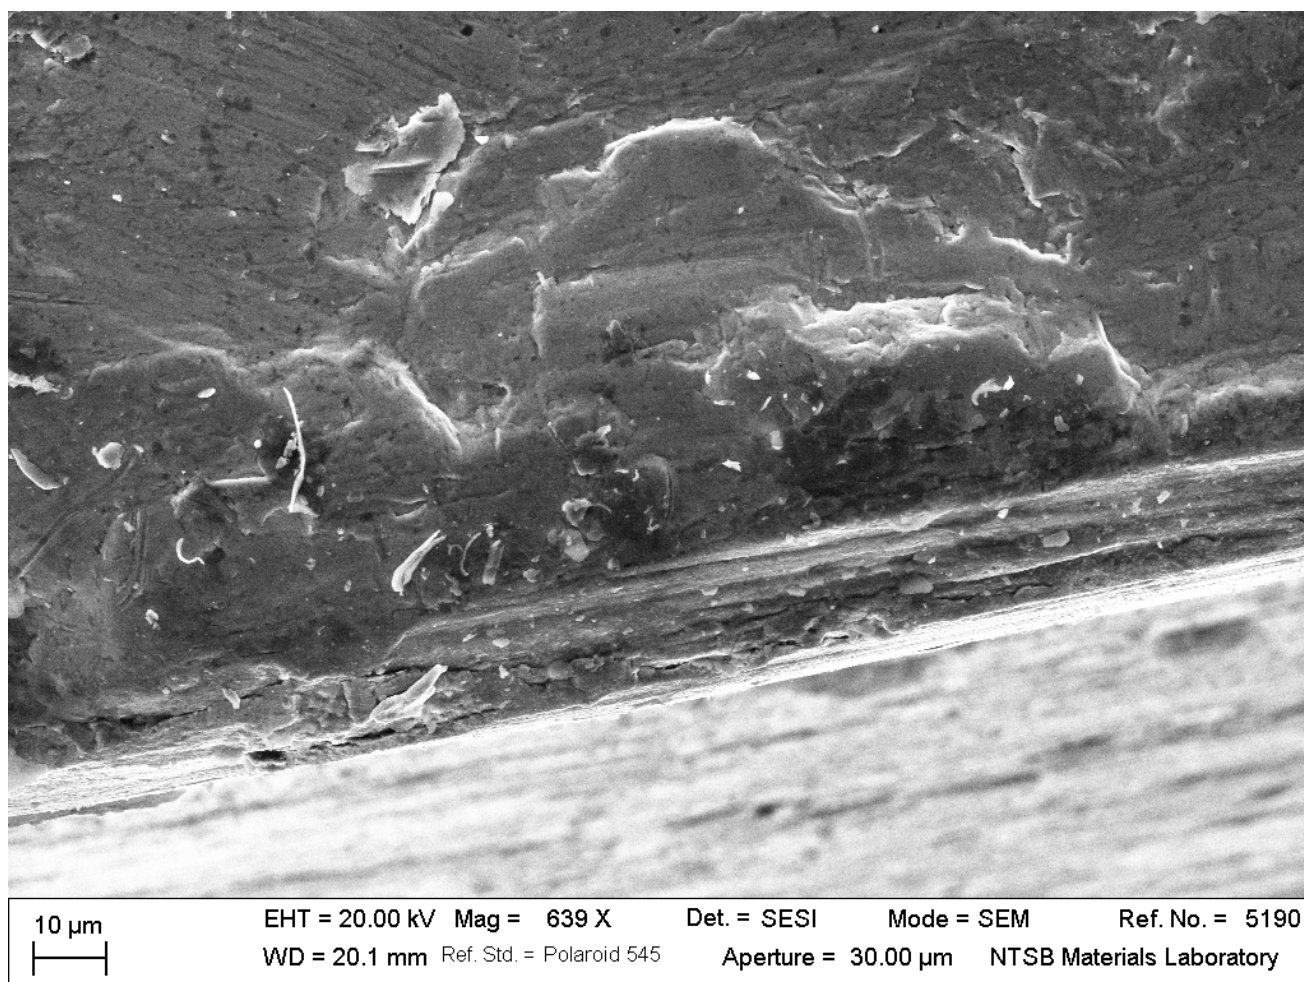
The crack initiation sites of the fatigue crack were examined, such as the one shown in Figure 14. While many had been obliterated by post-fracture smearing, this initiation site was undamaged, located between two ratchet marks with the edge intact. As shown in the figure, there were no indications of material defects, such as inclusions, corrosion pits, or voids. There were some indications of streaks or microwear marks along the fracture surface edge. Some parallel microcracks were present in this initiation site.

Figure 14 – SE micrograph of one of the fatigue crack initiation sites.

Figure 15 – SE micrograph of a closer view of the initiation site in Figure 14.

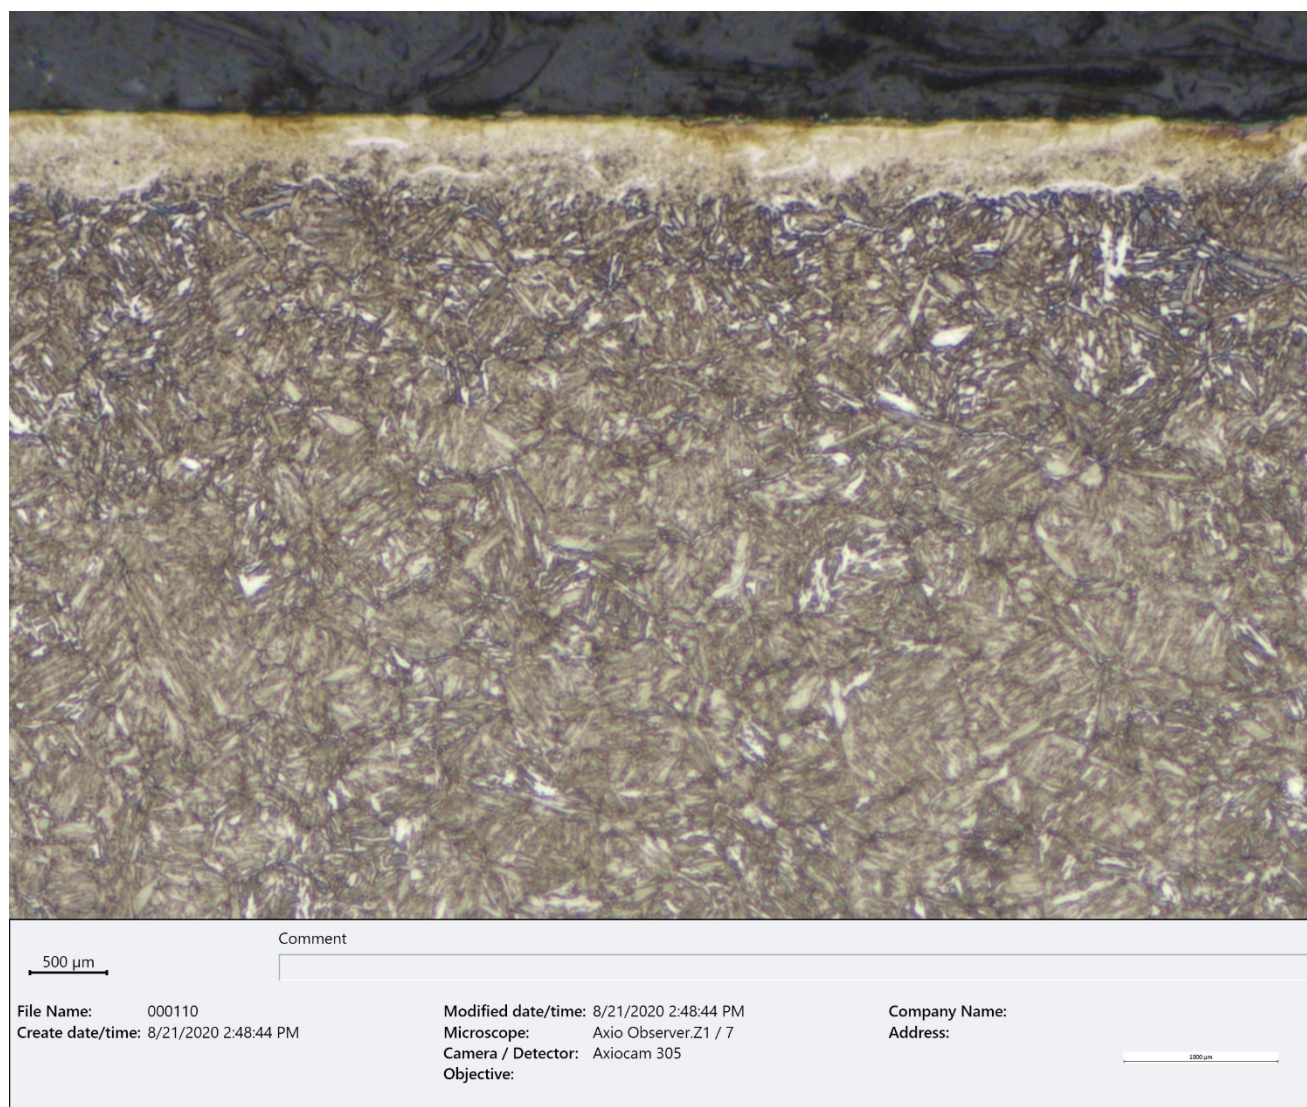
A portion of the web fracture surface was cross sectioned, mounted, polished, and etched with 2% Nital to examine the microstructure. Figure 16 shows a typical cross section of the web (unfractured) surface. The interior microstructure exhibited a lath microstructure inside polygonal grains, consistent with a tempered martensite microstructure, typical of this alloy chemistry and hardness.

The surface shown in Figure 16 exhibited a thin white layer. This layer was inspected using EDS, and it contained an elevated amount of nitrogen. These features were consistent with a nitrided case hardening, as prescribed for this part. The cross

Figure 16 – Bright-field (BF) optical micrograph of the surface of a cross section through the web, showing a surface nitrided layer, and underlying tempered martensite microstructure (~200X, etched 2% Nital).

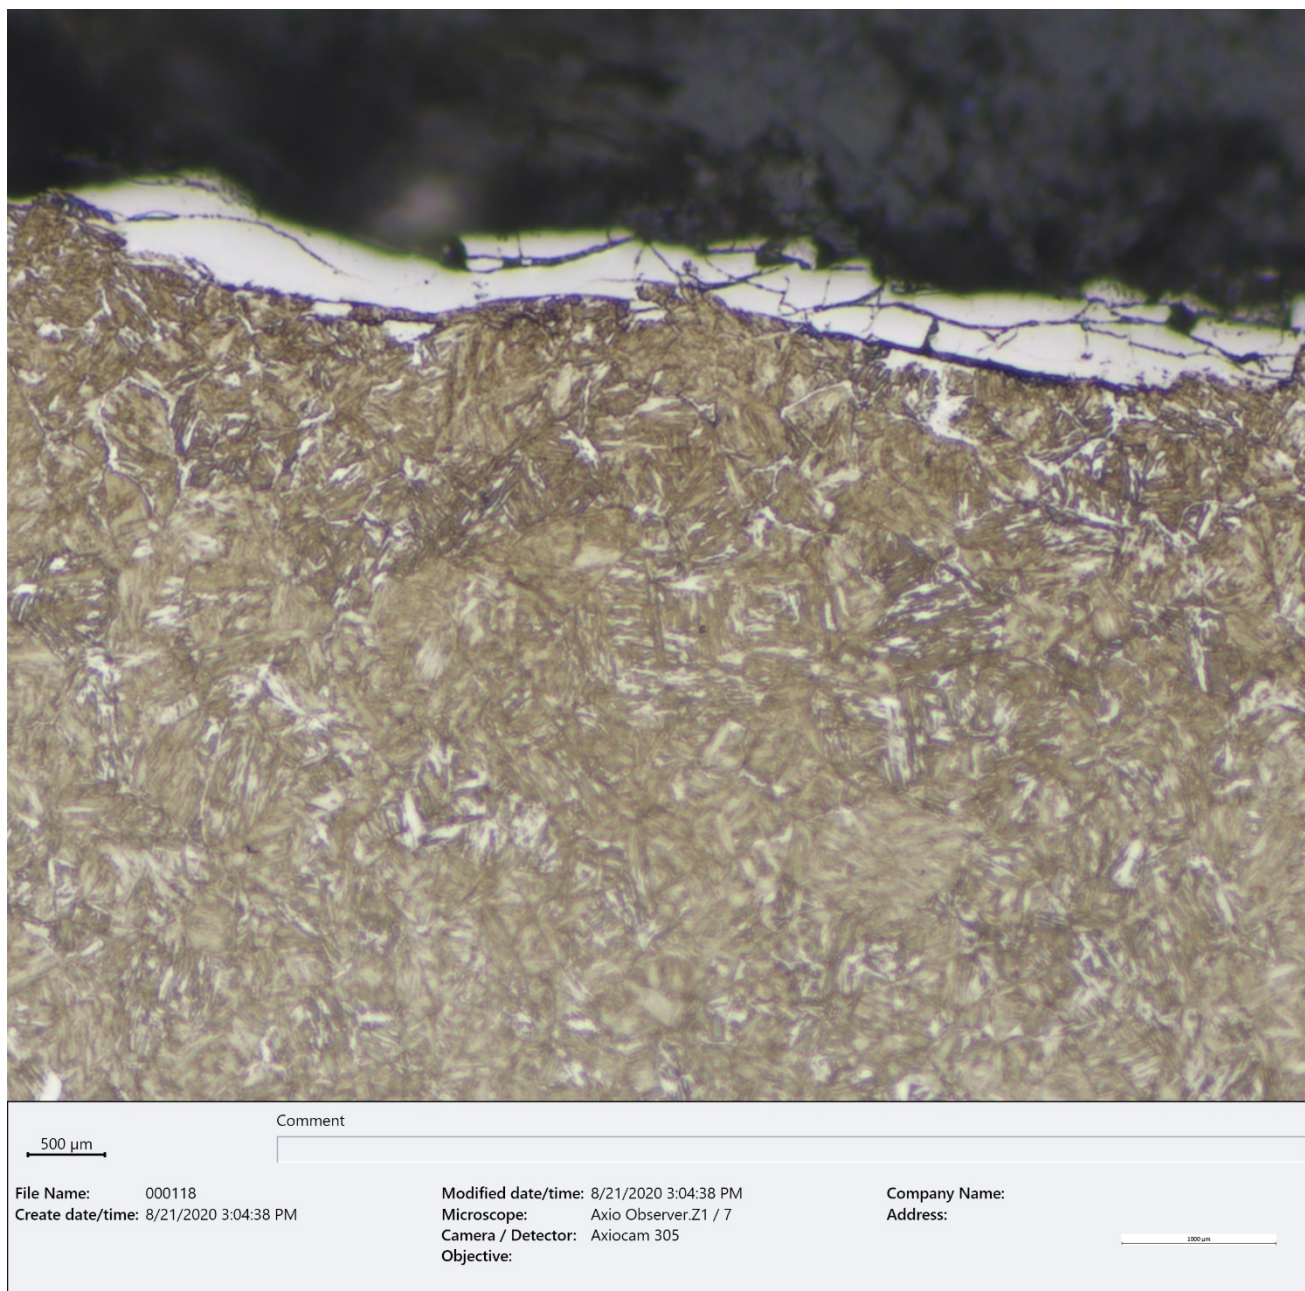
Figure 17 shows a cross section through the fracture surface. This exhibited a different type of white layer, exhibiting cracking perpendicular and parallel to the fracture surface. The area under this region also exhibited more light-colored phases than that further inward. This white layer was consistent with a region of untempered martensite. This phase can form when the region is heated above 727 °C and then rapidly cooled.

Figure 17 – Bright-field (BF) optical micrograph of the surface of a cross section through the web, showing an untempered martensite layer on the surface, consistent with exposure to locally elevated temperature (~500X, etched 2% Nital).
