# NATIONAL TRANSPORTATION SAFETY BOARD

## MATERIALS LABORATORY FACTUAL REPORT

Report No. 20-042

Place : Saginaw, Michigan  
Date : August 3, 2019  
Vehicle : Cessna A185E, N5806J  
NTSB No. : CEN19LA249  
Investigator : Craig Hatch, AS-CEN

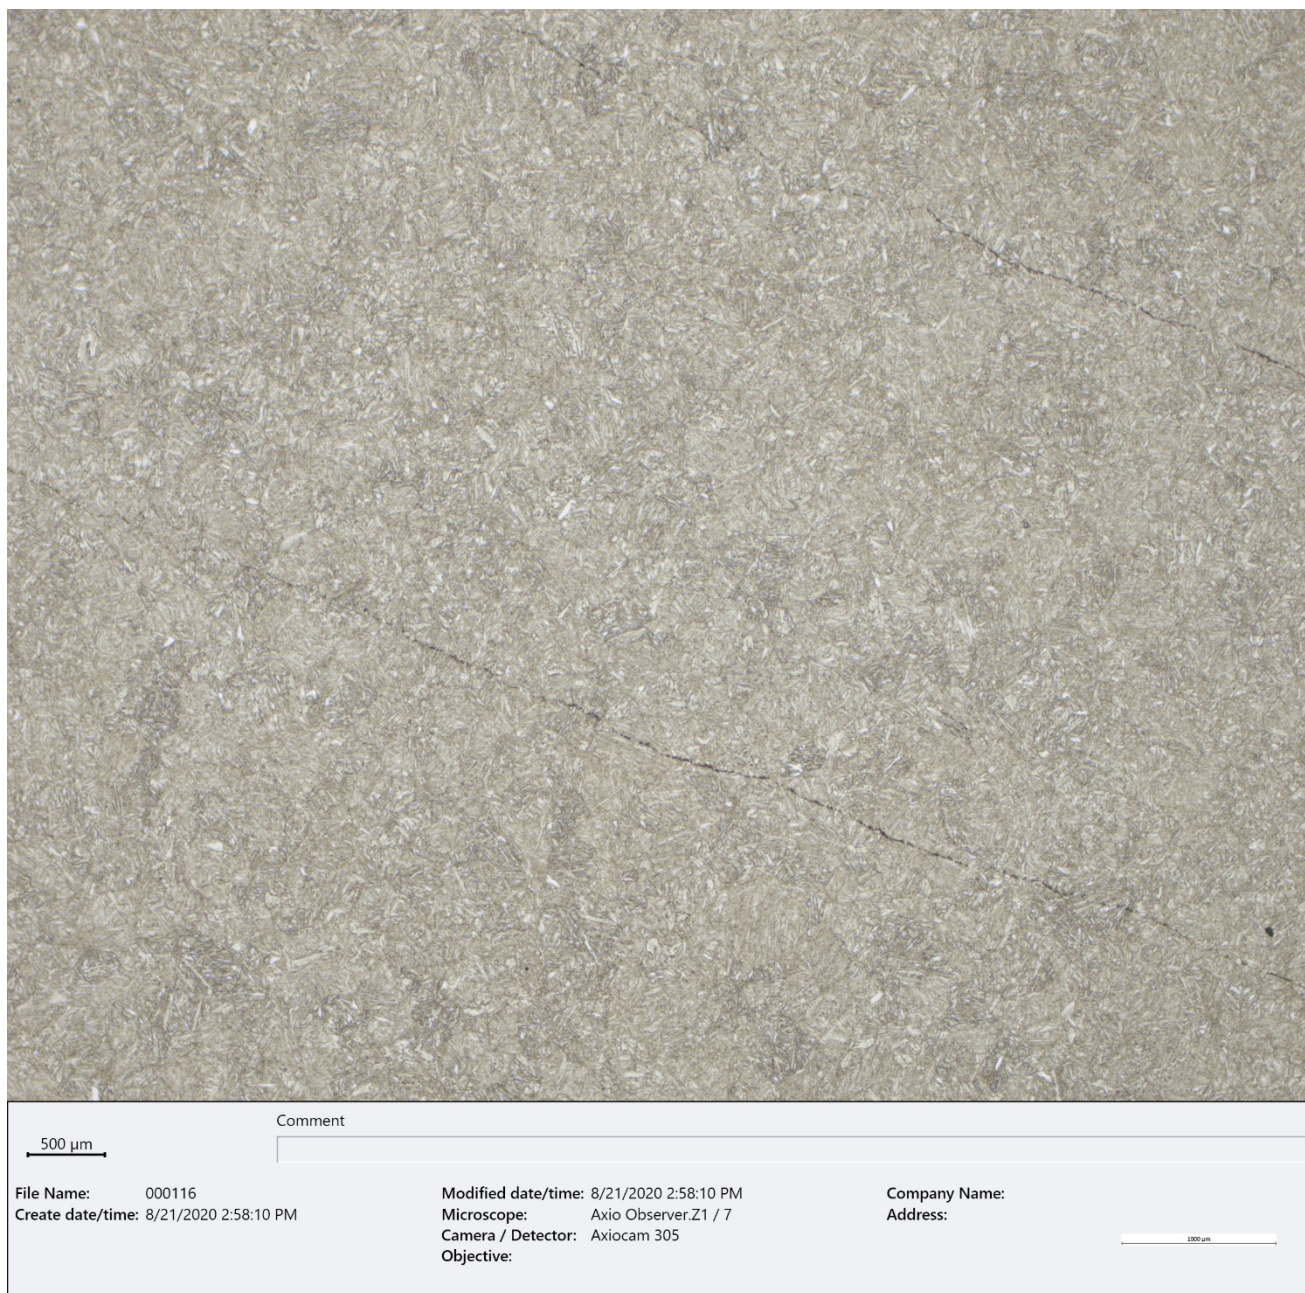
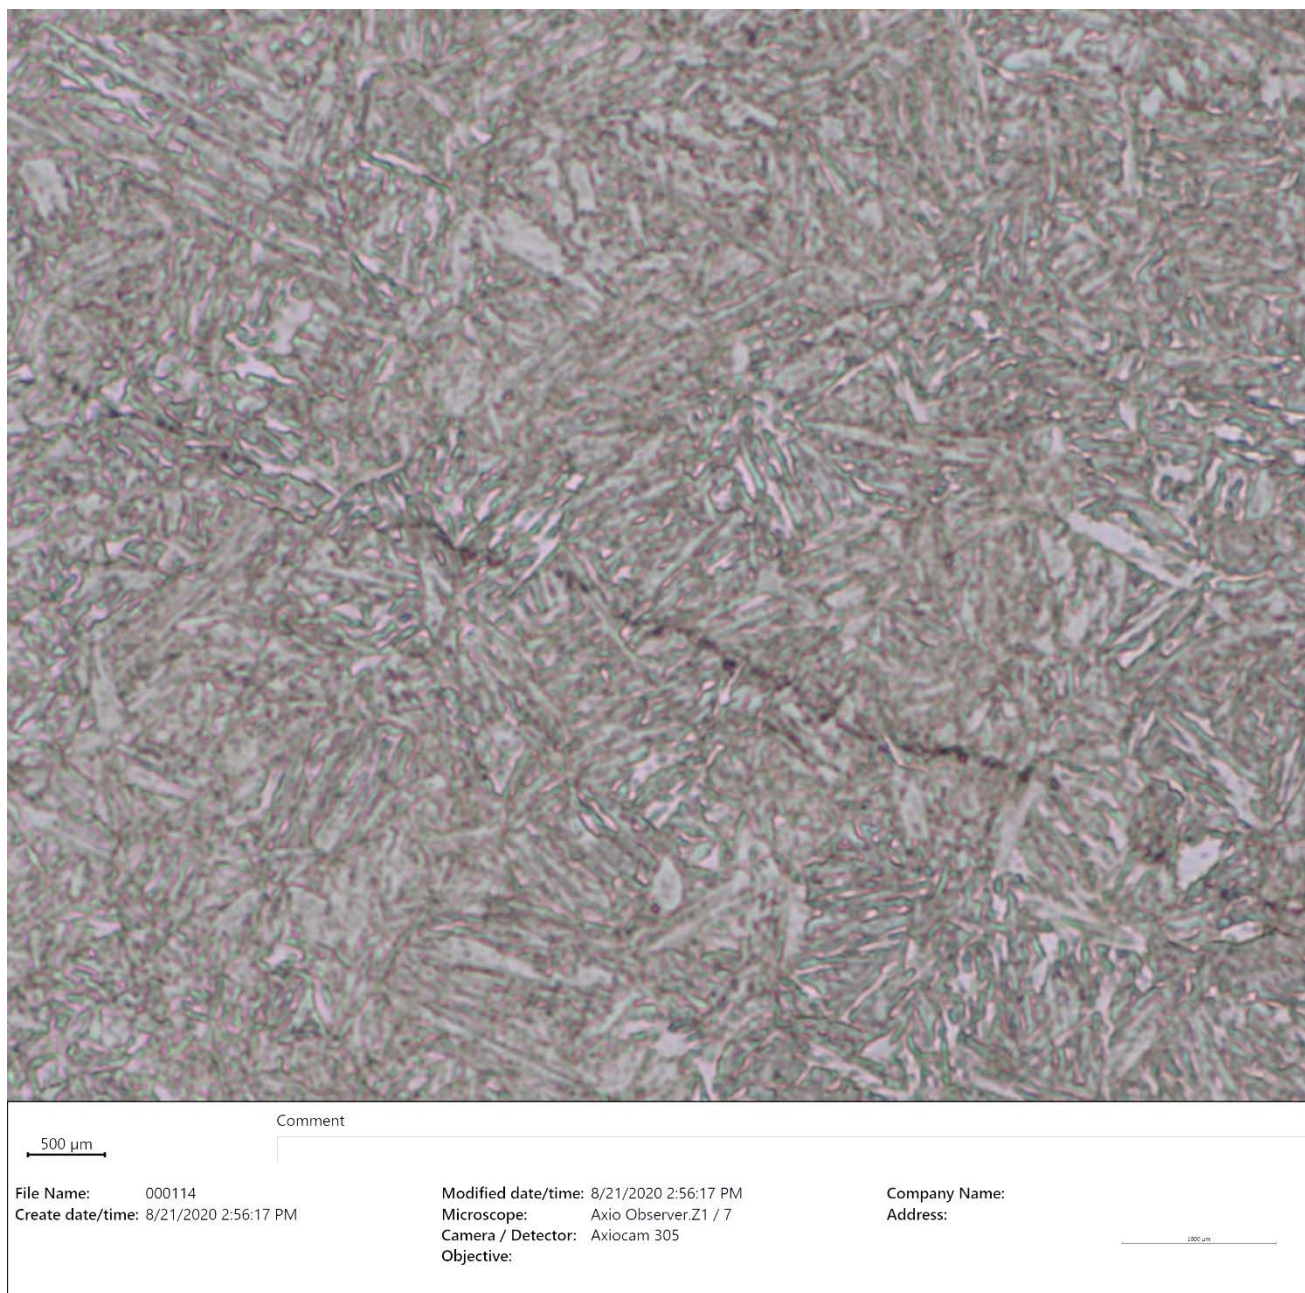
A closer look further into the core interior of the web segment microstructure revealed thin elongated microcracks, often oriented parallel to each other, as typified in Figure 18. A closer view of one of these cracks is shown in Figure 19. These cracks were oriented along the forging direction, typically running along the laths of the tempered martensite, rather than along the prior austenite grain boundaries.

Figure 18 – BF optical micrograph of a typical area of the crankshaft web microstructure, showing tempered martensite, and thin elongated cracks (~200X, etched 2% Nital).

Figure 19 – BF optical micrograph showing a closer view of one of the microcracks in Figure 18, (~1000X, etched 2% Nital).

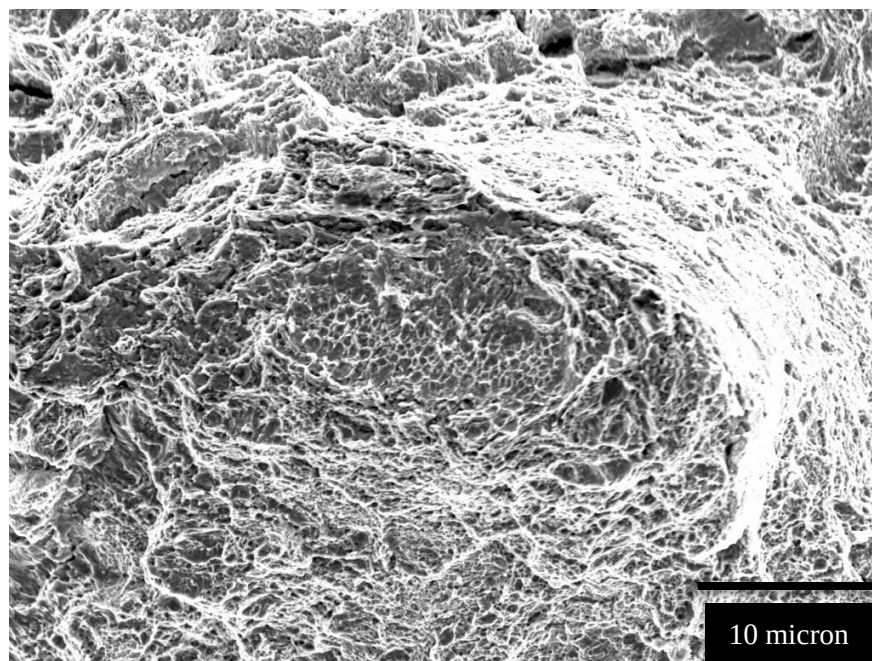
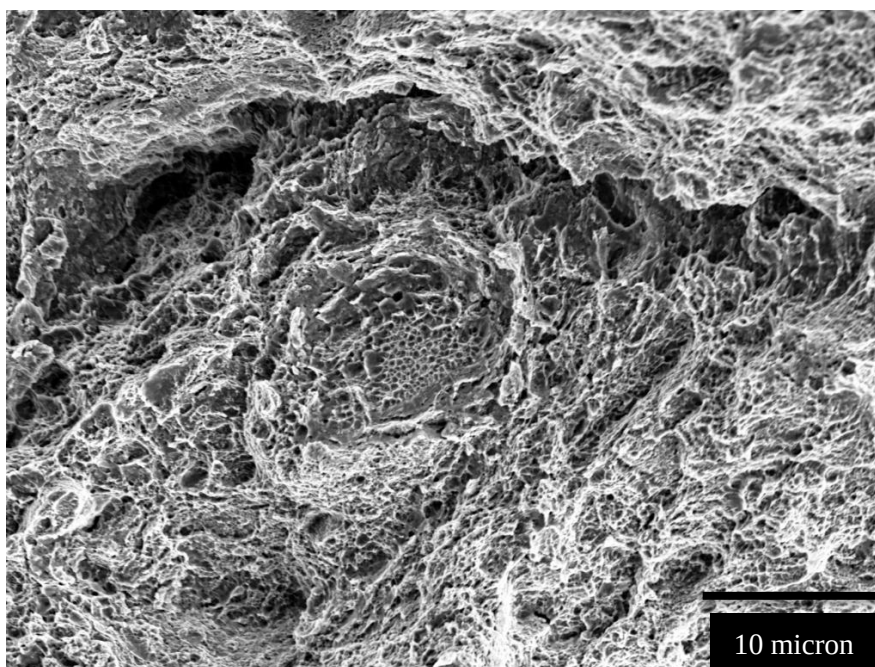
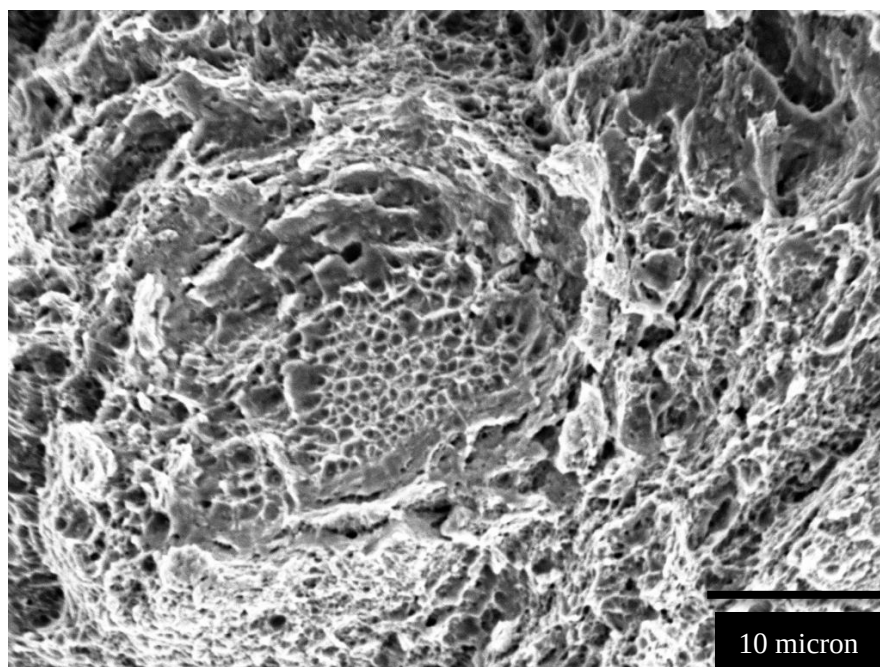
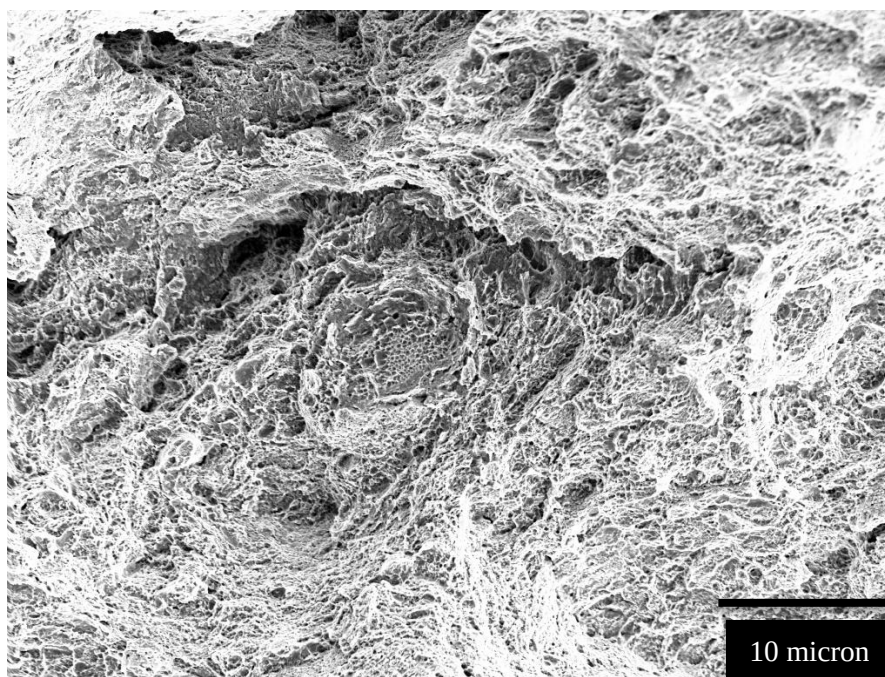
A scanning electron microscope was used to examine the fracture surface from 300X to 3000X per MSB00-5D. Regions containing the shallow planar dimple features were identified, indicating thermal damage of the microstructure. Figures 4-7 show these areas that were identified.

- 1] Fracture shows several shallow planar dimple areas per MSB00-5D.
- 2] Surface and core hardness met requirements.

*Figure 4 Shallow planar dimple feature*
