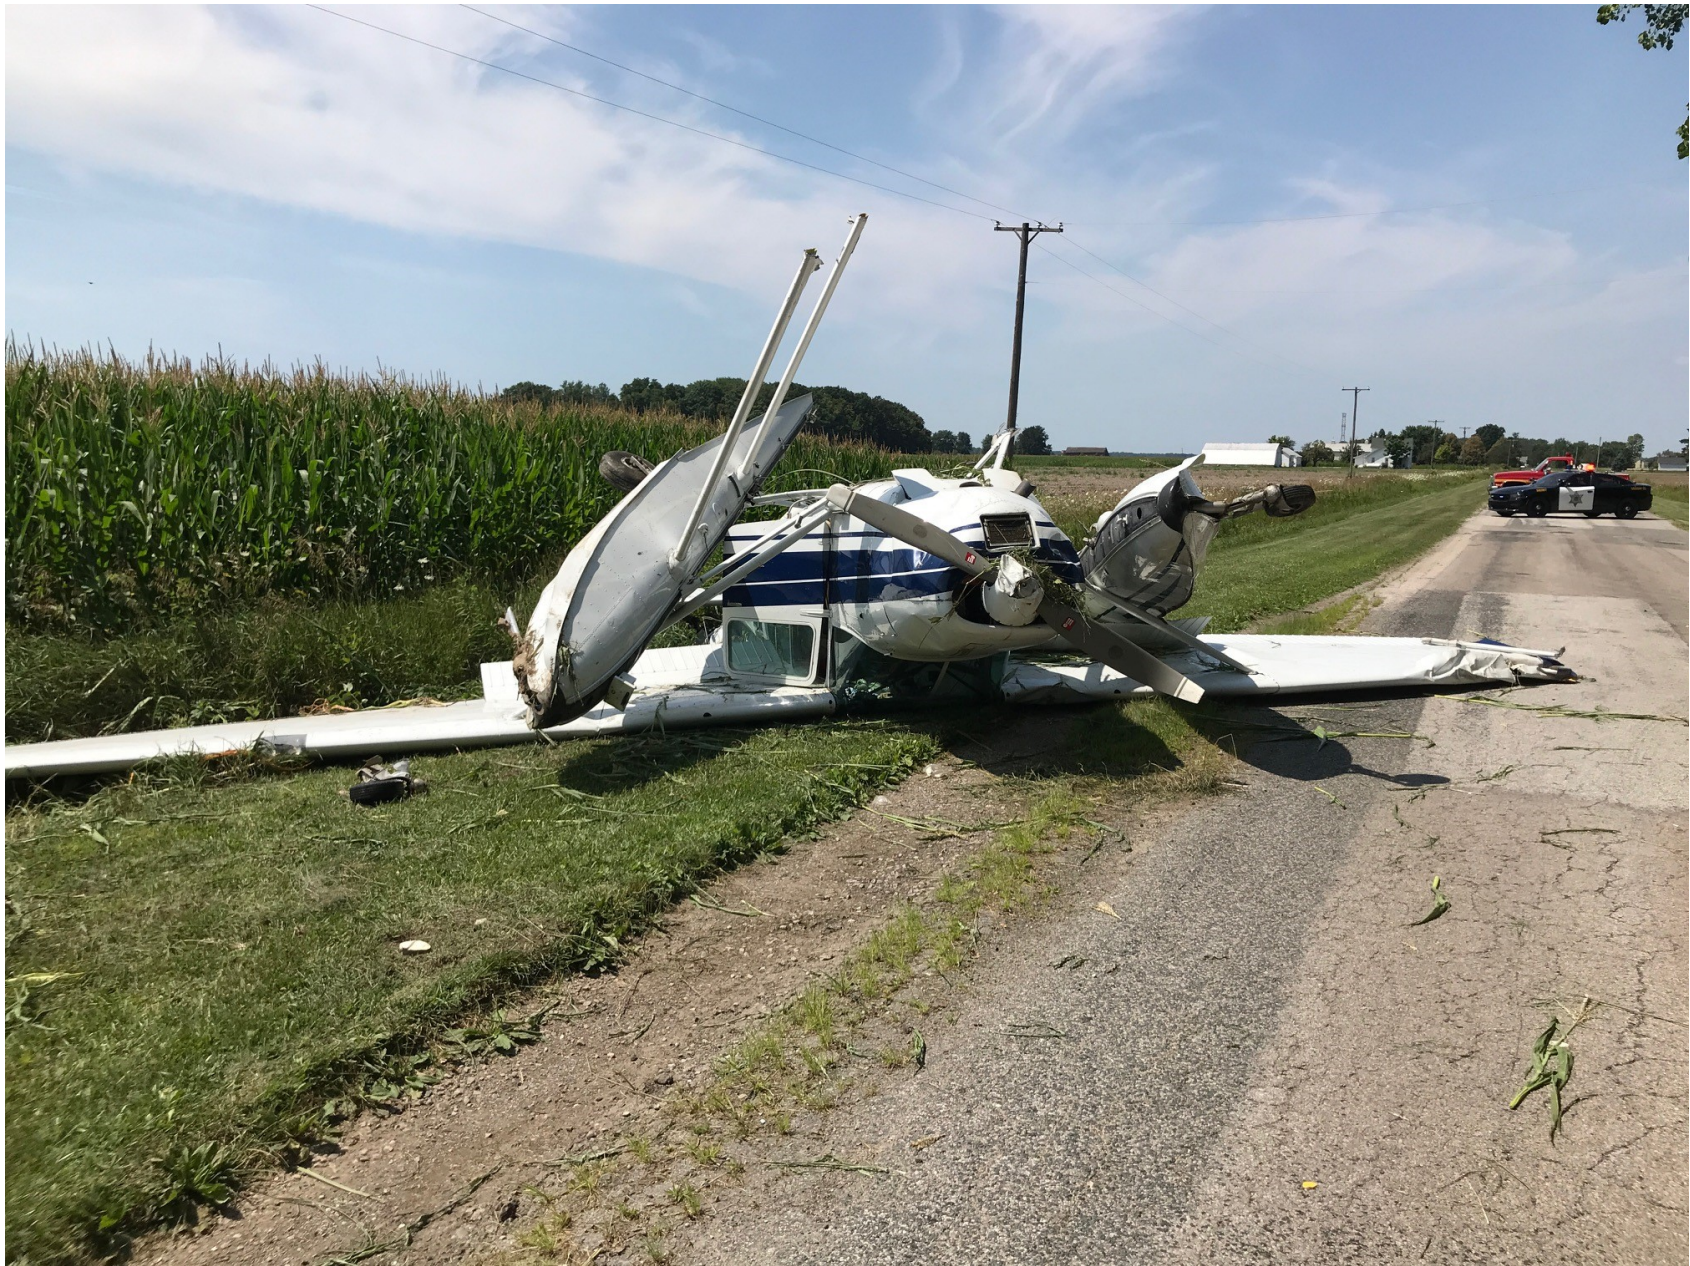
**Photo 1 – Accident Airplane**

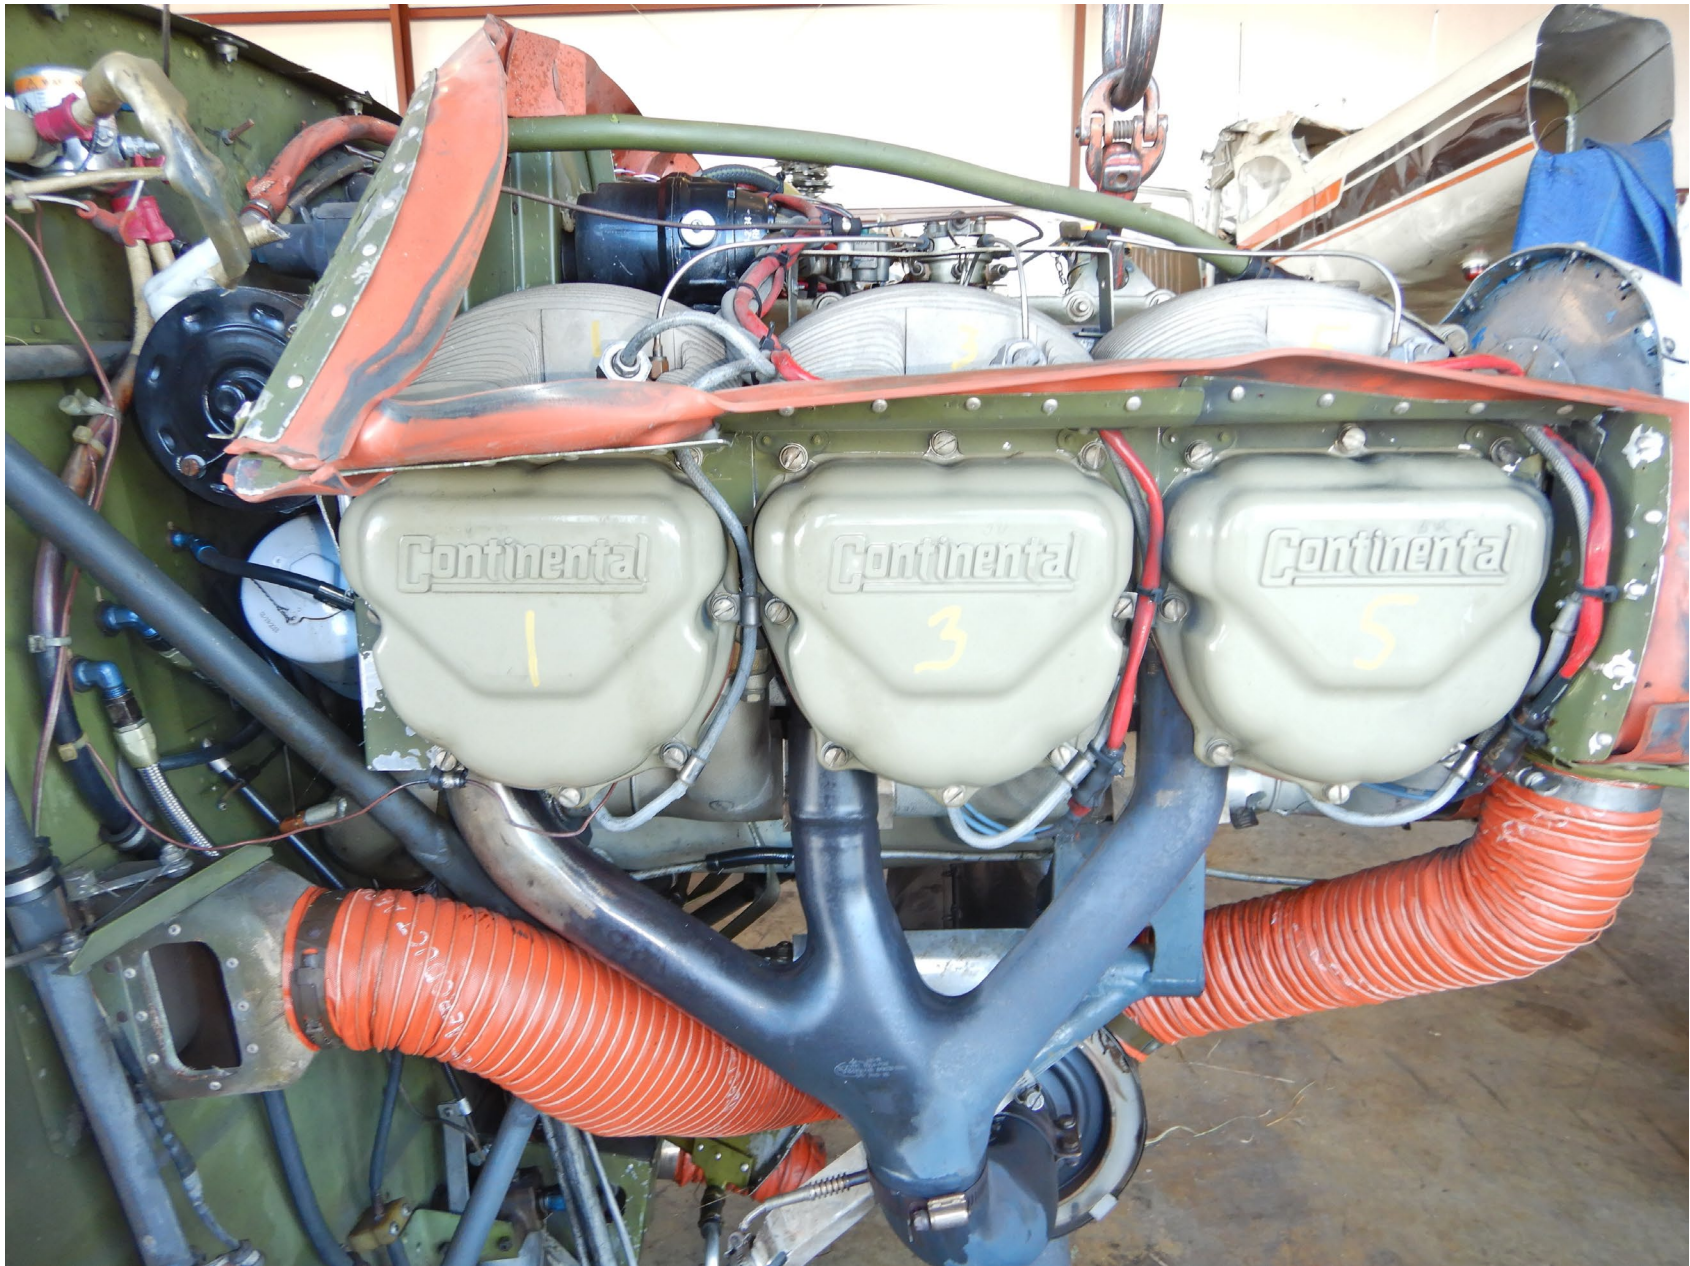
**Photo 2 – Engine Photo**

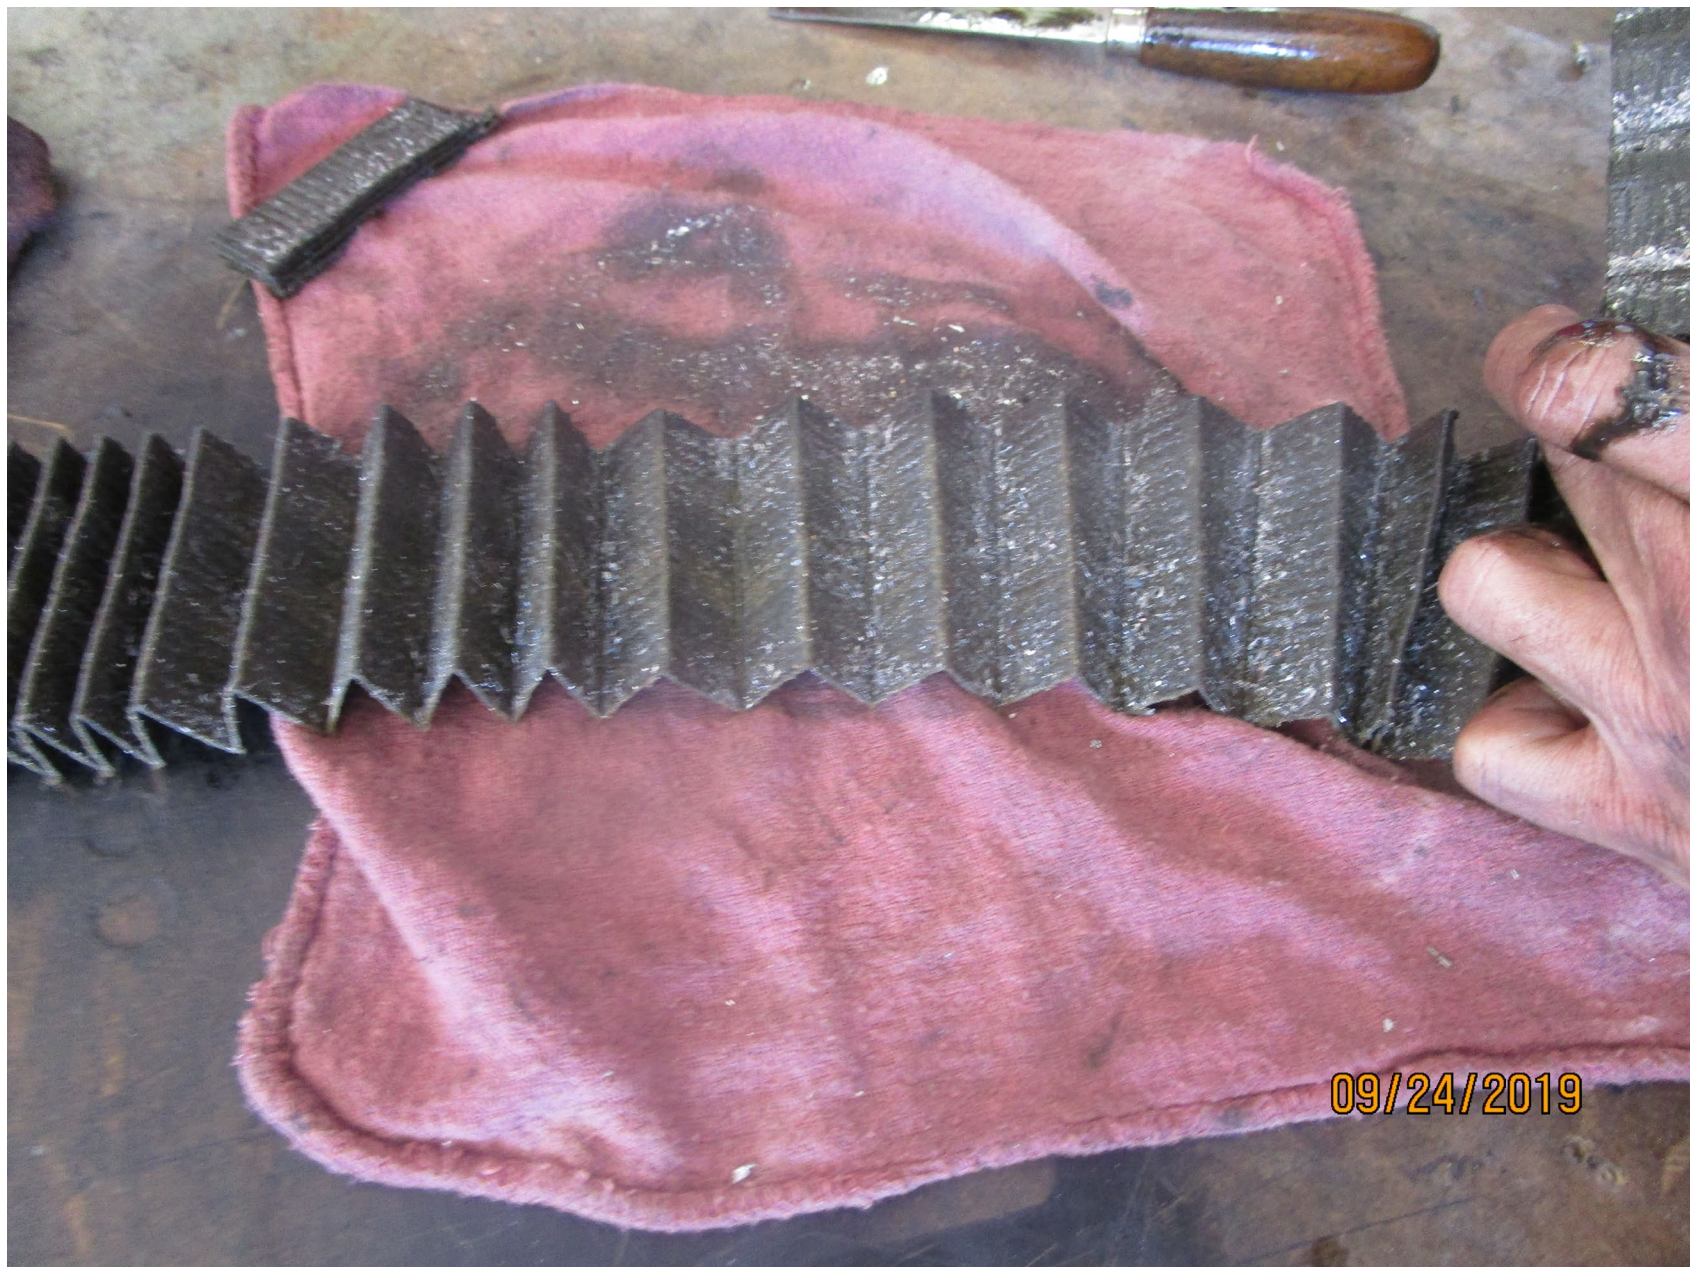
**Photo 3 - Oil Filter element**

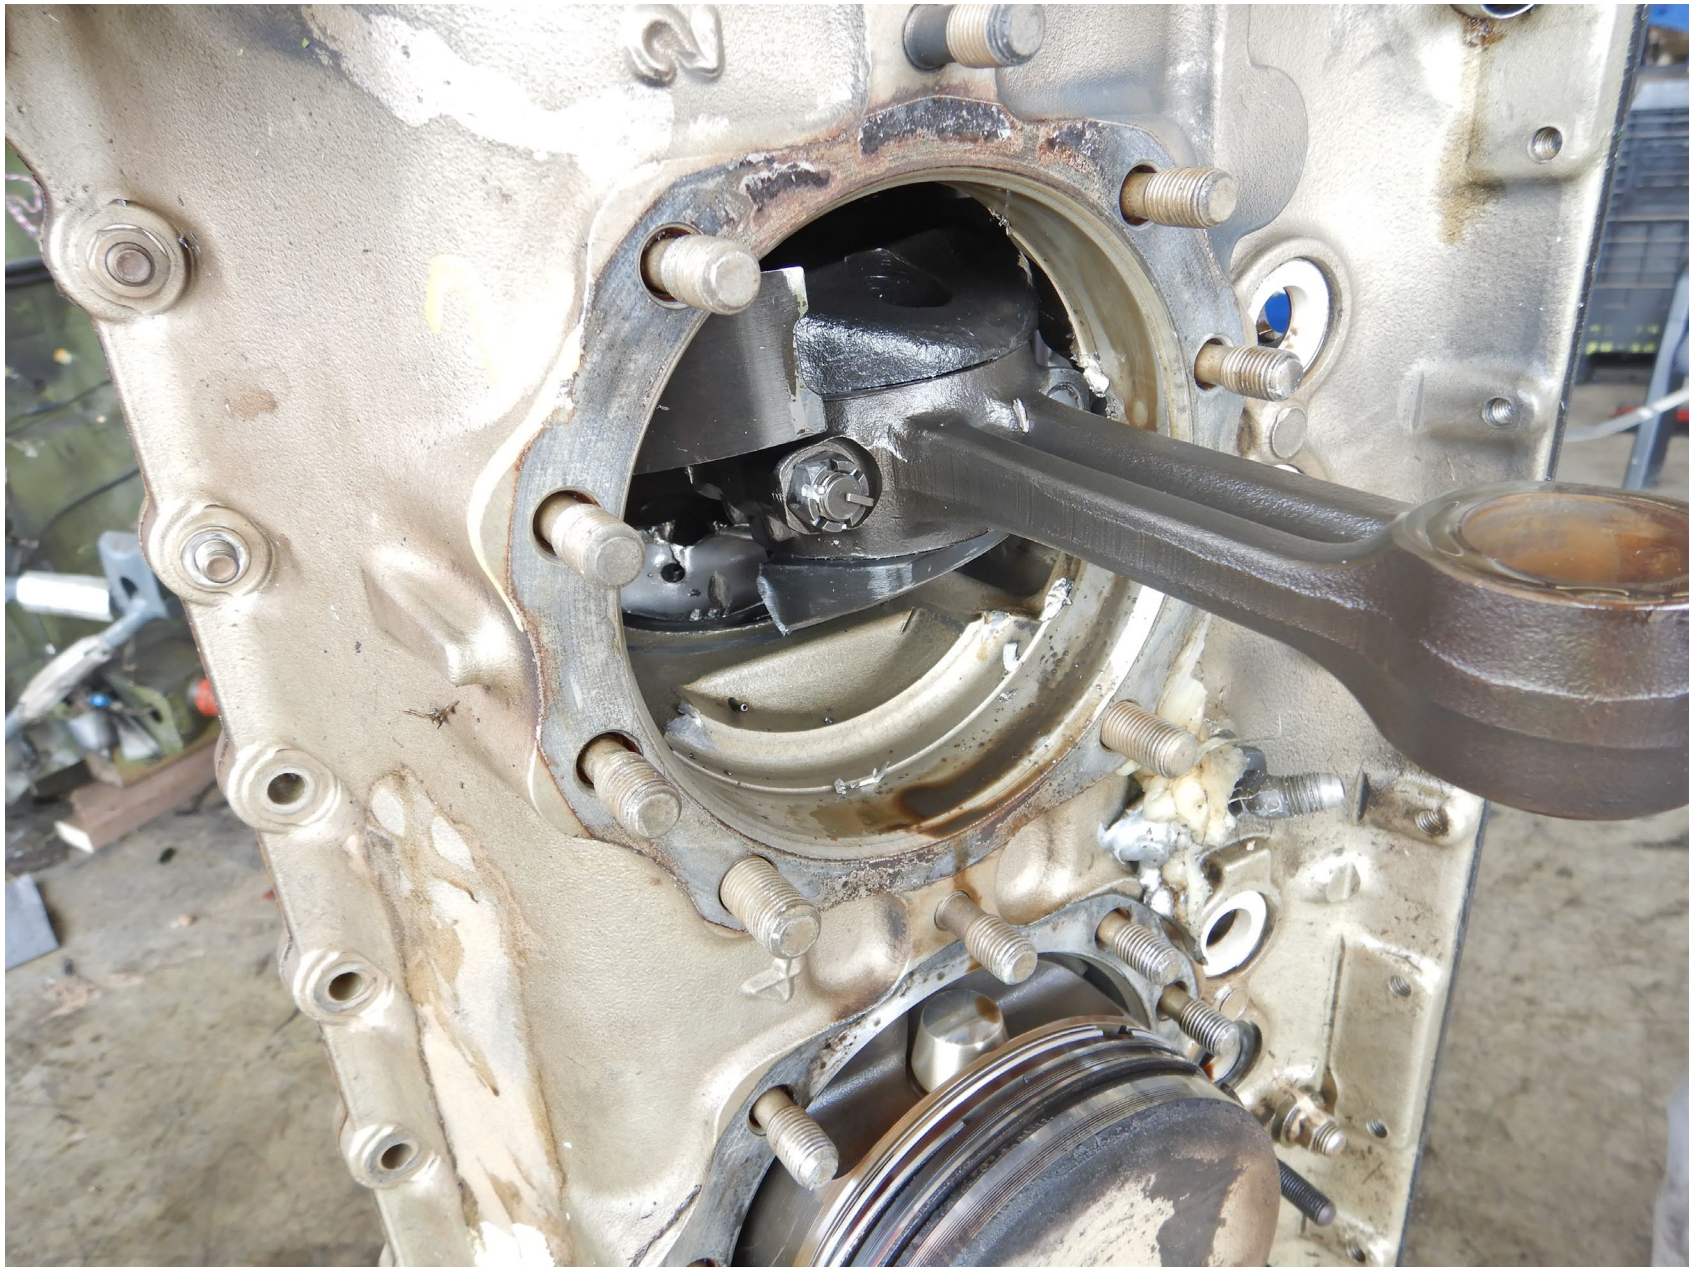
**Photo 4 – Broken crankshaft is seen, behind connecting rod**

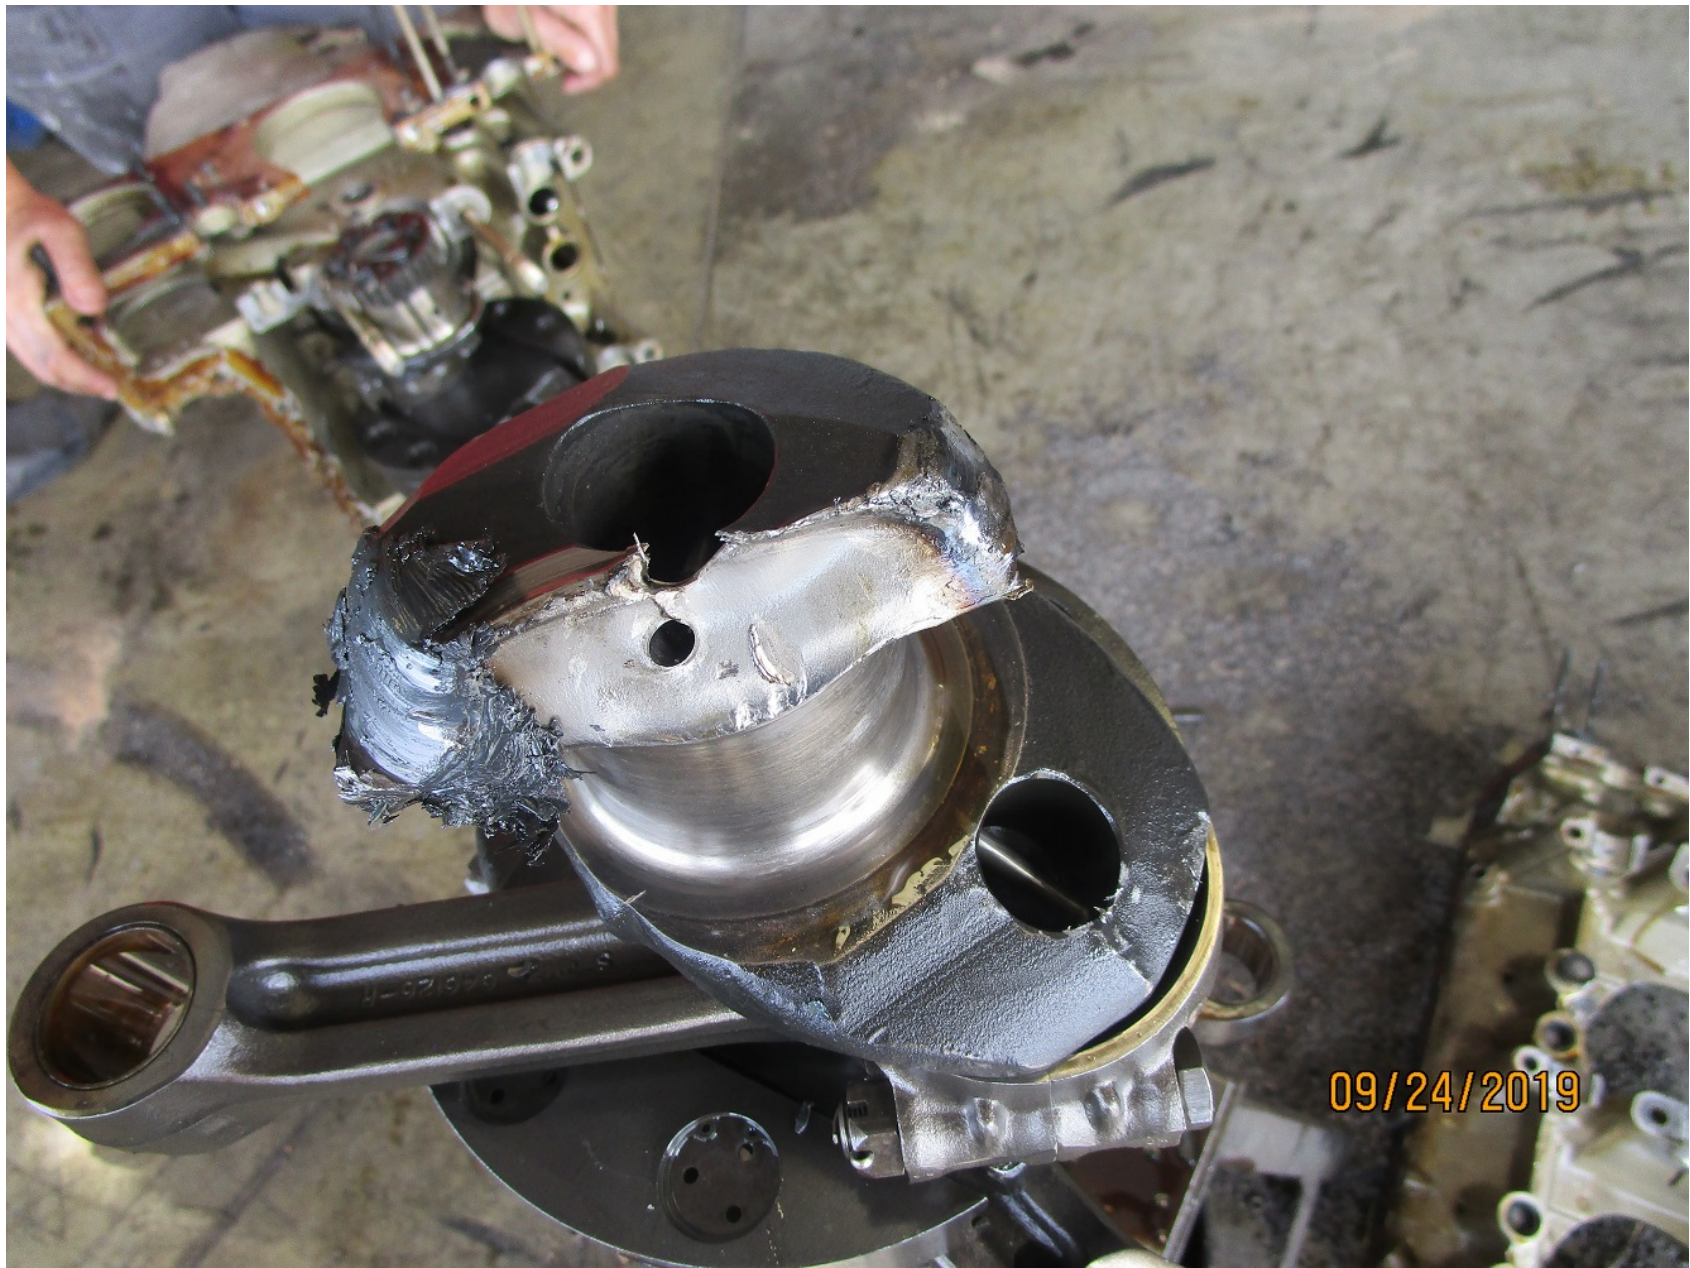
**Photo 5 – Broken Crankshaft**

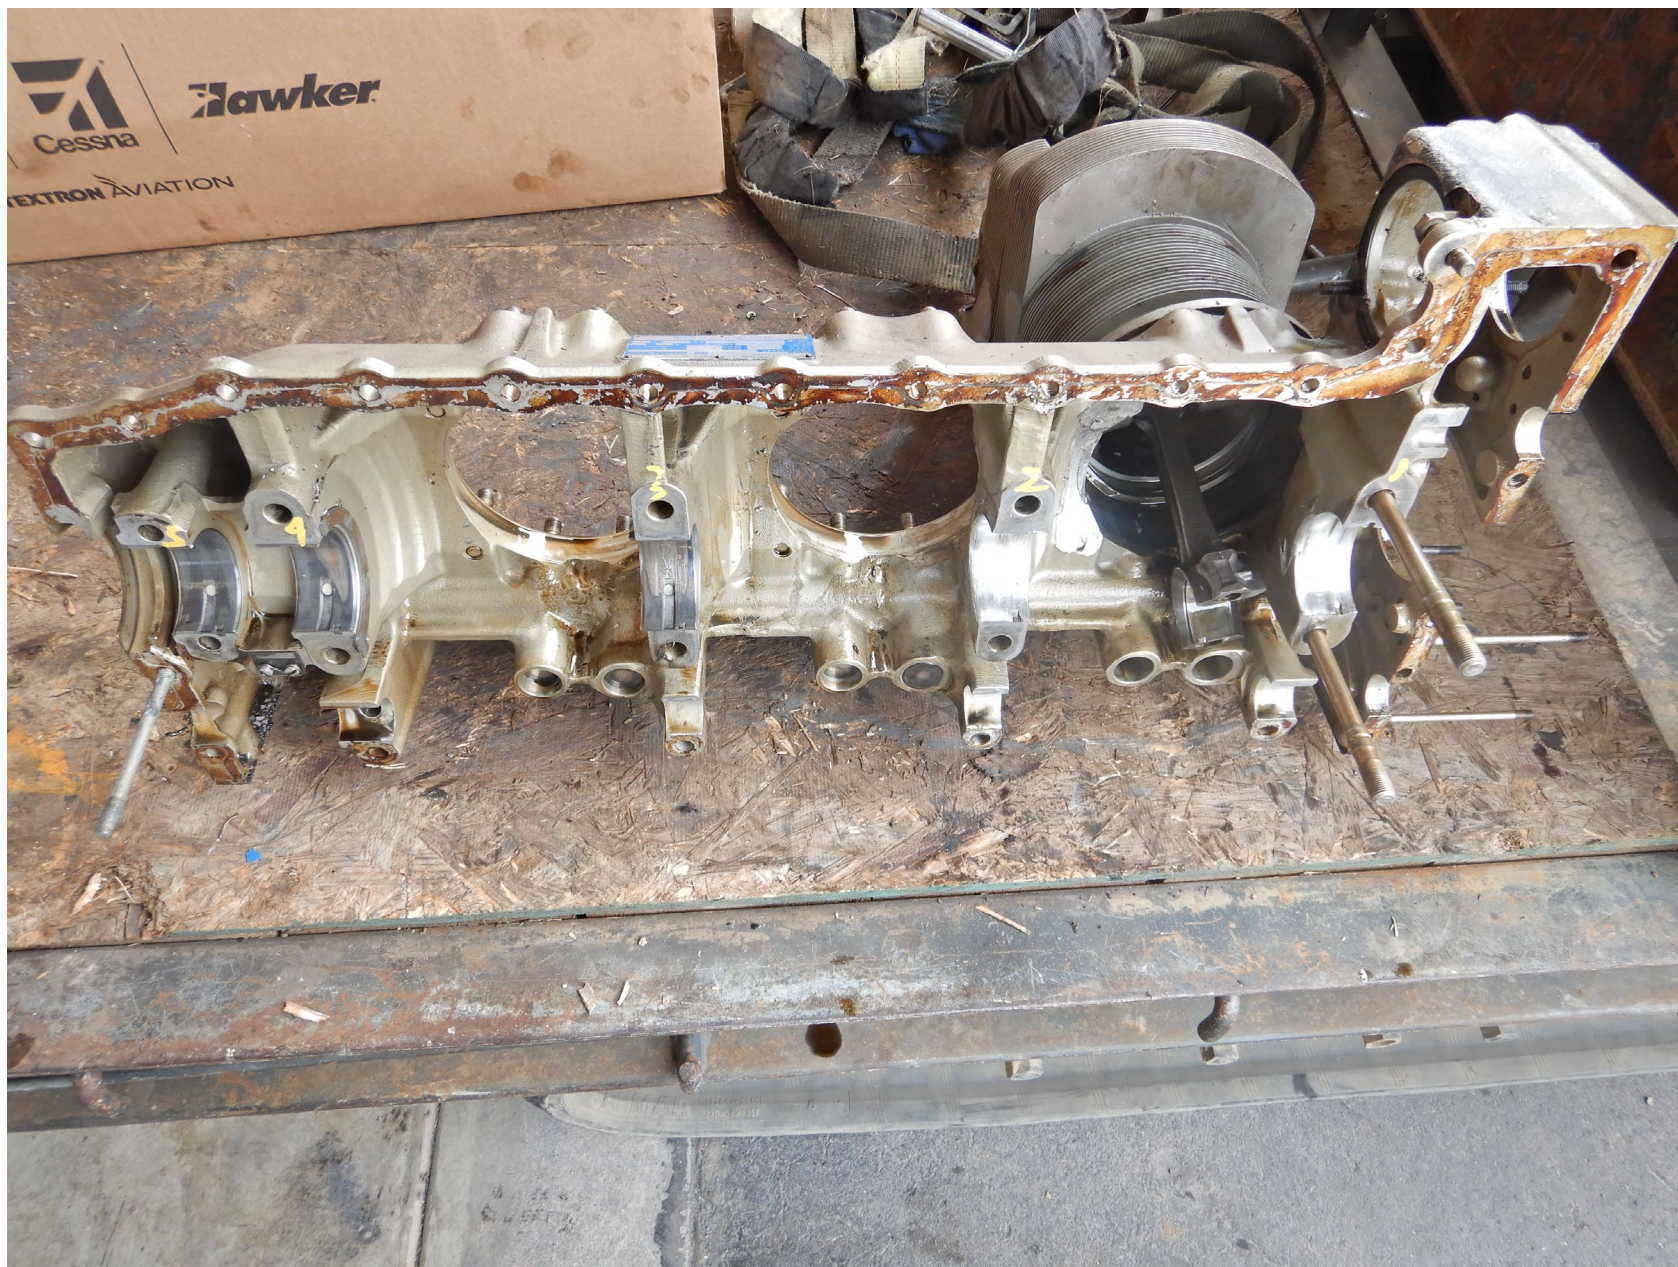
**Photo 6 – Engine case half**
